Year Two Monitoring Report

GROUNDHOG HOLLOW PROJECT

NCDMS Project #100049 (Contract #7417) | RFP 16-007277 (Issued 6/21/2017)

Alexander County, North Carolina
Catawba River Basin
HUC 03050101

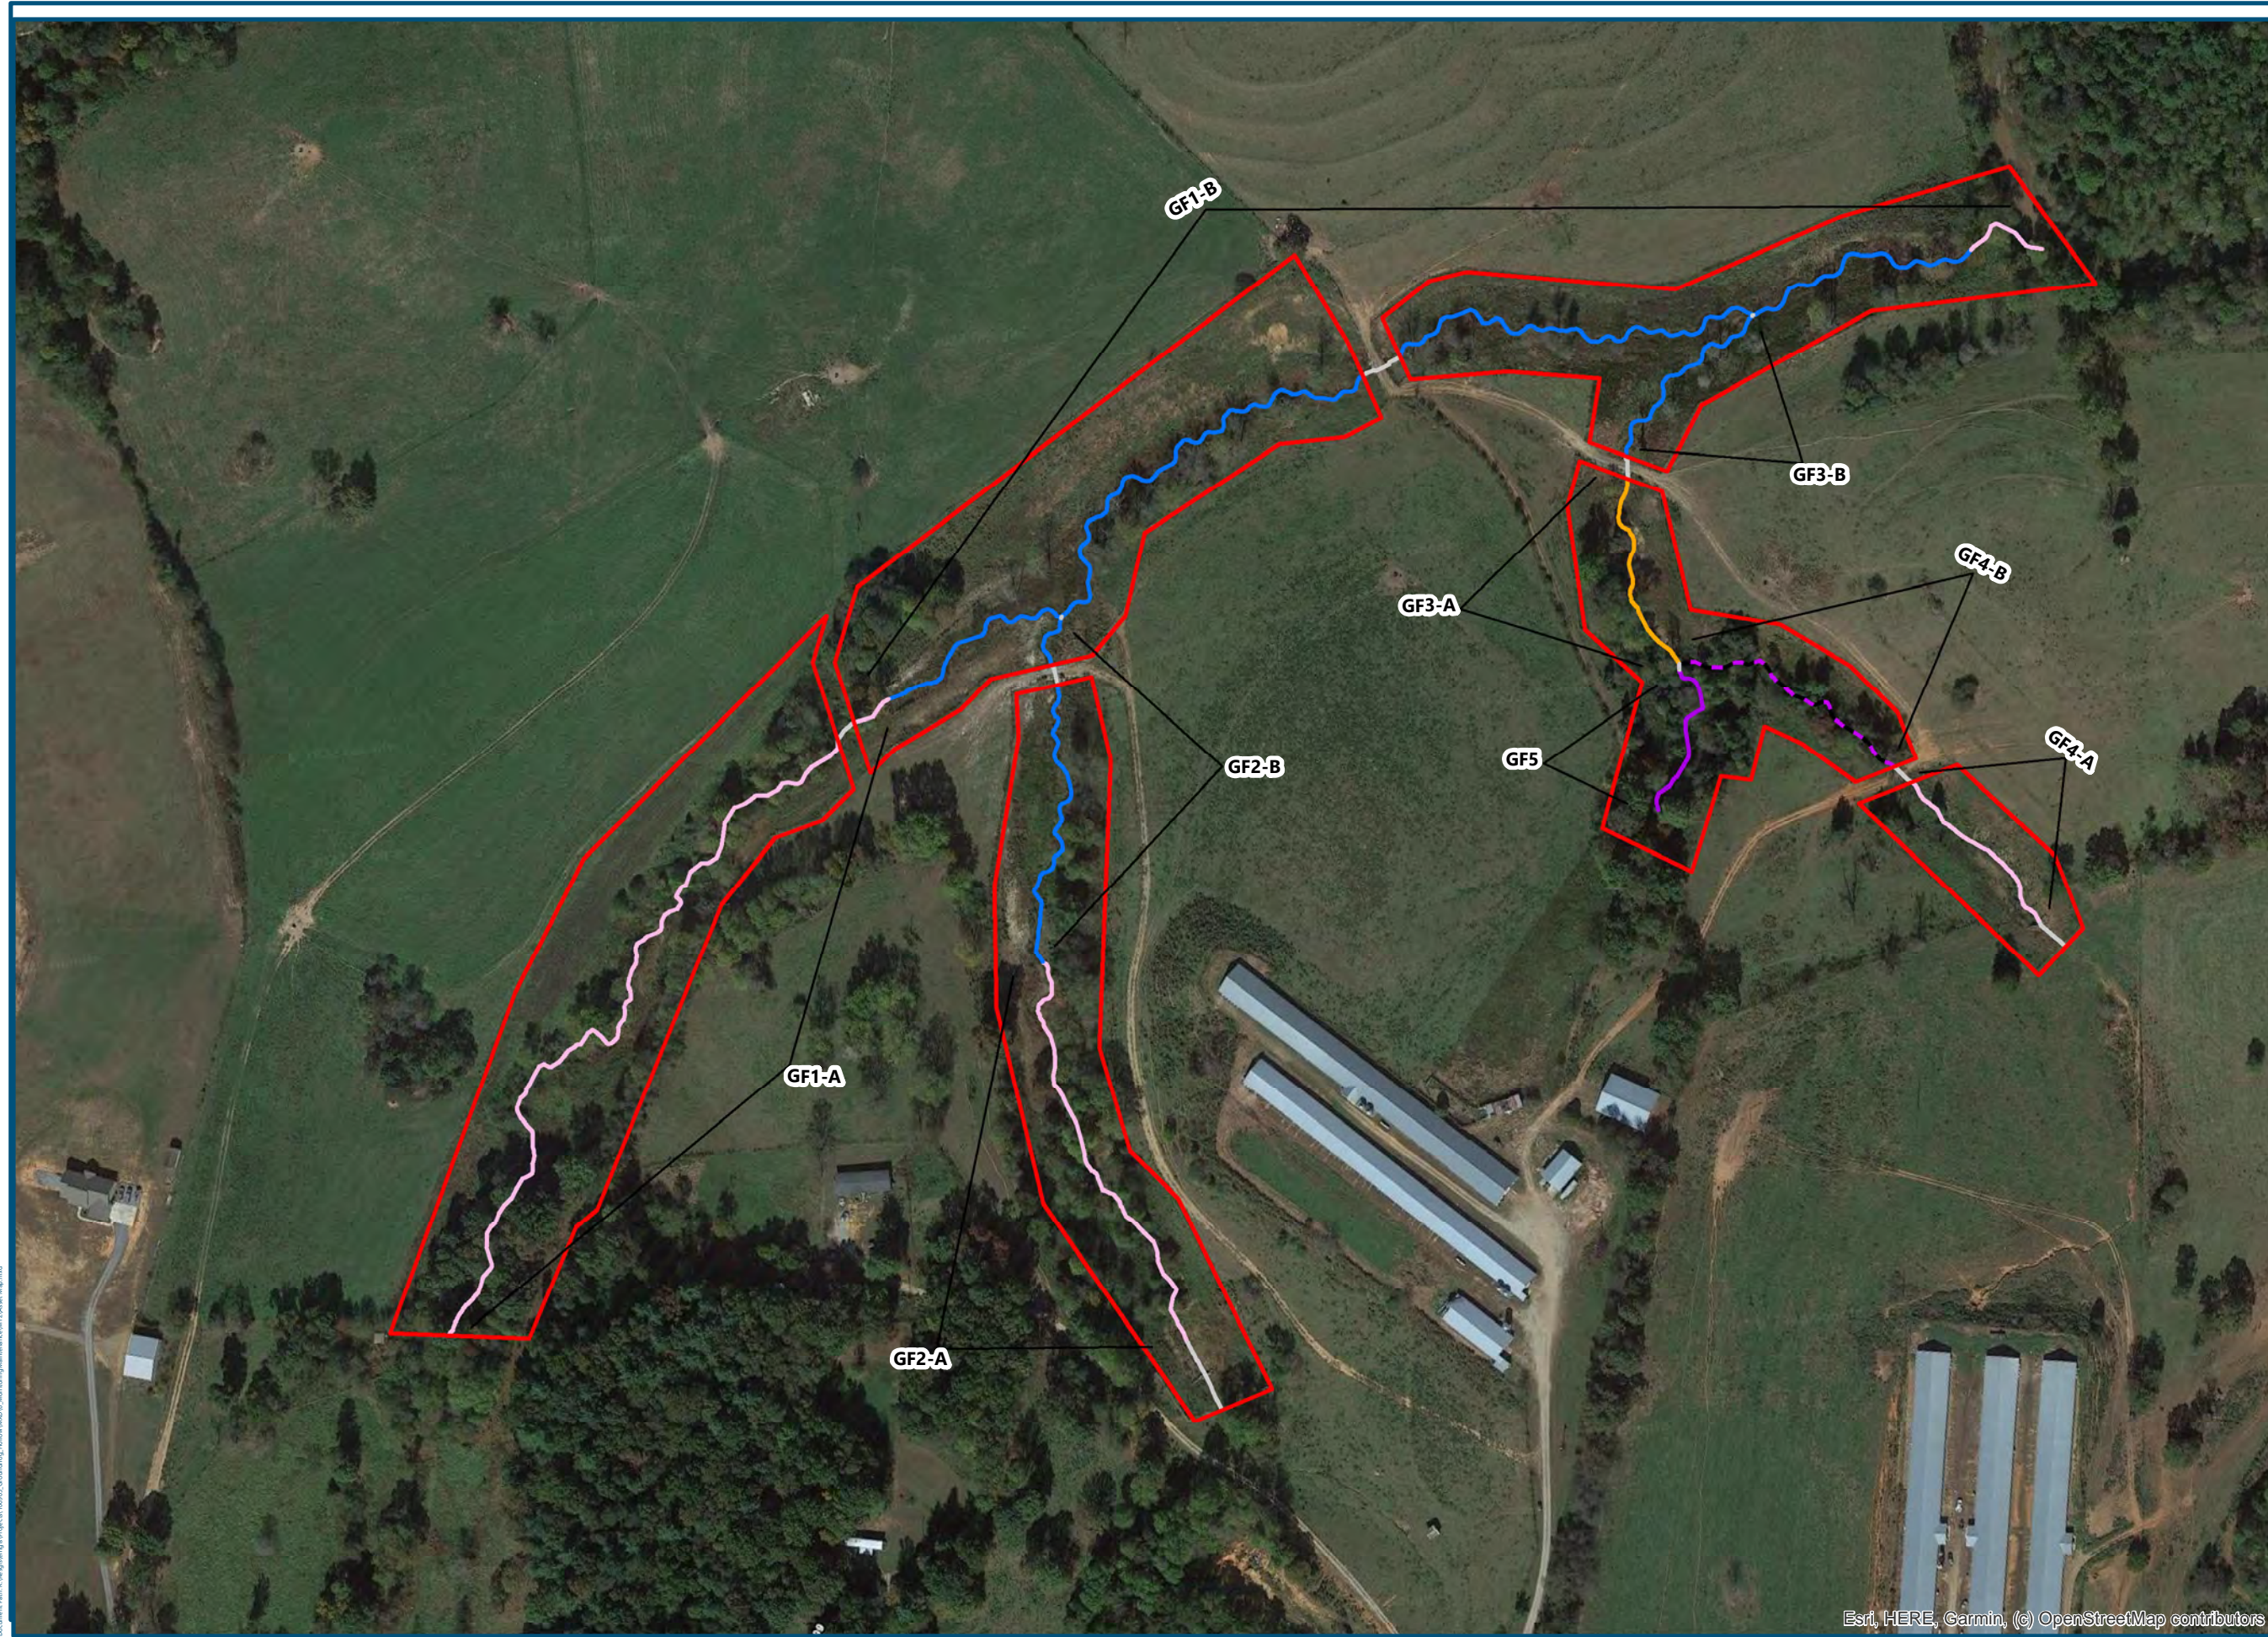
Figure 2 - CCPV MY2
Groundhog Hollow Mitigation Project
Alexander County, North Carolina

The stage recorder is present on the CCPV however is obscured by the XS 18 label and can be hard to see. The gage has been shifted slightly on the figure for clarification. The stream structure callout has been updated.

- Report Text/ Table 6/ CCPV Map: The report text indicates that approximately 0.21 acres of Chinese Privet was “flush cut” in MY1 and will require further invasive treatment in 2023. Chinese privet was also noted along GF1-A, GF1-B, GF2-B, and GF4-A during MY2 and is proposed for treated in 2023. Table 6 shows 0% invasive areas of concern and the CCPV maps provided in the draft report are not consistent with the report text in Section 1.7. Please review the report text, tables and CCPV Map and update them so the invasives reported on the project site are consistent through the final MY2 document. The report body and Table 6 has been updated with the correct acreage of Chinese privet of 0.26 acres not 0.21 acres as originally stated. The concentrations of Chinese privet have been noted on the CCPV, however there are scattered stems along GF1-A, GF1-B, GF2-B, and GF4-A.

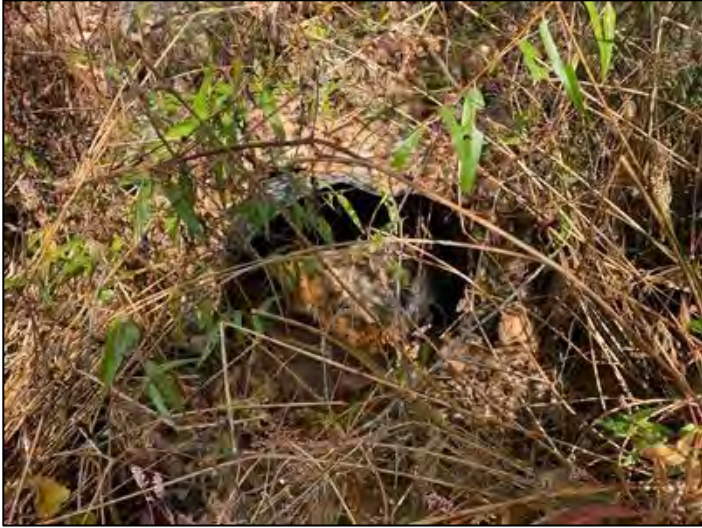
GF4A Crossing - Downstream

- Appendix B - Groundhog Hollow Crossing Photos: Please also include upstream and downstream photos of the crossing on GF4A/GF4B in the final MY2 report.
A downstream photo of the culvert crossing on GF4A/GF4B has bow been included in the report. A large hornets nest was located where the monitoring team would take an upstream photo, due to team mates allergies a photo was not taken. Photographs will be taken of the culvert crossing in MY3.

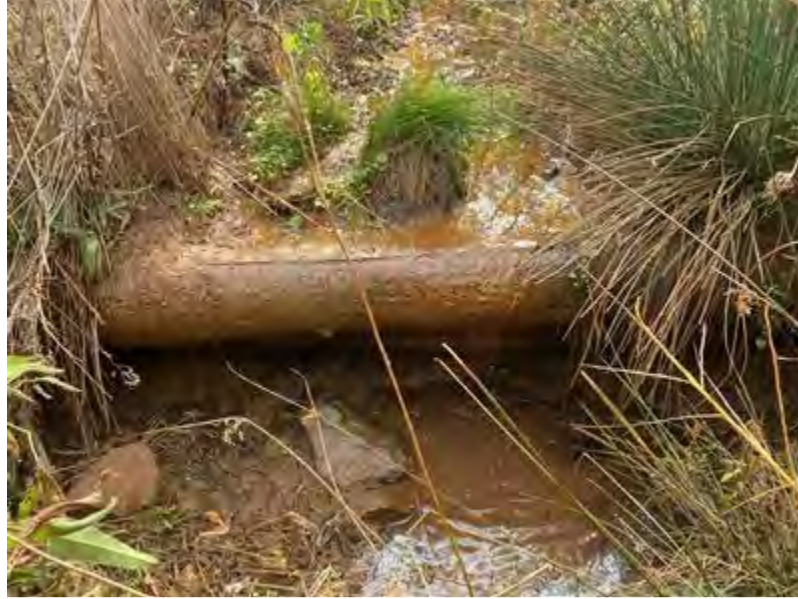
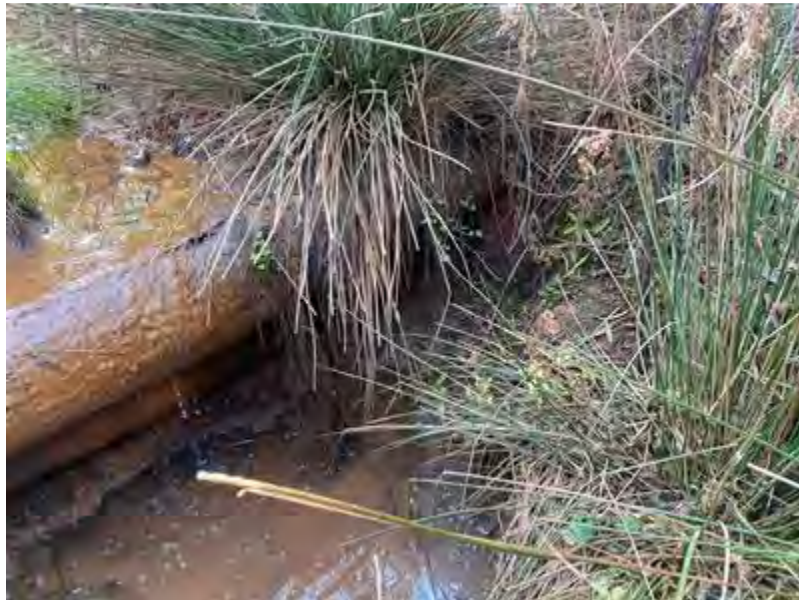
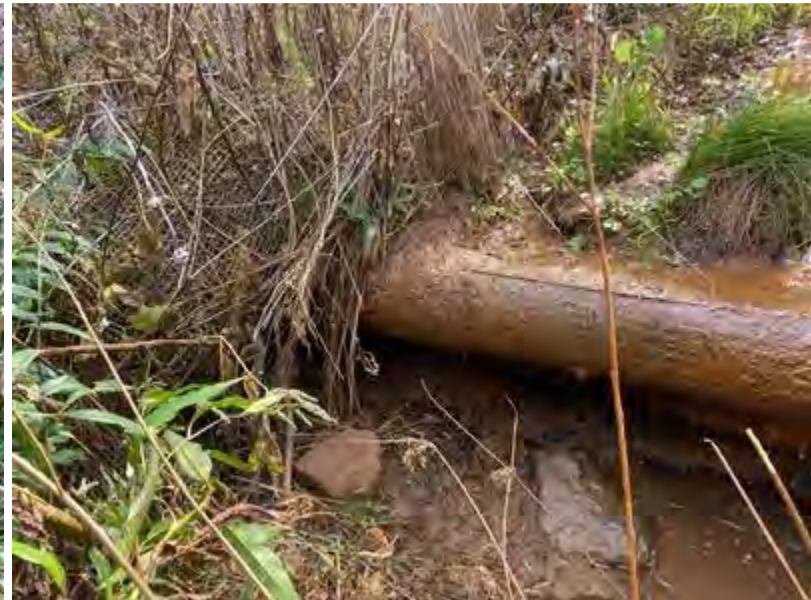
Visual assessment of the stream channel was performed to document signs of instability, such as eroding banks, structural instability, or excessive sedimentation. A structure on GF4-A is deteriorating where the stream is beginning to add stress to the banks around the log sills. This potential problem structure is still holding grade and shouldn't affect most aquatic passage due to its headwater proximity but will be monitored and addressed if it continues to worsen. Problem areas are cataloged in **Appendix B**. A structure on GF2-a noted in the MY1 monitoring report appears to have stabilized but will continue to be monitored. The channel over all is transporting sediment as designed and will continue to be monitored for aggradation and degradation.

Structure Decline GF4-A
