Year Three Monitoring Report

GROUNDHOG HOLLOW PROJECT

NCDMS Project #100049 (Contract #7417) | RFP 16-007277 (Issued 6/21/2017)

Alexander County, North Carolina
Catawba River Basin
HUC 03050101

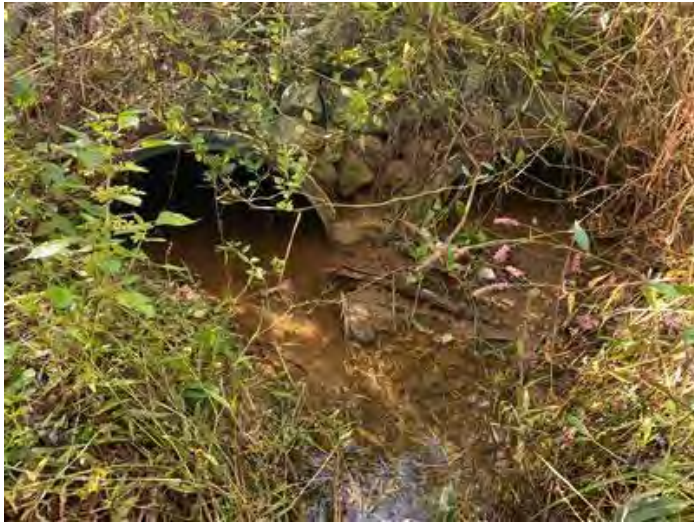
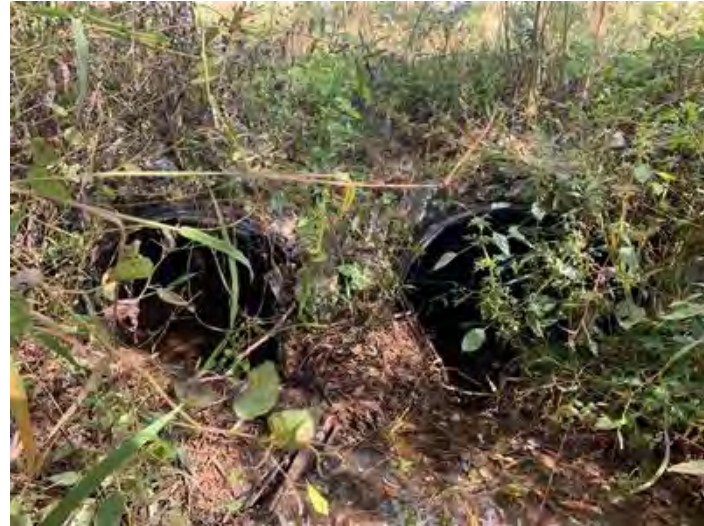
Crossing GF3 – Downstream)

Crossing GF3 – Upstream

- Crossing photo headers have been updated as well as maintenance photos. RES will investigate the GF3 culverts and determine the appropriate action to take once we determine the severity of sedimentation and potential causes.

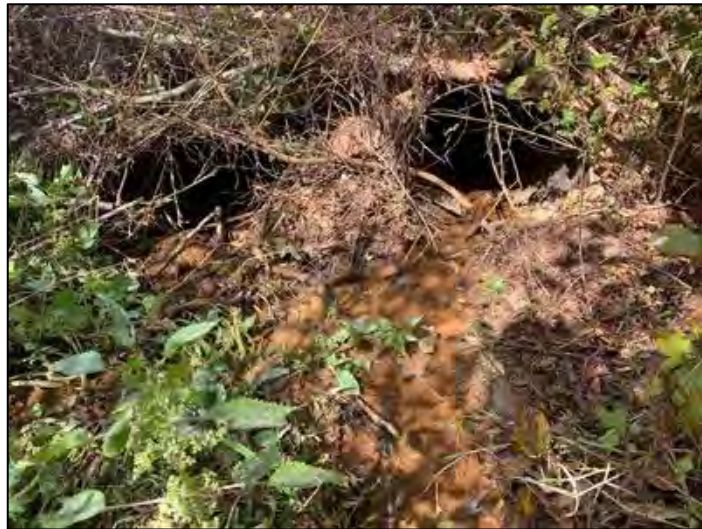
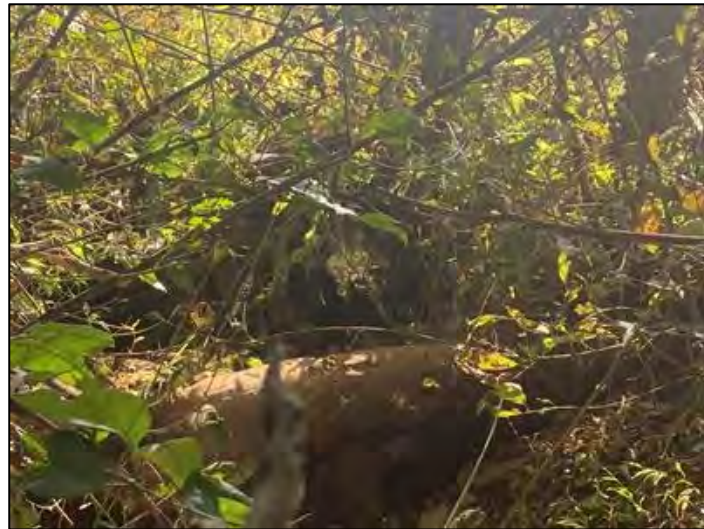
Crossing GF4-A – Downstream

Crossing GF4-A - Upstream

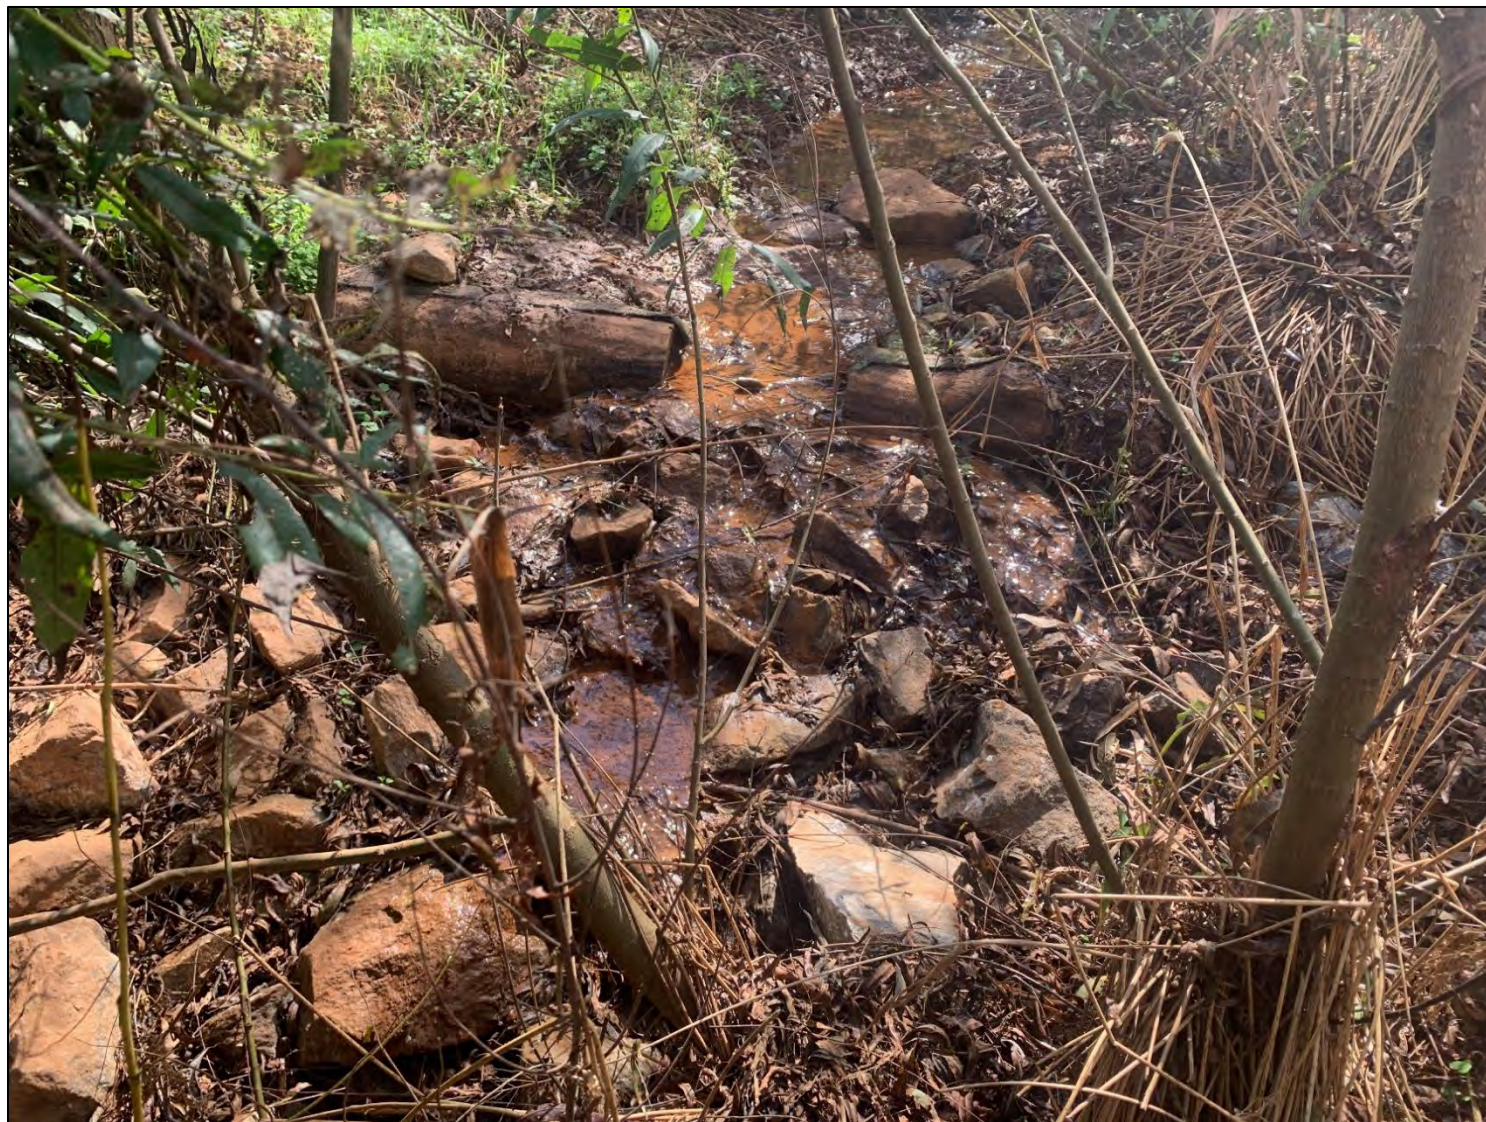
GF4 Structure Repair (looking Upstream)

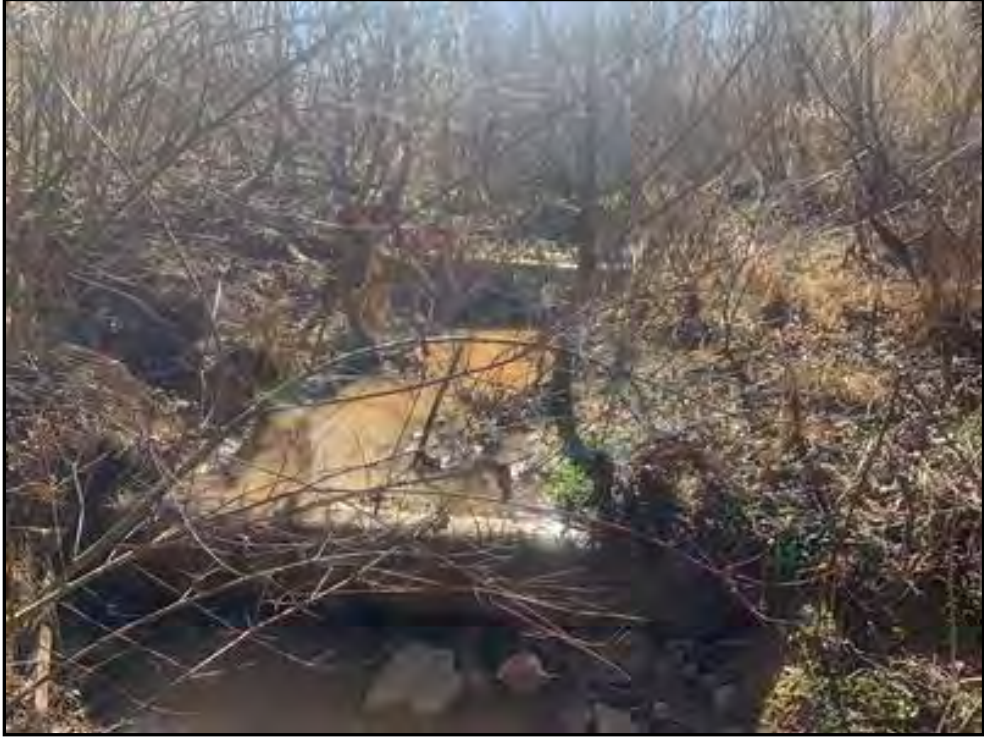
Log Sills GF3-A (02/13/2024)

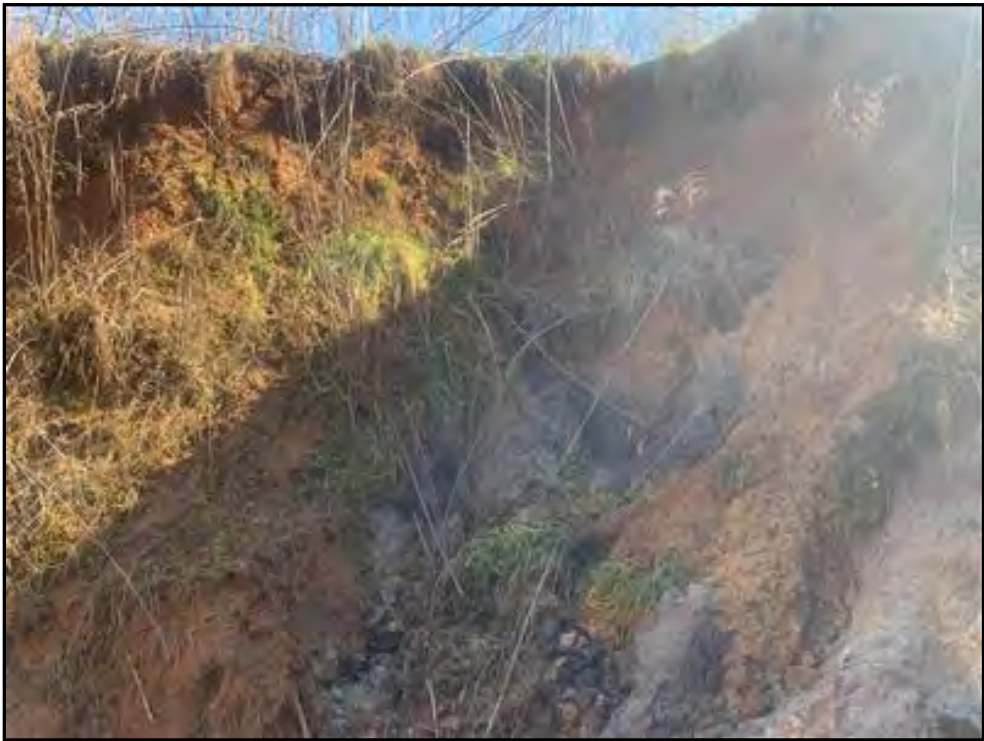
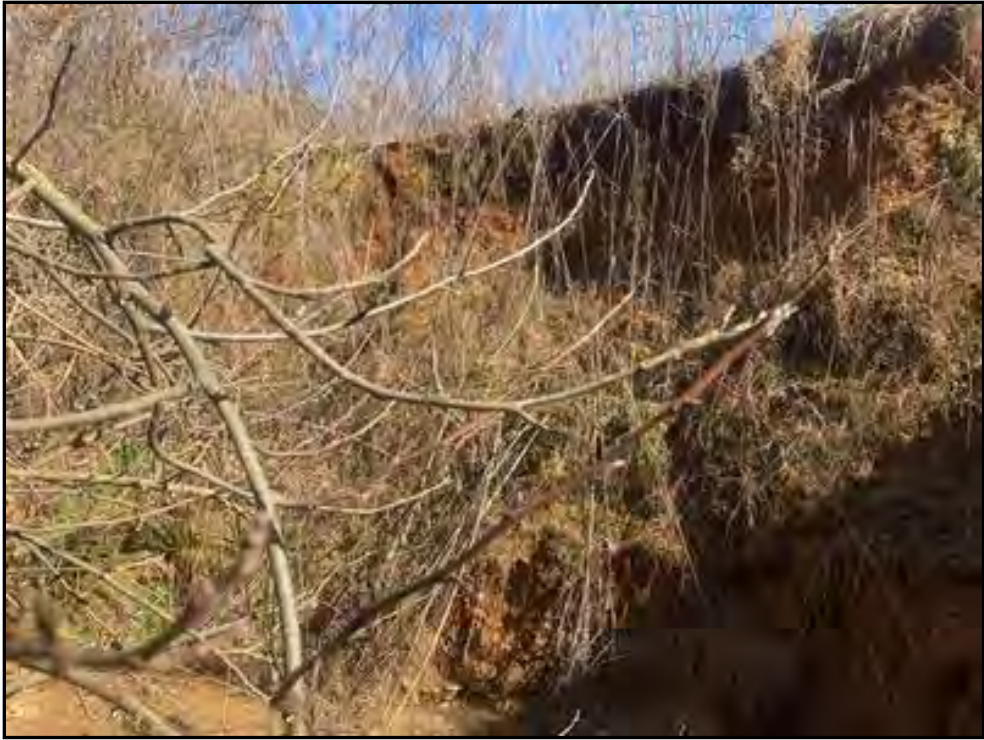
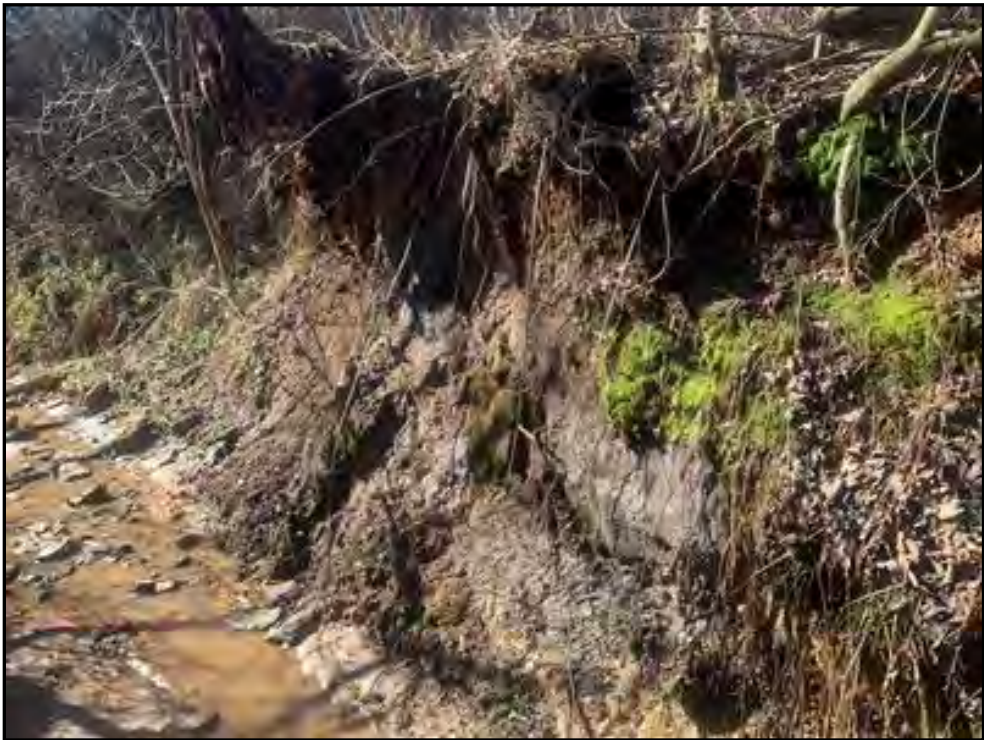
Eroding Slope – GF3A (02/13/2024)

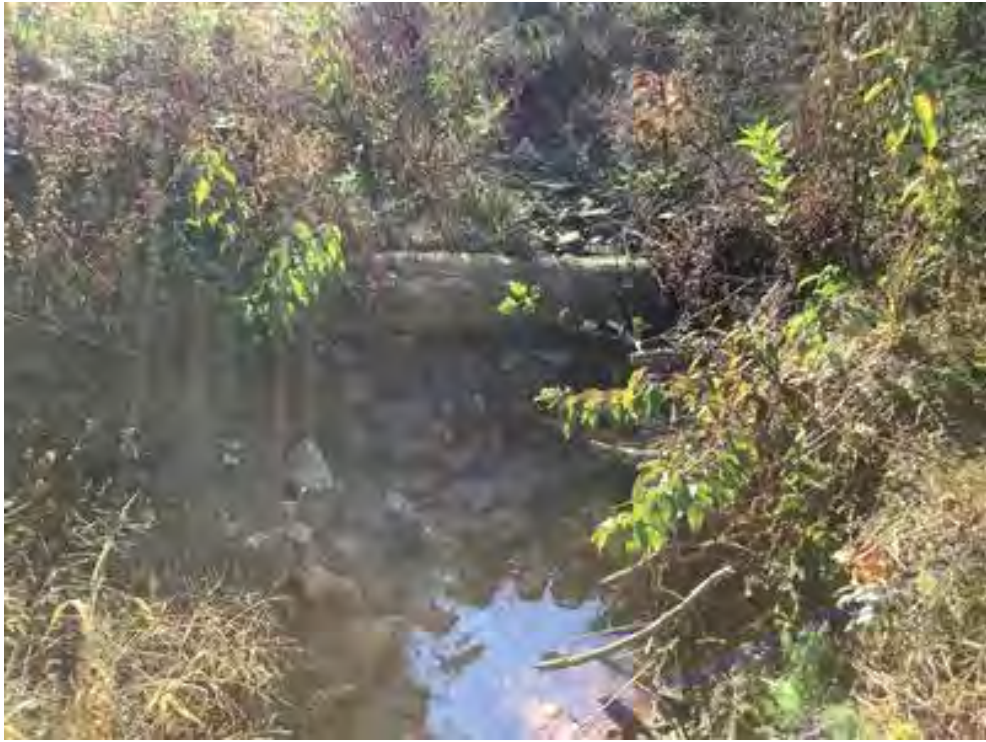
Structure Decline- GF2-A

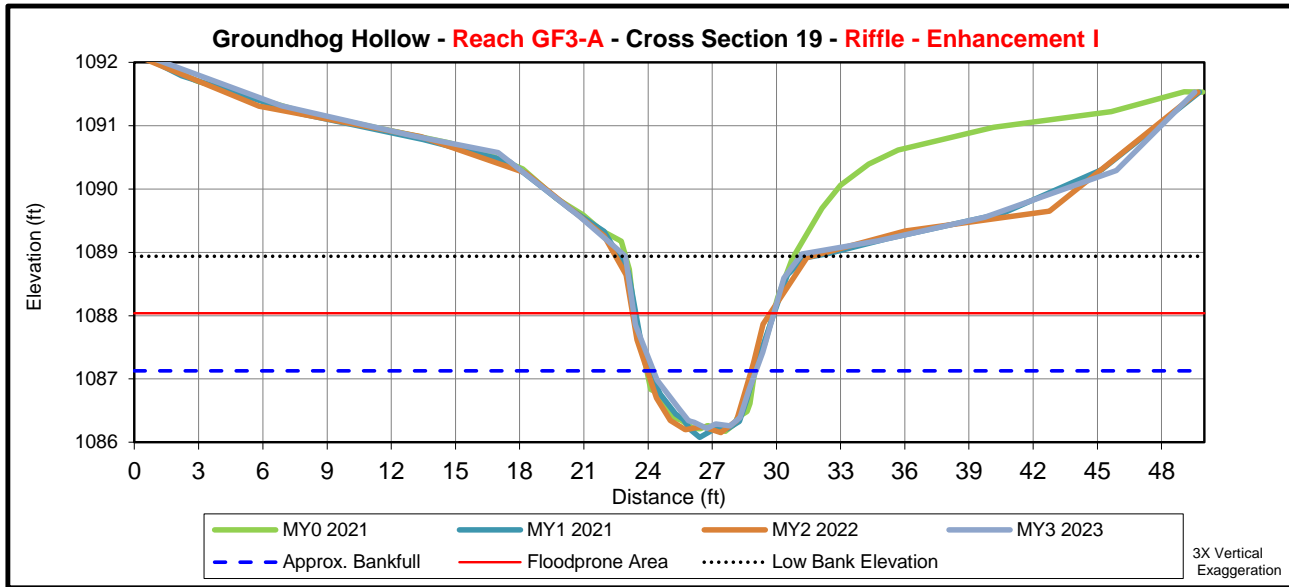
Cross Section 19 (Riffle)						
	MY0	MY1	MY2	MY3	MY5	MY7	MY+
Bankfull Elevation (ft) - Based on AB-XSA¹	1087.00	1087.0	1087.0	1087.1			
Bankfull Width (ft) ¹	4.9	4.7	4.6	4.8			
Floodprone Width (ft) ¹	6.3	6.4	>6	6.5			
Bankfull Max Depth (ft) ²	0.8	1.0	0.8	2.7			
Low Bank Elevation (ft)	1089.20	1088.9	1088.9	1089.0			
Bankfull Cross Sectional Area (ft ²) ²	3.0	3.0	2.9	14.7			
Bankfull Entrenchment Ratio ¹	1.3	1.4	>1.3	1.4			
Bankfull Bank Height Ratio ¹	3.6	2.9	3.2	3.0

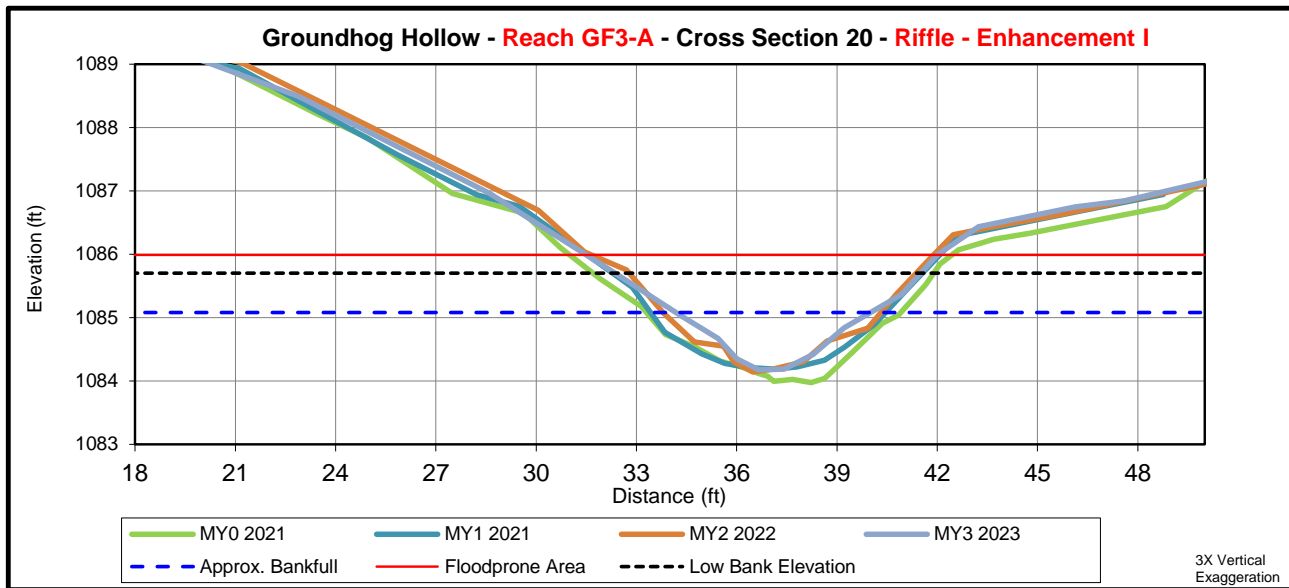
Cross Section 20 (Riffle)						
	MY0	MY1	MY2	MY3	MY5	MY7	MY+
Bankfull Elevation (ft) - Based on AB-XSA¹	1084.80	1084.9	1085.0	1085.1			
Bankfull Width (ft) ¹	6.2	6.4	6.2	5.8			
Floodprone Width (ft) ¹	9.6	8.7	>9.3	10.5			
Bankfull Max Depth (ft) ²	0.8	0.7	1.9	1.5			
Low Bank Elevation (ft)	1086.20	1086.3	1086.0	1085.7			
Bankfull Cross Sectional Area (ft ²) ²	3.0	3.0	11.1	7.7			
Bankfull Entrenchment Ratio ¹	1.5	1.4	1.5	1.8			
Bankfull Bank Height Ratio ¹	2.9	3.0	>2.2	1.7
