**As-Built Baseline Monitoring Report**

**GROUNDHOG HOLLOW PROJECT**

NCDMS Project #100049 (Contract #7417) | RFP 16-007277 (Issued 6/21/2017)

Alexander County, North Carolina  
Catawba River Basin  
HUC 03050101

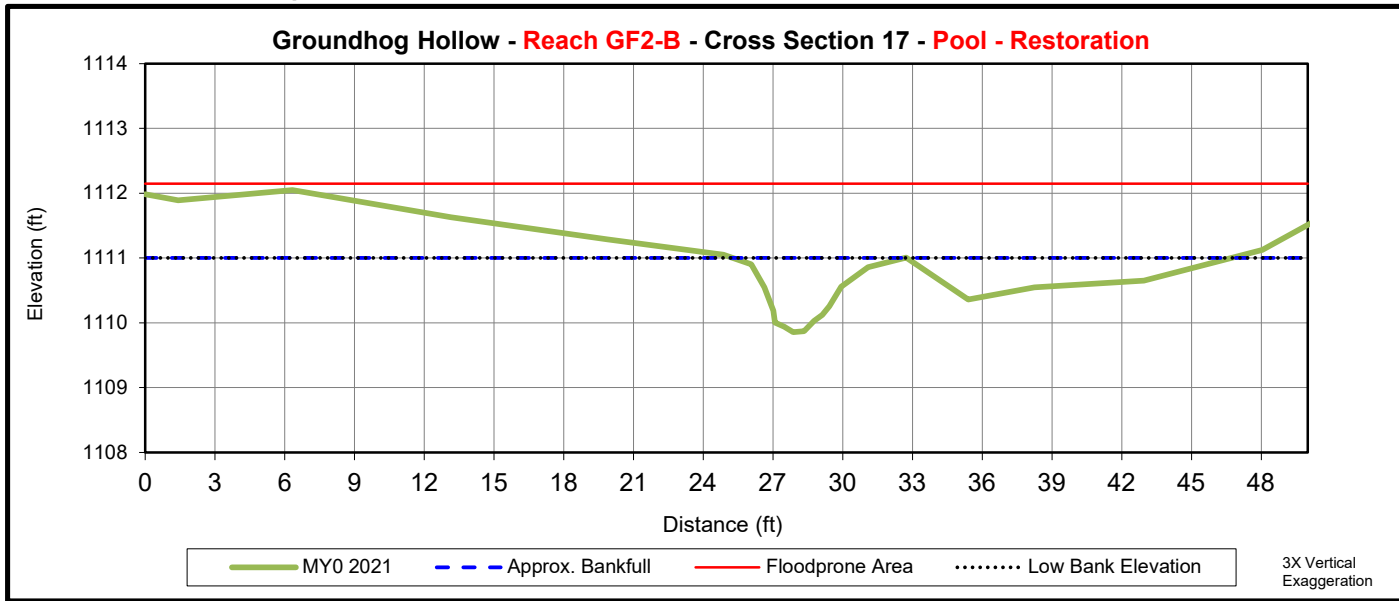
**Appendix D – Table 11:** Cross section 17 is identified as a Pool in Table 11; however, it is identified as a Riffle on the cross sections provide. Please QA/QC the data and tables and update as necessary.

This error has been corrected and the data and tables have been QA/QC.

<b>Cross Section 17 (Pool)</b>						
	MY0	MY1	MY2	MY3	MY5	MY7	MY+
<b>Bankfull Elevation (ft) - Based on AB-XSA<sup>1</sup></b>	1111.00						
Bankfull Width (ft) <sup>1</sup>	7.5						
Floodprone Width (ft) <sup>1</sup>	-						
Bankfull Max Depth (ft) <sup>2</sup>	1.1						
Low Bank Elevation (ft)	1111.00						
Bankfull Cross Sectional Area (ft <sup>2</sup> ) <sup>2</sup>	3.7						
Bankfull Entrenchment Ratio <sup>1</sup>	-						
Bankfull Bank Height Ratio <sup>1</sup>	-

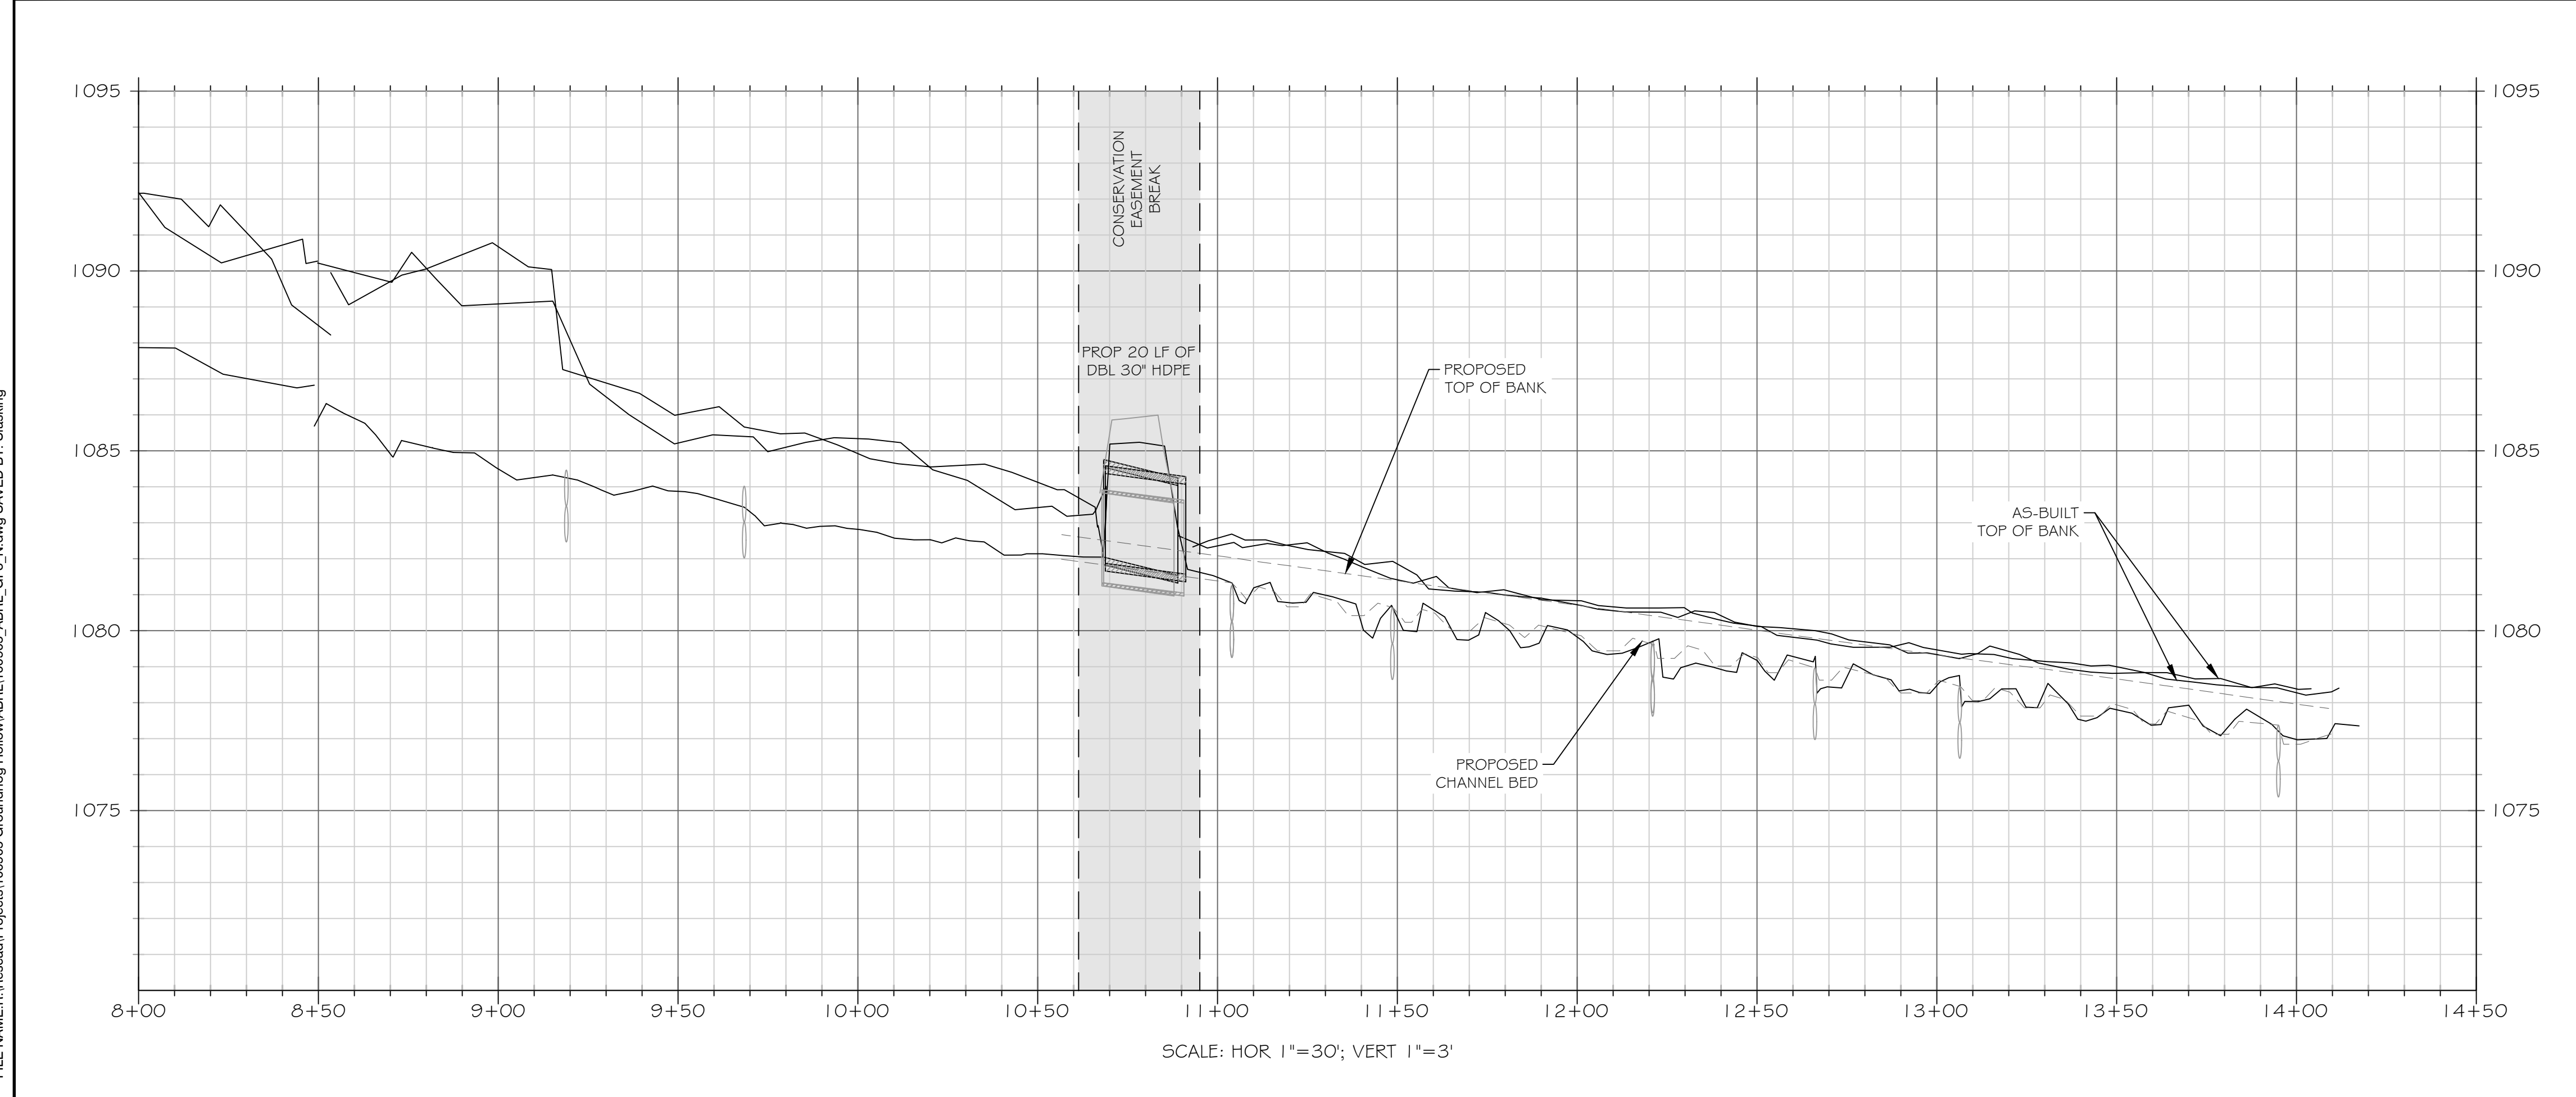
ROCK SILL AND BRUSH TOE  
INSTALLED DURING CONSTRUCTION  
FOR ADDED GRADE CONTROL
