ANNUAL REPORT FOR 2004

Hanging Rock Creek Stream Mitigation Site
Avery County
WBS Element 34402.4.1
TIP No. R-2237WM

Prepared By:
Office of Natural Environment & Roadside Environmental Unit
North Carolina Department of Transportation
March 2005

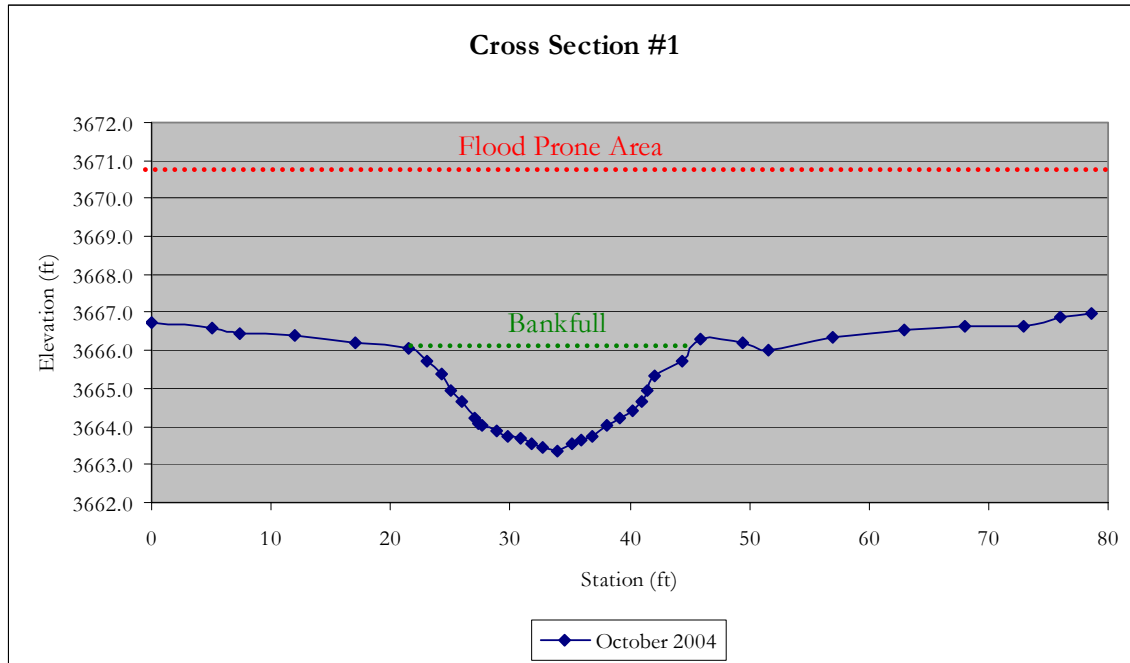
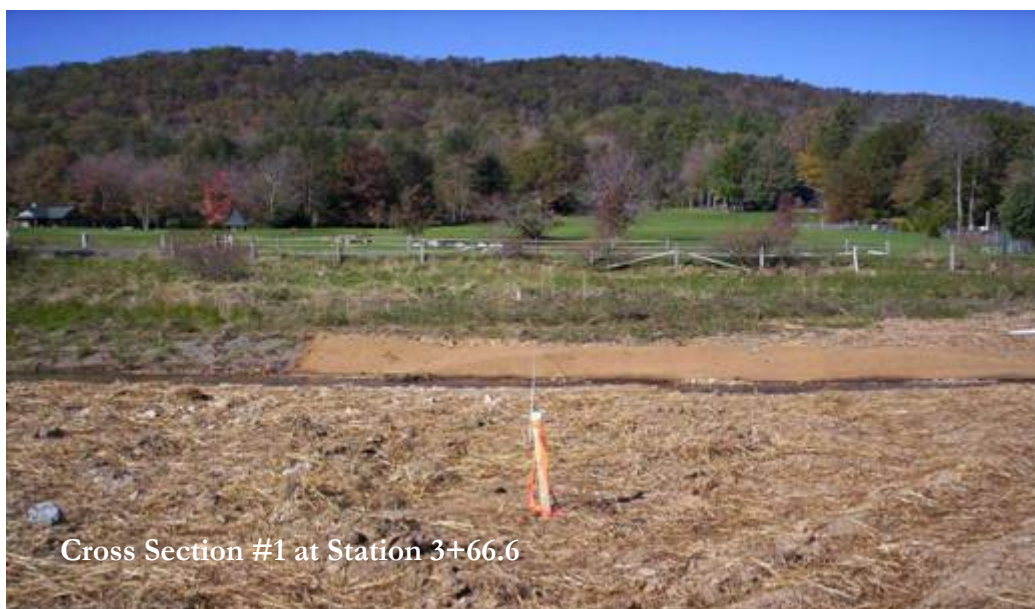
Cross-Section #1 (Riffle) Abbreviated Morphological Summary

2004	2005	2006	2007	2008
Bankfull Cross Sectional Area (ft²)	37.4				
Maximum Bankfull Depth (ft)	2.7				
Width of the Floodprone Area (ft)	300				
Bankfull Mean Depth (ft)	1.5				
Width/Depth Ratio	16.6				
Entrenchment Ratio	>5				
Bankfull Width (ft)	24.9

* BANKS WERE NEWLY CONSTRUCTED & OVERLAIN WITH MATING. ONCE VEGETATION ESTABLISHES BEHI WILL DROP TO LOW.

Near Bank Stress Rating	BEHI Rating
MODERATE	VERY HIGH

Bank Erosion Prediction (ft/yr)	
	0.3

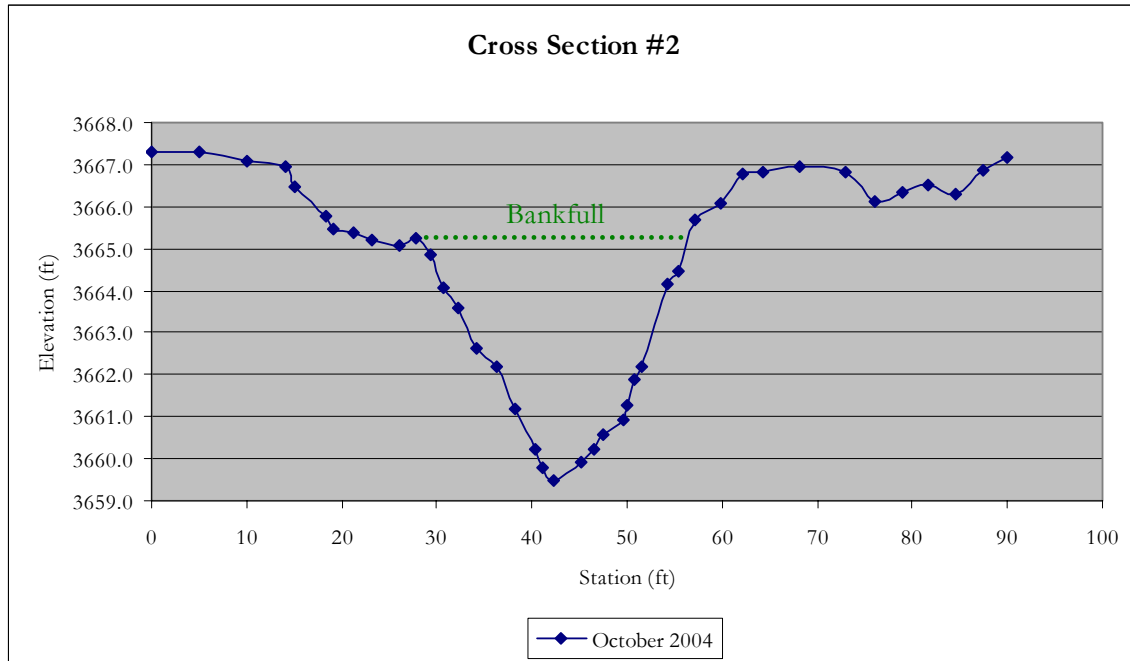
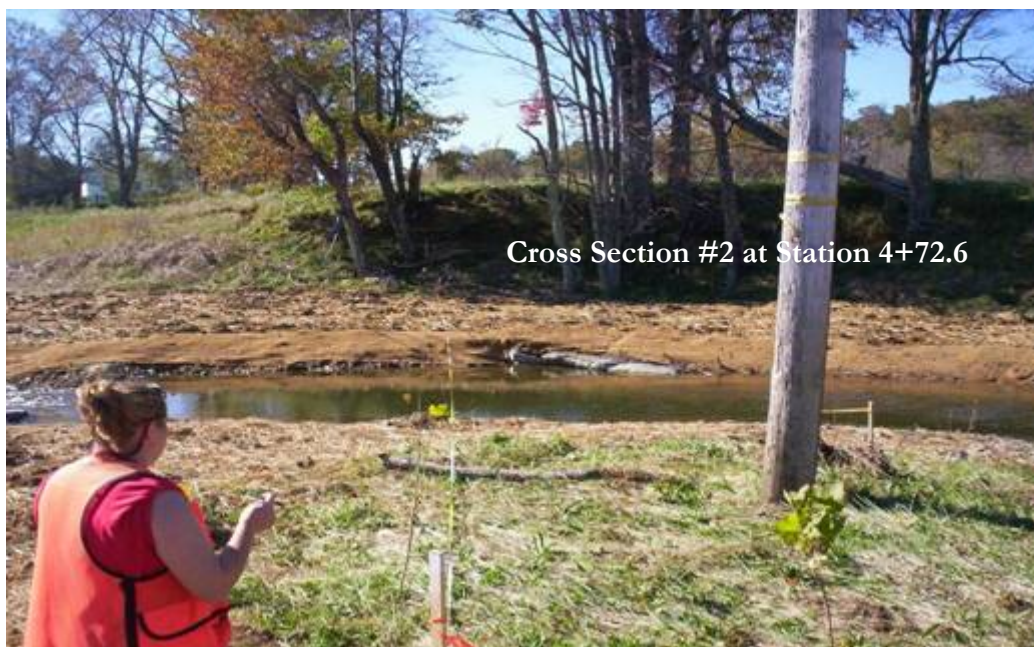
Cross-Section #2 (Pool) Abbreviated Morphological Summary*

2004	2005	2006	2007	2008
Bankfull Cross Sectional Area (ft²)	91.8				
Maximum Bankfull Depth (ft)	5.8				
Bankfull Mean Depth (ft)	2.7				
Bankfull Width (ft)	34

* BANKS NEWLY CONSTRUCTED, VEGETATION NOT YET ESTABLISHED.

Near Bank Stress Rating	BEHI Rating
VERY HIGH	VERY HIGH

Bank Erosion Prediction (ft/yr)	0.8
---------------------------------	-----

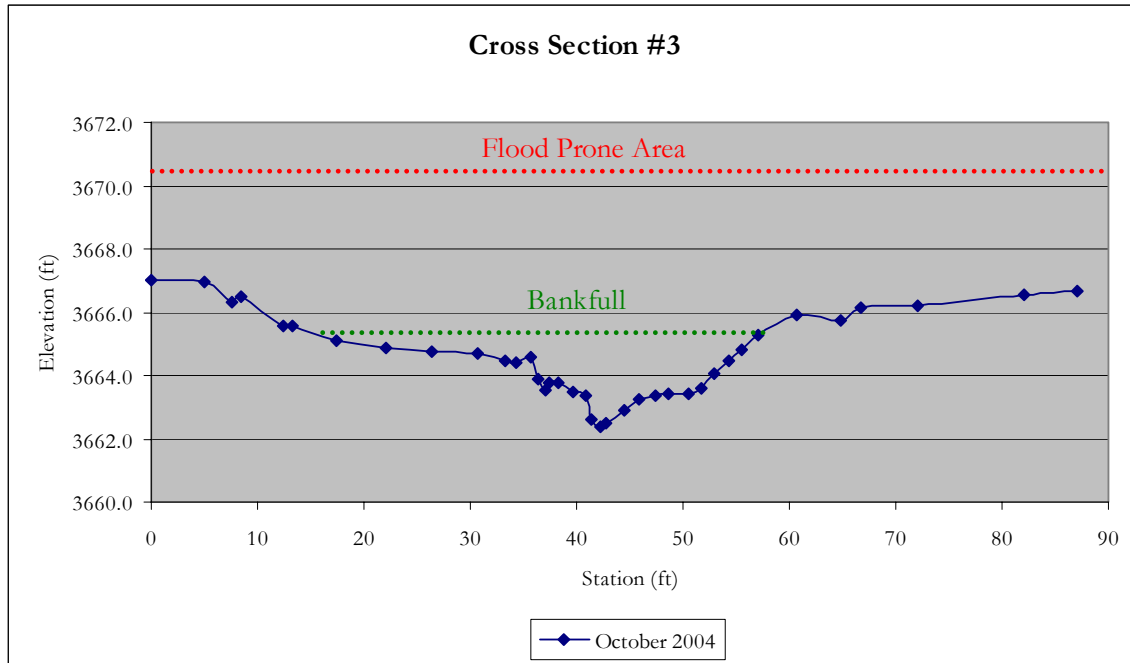
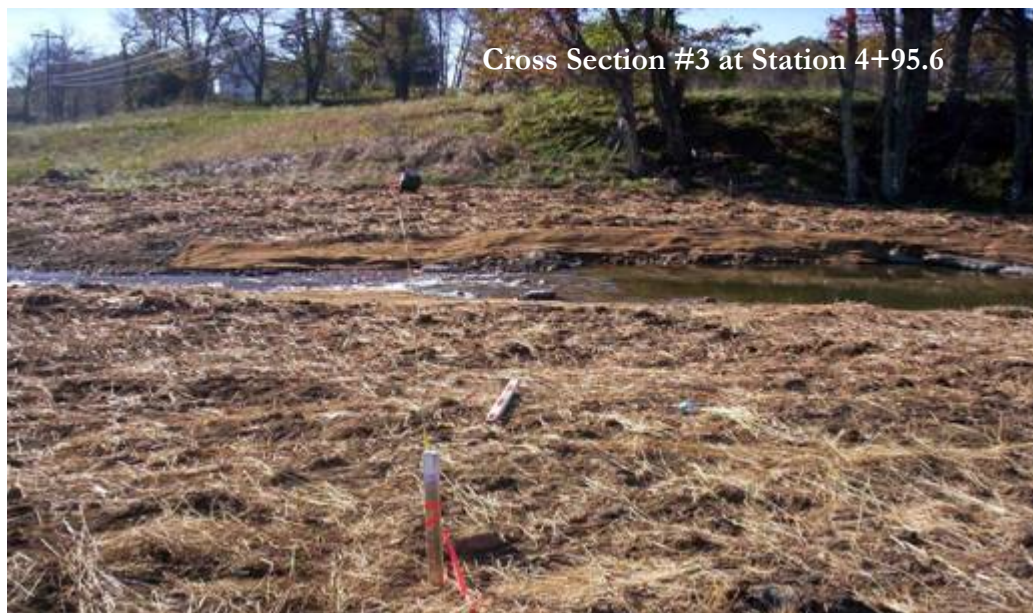
Cross-Section #3 (Riffle) Abbreviated Morphological Summary

2004	2005	2006	2007	2008
Bankfull Cross Sectional Area (ft ²)	44.7				
Maximum Bankfull Depth (ft)	2.9				
Width of the Floodprone Area (ft)	300				
Bankfull Mean Depth (ft)	1.1				
Width/Depth Ratio	36.9				
Entrenchment Ratio	>5				
Bankfull Width (ft)	40.6

* NEWLY CONSTRUCTED BANKS, VEGETATION NOT YET ESTABLISHED.

Near Bank Stress Rating	BEHI Rating
VERY HIGH	VERY HIGH

Bank Erosion Prediction (ft/yr)	0.8
---------------------------------	-----

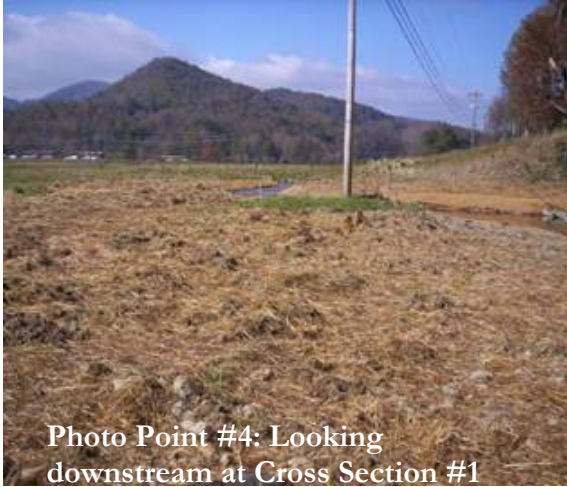
Photo Point #4: Looking downstream at Cross Section #1

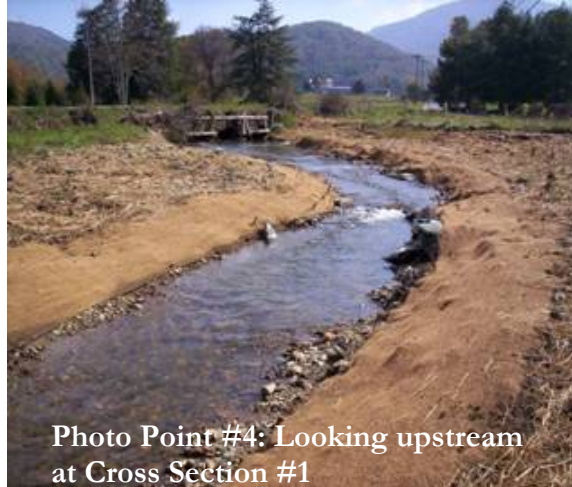
Photo Point #4: Looking upstream at Cross Section #1

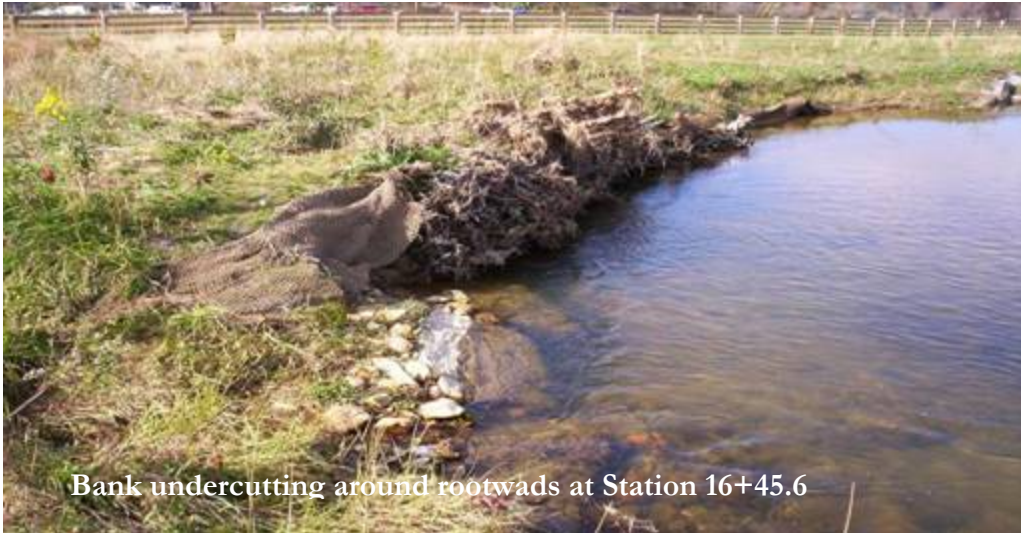
Bank undercutting around rootwads at Station 16+45.6

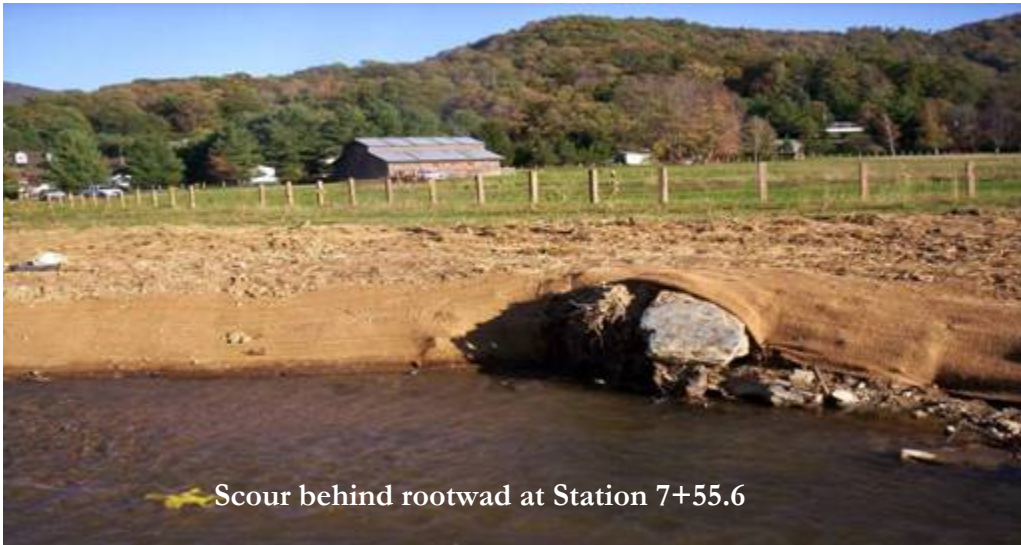
- ◆ Station 7+55.6. Active scouring was noted around the rootwad on the left bank (facing downstream) in 2004. The scour did not appear to be compromising the structure. Establishment of vegetation should help to stabilize this area.
- ◆ Station 16+45.6. Bank undercutting was noted around a rootwad structure embedded in the left streambank. The structure, however, appeared stable. This area will be reassessed during the next monitoring period.

Scour behind rootwad at Station 7+55.6

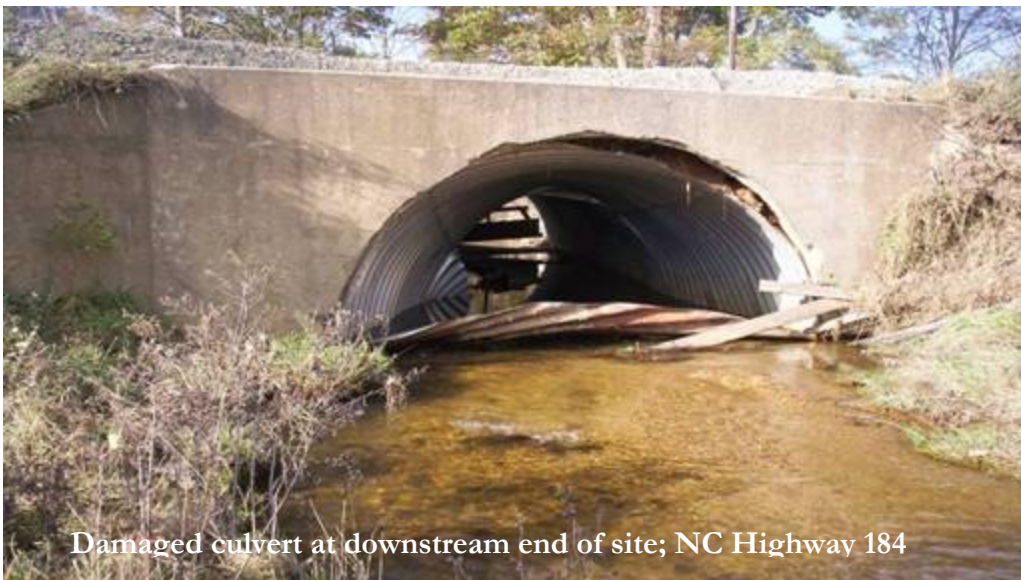
Significant rainfall events in September 2004 resulted in Hanging Rock Creek reaching stages above bankfull. These events caused the erosion of streambanks and undermined rock structures throughout the restored channel, principally in a section of the main channel immediately downstream of the Dobbins Road culvert. Action to correct the damage was completed by the time of monitoring.

Damaged culvert at downstream end of site; NC Highway 184
