Hanging Rock Creek and Tributary Stream Restoration

NCEEP Project Number: 00165

Monitoring Year 3 of 5

2006 Annual Monitoring Report

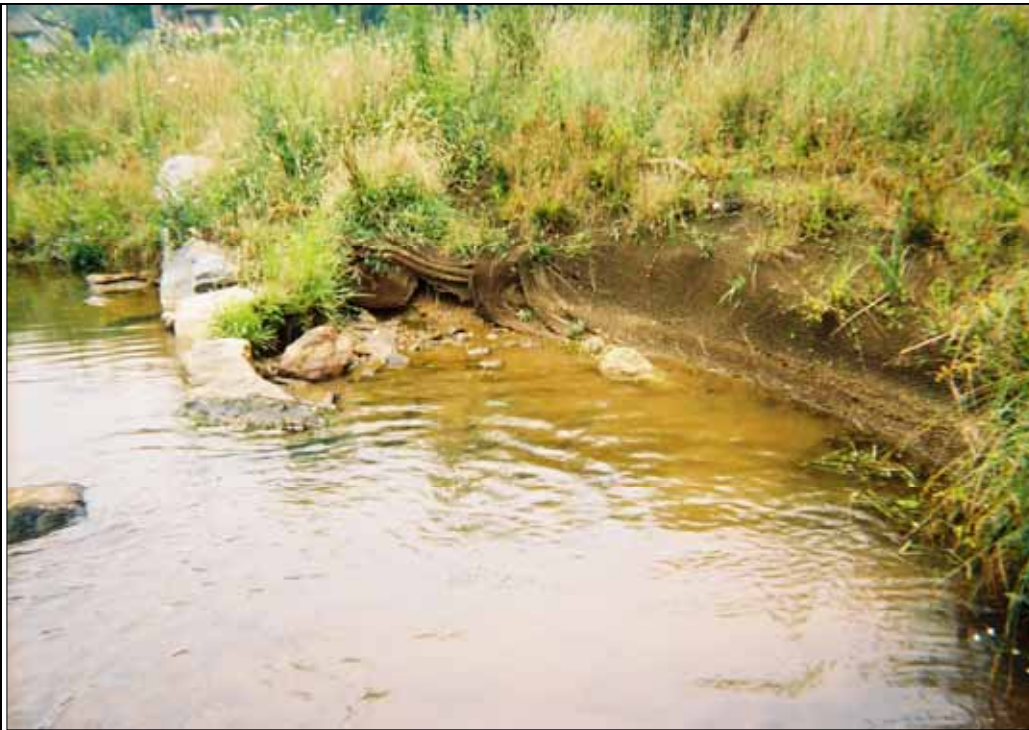
PHOTOLOG SHEET
Site: Hanging Rock Creek Station 14+15
Avery County, North Carolina
Project No: 6470-06-1410.04
Date: October 2006
Photo #: 1
Photographed by: R.E. Spears
Description: J-hook vane severely eroded and likely to fail soon.

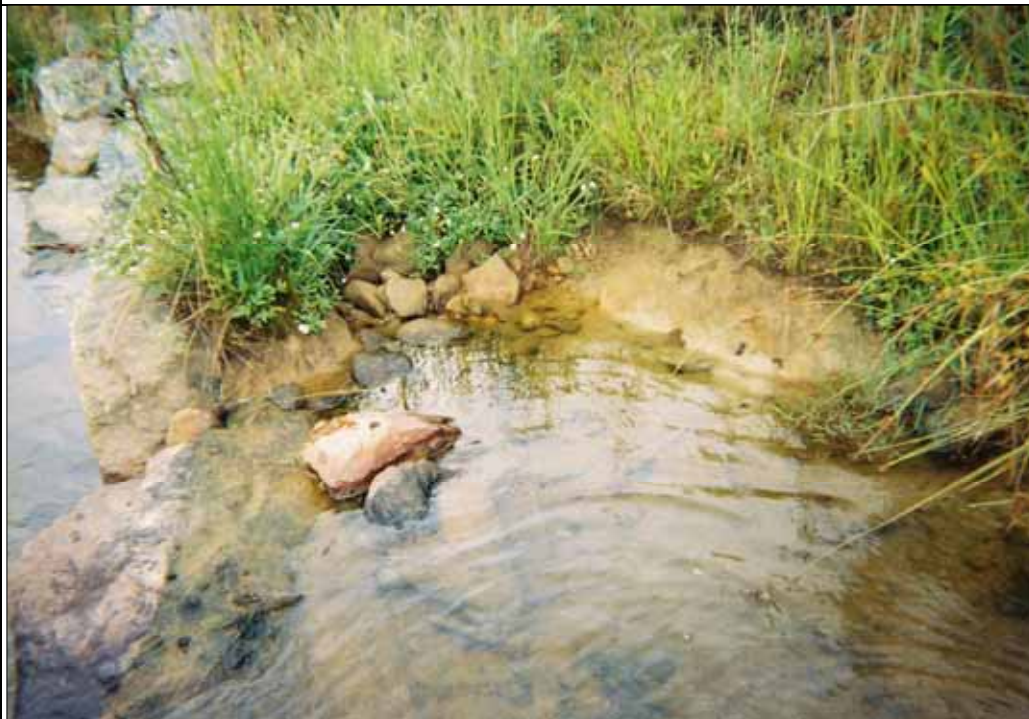
Site: Hanging Rock Creek Station 18+05
Avery County, North Carolina
Project No: 6470-06-1410.04
Date: October 2006
Photo #: 2
Photographed by: R.E. Spears
Description: Moderate erosion and slumping of J-hook vane. Failure anticipated soon.

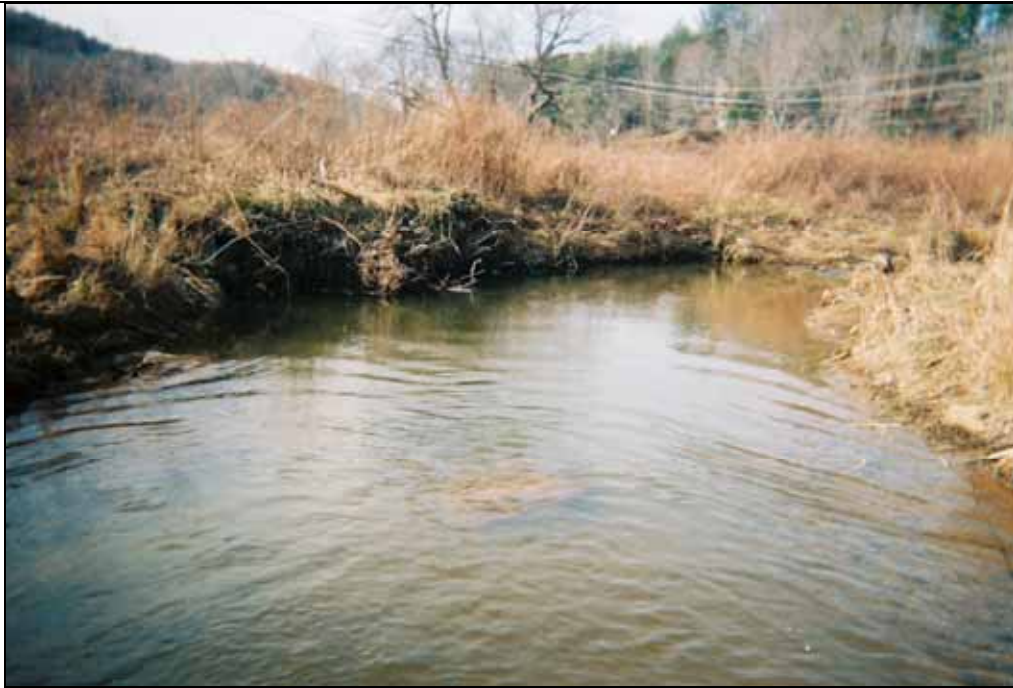
PHOTOLOG SHEET
Site: Hanging Rock Creek Station 17+80
Avery County, North Carolina
Project No: 6470-06-1410.04
Date: October 2006
Photo #: 3
Photographed by: R.E. Spears
Description: J-hook vane failed and bank scour.

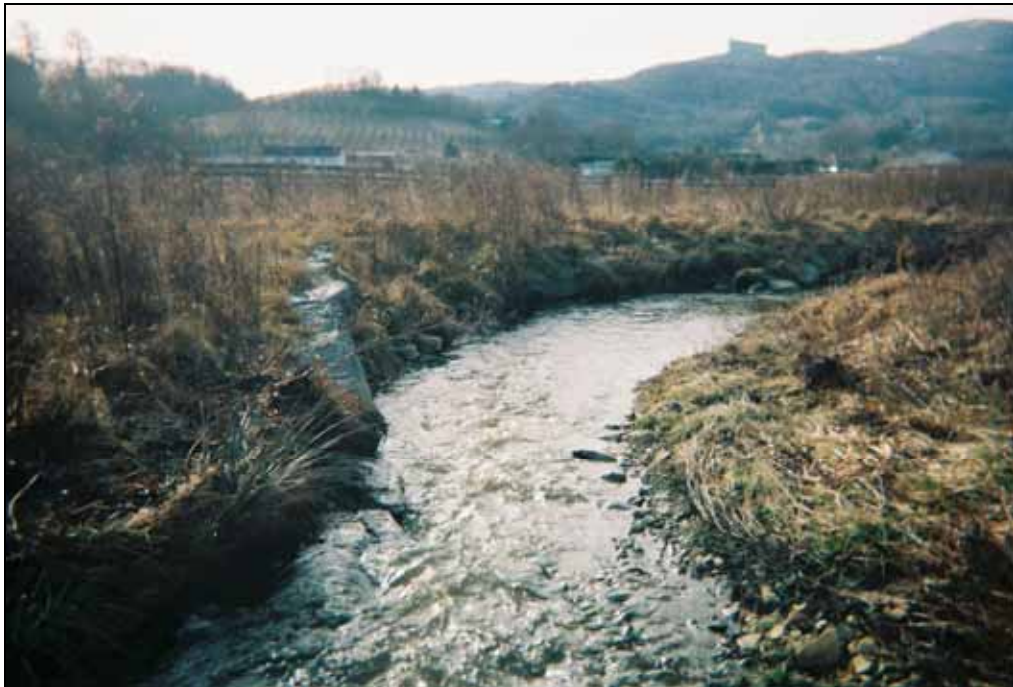
Site:
Avery County, North Carolina Station 7+25
Project No: 6470-06-1410.04
Date: October 2006
Photo #: 4
Photographed by: R.E. Spears
Description: Downstream view of Station 7+50 showing slumping vane and bank scour.

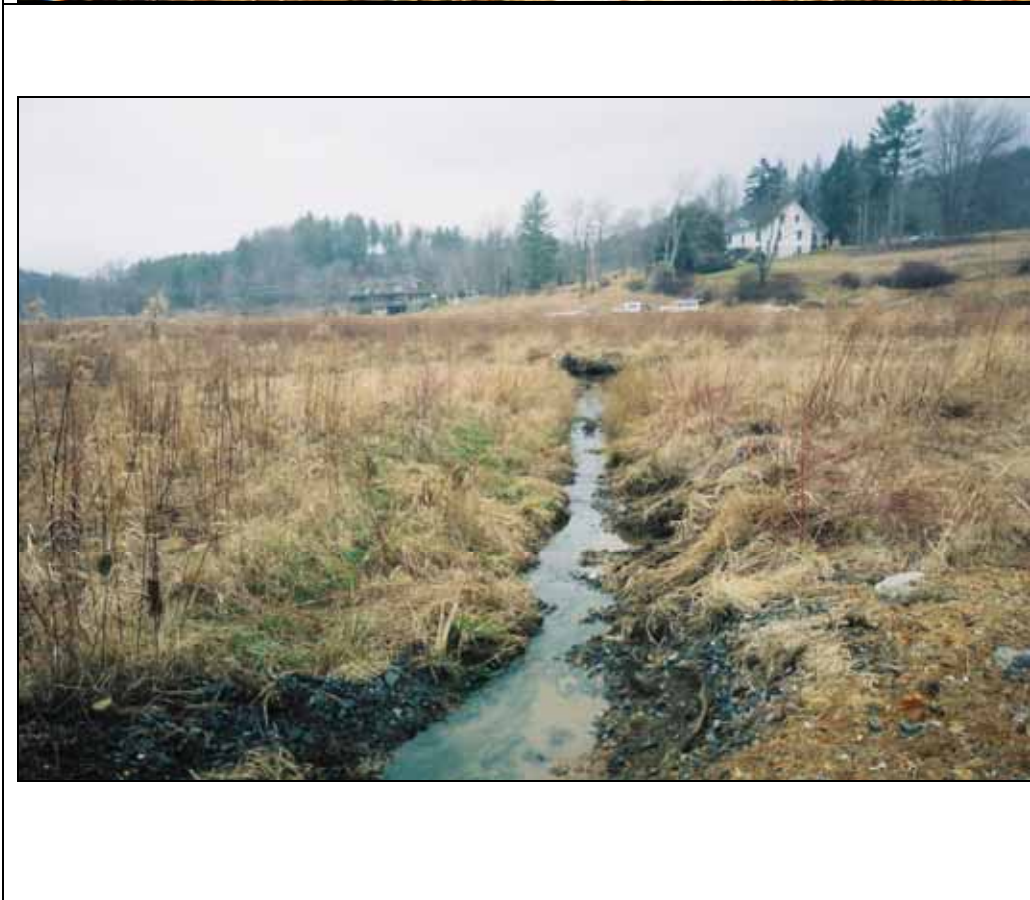
Site:
	Avery County, North Carolina
	Project No: 6470-06-1410.04
	Date: December 2006
	Photo #: 6
	Photographed by: R.E. Spears
	Description: Second ditch showing recent grading work with an addition of a culvert pipe under a constructed road crossing.

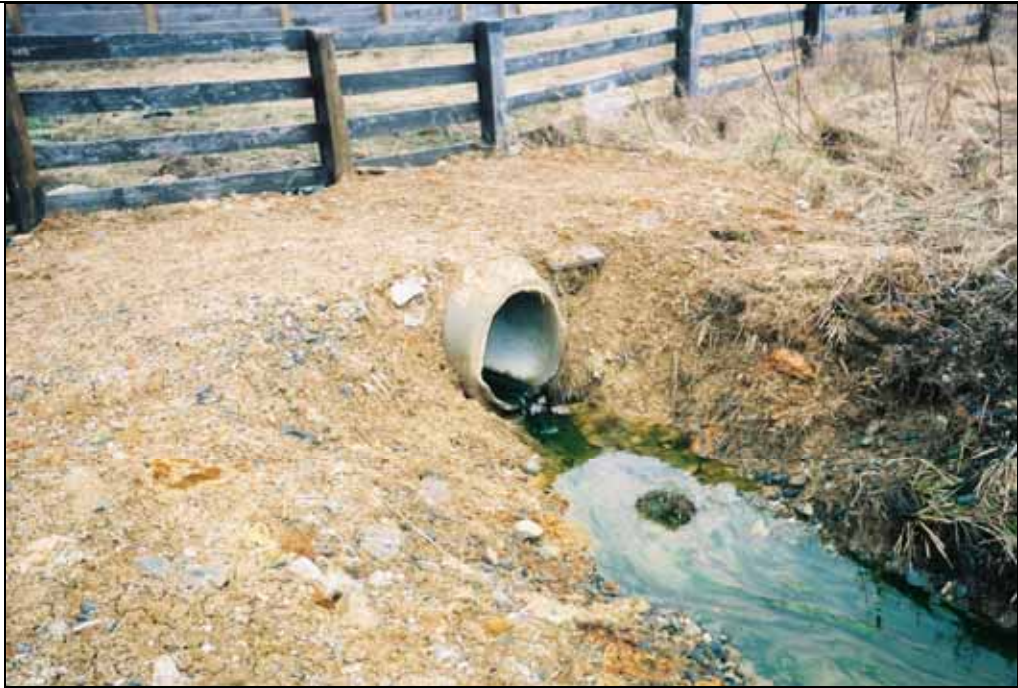
PHOTOLOG SHEET	
Site:	Hanging Rock Creek
	Avery County, North Carolina
	Project No: 6470-06-1410.04
	Date: December 2006
	Photo #: 7
	Photographed by: R.E. Spears
Description:	Culvert pipe under a constructed road crossing. No vegetation or BMP's being used.
Site:	
	Avery County, North Carolina
	Project No: 6470-06-1410.04
	Date: December 2006
	Photo #:
	Photographed by:
Description:
