Hanging Rock Creek and Tributary Stream Restoration

NCEEP Project Number: 00165

Monitoring Year 4 of 5

2007 Annual Monitoring Report

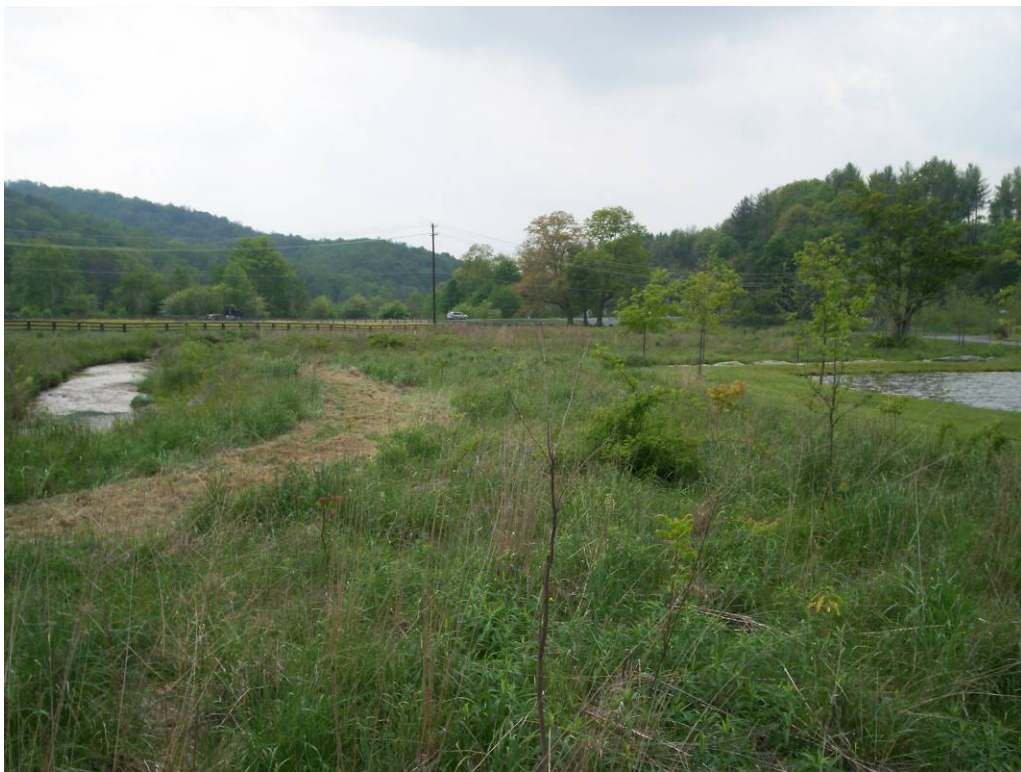
<p>PHOTOLOG SHEET</p> <p>Site: Hanging Rock Creek Station 14+20</p> <p>Avery County, North Carolina</p> <p>Project No: 6470-06-1410.07</p> <p>Date: June 2007</p> <p>Photo #: 3</p> <p>Photographed by: R.E. Spears</p> <p>Description: Mowed path throughout riparian buffer. View is to the East.</p>

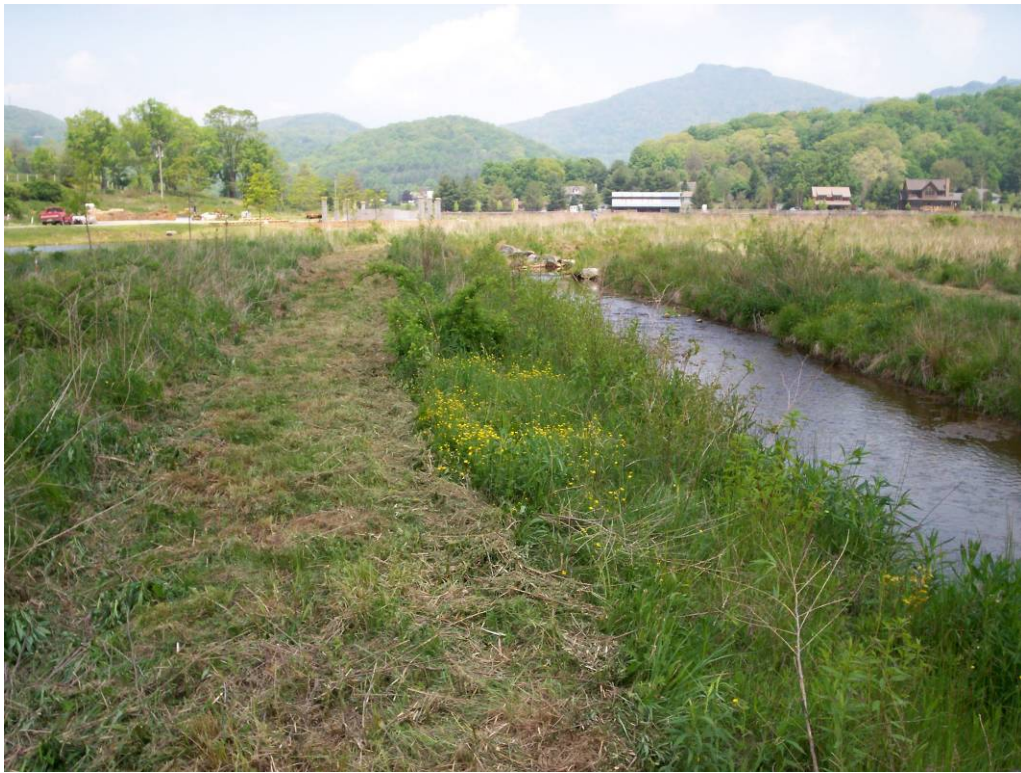
<p>Site: Hanging Rock Creek Station 20+25</p> <p>Avery County, North Carolina</p> <p>Project No: 6470-06-1410.07</p> <p>Date: June 2007</p> <p>Photo #: 4</p> <p>Photographed by: R.E. Spears</p> <p>Description: Mowed path along riparian buffer near pond. Two new home construction sites. View is to the West.</p>

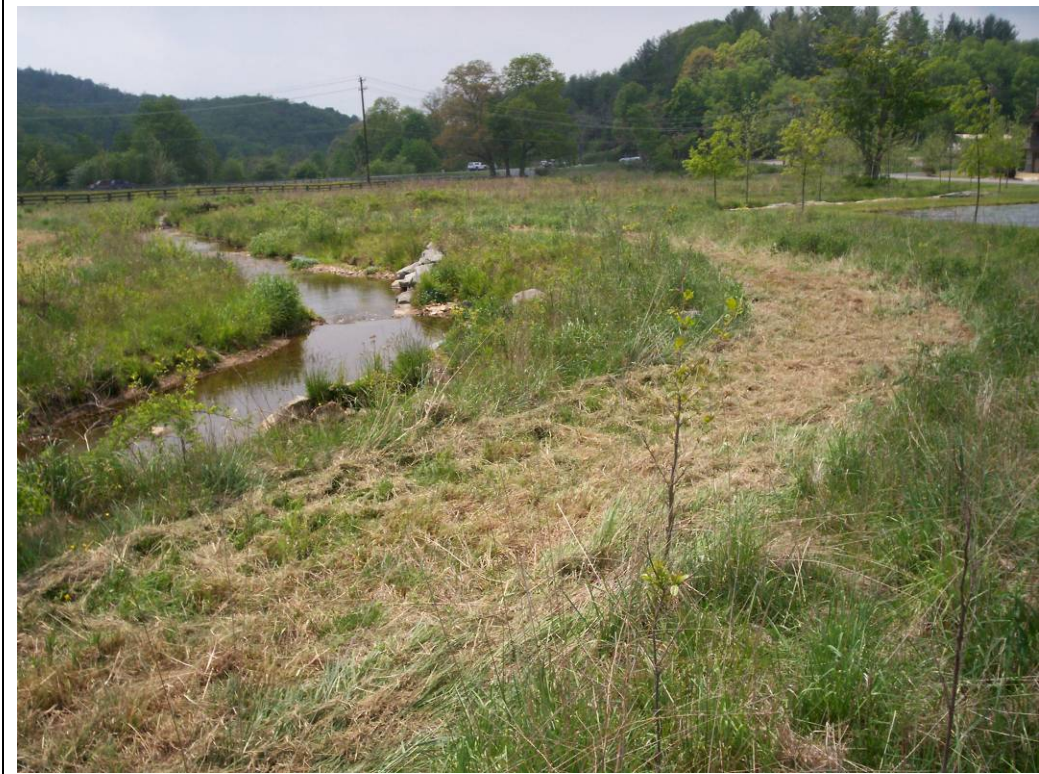
<p>PHOTOLOG SHEET</p>
	<p>Site: Hanging Rock Creek Near Station 14+00</p>
	<p>Avery County, North Carolina</p>
	<p>Project No: 6470-06-1410.07</p>
	<p>Date: May 2007</p>
	<p>Photo #: 9</p>
<p>Photographed by: R.E. Spears</p> <p>Description: Mowed path near Vegetation Plot BBP-7 between constructed pond and stream channel.</p>

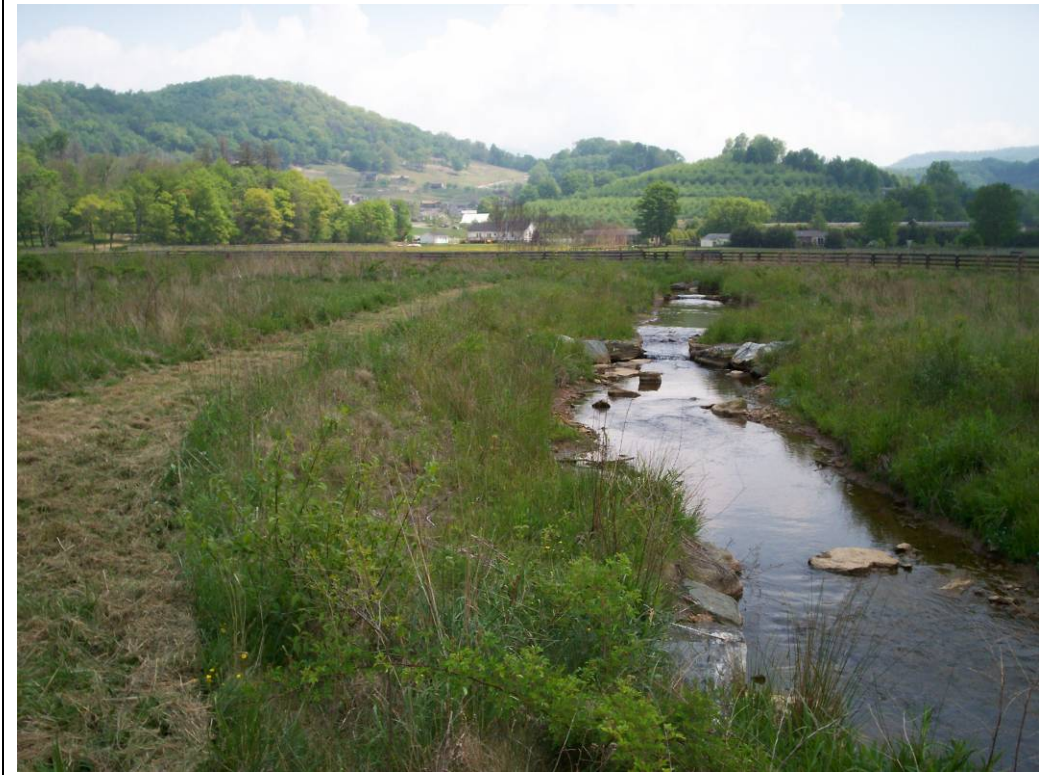
<p>Site: Hanging Rock Creek</p>
	<p>Avery County, North Carolina</p>
	<p>Project No: 6470-06-1410.07</p>
	<p>Date: June 2007</p>
	<p>Photo #: 10</p>
	<p>Photographed by: N/A</p> <p>Description: Mowed path on left stream bank. View is to the east and to the south.</p>

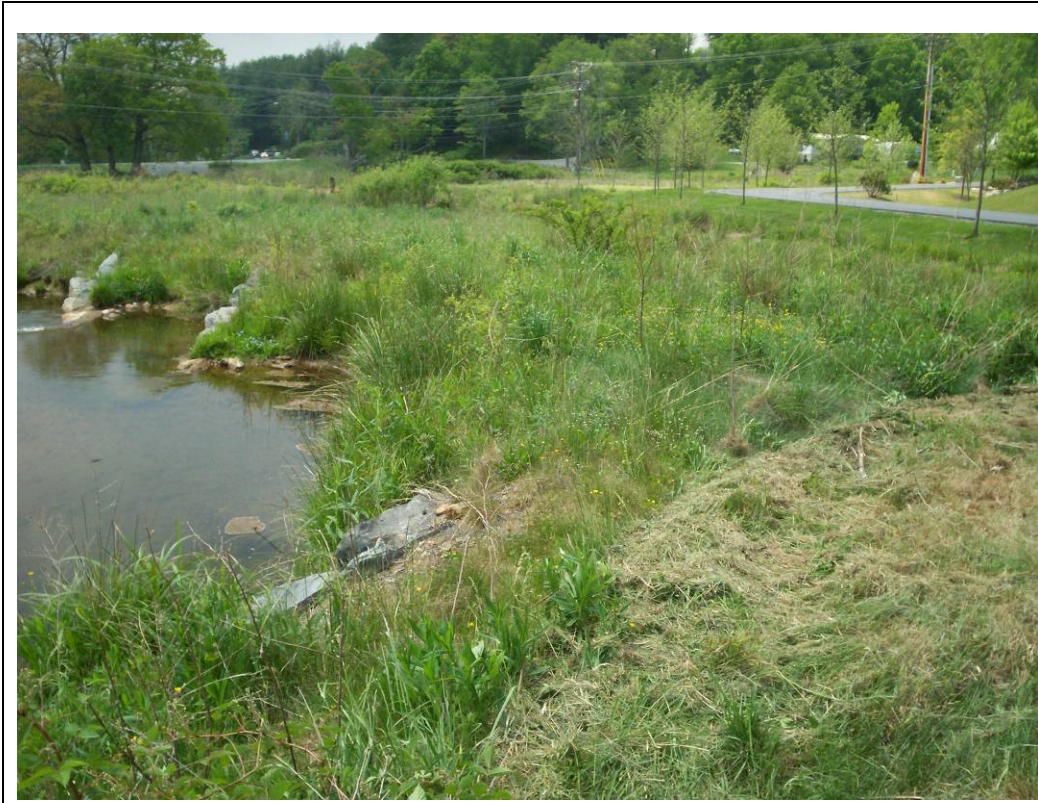
PHOTOLOG SHEET	
Site:	Hanging Rock Creek
	Avery County, North Carolina
	Project No: 6470-06-1410.07
Date:	May 2007
Photo #:	11
Photographed by:	R.E. Spears
Description:	Mowed path near Vegetation Plot BBP-8.

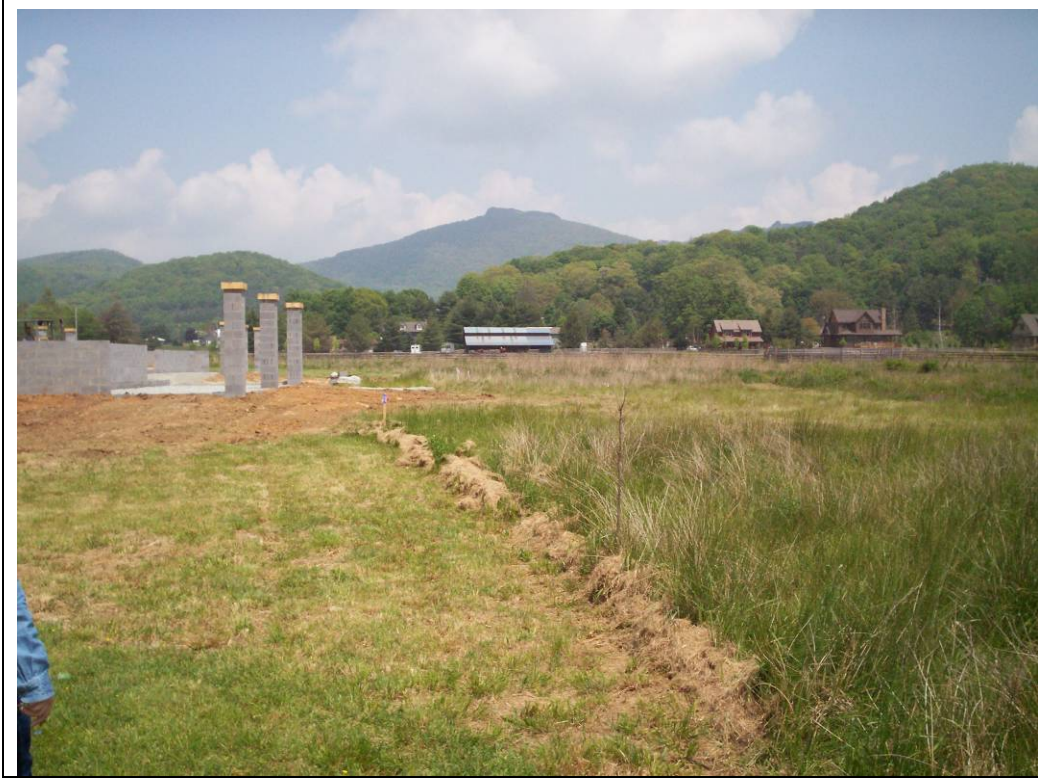
Site:	Hanging Rock Creek
	Avery County, North Carolina
	Project No: 6470-06-1410.07
Date:	June 2007
Photo #:	12
Description:	Construction of two homesites along the restoration corridor. View is to the south.

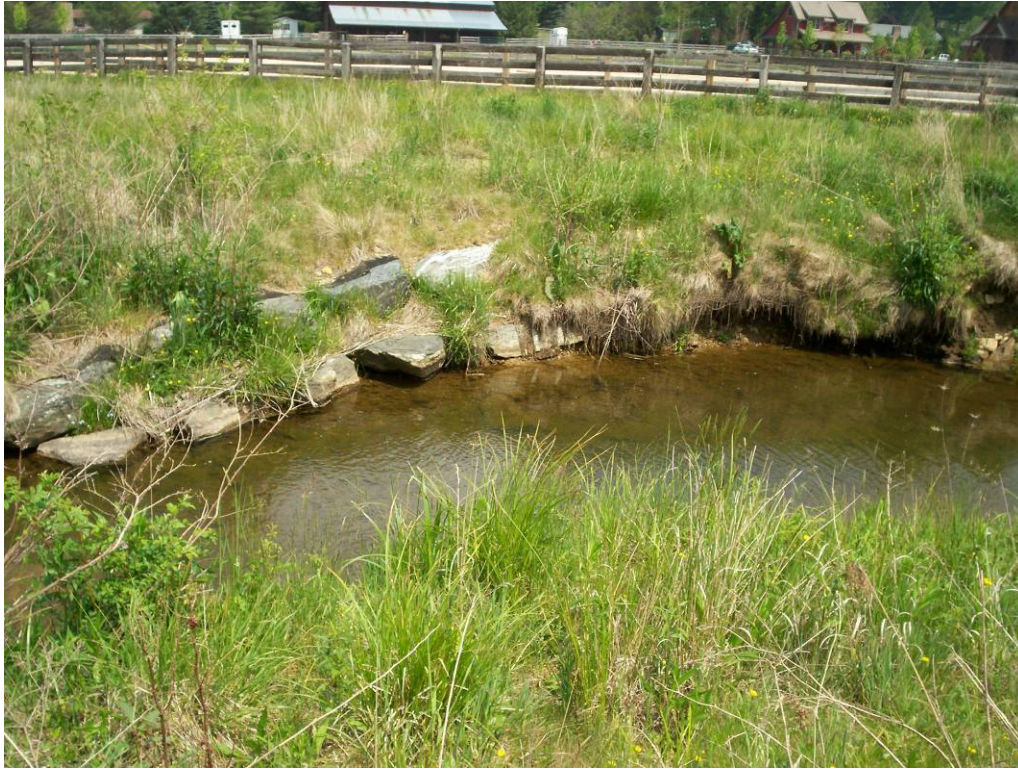
Description:
Problem Area # 2 and #3 with
observed bank scour on the
outside meander bend.

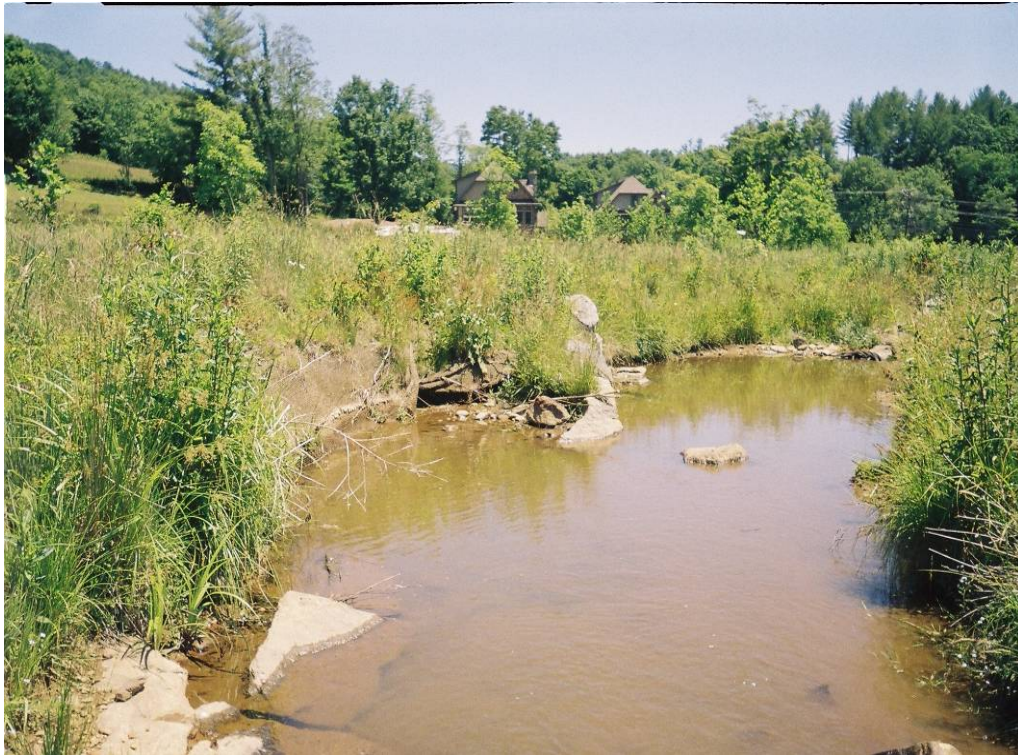
Site: Hanging Rock Creek
Station 07+56

Description:
Problem Area #4 with
observed bank scour on the
outside meander bend behind
rock-vane.

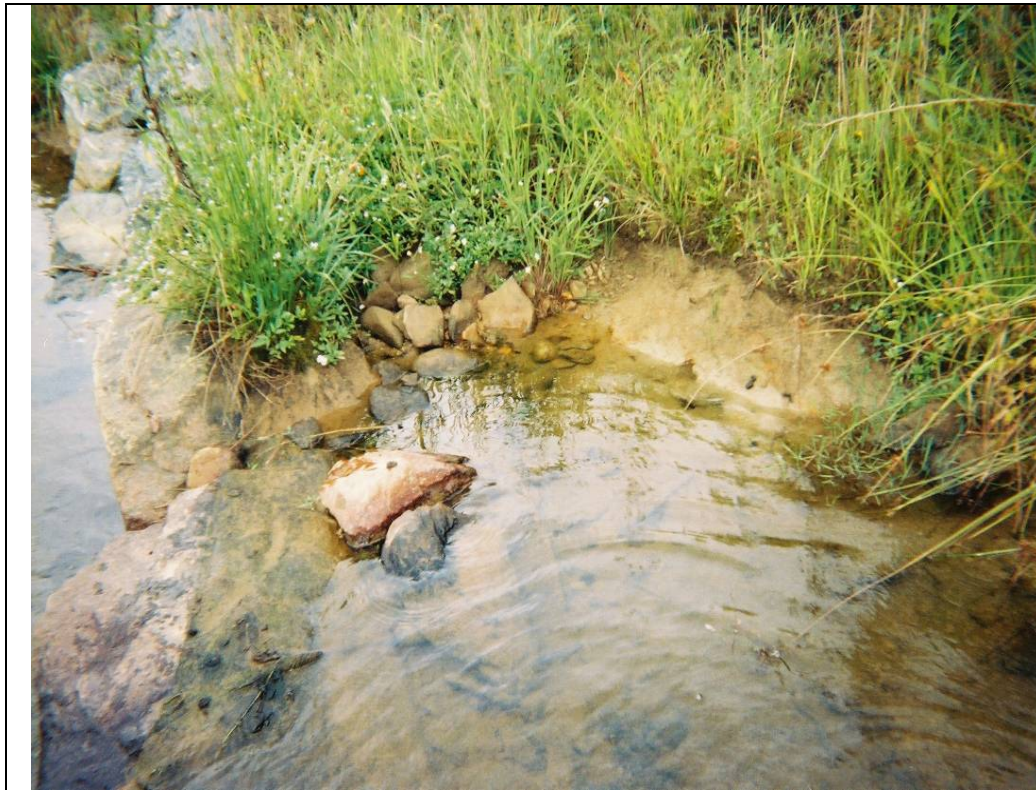
During last year's MY3 monitoring effort two "imminent failure" risk, problem areas were identified. These problem areas located around stations 14+00 and 18+00 were re-evaluated during MY4. The MY4 effort again recognized these areas as potential problems but not in risk of immediate, "imminent failure." Scouring has occurred around several rock structures but good vegetation appears to be holding the adjacent banks in place. These areas should be closely observed during future monitoring efforts.

PHOTOLOG SHEET
Site: Hanging Rock Creek Station 18+05
Avery County, North Carolina
Project No: 6470-06-1410.07
Date: June 2007
Photo #: 5
Photographed by: R.E. Spears
Description: Problem Area #7 indicating active bank scour on the outside of the meander bend.

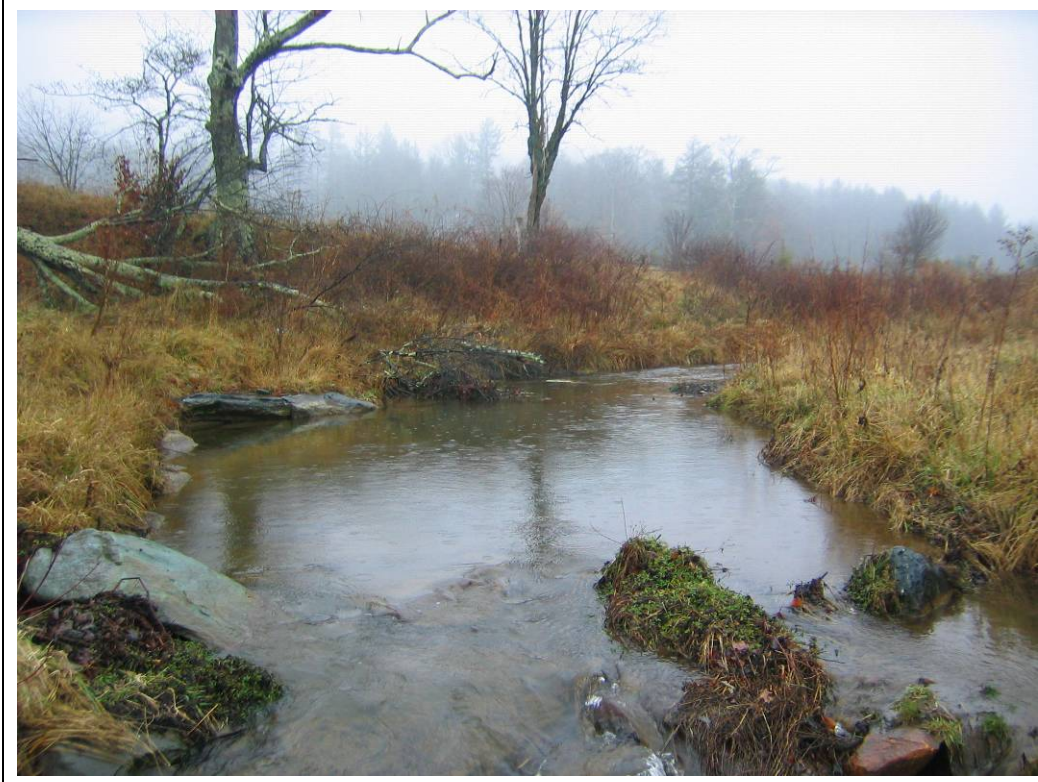
Site: Hanging Rock Creek Station 01+90
Avery County, North Carolina
Project No: 6470-06-1410
Date: December 2007
Photo #: 2
Photographed by: R.L. Sain
Description: Photo taken facing upstream. Location is in between cross-section number 2 and 3. Depicts heavily silted cross-section 2.
