Hanging Rock Creek and Tributary Stream Restoration

NCEEP Project Number: 165

Monitoring Year 5

2008 Final Report

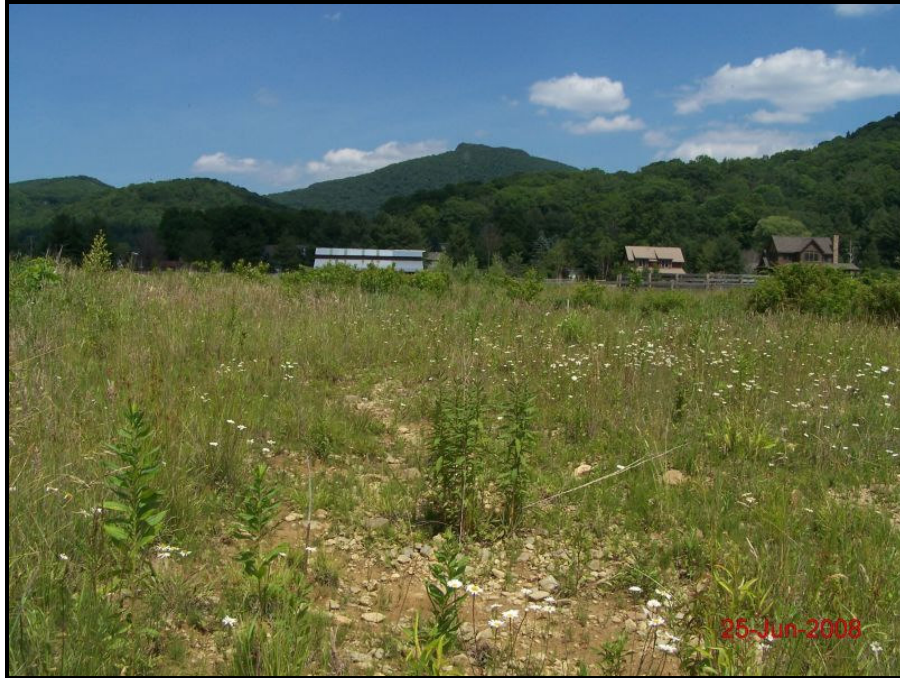
Vegetative growth at two stream bench locations was stunted and appeared to be related to poor soil substrate. The bare floodplain areas were the result of unauthorized mowing outside hiking paths sanctioned in the easement. NCDOT and NCEEP readdressed these restrictions with adjacent landowners in 2007. Based on the MY 4 Current Condition Plan View (NCEEP 2007), the extent of mowed hiking trails had been minimized in MY 5.

Vegetation Problem Area (VPA 1) – Bare bench
Monitoring Year 5 – June 25, 2008

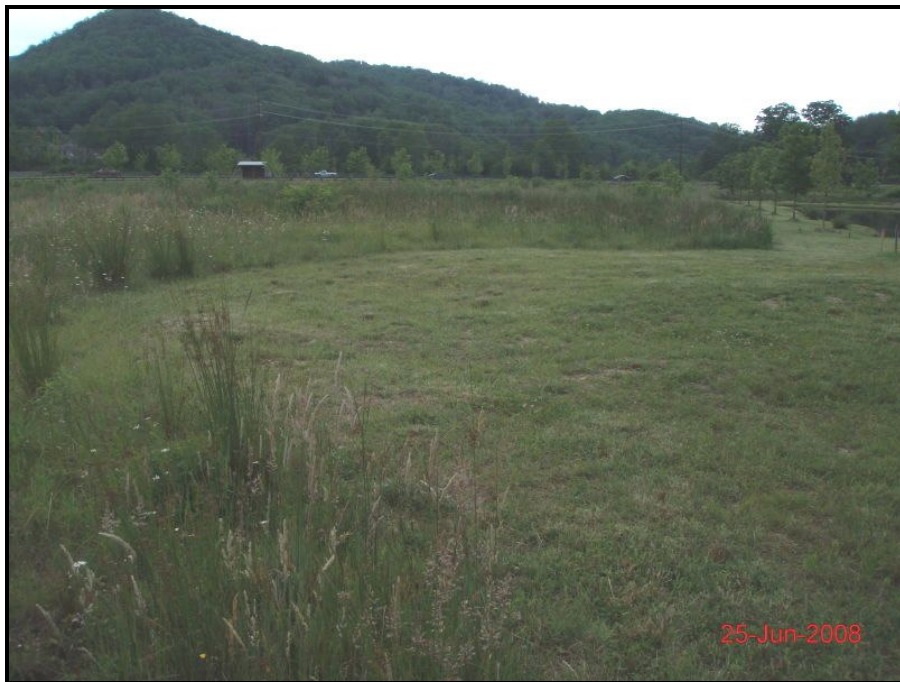
Vegetation Problem Area (VPA 2) – Mowed floodplain
Monitoring Year 5 – June 25, 2008

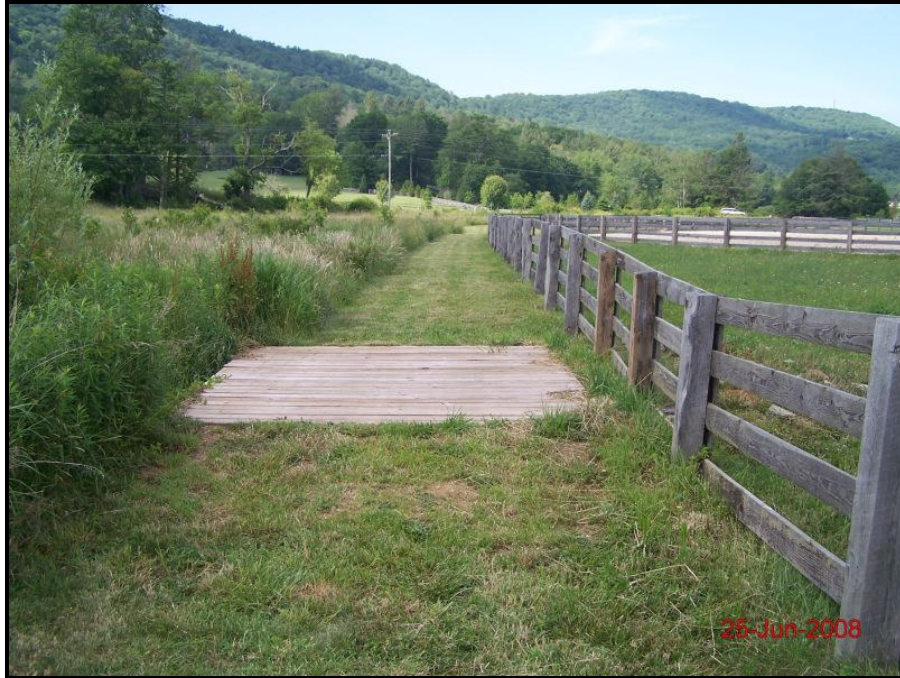
Vegetation Problem Area (VPA 3) – Mowed path
Monitoring Year 5 – June 25, 2008

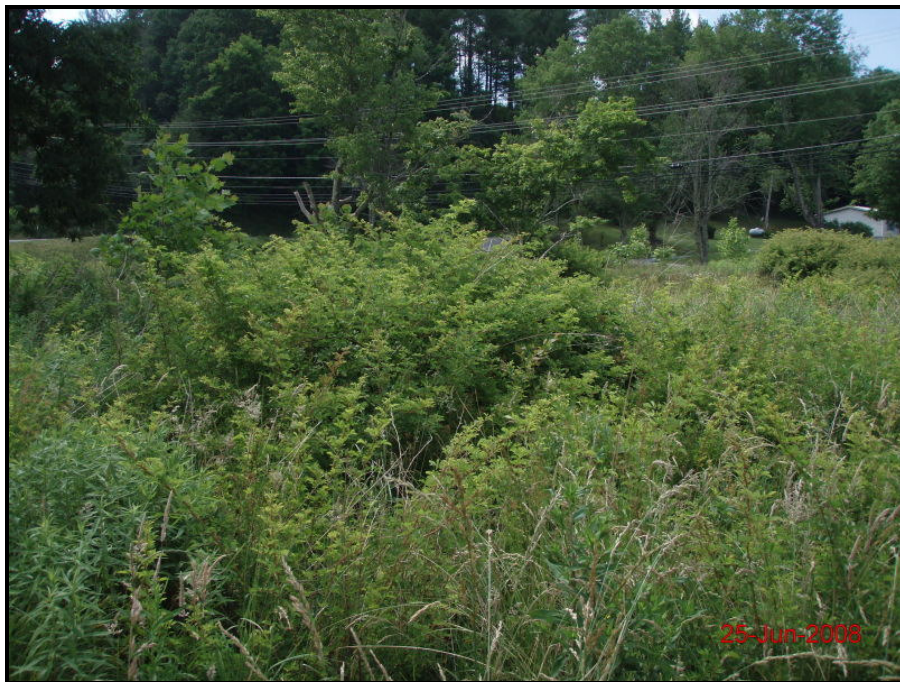
Vegetation Problem Area (VPA 4) – *Rosa multiflora*
Monitoring Year 5 – June 25, 2008

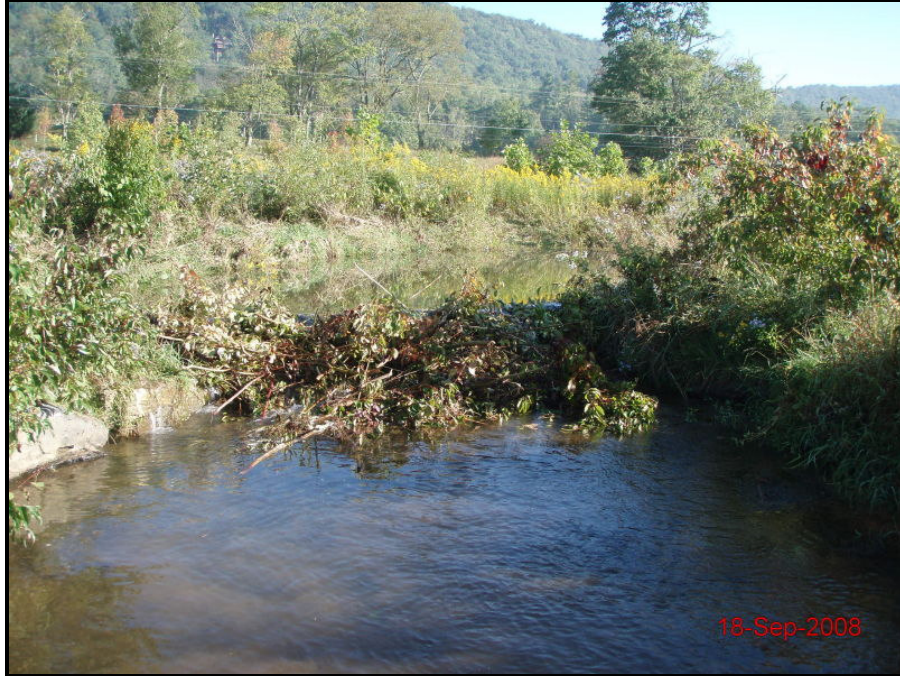
Stream Problem Area (SPA 1) – Beaver dam causing upstream aggradation
Monitoring Year 5 – September 18, 2008

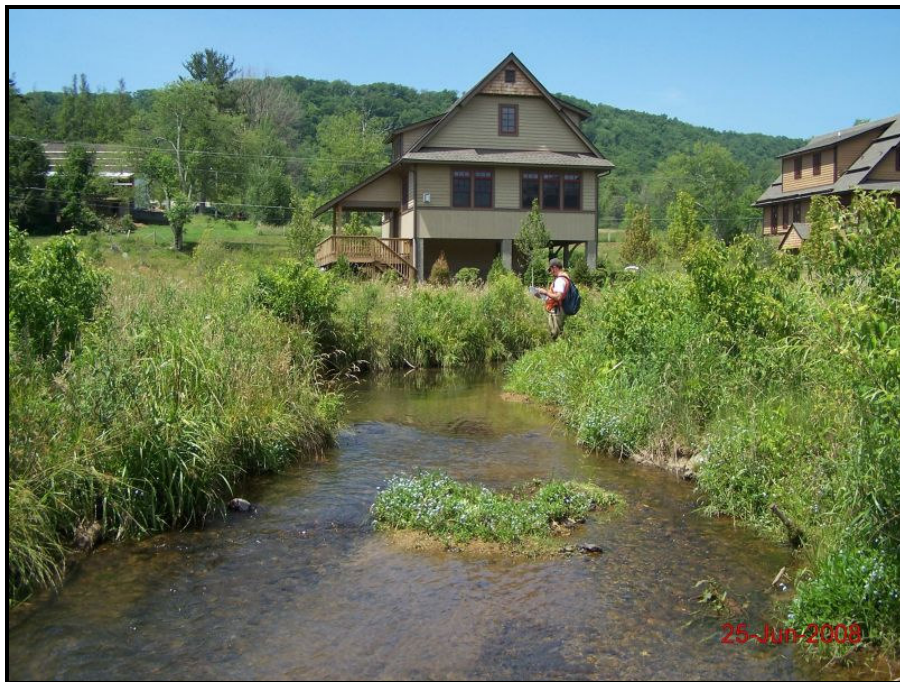
Stream Problem Area (SPA 2) – Mid channel bar associated with failing structure
Monitoring Year 5 – June 25, 2008

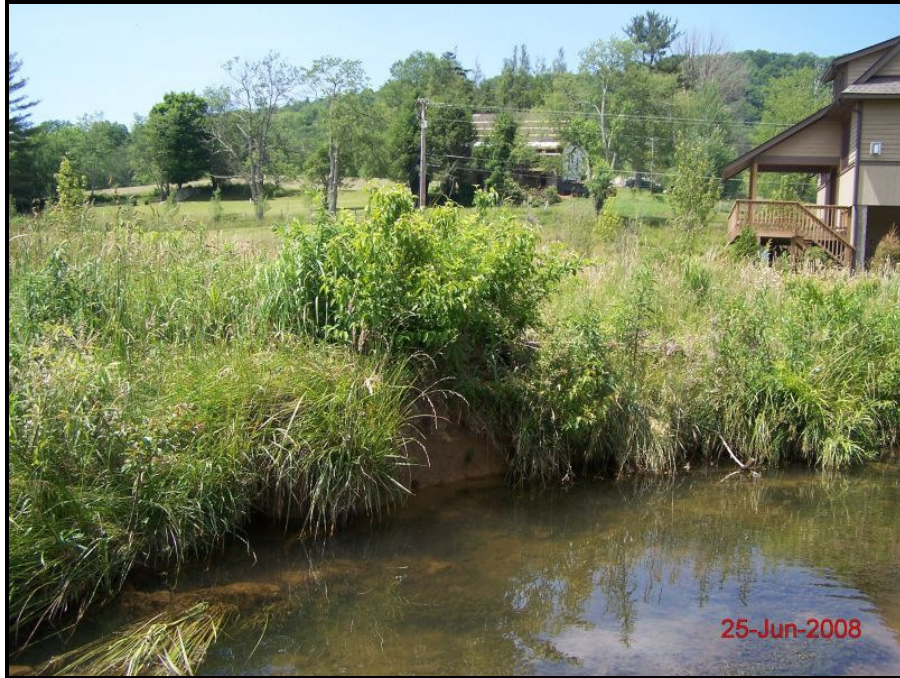
Stream Problem Area (SPA 3) – Bank scour
Monitoring Year 5 – June 25, 2008

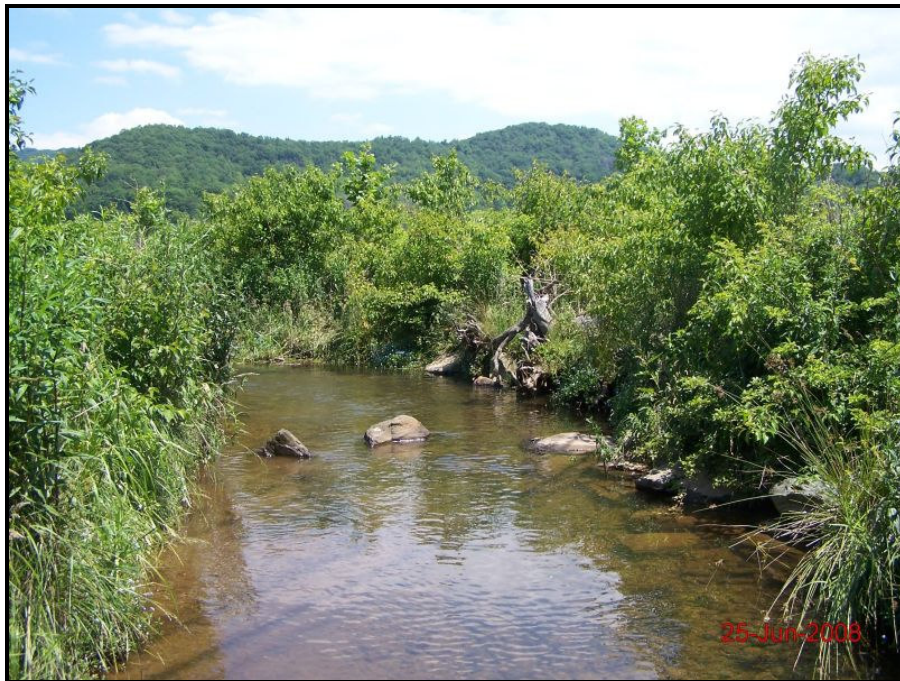
Stream Problem Area (SPA 4) – Failed engineered structure
Monitoring Year 5 – June 25, 2008

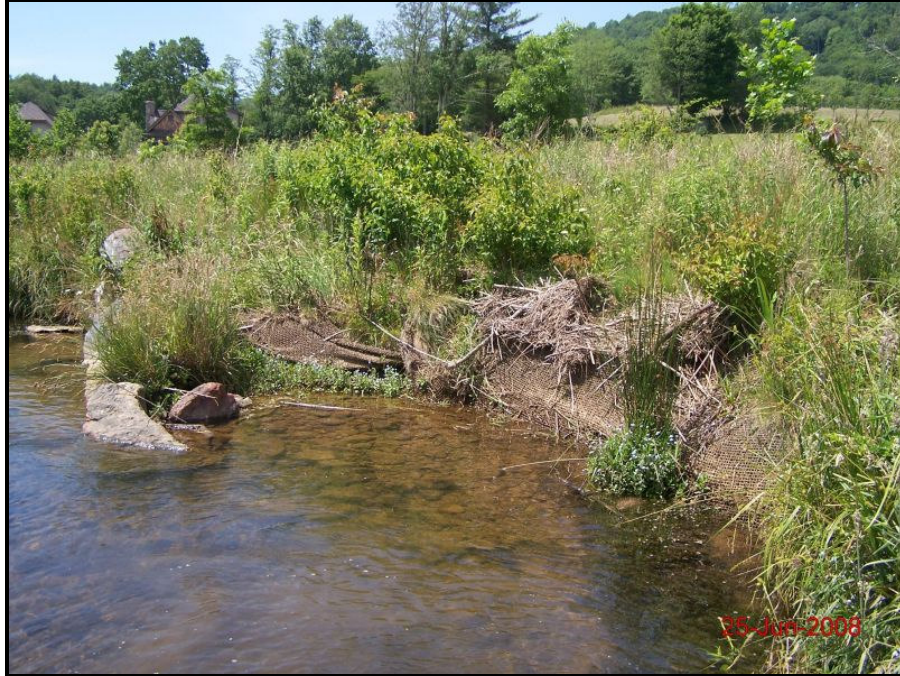
Stream Problem Area (SPA 5) – Stressed engineered structure
Monitoring Year 5 – June 25, 2008

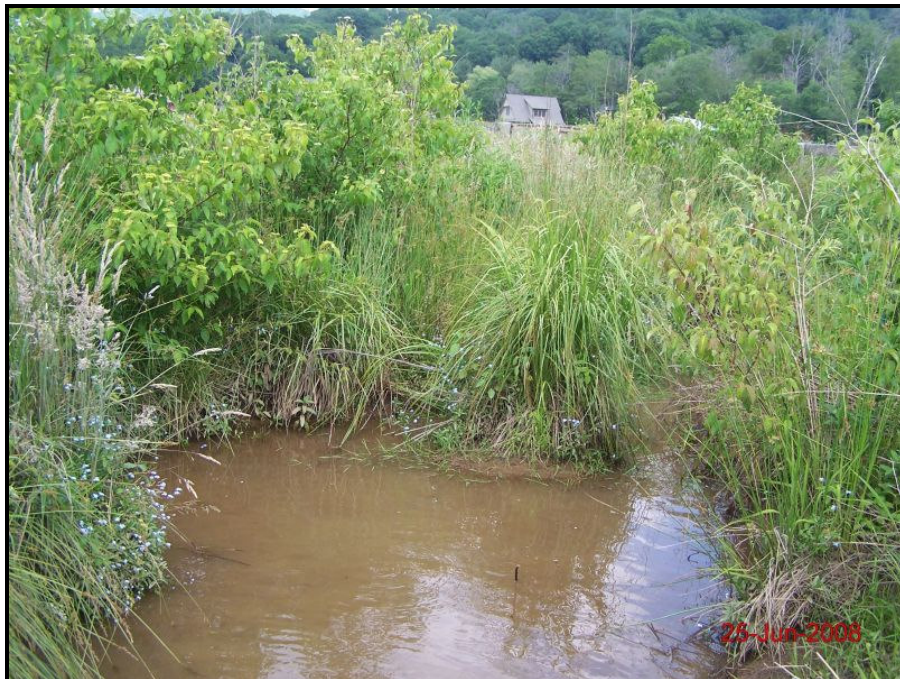
Stream Problem Area (SPA 6) – Mid channel bar within unnamed tributary
Monitoring Year 5 – June 25, 2008
