Monitoring Report

Harrell Stream and Wetland Mitigation Site

Monitoring Year 1-2020

NCDMS Project No. 100005

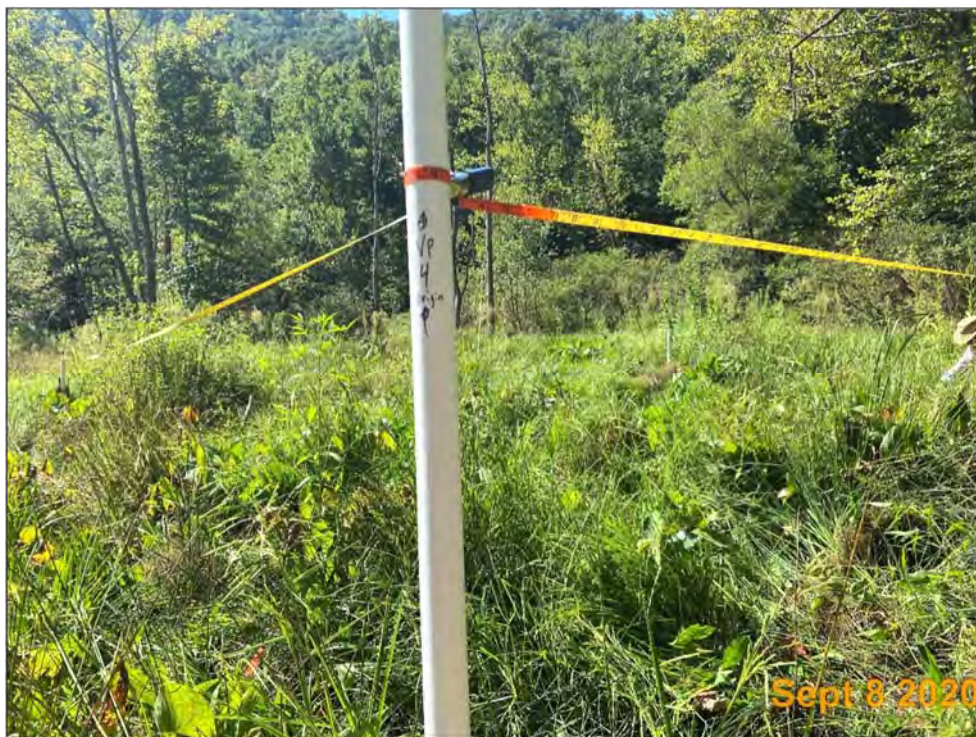
Vegetation Monitoring Plot 4

Section 1.5.1 Vegetation: Is any supplemental planting of more wet tolerant species proposed in the vicinity of VP4 during MY2 (2021)? Please briefly discuss and update the report text accordingly. **Supplemental planting is proposed for that area. Report and text updated accordingly.**

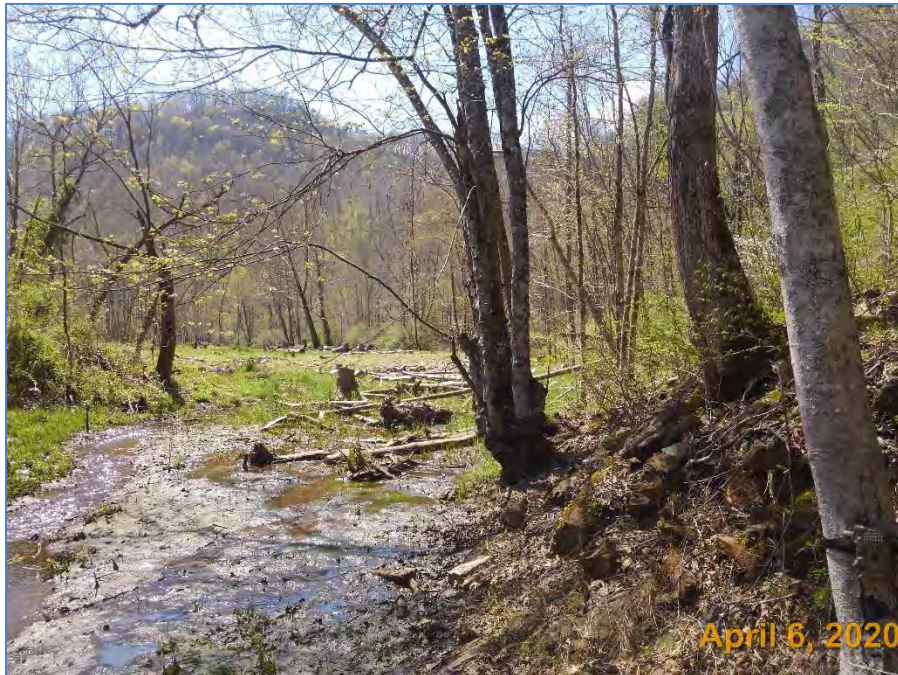
Section 1.5.2 – Stream Geomorphology (Reach 1D): Based on the Reach 1D photos provided and cross section 5, does EW Solutions have any concerns about this reach maintaining bed and bank stream features through the monitoring term? Please note that the IRT has historically required that mitigation project streams maintain jurisdictional bed and bank features for stream mitigation credit. DMS understands that EW Solutions has worked with NCDOT to keep the downstream culvert clear. These efforts should also be reported in the text. Please consider, discuss and update the report text accordingly. **EWS understands the concerns related to Reach 1D. Our primary concern is clogging of the DOT Culvert which has been monitored by both NCDOT and Equinox staff. MY1 data suggests stability within Reach 1D.**

Photo point #7, facing upstream, Reach 1D.

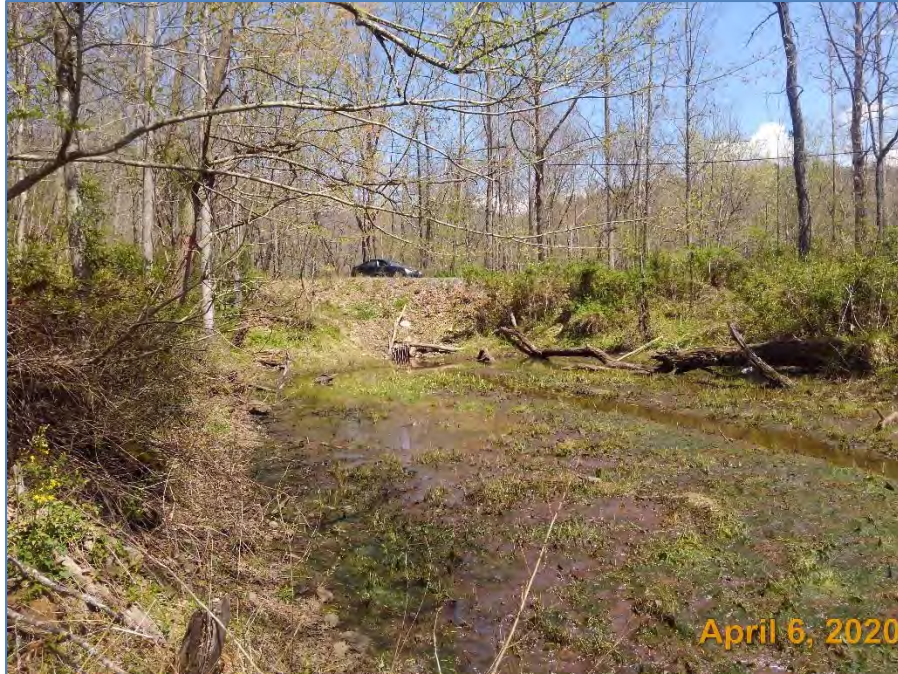
Photo point #7, facing downstream, Reach 1D.

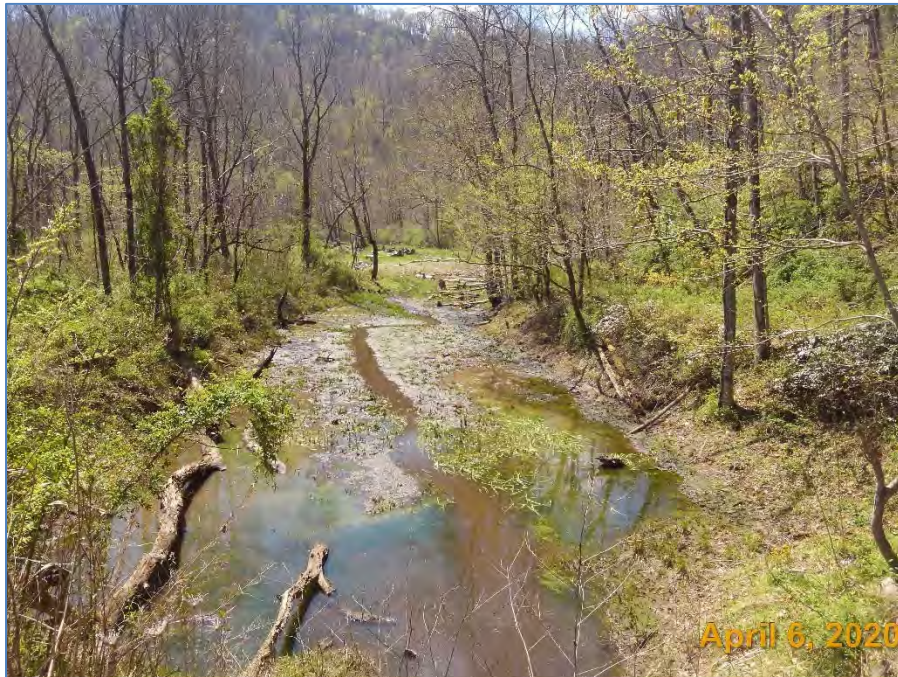
Photo point #8, facing upstream, Reach 1D.

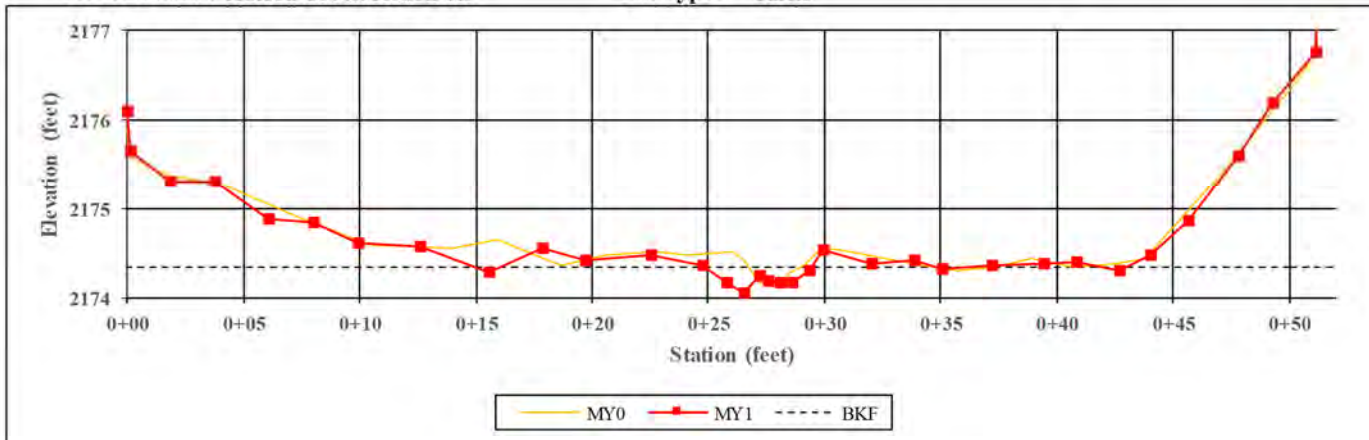
XS Number: 5
XS Type: Riffle

CHANNEL DIMENSIONS SUMMARY	MY0	MY1	MY2	MY3	MY4	MY5	MY6	MY7
Bankful Width (ft)	2.5	4.4	-	-	-	-	-	-
Floodprone Width (ft)	33.4	33.4	-	-	-	-	-	-
Bankfull Mean Depth (ft)	0.3	0.2	-	-	-	-	-	-
Bankfull Max Depth (ft)	0.4	0.3	-	-	-	-	-	-
Bankfull Cross-Sectional Area (ft ²)	0.7	0.7	-	-	-	-	-	-
Width/Depth Ratio	8.6	29.6	-	-	-	-	-	-
Entrenchment Ratio	13.2	7.5	-	-	-	-	-	-
Bank Height Ratio	1.0	1.1	-	-	-	-	-	-

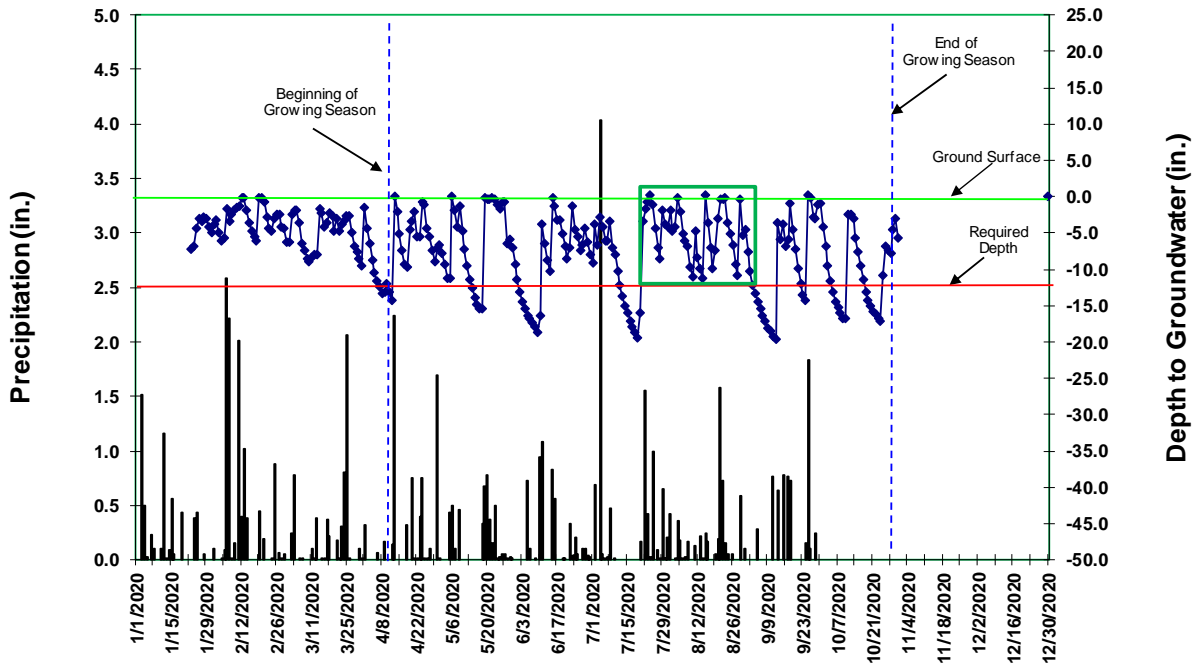
Two groundwater wells, #5 and 7, failed to meet the success criteria during MY1. Monitoring well 2 was meeting at a marginal level. Additional gages will be installed in the MY2 monitoring period to identify the wetland boundary and track both current and future wetland development along the northeastern wetland re-establishment zone. Monitoring well data shows some inconsistencies regarding total days deployed and number of days data was recorded. Groundwater gages #4 and 5 required replacement in April of 2020 due to unexpected gage failures. Gages #4 and 6 were frozen in place

Gauge ID: **MW2** Reported Growing Season Days: 201
 Total Number of Consecutive Days Water Table within 12 inches of Soil Surface: **34** 04/12-05/15
 Percentage of Growing Season Water Table within 12 inches of Soil Surface: **17%**

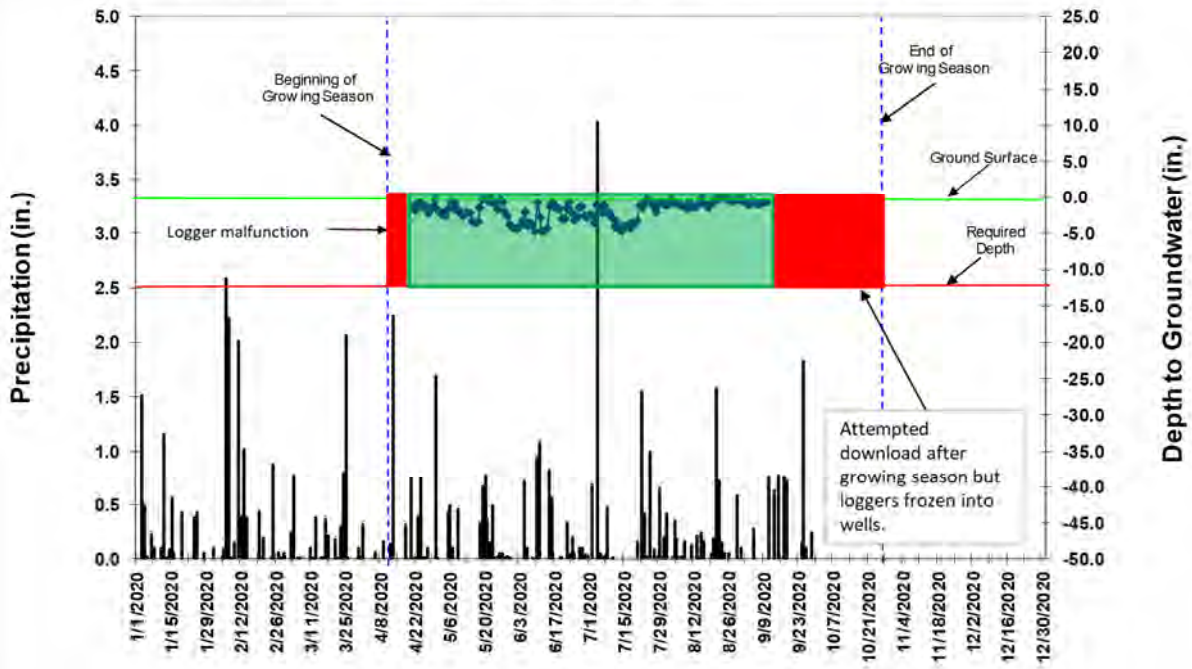
Gauge ID: **MW5** Reported Growing Season Days: 191
 Total Number of Consecutive Days Water Table within 12 inches of Soil Surface: **6**
 Percentage of Growing Season Water Table within 12 inches of Soil Surface: **3%**

Dates: **04/21-04/26**

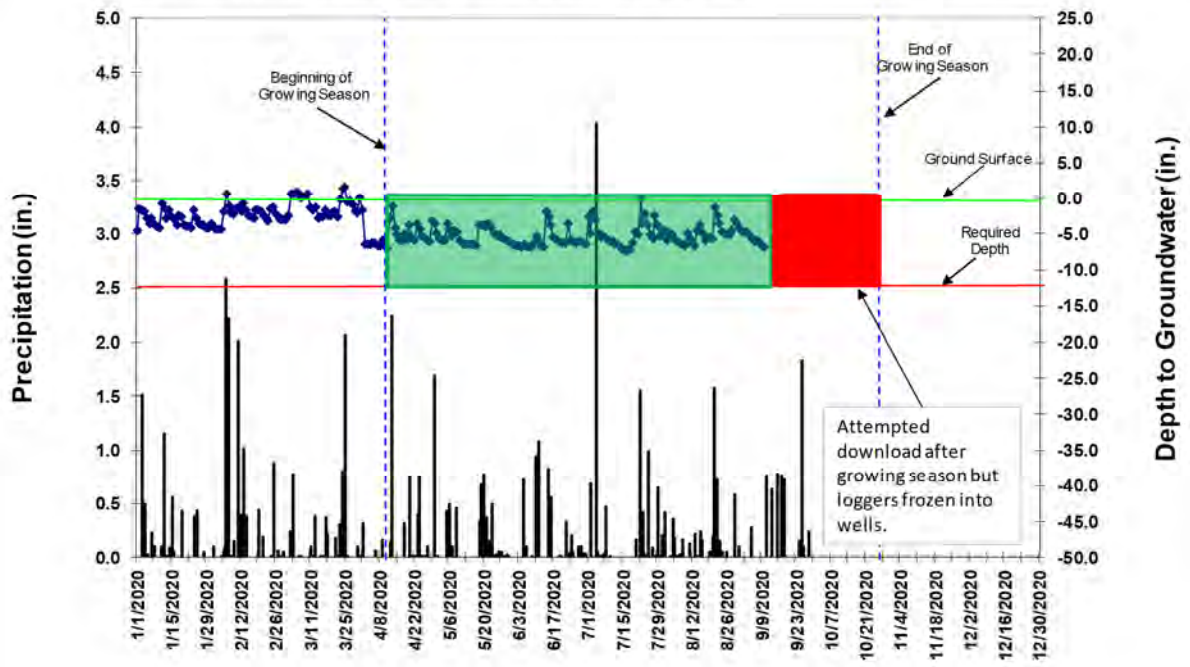
Gauge ID: **MW7** Reported Growing Season Days: 201
 Total Number of Consecutive Days Water Table within 12 inches of Soil Surface: **7** **05/18-05/23**
 Percentage of Growing Season Water Table within 12 inches of Soil Surface: **3%**
