Monitoring Report

Harrell Stream and Wetland Mitigation Site

Monitoring Year 3 (2022)

NCDMS Project No. 100005

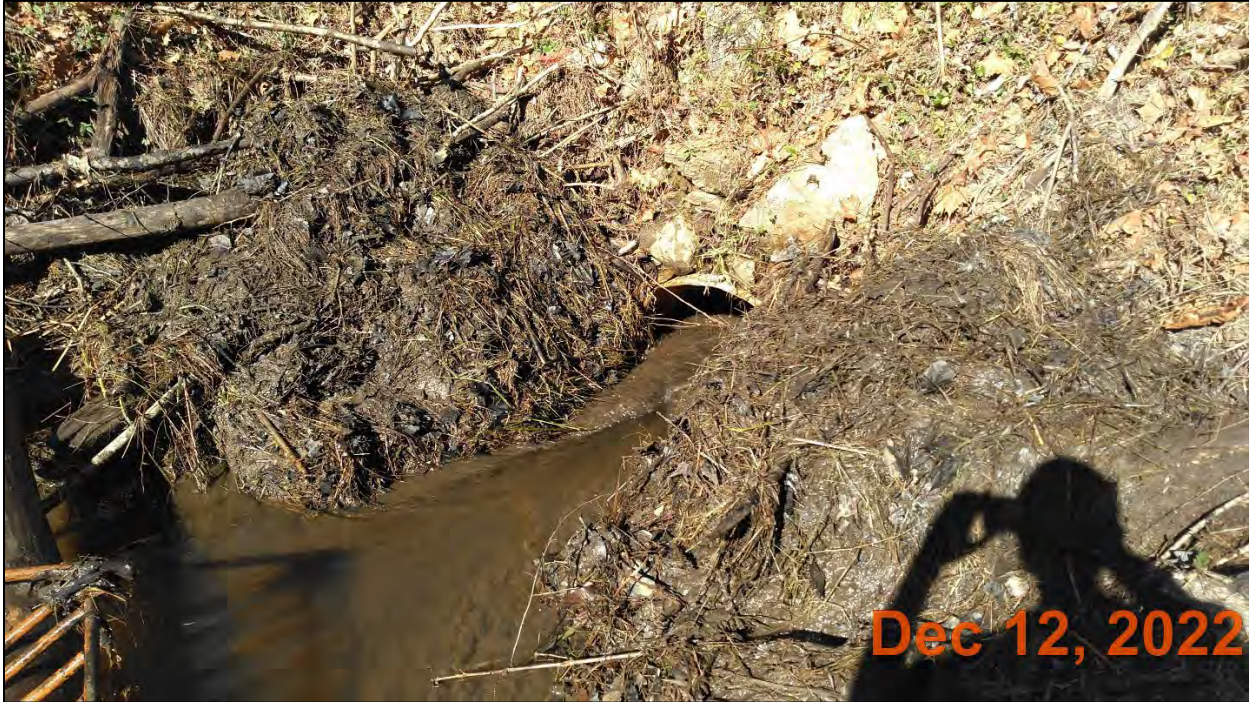
One beaver dam was identified during MY3. This dam was located just outside of the easement at the Caney Fork Rd culvert. This dam was removed following a trapping effort in June 2022, and again in November 2022. Beaver have been an intermittent problem in Reach D since project completion. Aphis is actively working the site. The site will continue to be monitored for beaver activity. No other areas of instability were noted in MY3.

Beaverdam at Caney Fork Rd Culvert

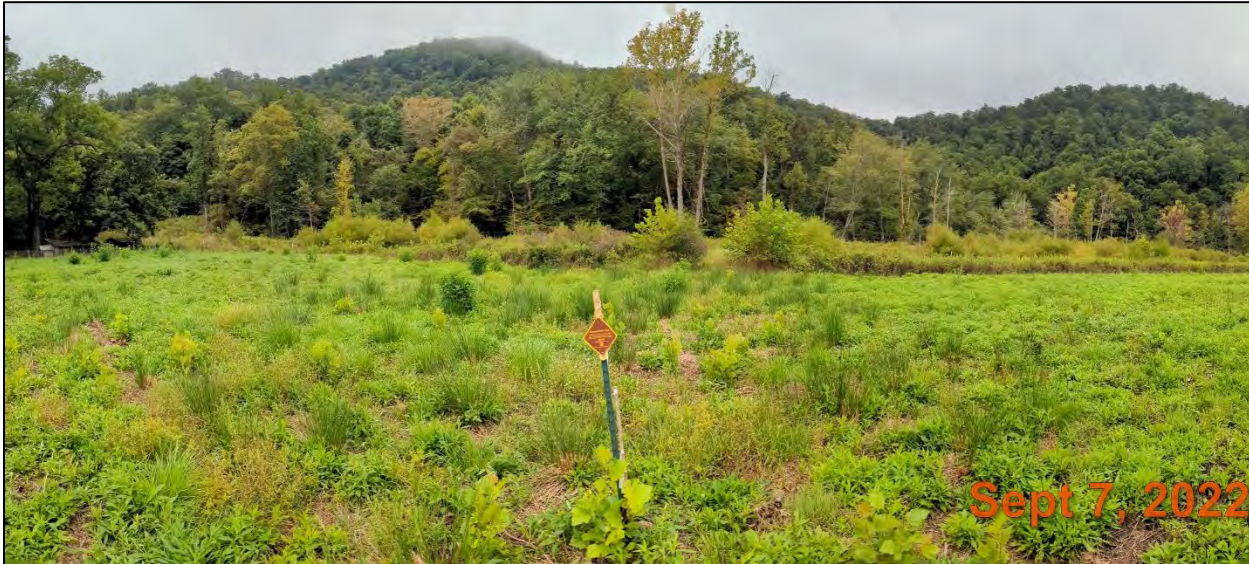
Easement Violation (Mowing) Station 103+00 to 105+50

- Mowed areas will require re-planting in accordance with the approved mitigation plan and IRT coordination. **Replanting of woody stems will be conducted as part of the repair and reclamation of encroachment areas. Species will be selected from those within the approved mitigation plan.**

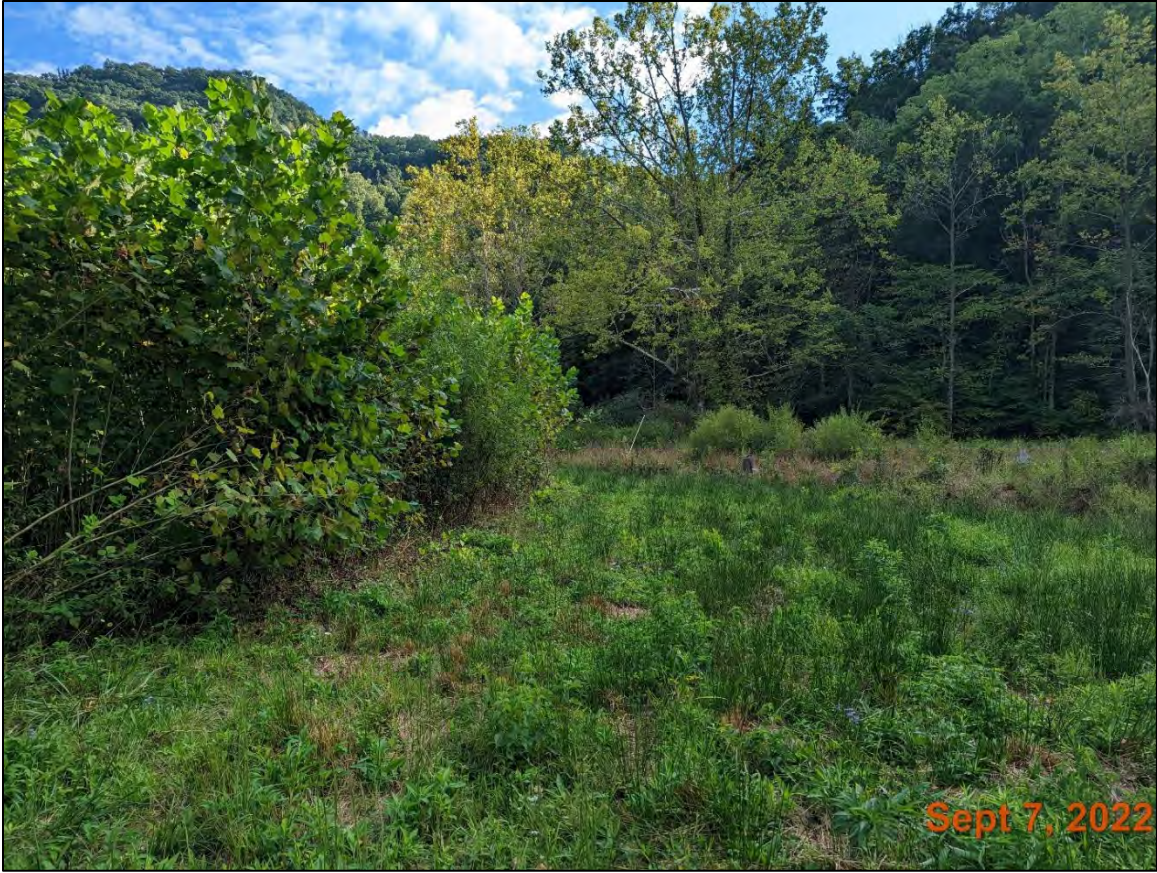
Easement Violation (Mowing) Station 113+00 to 115+00

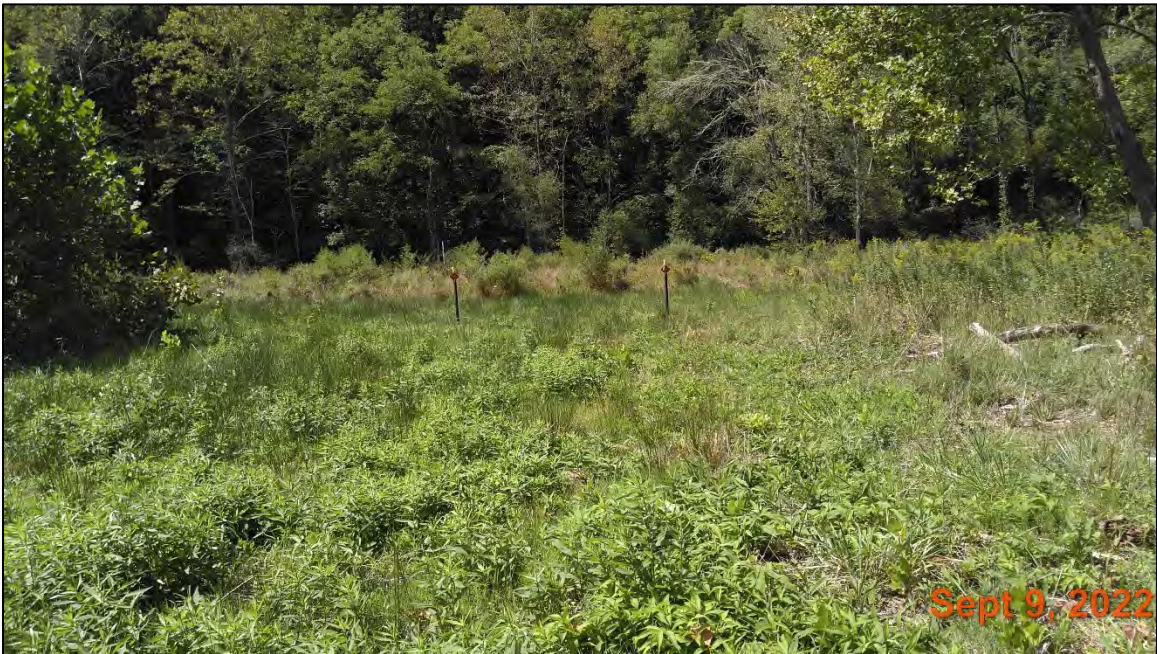
Easement Violation additional signs, 113+00 to 115+00

- Repair damaged and improperly fastened signs. **Damaged signs will be replaced and upgraded to solid aluminum fastener and u-post configuration. Low visibility signage will be retained on the northern easement boundary/field interface as per request from the original property owner.**

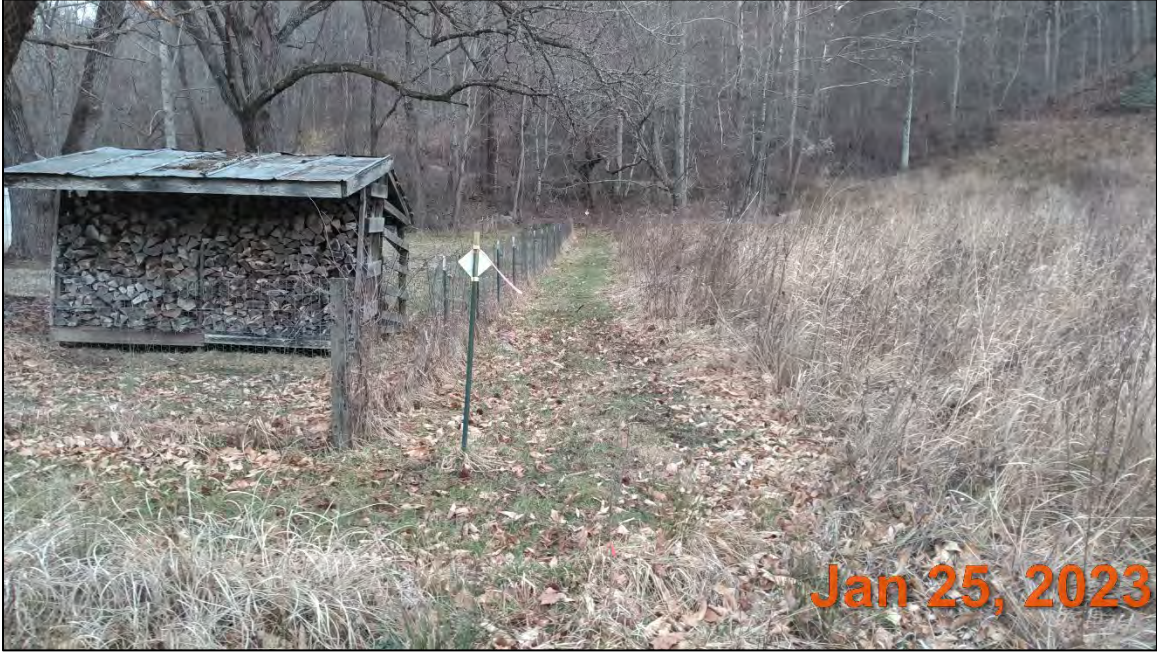
Problem Area Photos: Please include an additional photo of the third encroachment area along the residential fence line as reported in the report text and observed on-site. **Added.**

Easement Violation (Mowing) along residential fence line.

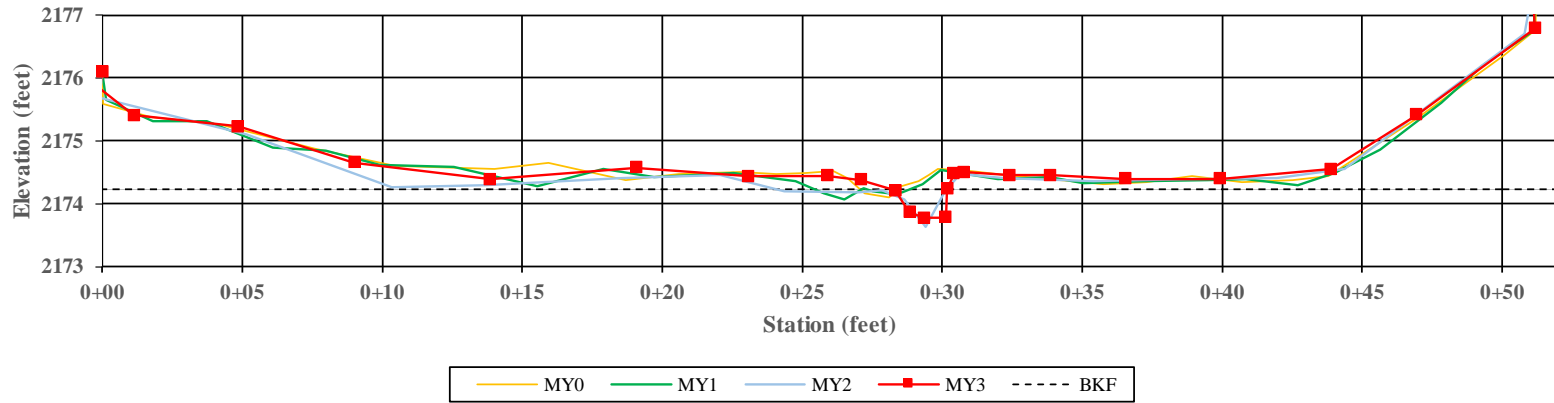
XS Number: 5
XS Type: Riffle

CHANNEL DIMENSIONS SUMMARY	MY0	MY1	MY2	MY3	MY4	MY5	MY6	MY7
Bankfull Width (ft)	2.5	4.4	5.8	1.8	-	-	-	-
Floodprone Width (ft)	33.4	33.4	33.4	33.4	-	-	-	-
Bankfull Mean Depth (ft)	0.3	0.2	0.1	0.4	-	-	-	-
Bankfull Max Depth (ft)	0.4	0.3	0.6	0.5	-	-	-	-
Bankfull Cross-Sectional Area (ft ²)	0.7	0.7	0.7	0.7	-	-	-	-
Width/Depth Ratio	8.6	29.6	46.4	4.9	-	-	-	-
Entrenchment Ratio	13.2	7.5	5.8	18.5	-	-	-	-
Bank Height Ratio	1.0	1.1	1.4	1.0	-	-	-	-

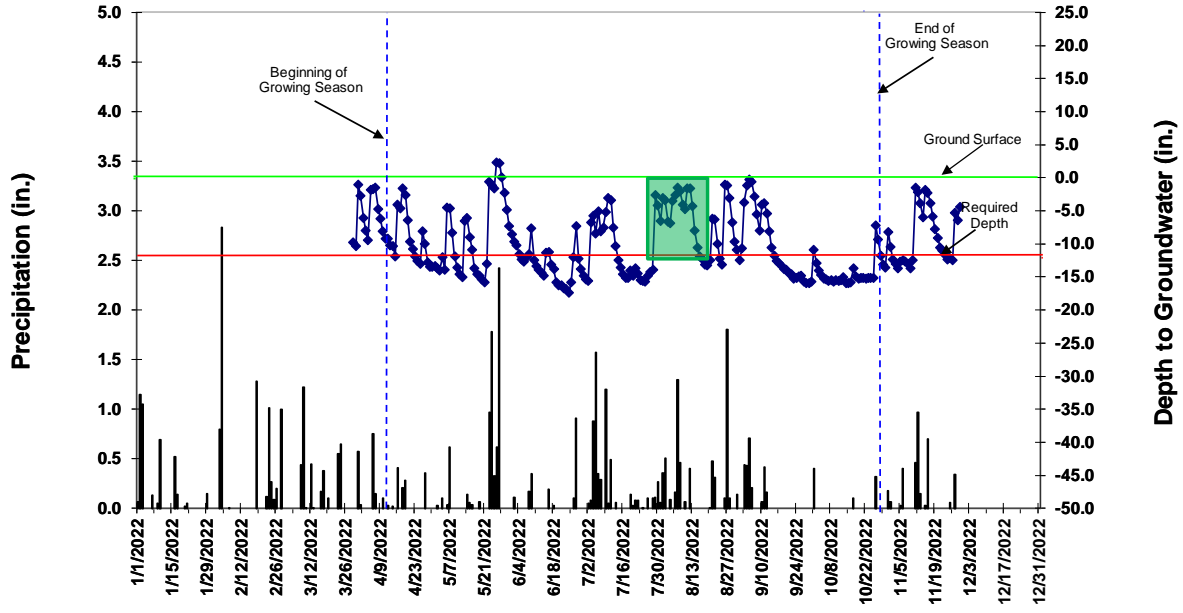
Four groundwater wells, #1, 2, 5, and 7, failed to meet the success criteria during MY3. Monitoring well #1 fell short of the performance criteria at 10%. Monitoring well #2 was similarly short of performance thresholds at 9%. The region had been experiencing intermittent level of drought conditions during MY3 (Drought.gov). Based upon the past performance of groundwater wells 5 and 7

Gauge ID: **MW2** Reported Growing Season Days: 201
Total Number of Consecutive Days Water Table within 12 inches of Soil Surface:
Percentage of Growing Season Water Table within 12 inches of Soil Surface:

Dates: **19 07/29-08/16**
9%

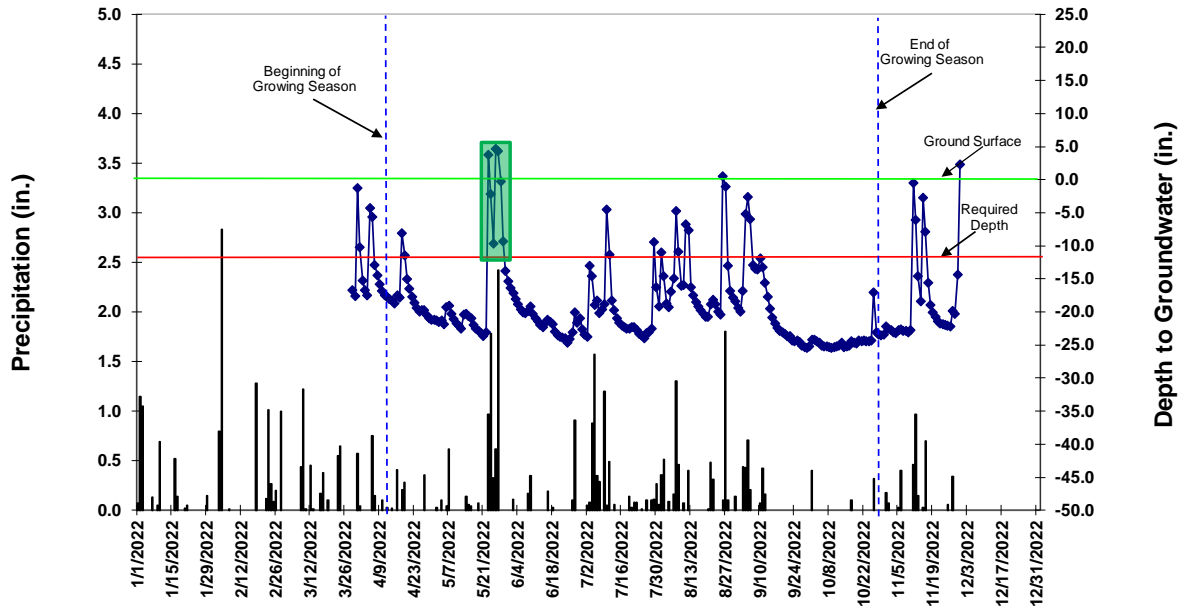
Gauge ID: **MW5** Reported Growing Season Days: 201
 Total Number of Consecutive Days Water Table within 12 inches of Soil Surface: **7**
 Percentage of Growing Season Water Table within 12 inches of Soil Surface: **3%**

Dates: **7 05/22-05/28**
3%

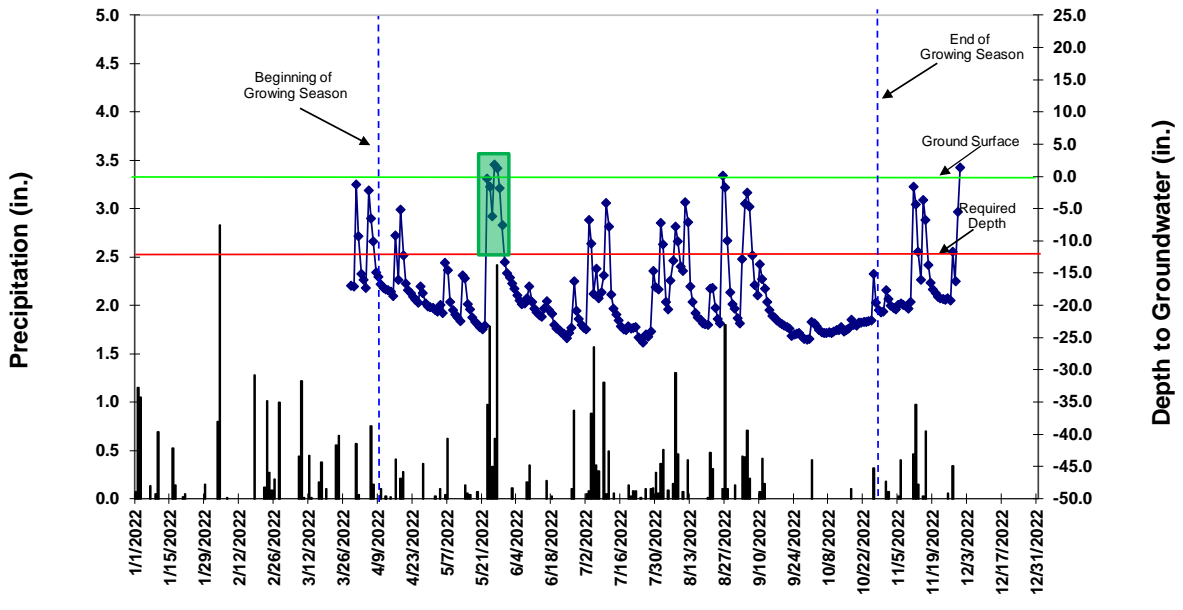
Gauge ID: **MW7** Reported Growing Season Days: 201
 Total Number of Consecutive Days Water Table within 12 inches of Soil Surface: **7** 05/22-05/28
 Percentage of Growing Season Water Table within 12 inches of Soil Surface: **3%**
