# **Monitoring Report**

Harrell Stream and Wetland Mitigation Site

Monitoring Year 4 (2023)

NCDMS Project No. 100005

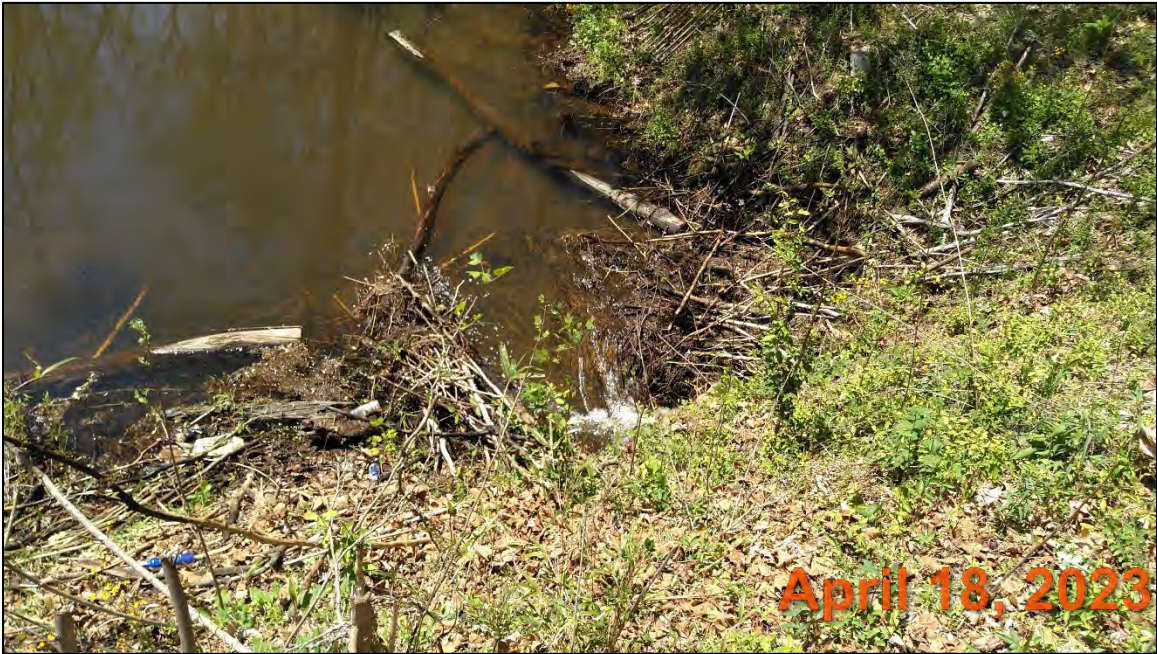
One beaver dam was identified during MY4. This dam was located just outside of the easement at the Caney Fork Rd culvert. This dam was removed in April, 2023 following trapping efforts in late March 2023. Beaver have been an intermittent problem in Reach D since project completion. EWS has an active agreement with Aphis for beaver management. The site will continue to be monitored for beaver activity. No other areas of instability were noted in previous monitoring years.

Beaverdam at Caney Fork Rd Culvert

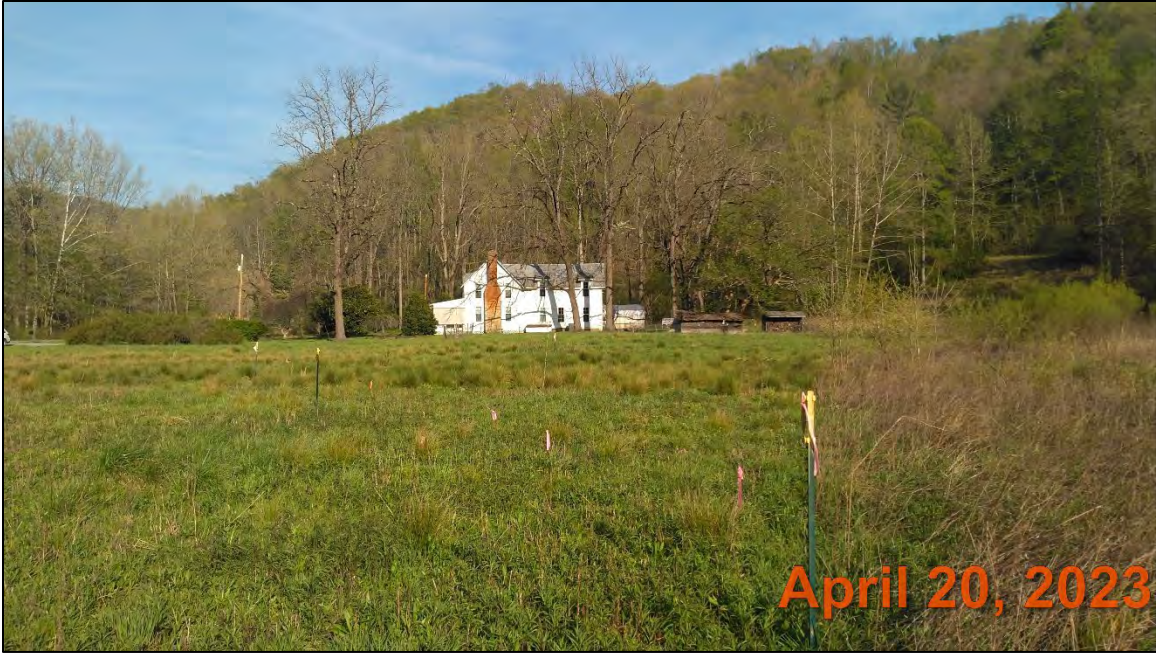
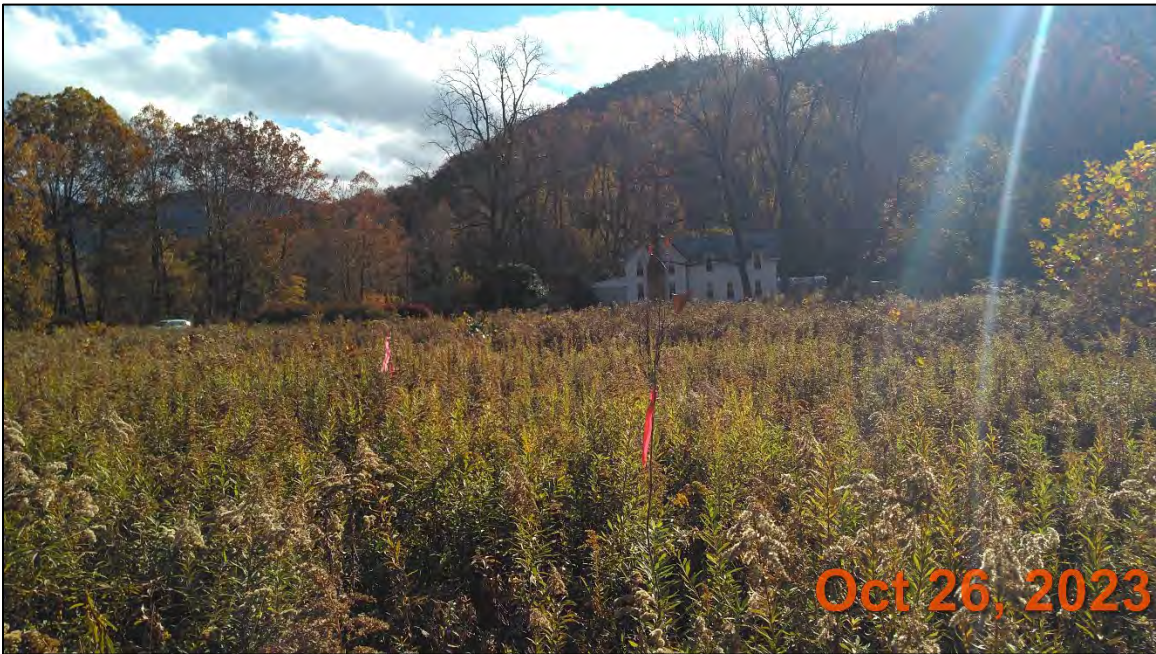
A supplemental planting was conducted on March 2, 2023 in two areas impacted by a mowing encroachment during MY3. One-gallon plantings were installed along the northern portion of the easement adjacent to Wetland B. A second area located along the northwestern easement boundary near vegetation plot #5 was planted during this effort. Refer to Appendix A, CCPV for the supplemental planting area. A table of species and material type can be found in Appendix F.

Replanted Easement Violation (Mowing) Station 103+00 to 105+50

- Mowed areas will require re-planting in accordance with the approved mitigation plan and IRT coordination. **Replanting was conducted using size appropriate species, at year appropriate density, drawn from the approved mitigation plan.**

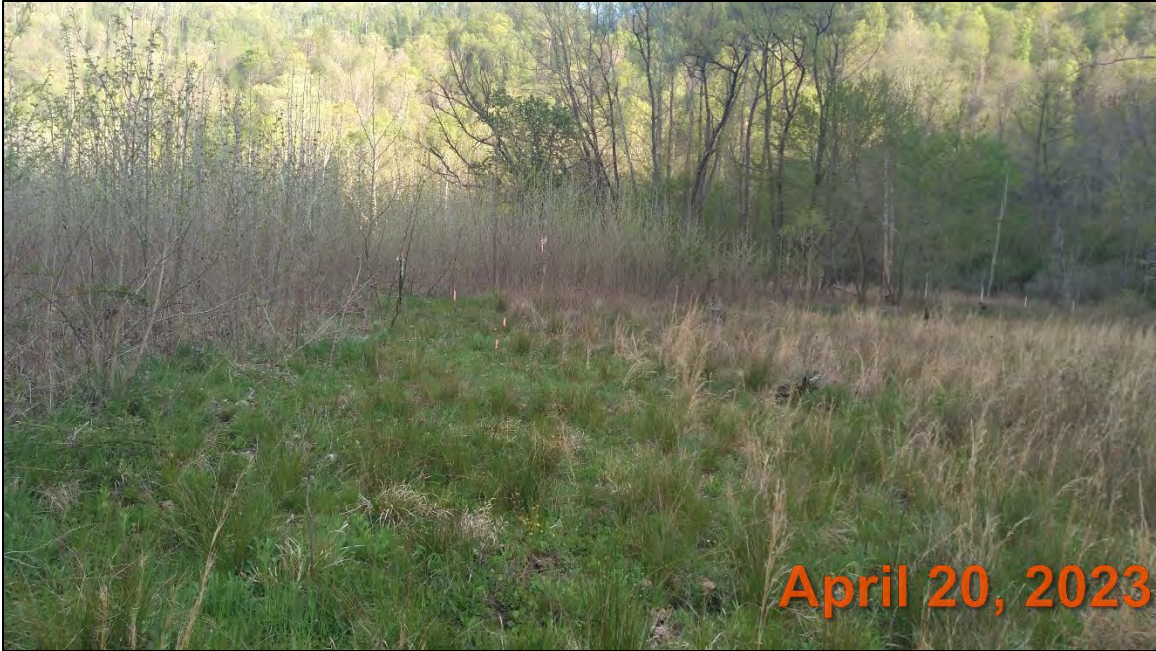
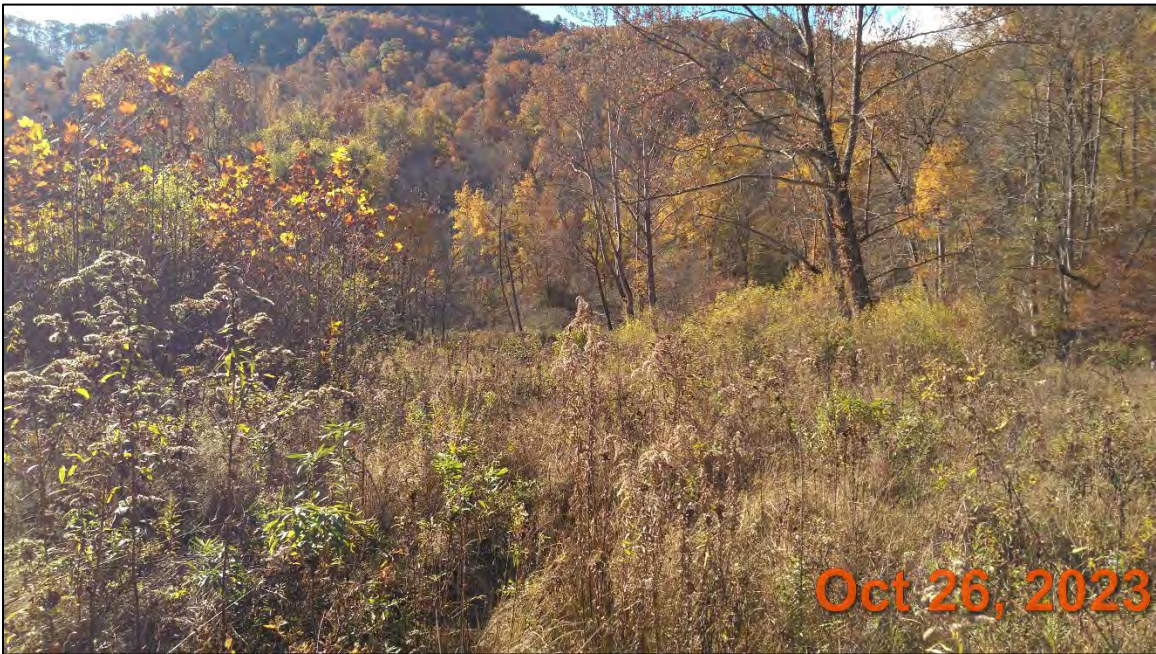
Replanted easement violation Station 113+00 to 115+00, US.

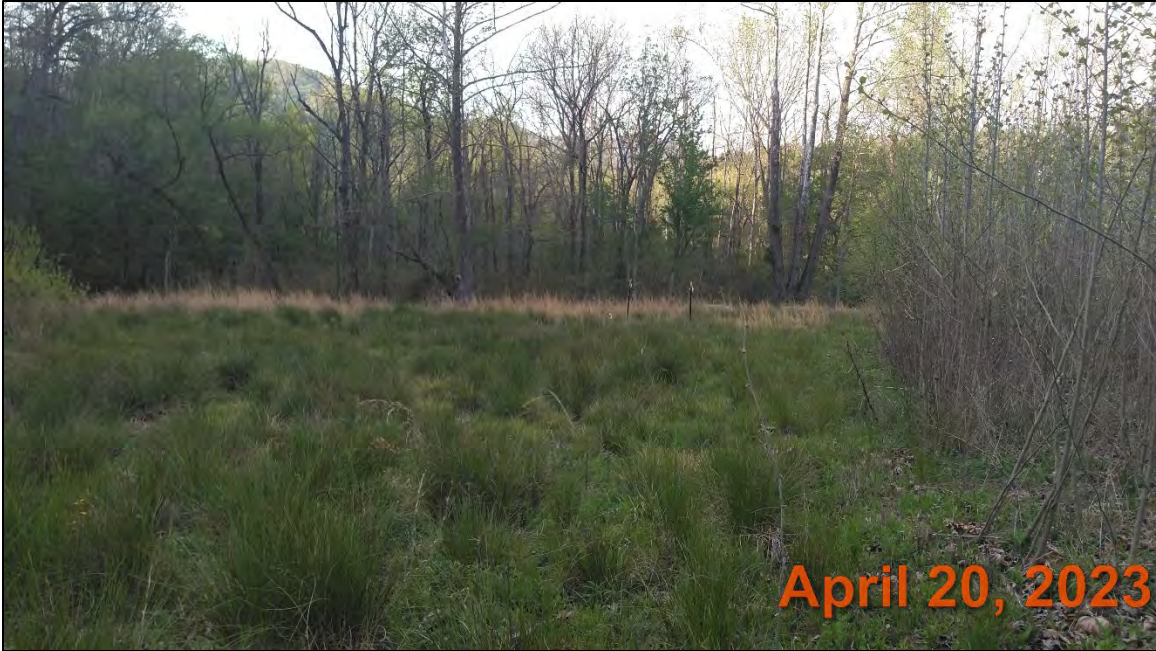
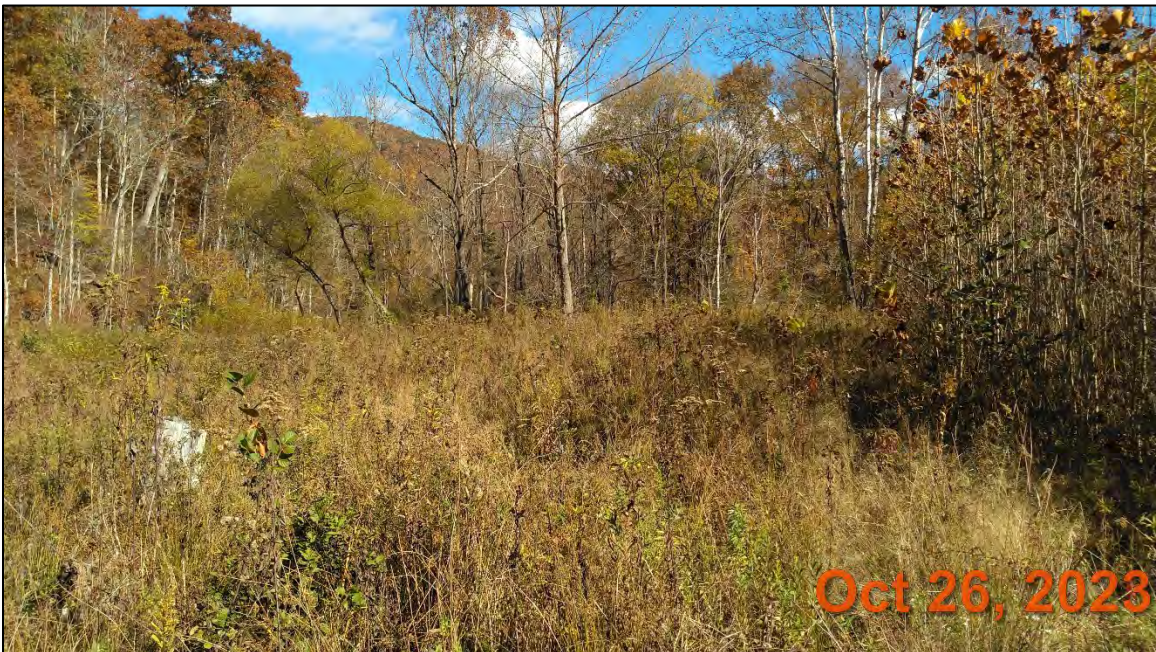
Replanted easement violation, Station 113+00 to 115+00, DS.

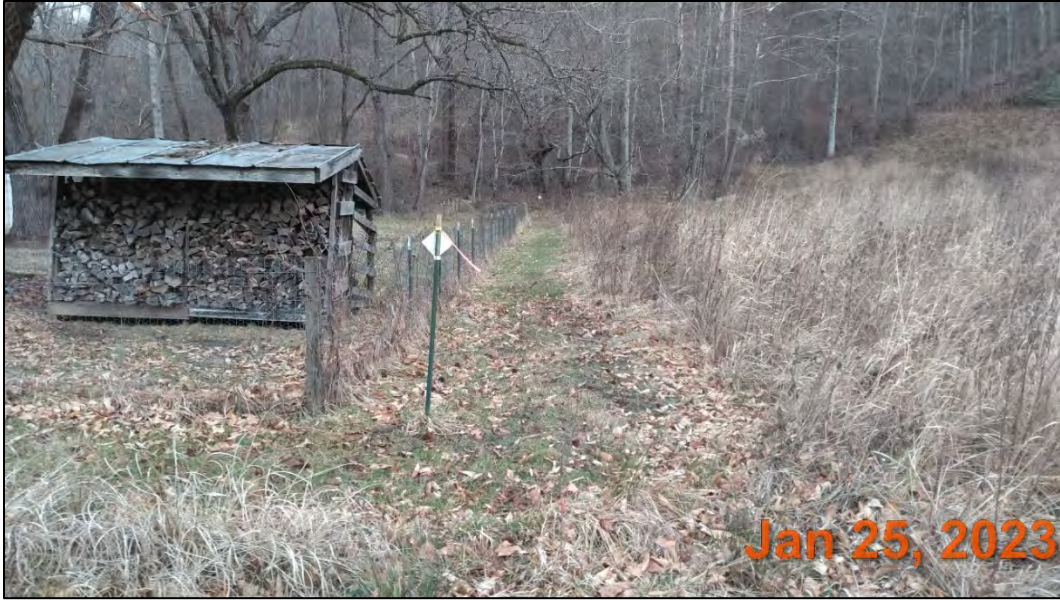
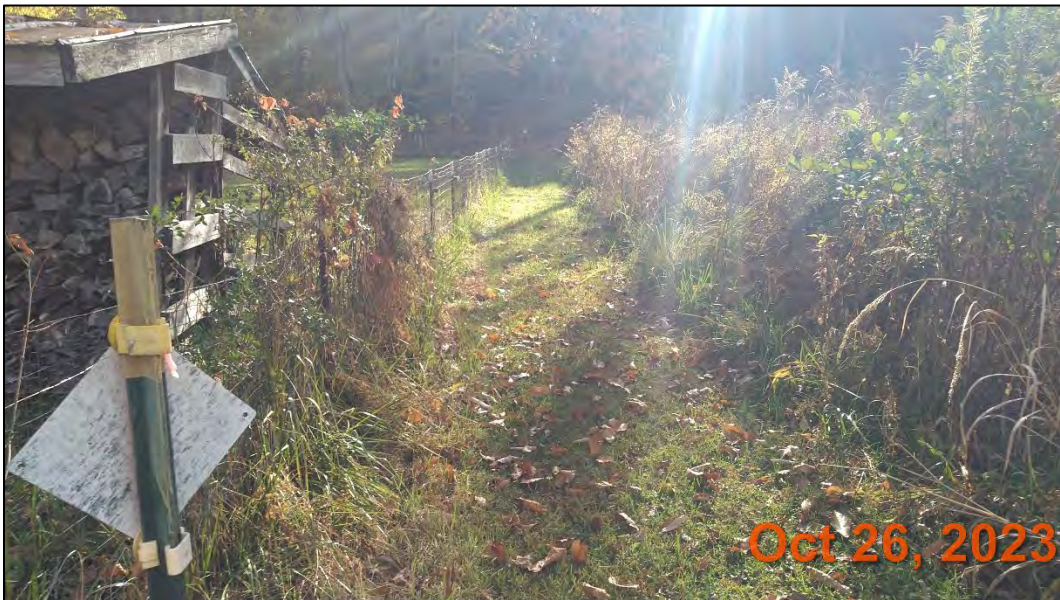
Easement Violation (Mowing) along to be realigned residential fence line.

Please review the notes and confirm that all the requests, IRT questions and full delivery provider commitments from the 2023 credit release meeting have been addressed and included in the final MY4 (2023) report. **Yes, with the exception of moving a segment of residential fence and replanting the**

**linear mowing encroachment along the southern boundary of the residential yard.**

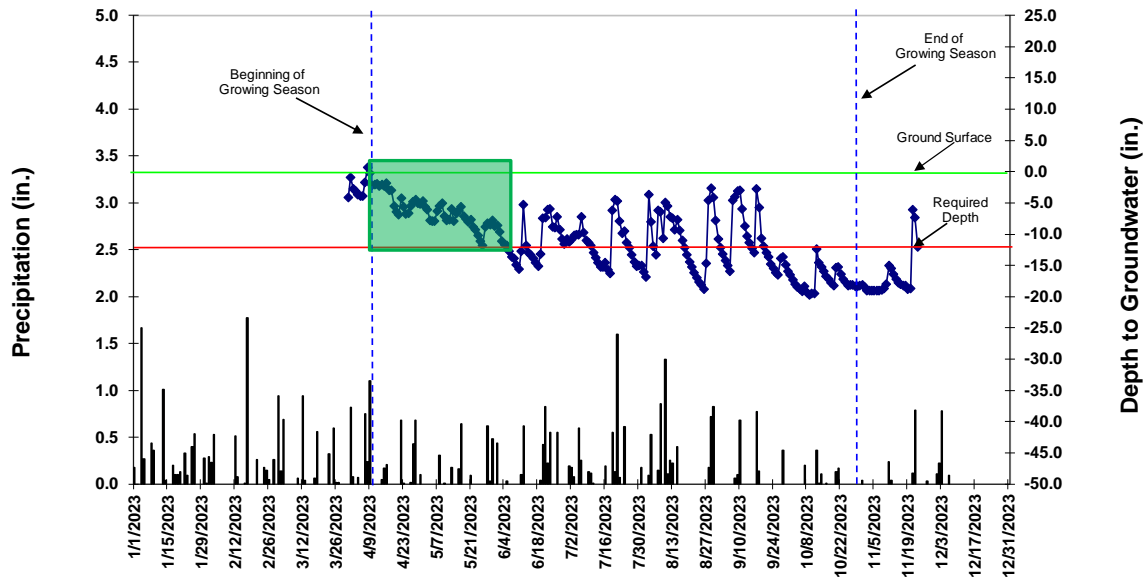
Gauge ID: **MW8** Reported Growing Season Days: 201  
Total Number of Consecutive Days Water Table within 12 inches of Soil Surface:  
Percentage of Growing Season Water Table within 12 inches of Soil Surface:

Dates:  
**56 04/11-06/05**  
**28%**

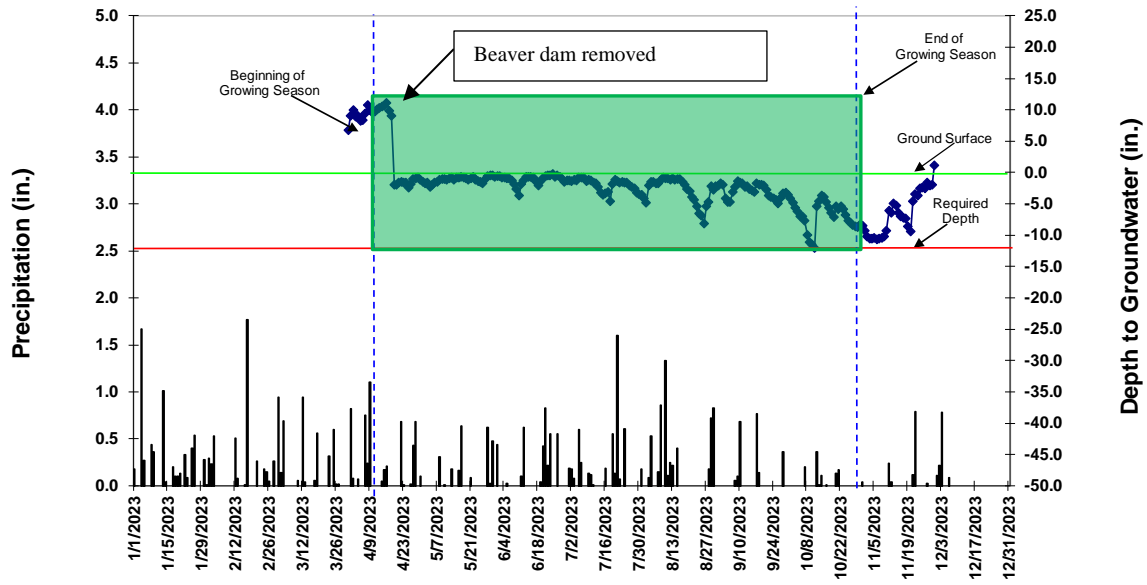
Gauge ID: **MW9** Reported Growing Season Days: 201  
Total Number of Consecutive Days Water Table within 12 inches of Soil Surface:  
Percentage of Growing Season Water Table within 12 inches of Soil Surface:

Dates:  
**201 04/11-10/28**  
**100%**
