Harrell Stream and Wetland Restoration Site Monitoring Report – MY01 Edgecombe County, NC

December 2008

EXECUTIVE SUMMARY

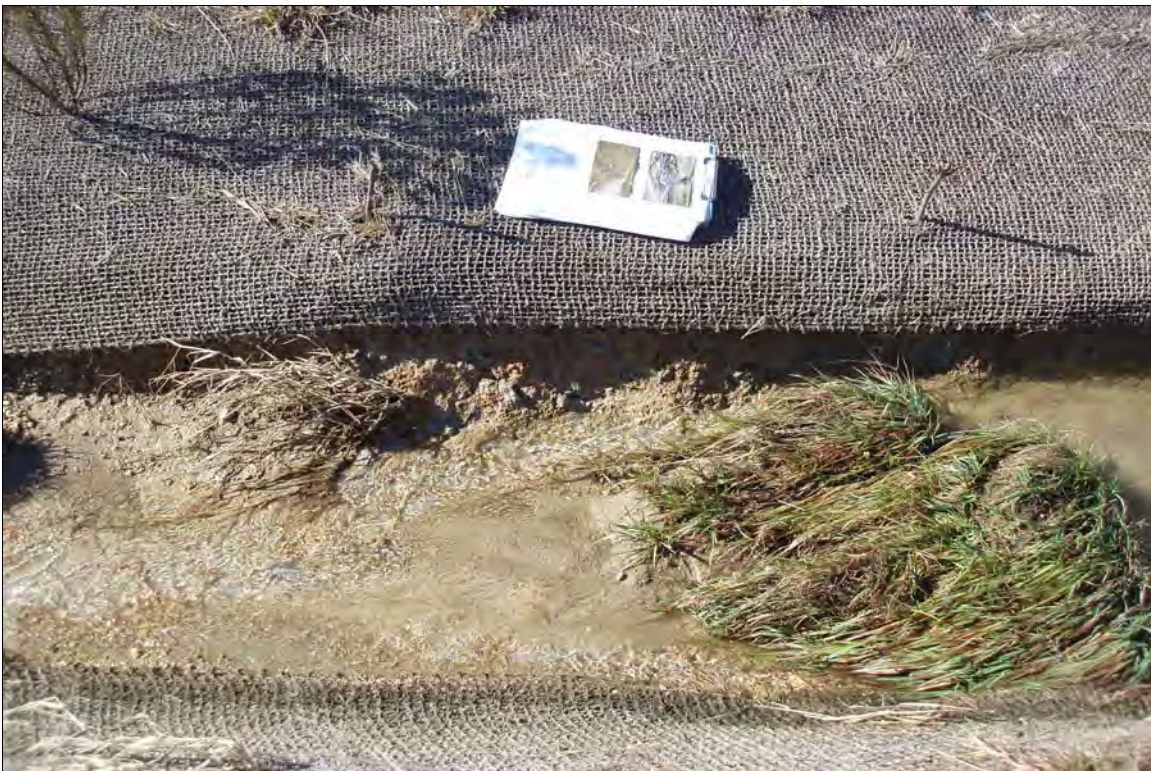
SP2 – Bed degradation near Station 33+40. 11/19/08 – MY-01

Maintenance was performed along the restored stream near stations 23+00, 37+00, 39+60 and 52+75. Minor bank and bed stabilization was conducted with rock at station 23+00 due to bed degradation. Near station 37+00 the banks of an incoming drainage ditch within the easement were sloped back and stabilized to alleviate bank erosion from the ditch. To further facilitate floodplain drainage, rock stabilization was added near Stations 39+60 and 52+75 where erosion was occurring as field drainage entered the channel. At each station erosion had been occurring. If any further maintenance actions are warranted, they will be documented in future monitoring reports.

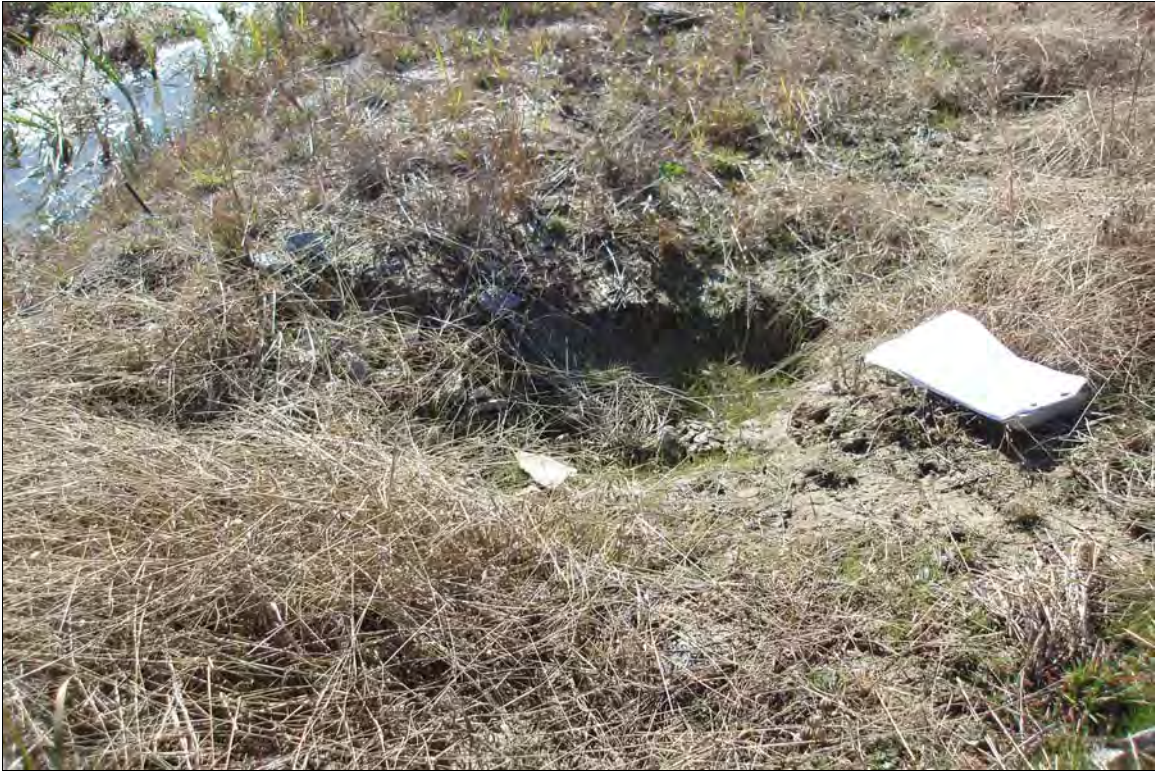
SP3 – Floodplain erosion near Station 43+95. 11/19/08 – MY-01

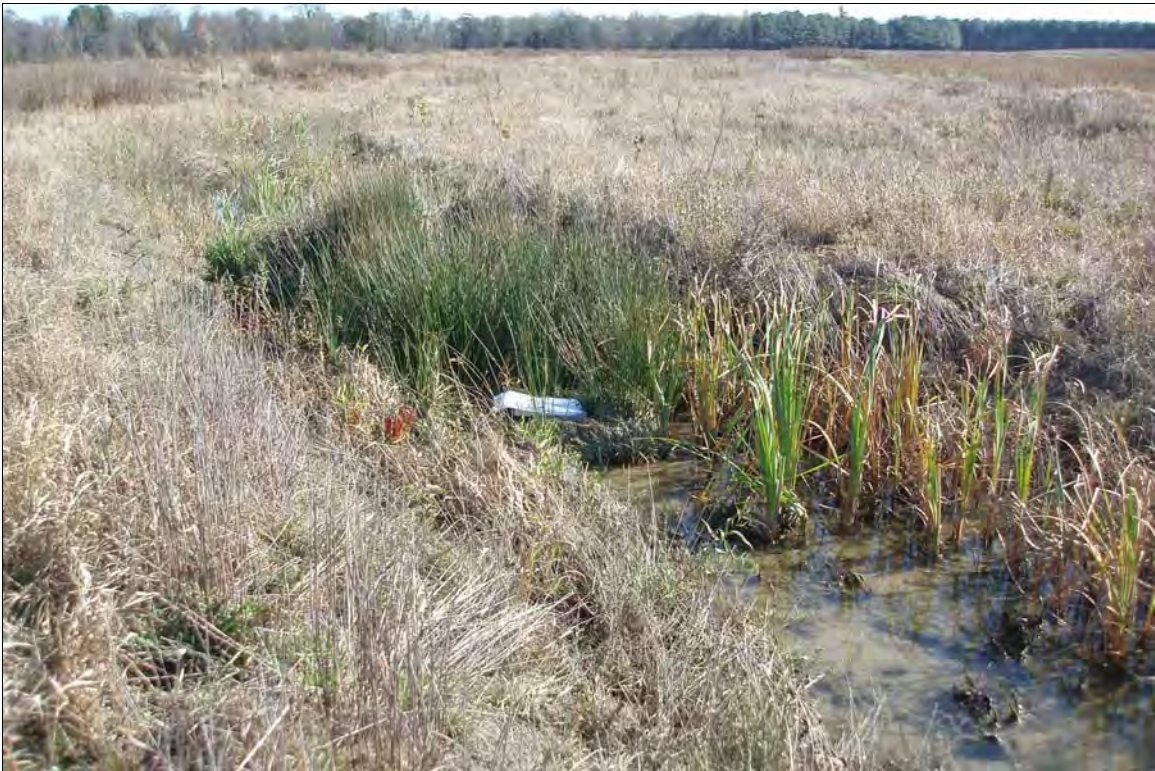
The low stream flow throughout the summer months allowed vegetation to become established in the stream channel. This vegetation included grasses, rushes, cattails, and Asian dayflower (*Murdannia keisak*). While contributing to the overall stream stability, this vegetation could contribute to aggradation in the channel by trapping sediment. Further monitoring will determine if channel vegetation becomes a problem.

SP4 – Dense vegetation in channel near Station 56+50. 11/19/08 – MY-01

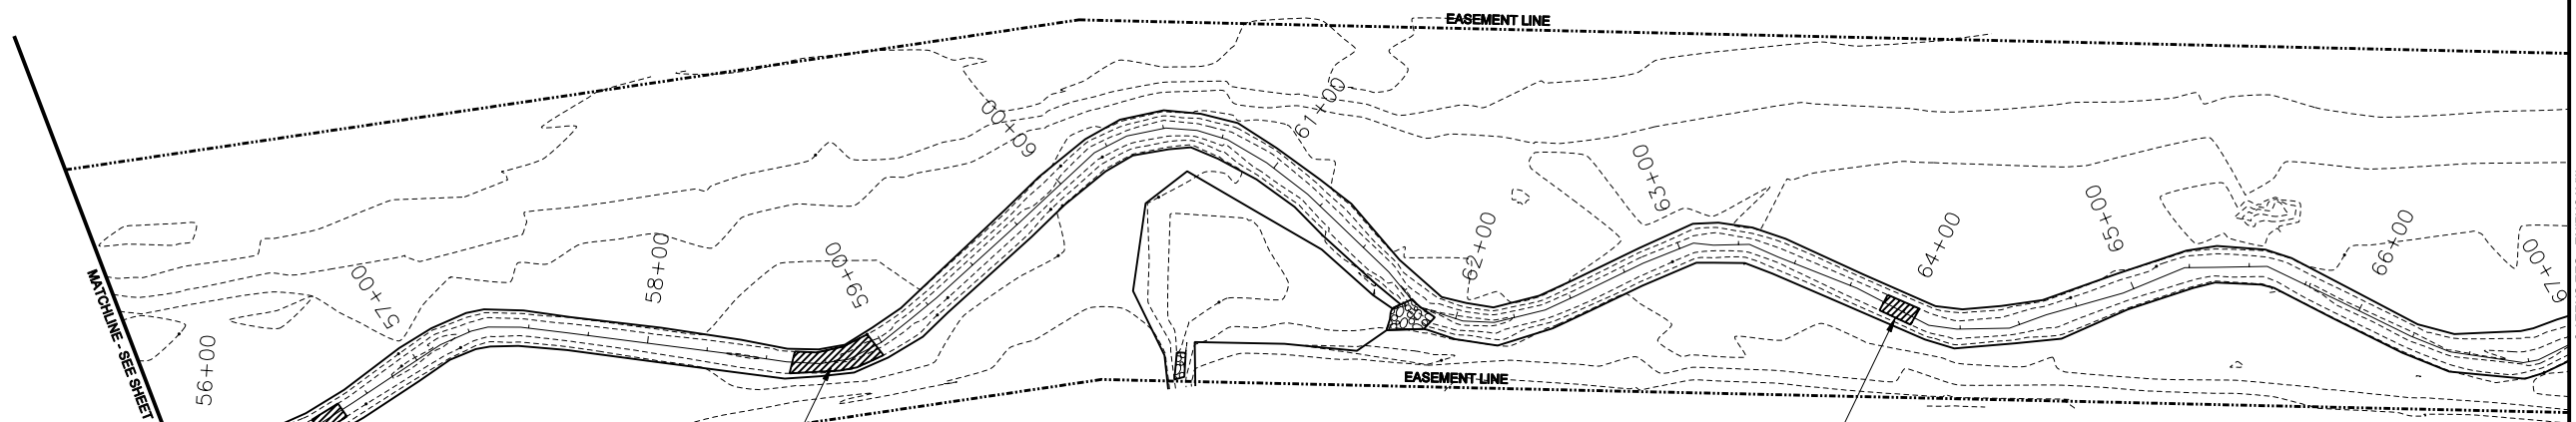
**HARRELL SITE
STREAM AND WETLAND RESTORATION**
EDGEcombe CO., NORTH CAROLINA
STATION 55+86 TO STATION 66+94

DENSE
VEGETATION
IN CHANNEL
