**Year 1 of 5 Monitoring Report  
Heath Dairy Road Stream Restoration Site  
Randolph County, NC**

**SCO Project Number 040633101  
NCDENR Division of Mitigation Services Project Number 170  
NCDENR D06017S  
USACE Action Item # SAW 2008 02860**

**Construction Completed: August 2013  
Data Collection: November 2014  
Submitted: March 2015**

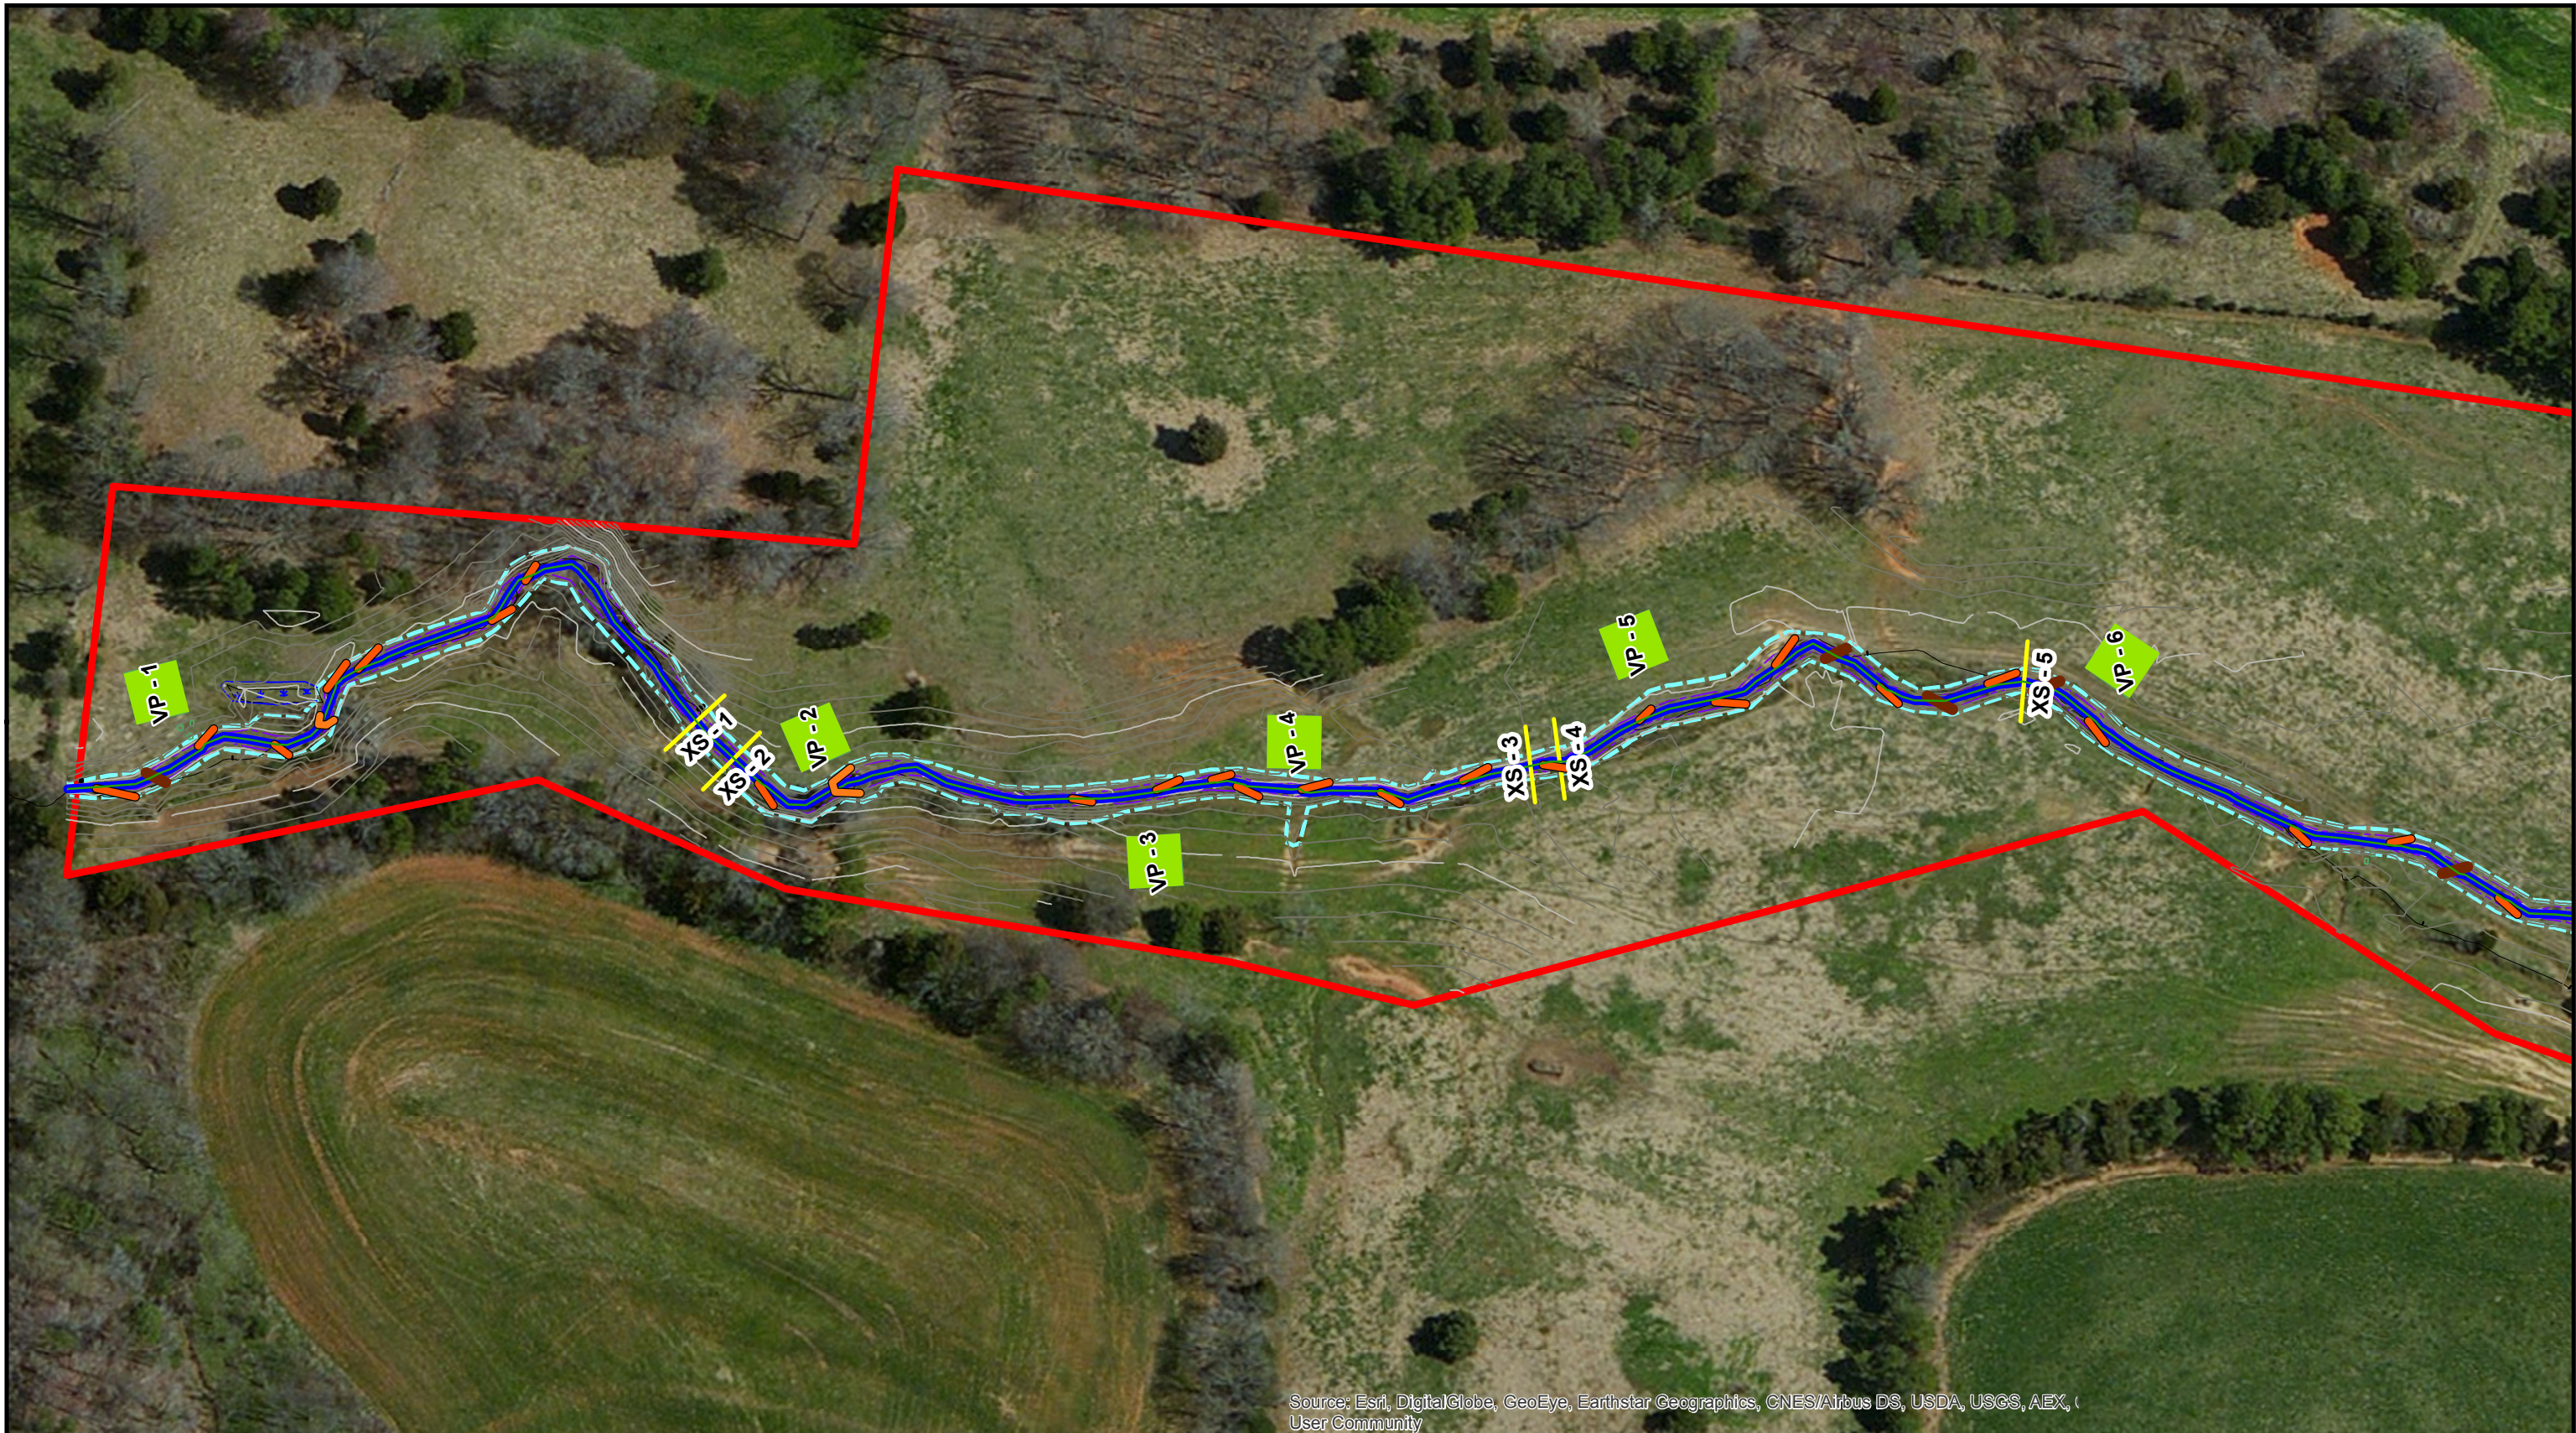
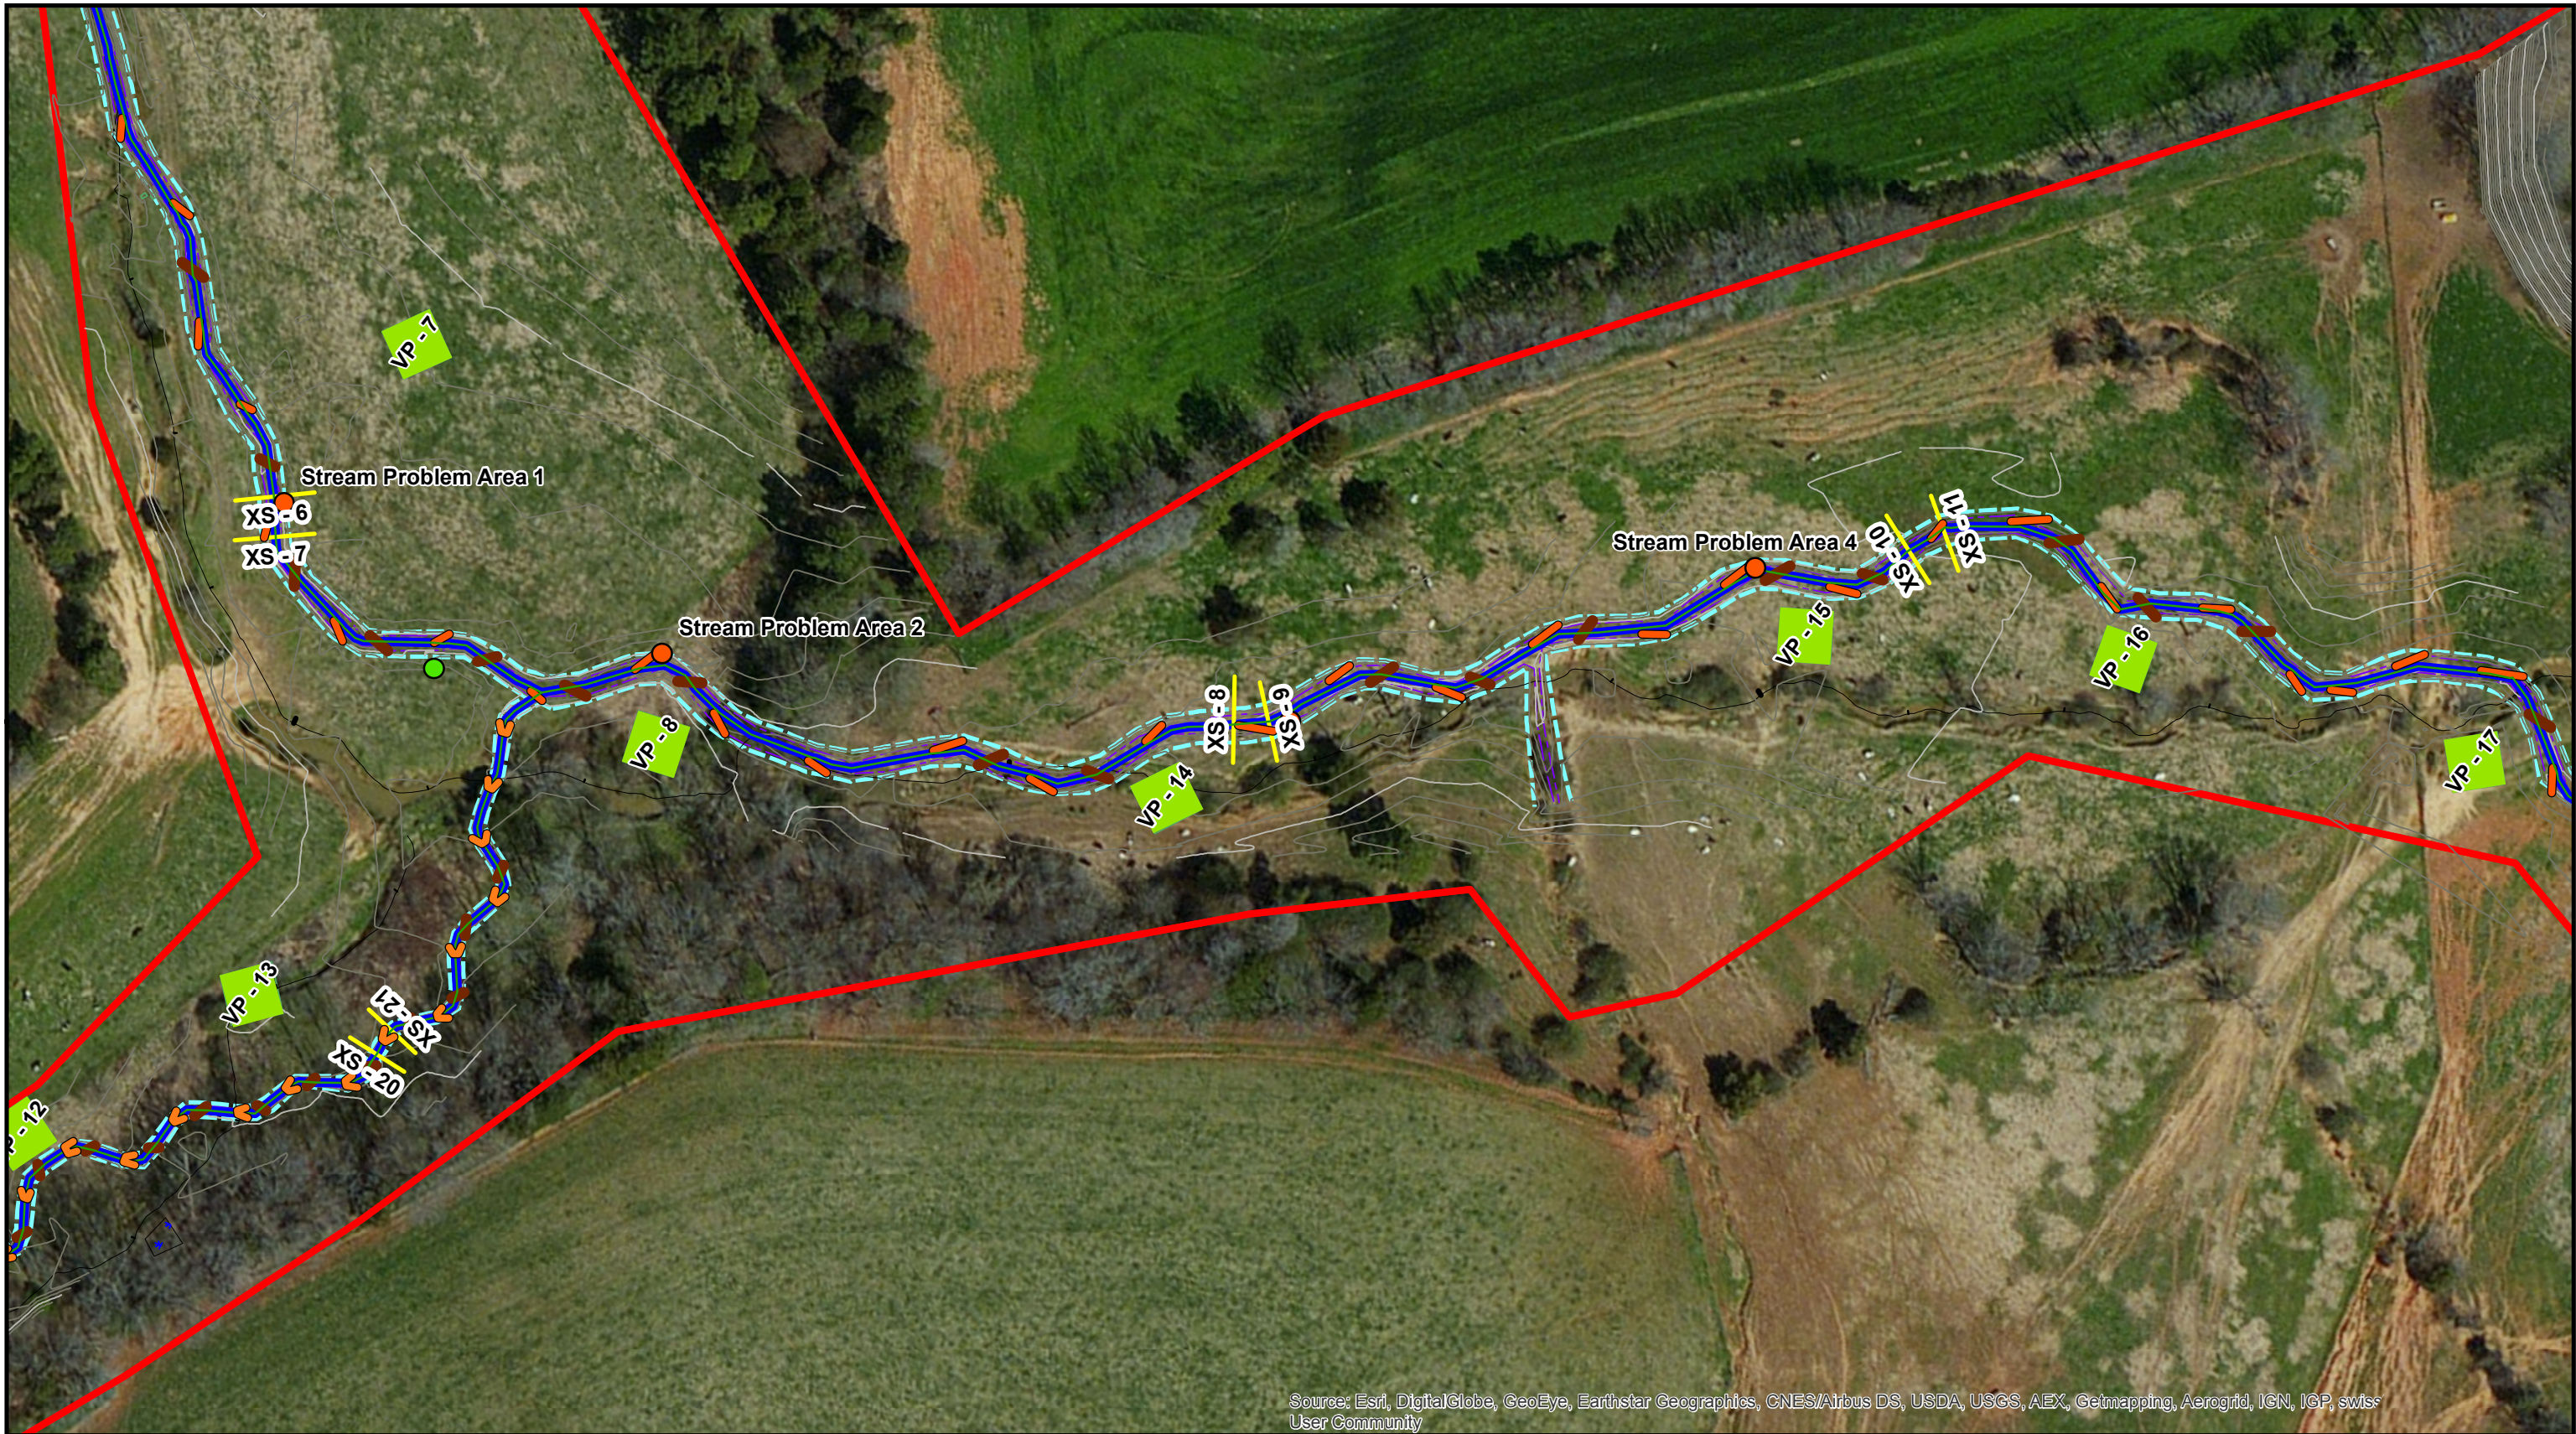
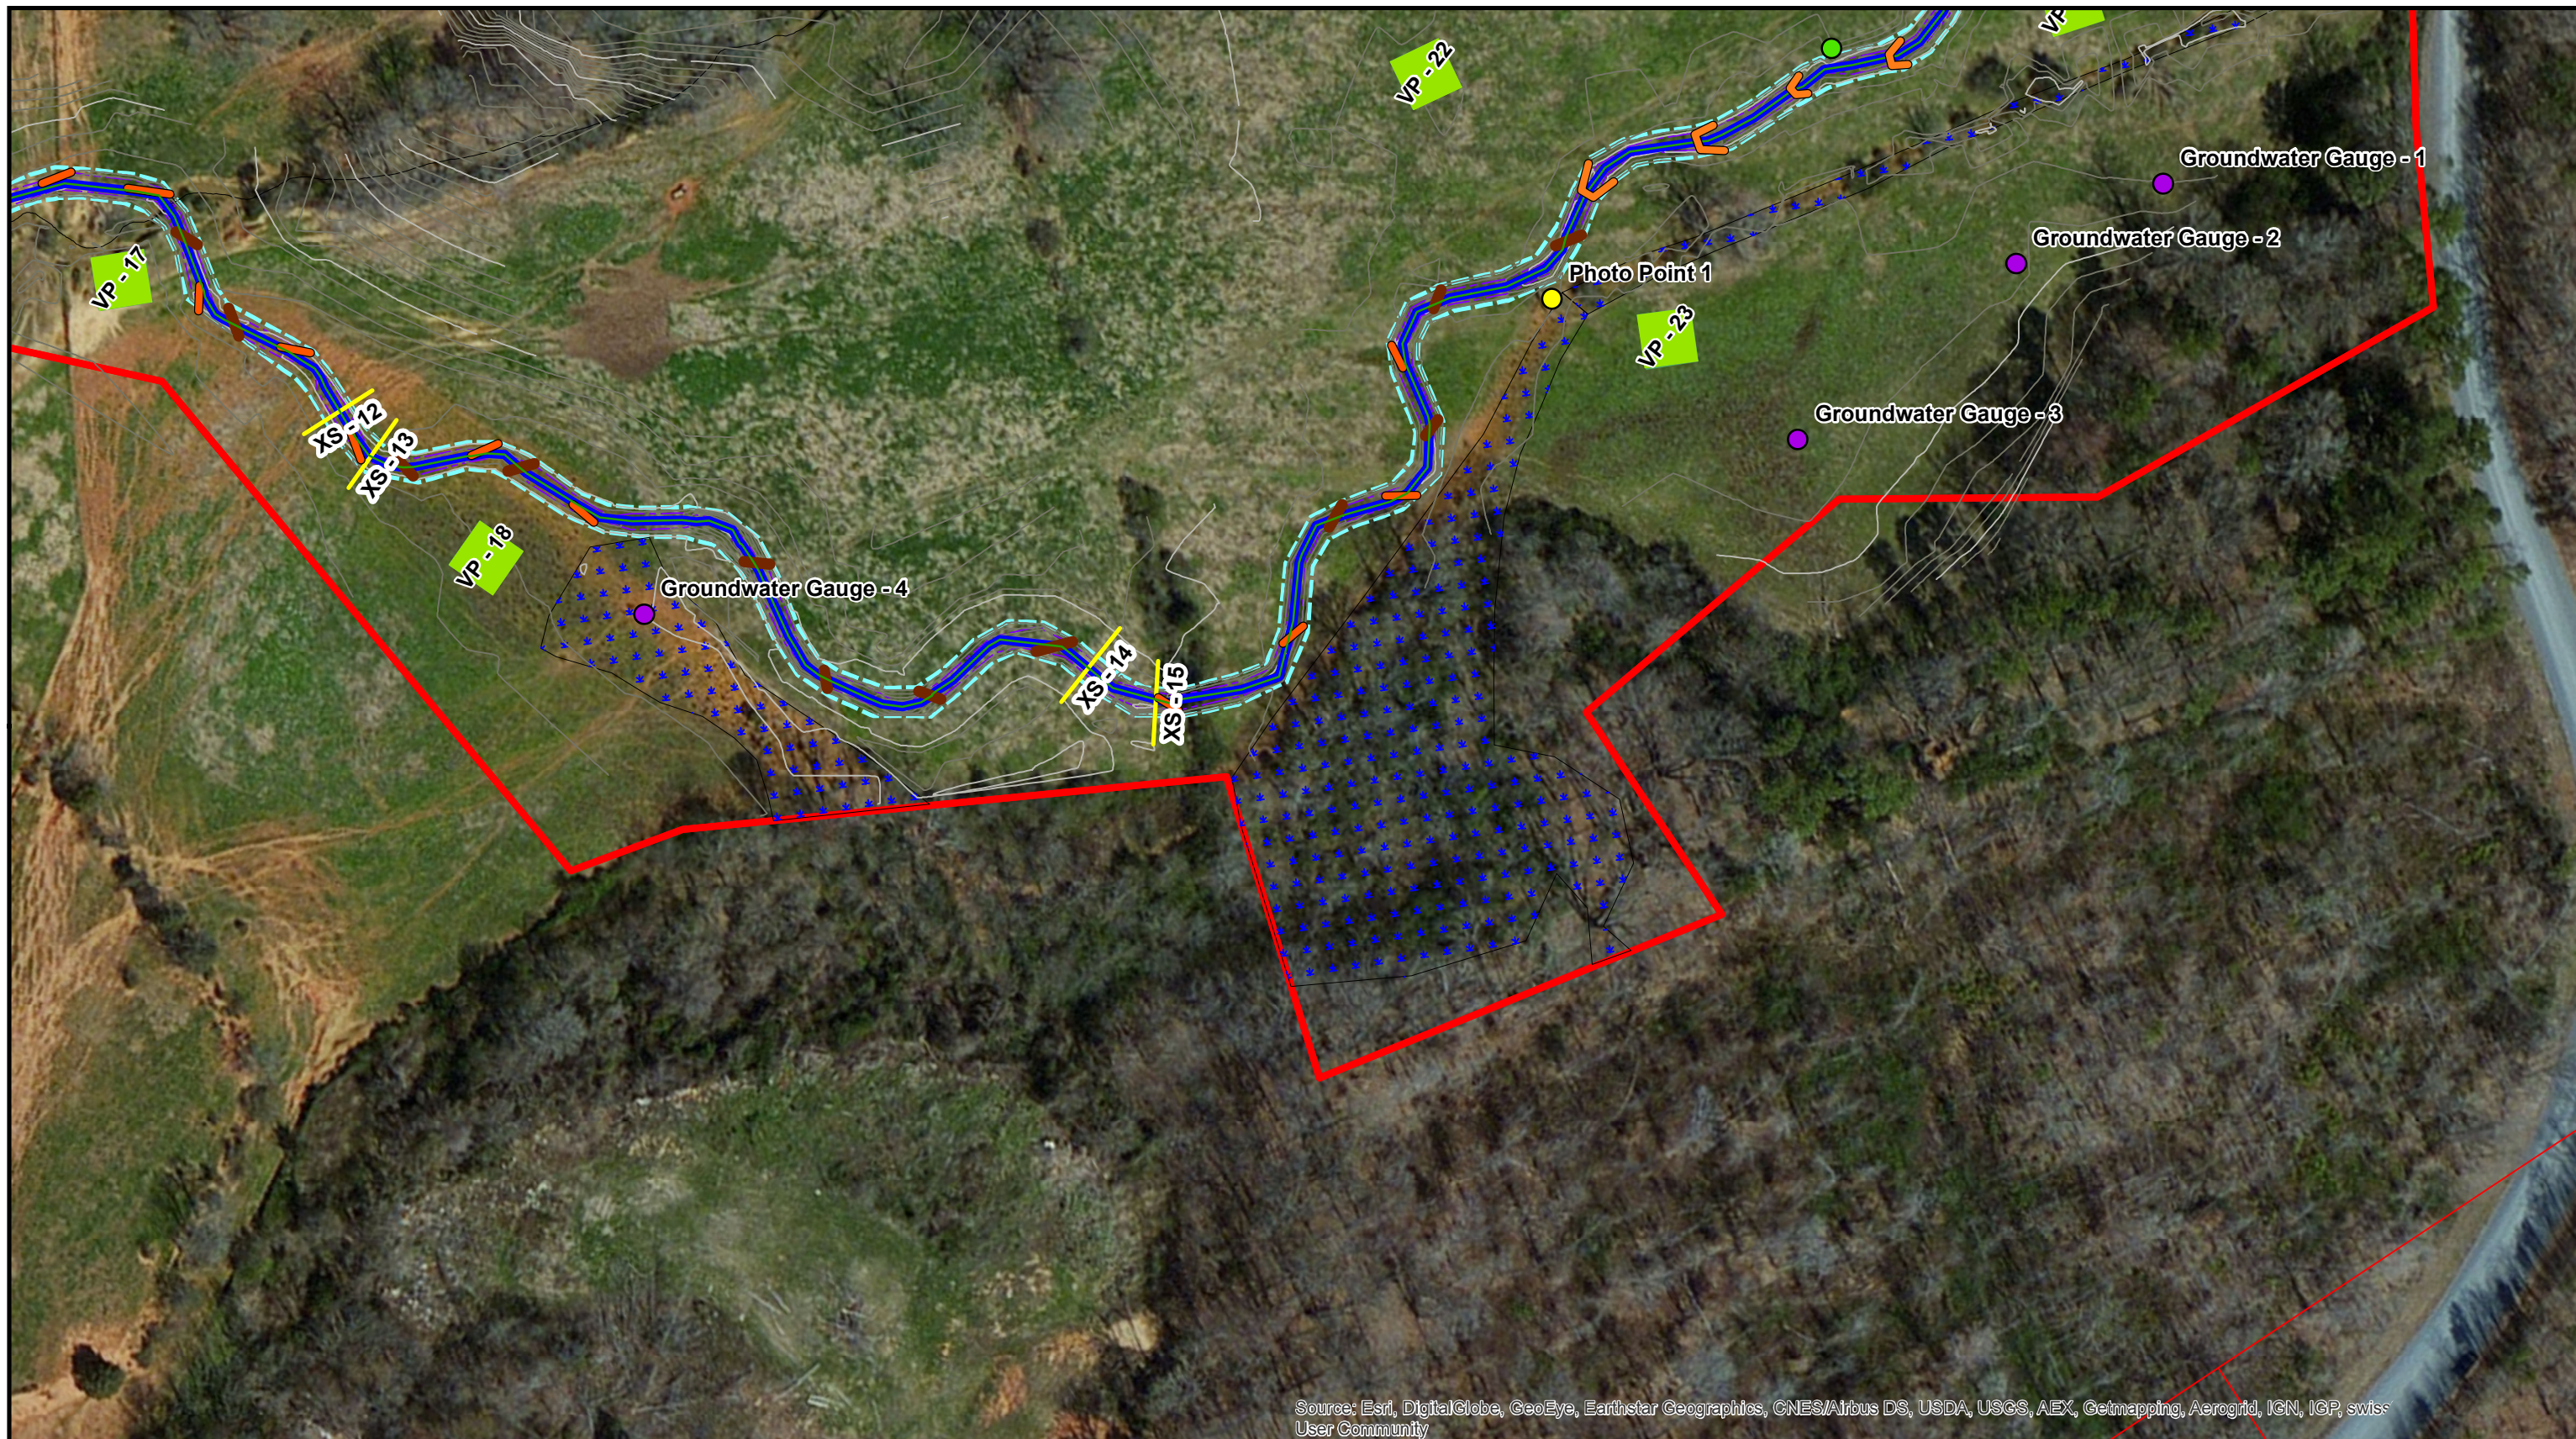
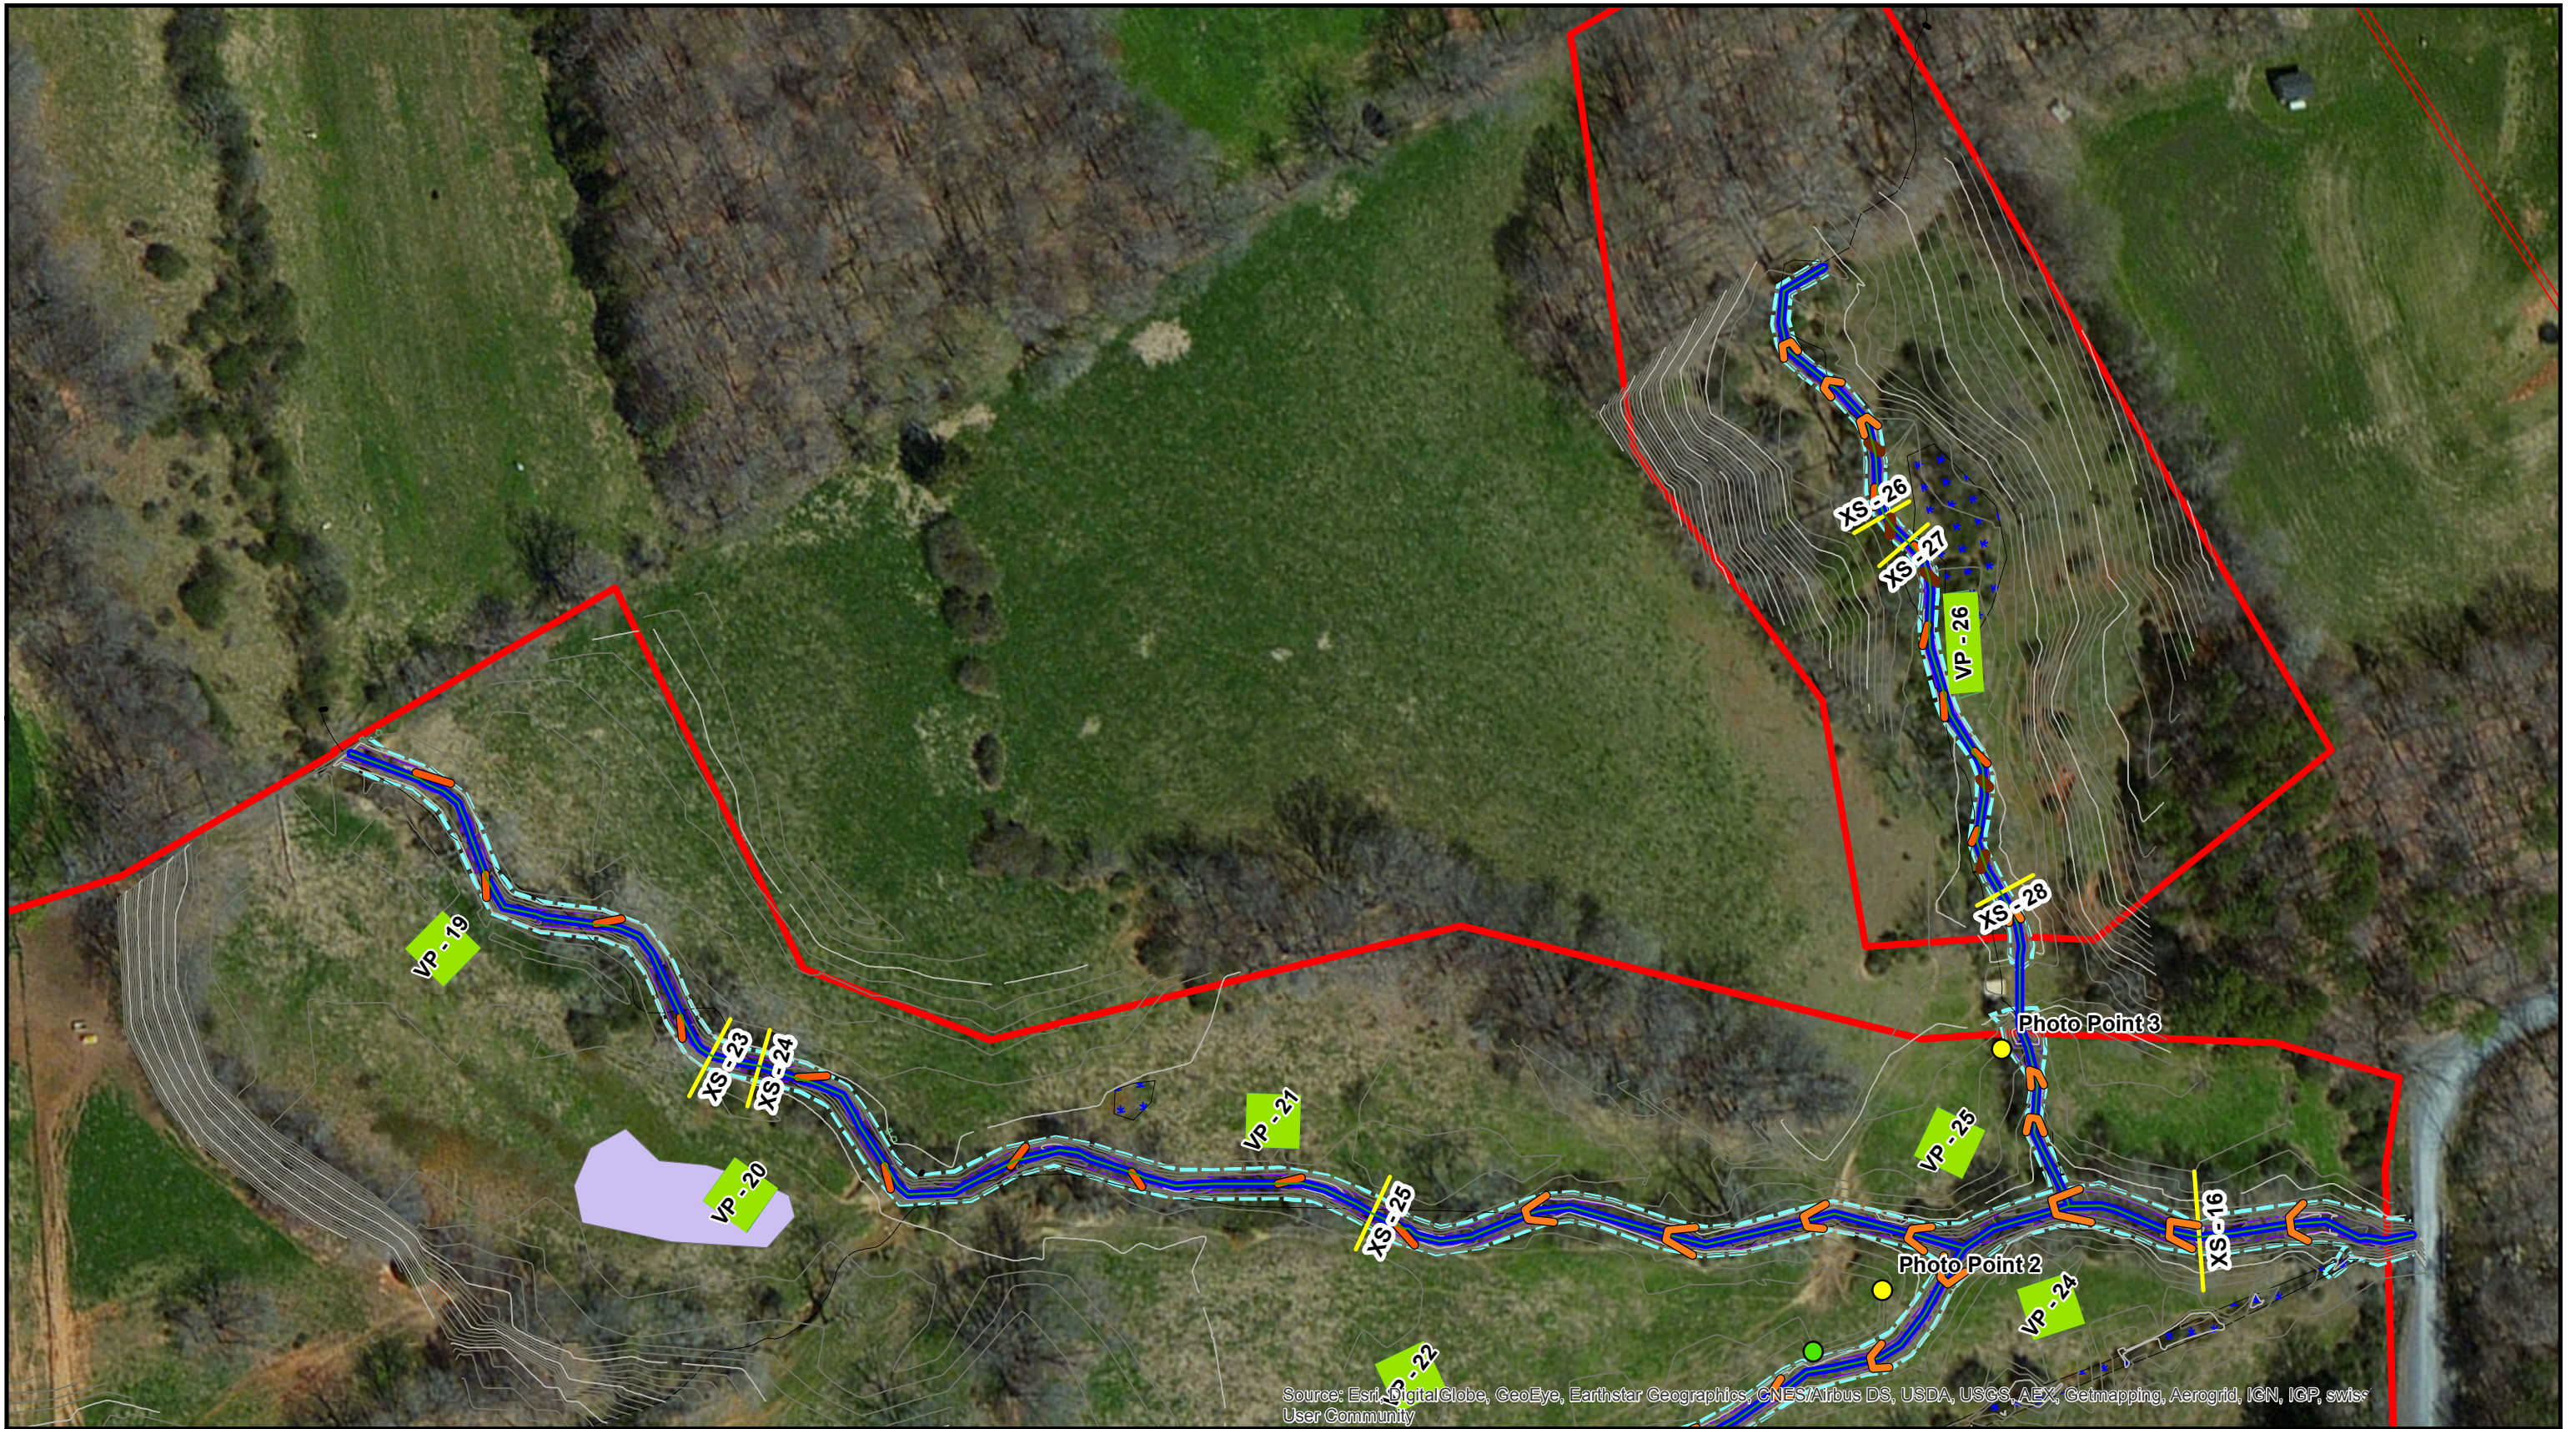
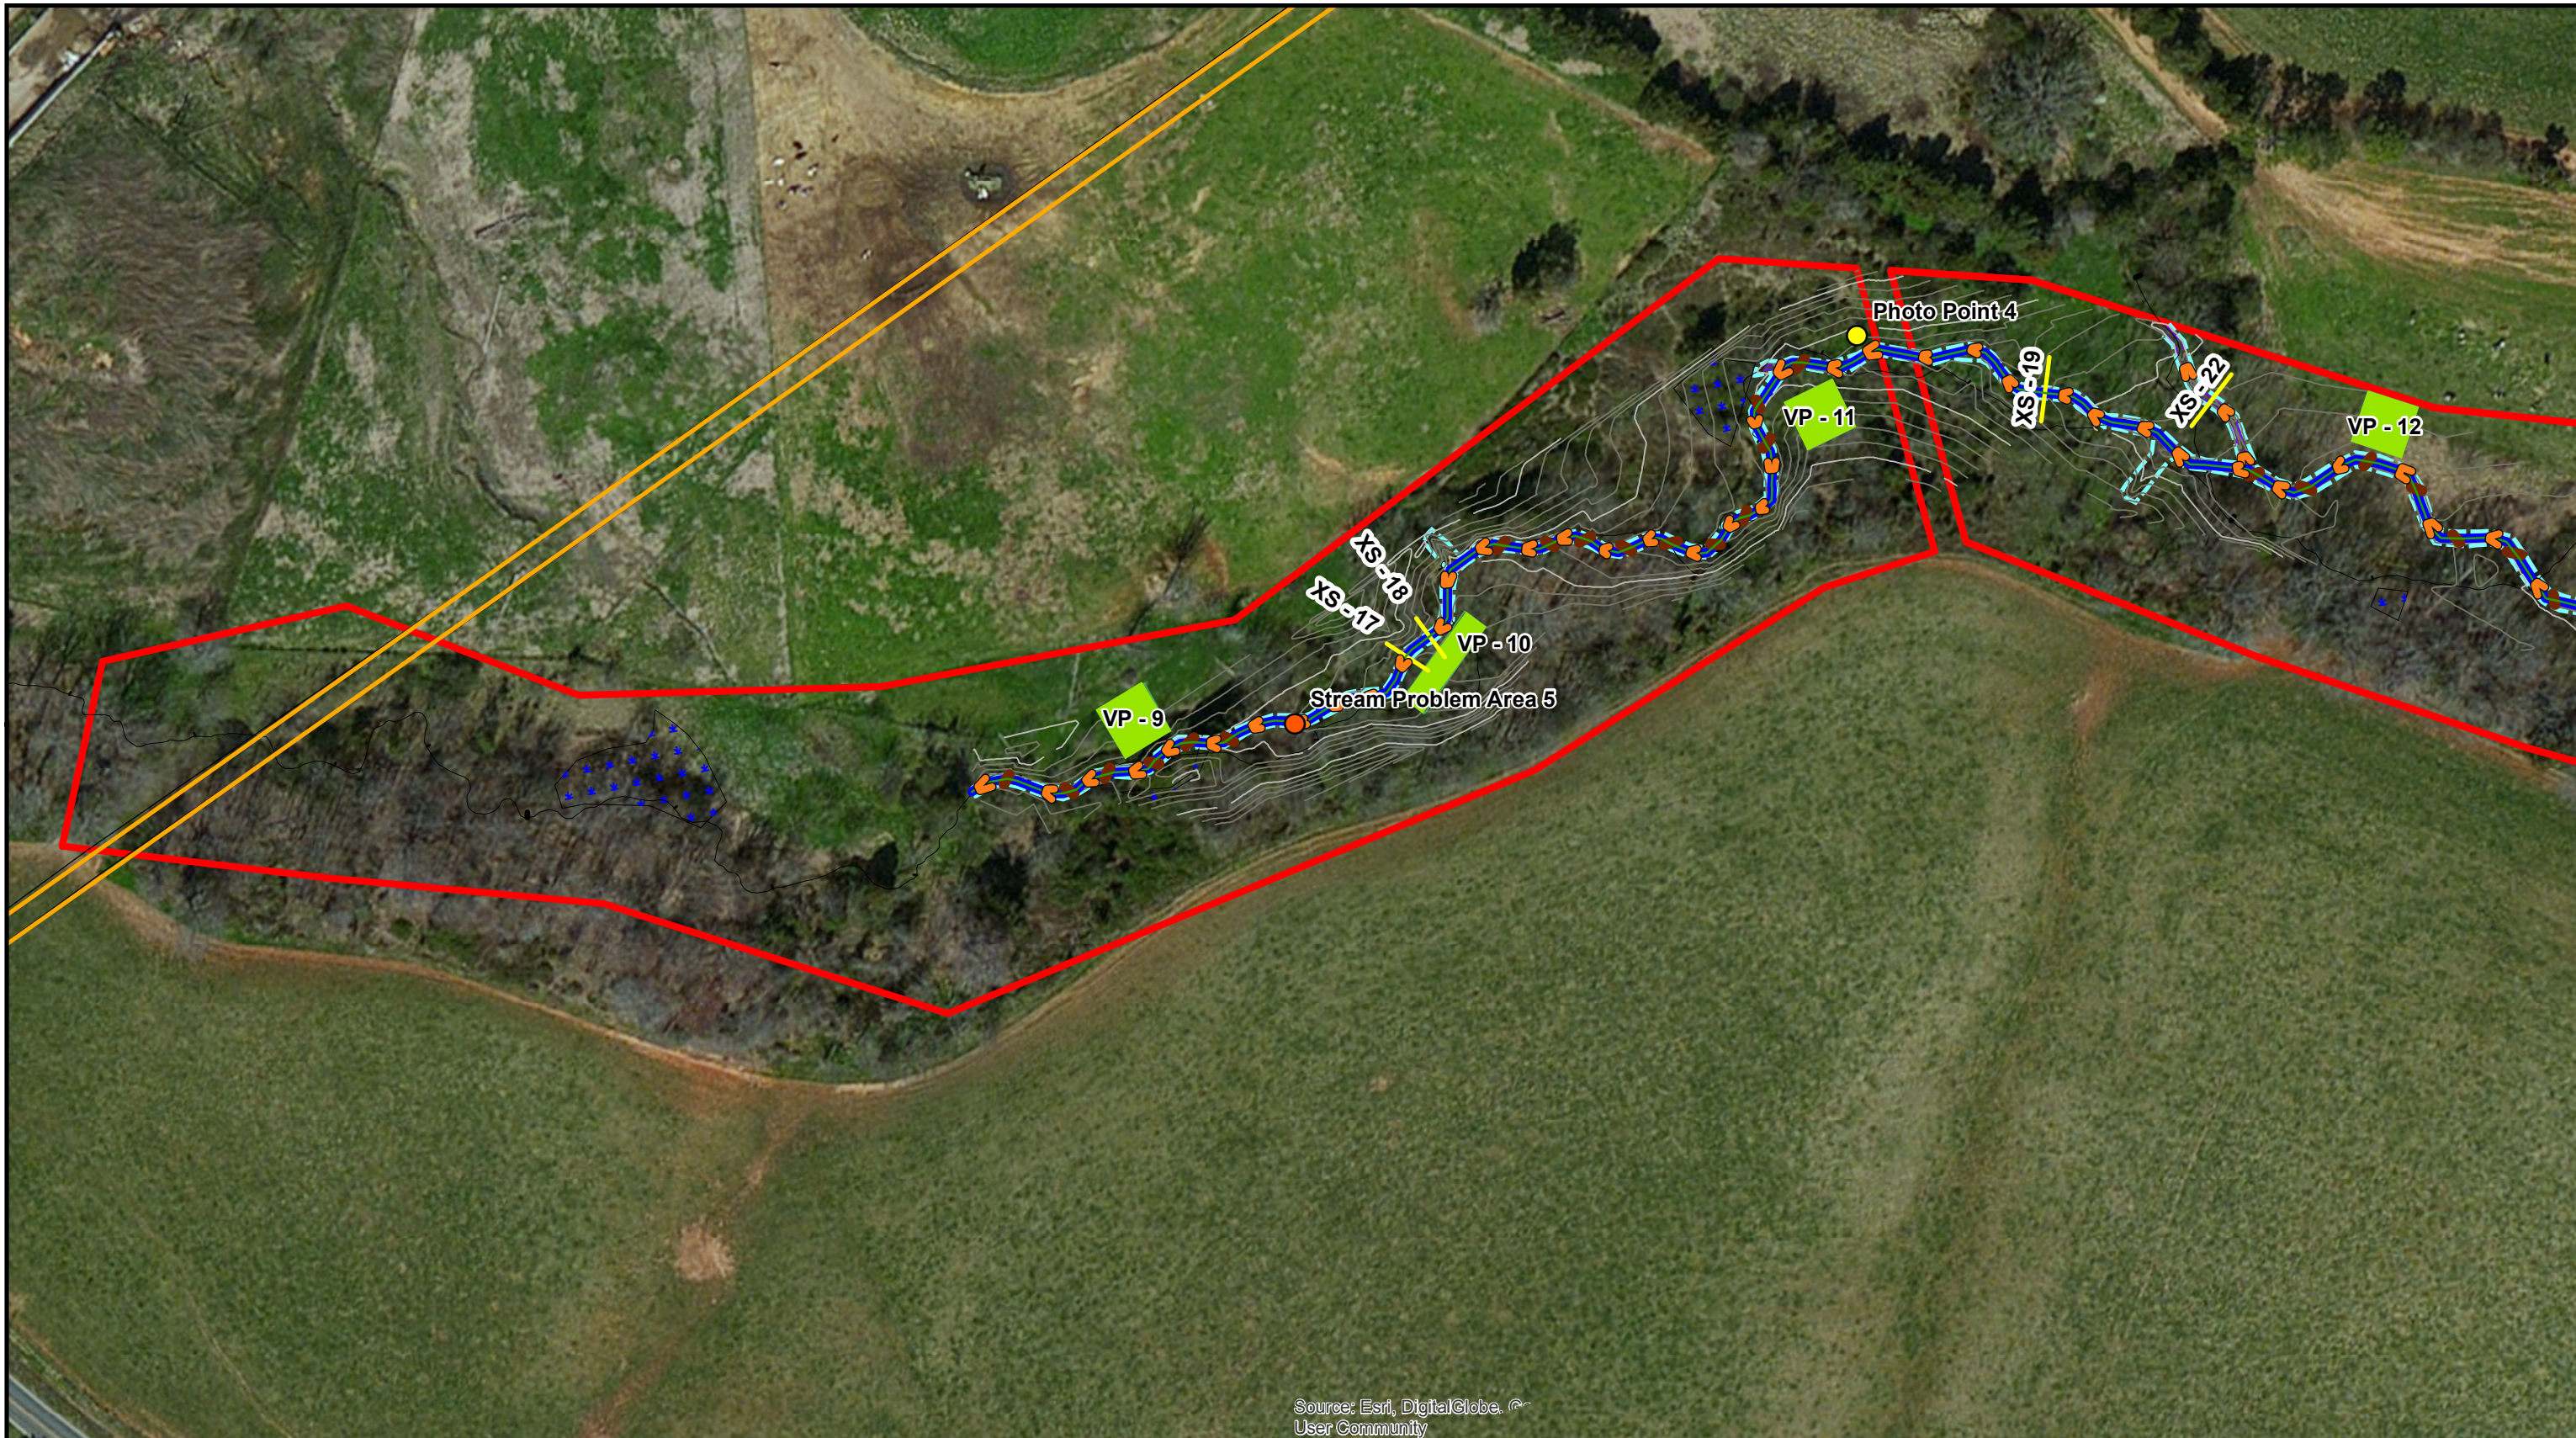
**2. Current Condition Plan View**

Visual assessment and geomorphic surveys completed for the site indicate that project reaches are currently performing within established success criteria ranges shown in Table 8a Appendix D. Several areas of concern were observed along stream monitoring reaches within the sites. The table below describes the issues and each area is identified on Figure 2 (Appendix B).

<b>Map Identifier</b>	<b>Feature/Issue</b>
Stream Area of Concern #1	Slumping on left bank (outside of meander bend) / Log vane exposed not functioning
Stream Area of Concern #2	Slumping on left bank of pool /Short steep riffle leading to pool
Stream Area of Concern #3	Wide pool with some slumping on left bank
Stream Area of Concern #4	Transverse riffle formed
Stream Area of Concern #5	Log vane appears to have failed several short steep riffles

reach riffle slopes of 0.013 ft/ft. No remedial action is proposed at this time, however, these reaches should be monitored closely and a remedial action plan developed if they do not stabilize over the next few years. West and East Branch appear quite stable.

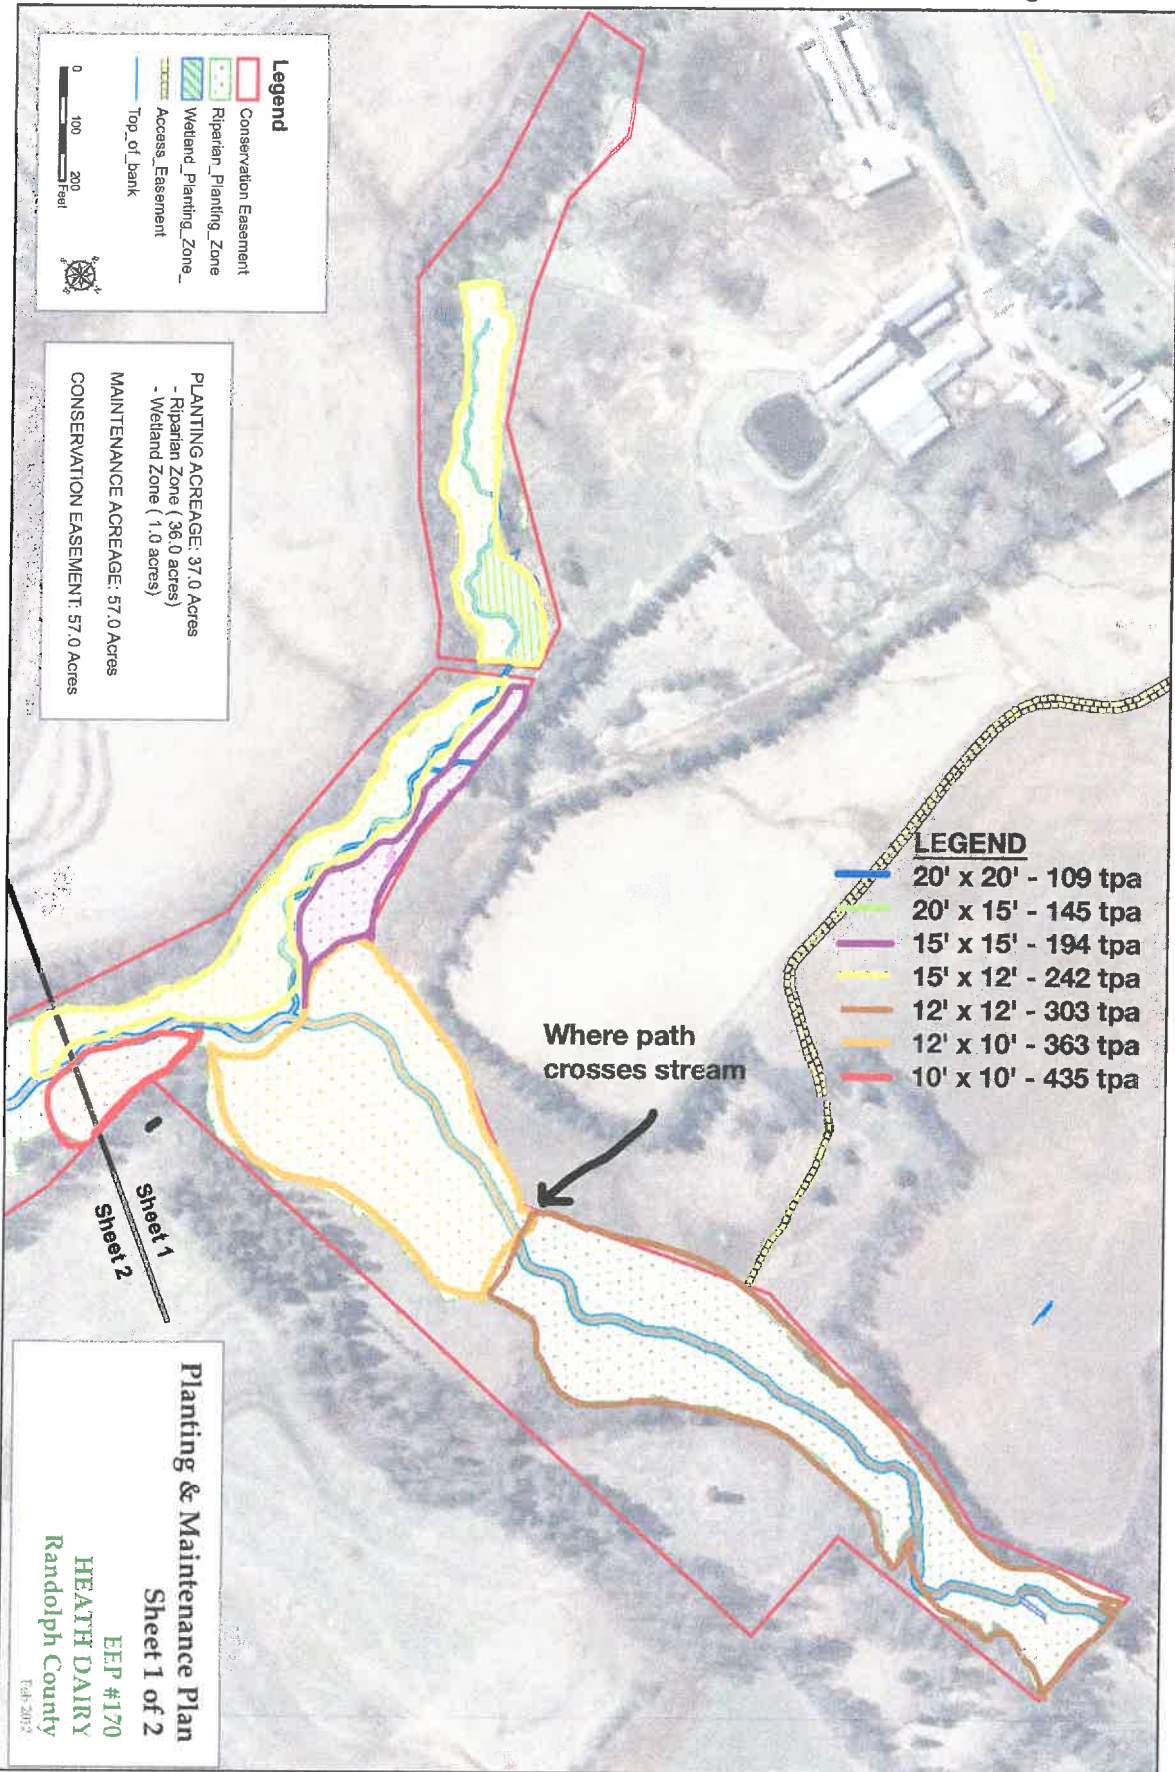
**Approximate Spacing and Location of Warranty Replant Stems**  
**February 2015**  
**Carolina Silvics, Inc.**

The DMS exercised a warranty clause of the vegetation installation contract and on 2/10/2015 – 2/12/2015 an additional 10,500 stems were installed to address the low density reported above. A species list and planting zone map are included in Appendix C of this document.
