Heath Dairy Road Stream Restoration Site Randolph County, North Carolina

DMS Project #170

MY – 03 Fall Monitoring Report

Data Collected: September/October 2016

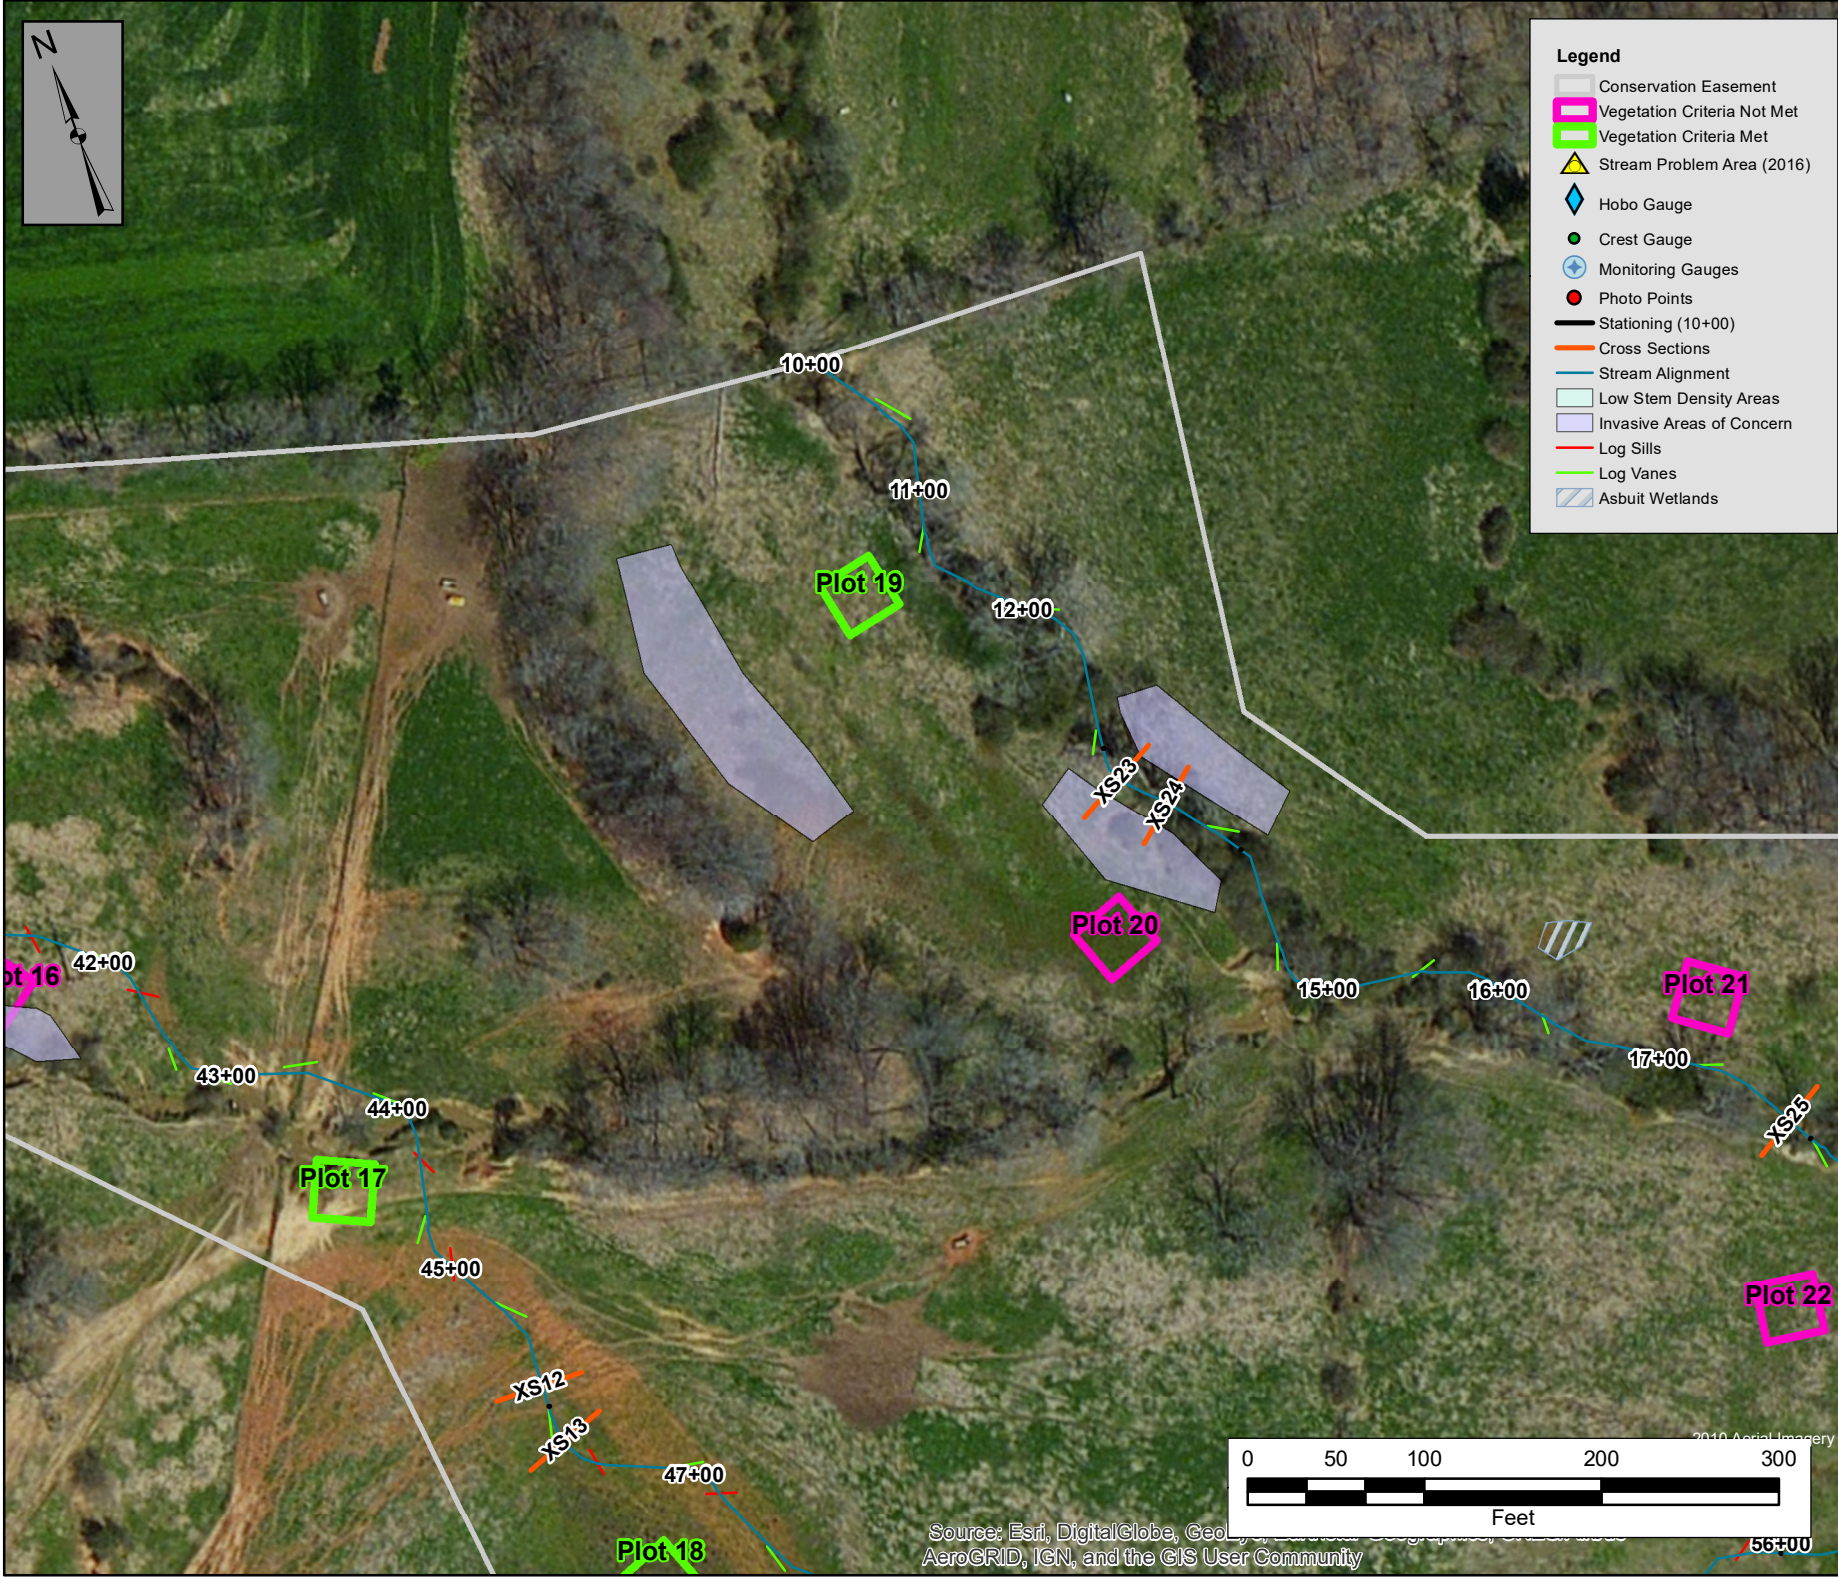
The hoof shear along West Branch that was noted in the spring site visit was no longer evident, however West Branch continues to be inundated with a thick herbaceous understory and native vines. One problem area was noted upstream of the confluence with the unnamed tributary to West Branch, whereby a large fallen tree is draped across the channel and may create erosion problems or minor stream diversion in the future (~sta. 19+20; fig 2.1).

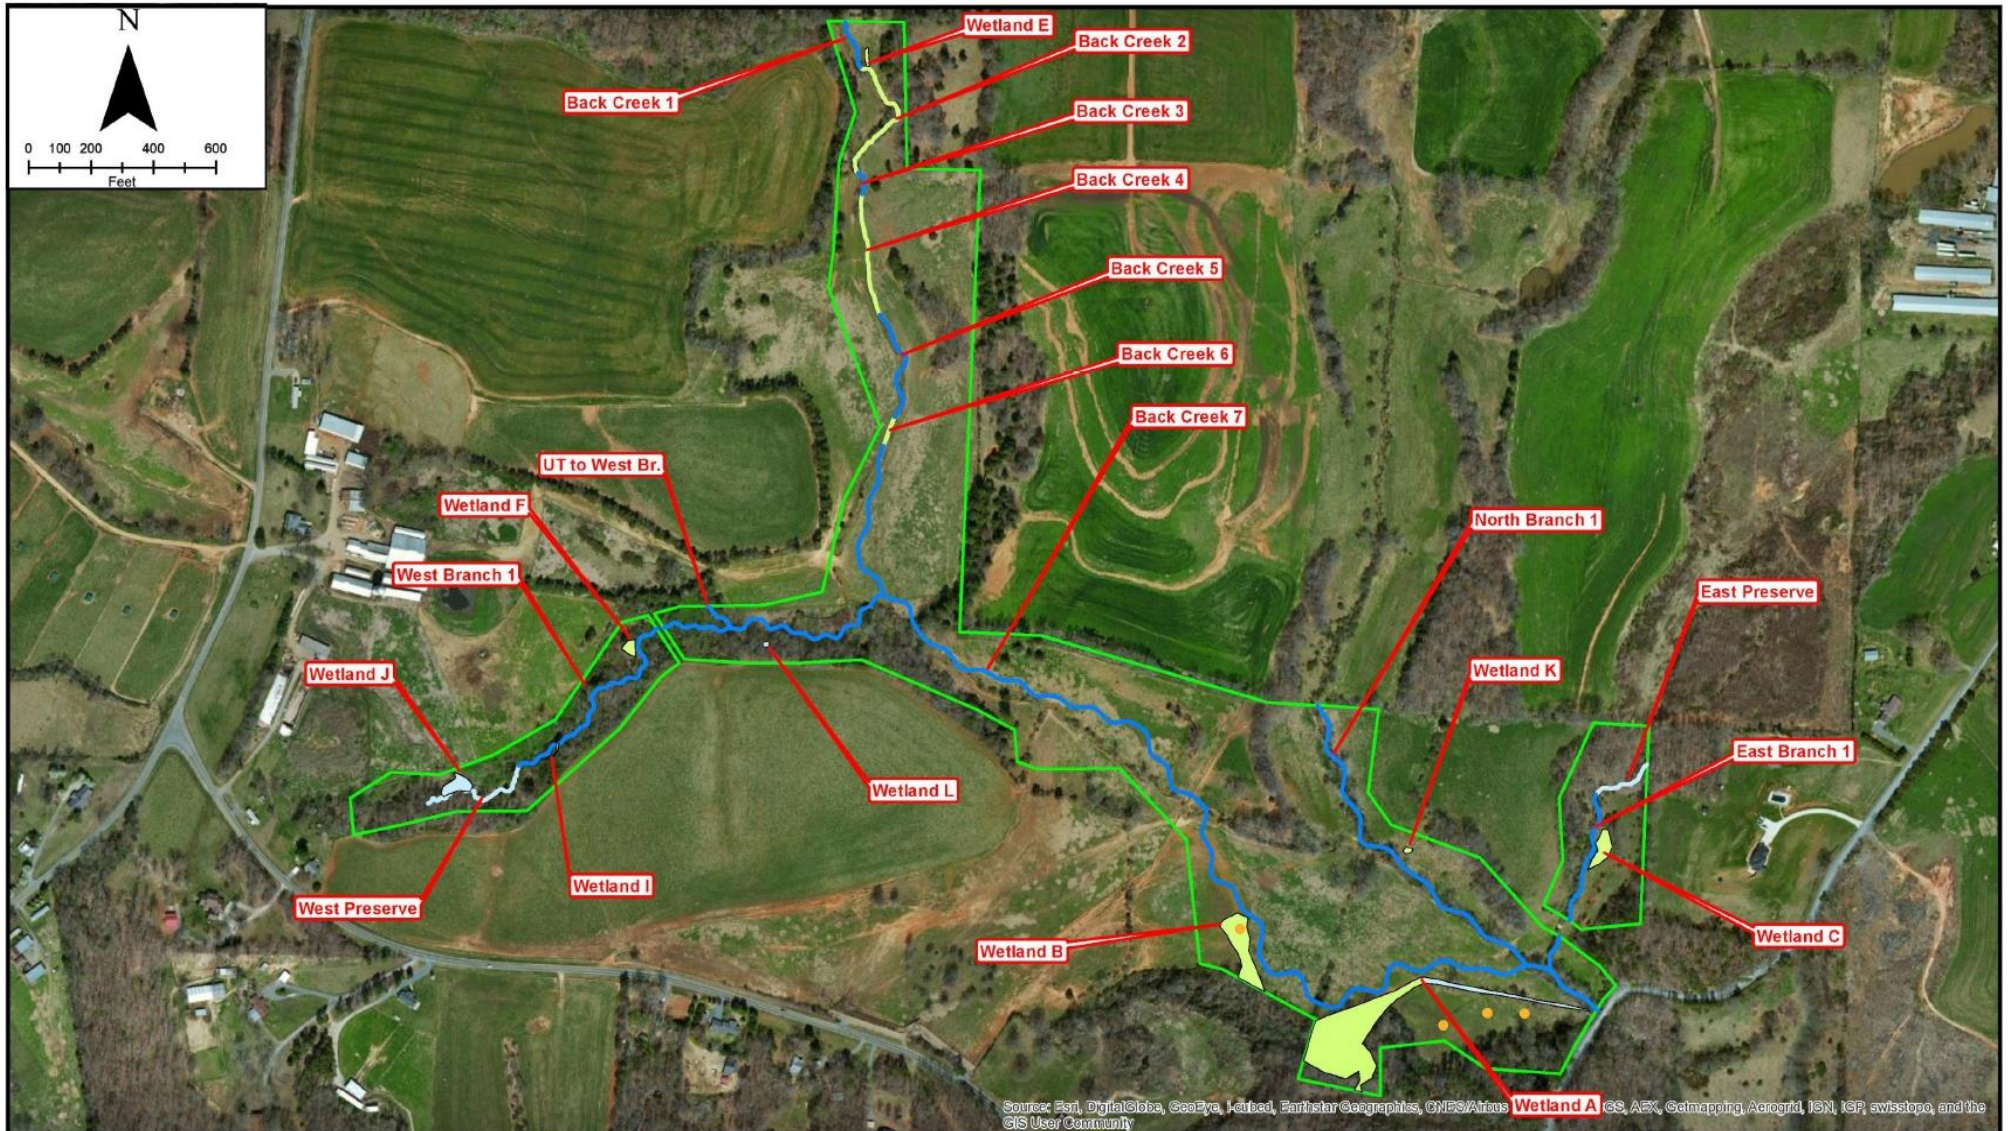
Figure 2.8

Several new minor structural stream problem areas were noted near the downstream end of the project on Back Creek and East Branch. These include: **1)** piping under a riffle section on East Branch (~ sta. 14+50; fig 2.8), **2)** piping below the culvert at the access trail crossing on East Branch (~sta. 15+20; fig 2.8), **3)** piping below a riffle section at the confluence of East Branch and Back Creek (~ sta. 16+00; fig 2.8), and piping below a riffle section of Back Creek just above the confluence with North Branch (~sta. 59+50; fig 2.8). Locations of these problems are depicted by yellow triangles on the CCPV and photos of the more severe cases issues are included in the electronic submission.

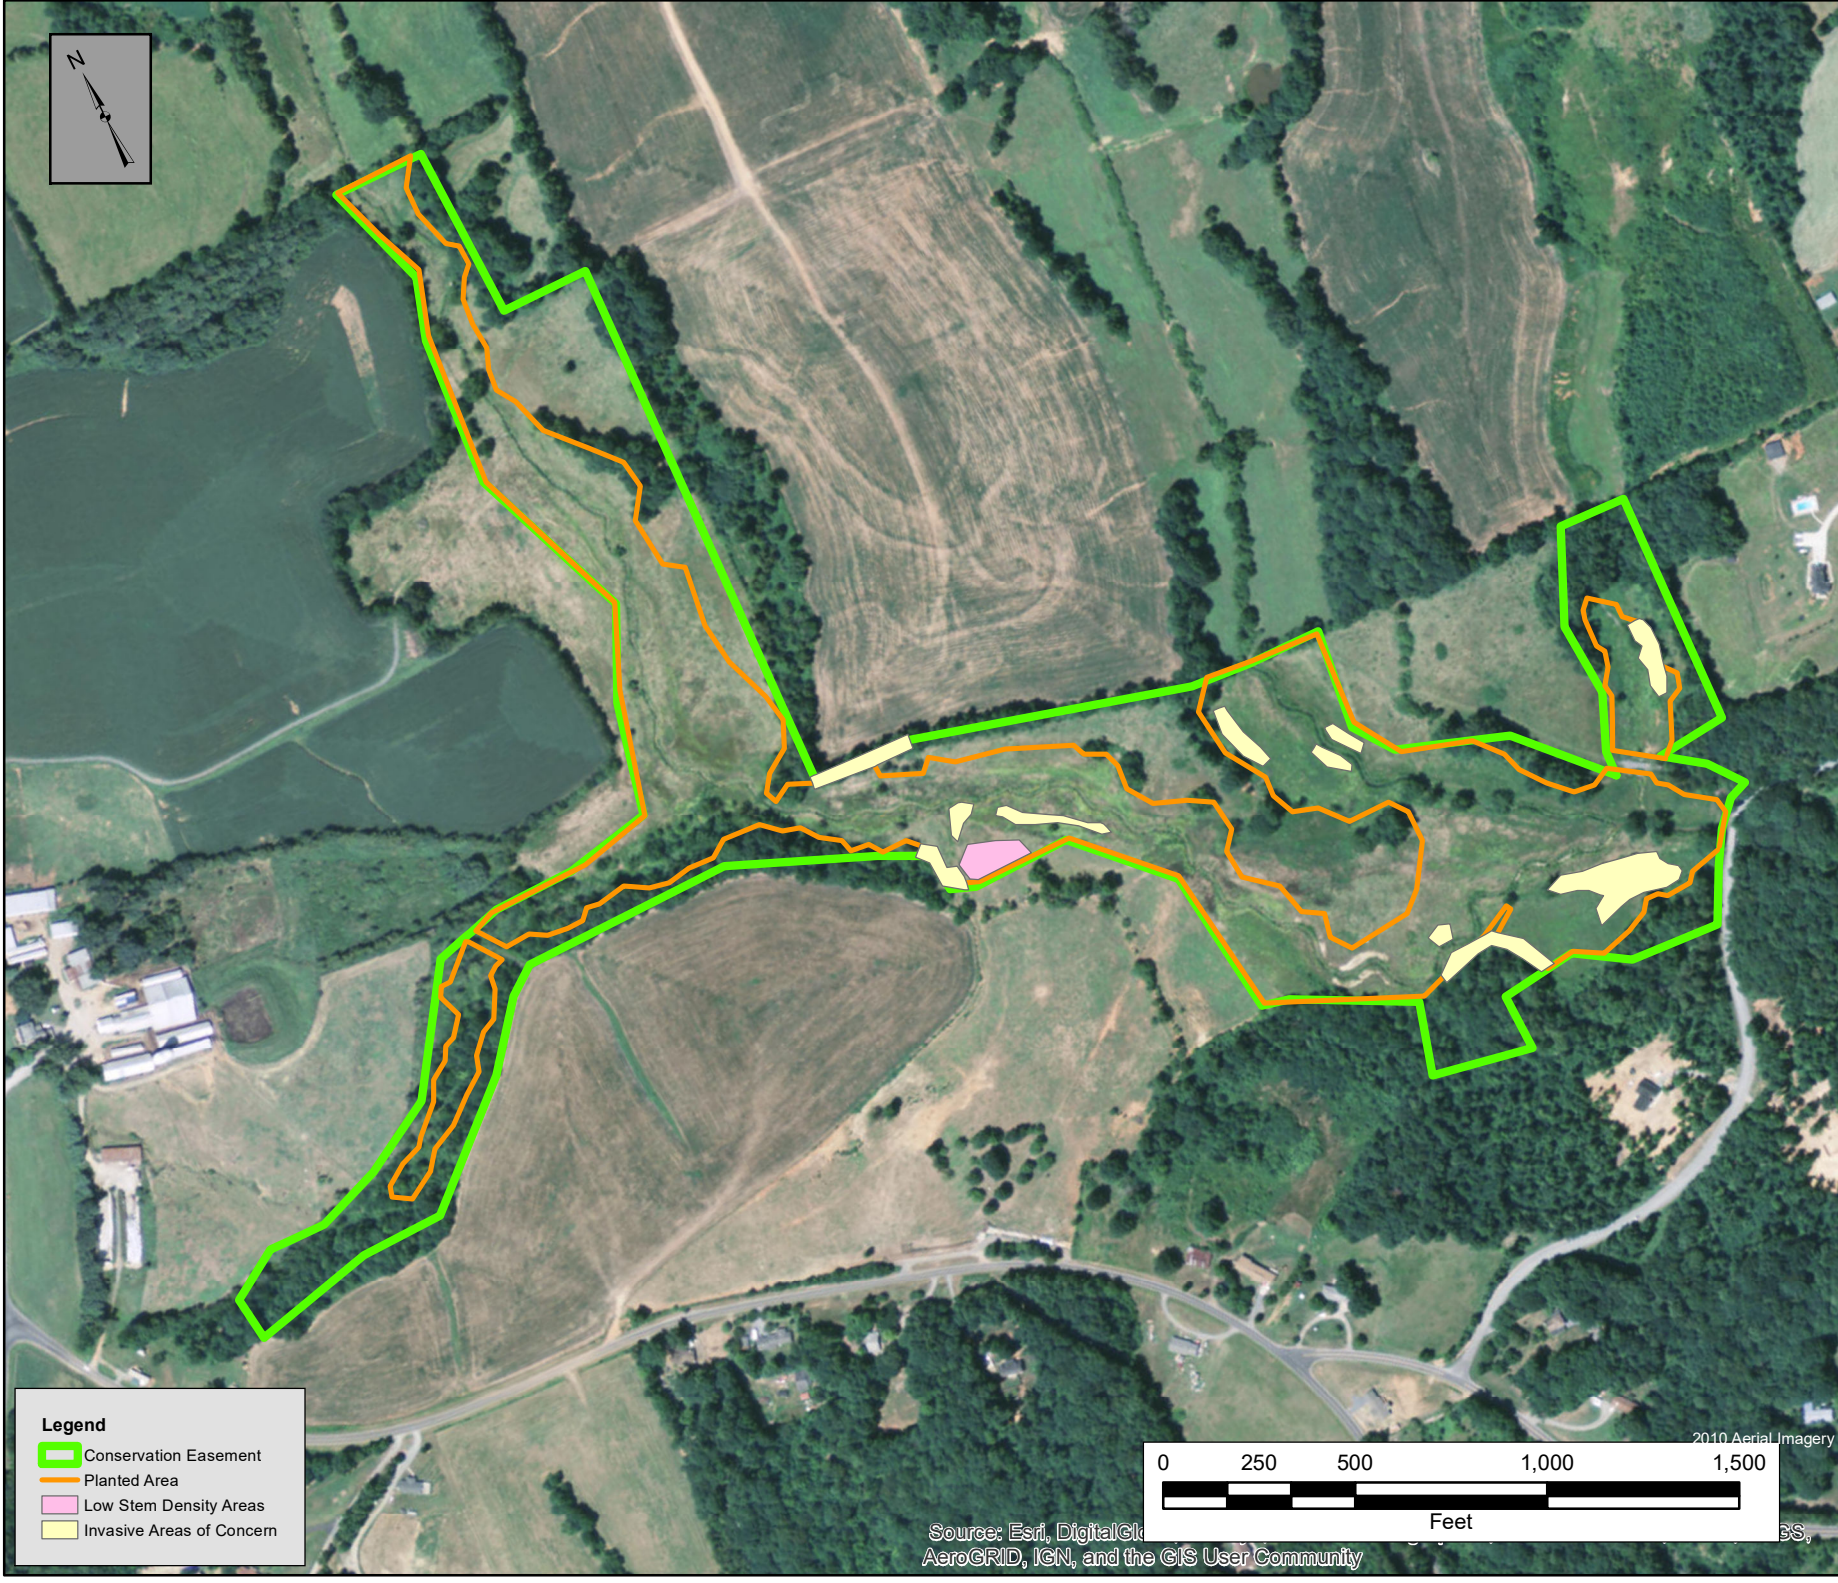
HEATH DAIRY MONITORING YEAR 3
VEGETATION PROBLEM AREAS
CURRENT CONDITIONS PLAN VIEW - DMS #170

Non-native woody species were observed in several locations throughout the easement area (Table 6; Figure 2.10). Thickets of Chinese privet (*Ligustrum sinense*) are beginning to increase in abundance in isolated pockets on the right bank of Back Creek downstream of the confluence with West Branch in the vicinity of Veg Plots # 15 & 16. Isolated stems of Privet are also scattered throughout the hillside between North Branch and Back Creek in the vicinity of Veg Plots #19-20, and along the south side of the upstream end of East Branch. Several large clusters of Multiflora Rose (*Rosa multiflora*) were found throughout the restored wetland area in the vicinity of Groundwater Gages #1-3. We flagged several of the larger clusters of non-native woody plants in the field, and denoted the general areas where invasives were observed as polygons on the current CCPV (Figure 2). In future monitoring years, we will record woody invasive volunteers with the vegetation plot stem data.
