Heath Dairy Road Stream Restoration Site Randolph County, North Carolina

DMS Project #170

MY – 04 Fall Monitoring Report

Mogensen Mitigation, Inc.

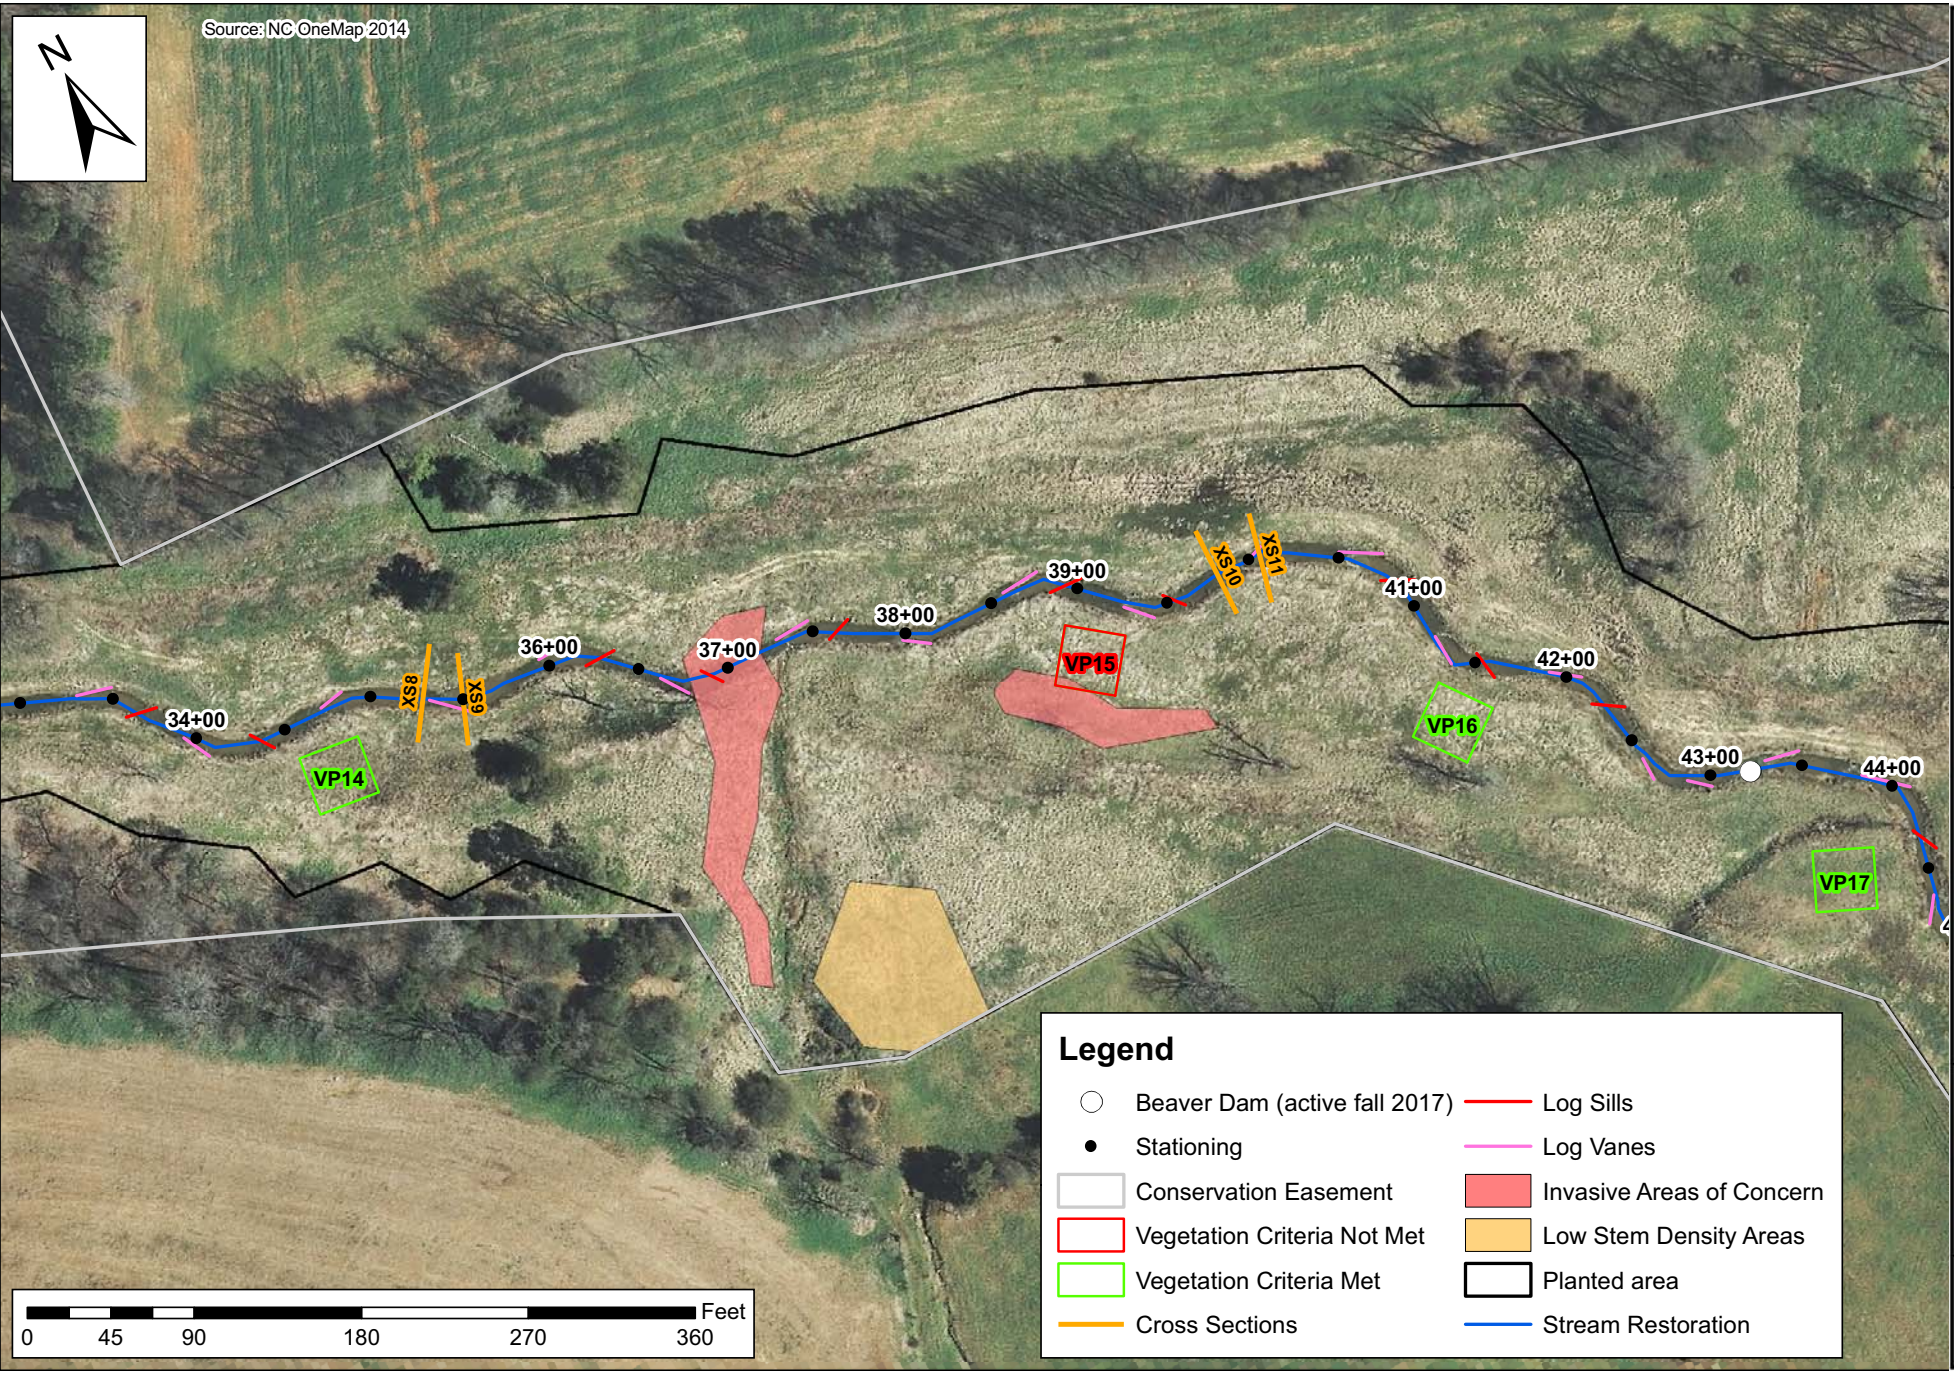
HEATH DAIRY MONITORING YEAR 4 (2017)
 CURRENT CONDITIONS PLAN VIEW OVERVIEW
 DMS #170 - BACK CREEK
 RANDOLPH COUNTY
 NORTH CAROLINA

The only new, larger issue we observed during the fall site visit is the evidence of beaver activity in several places along Back Creek. During a routine visit to check gages in July, we discovered one dam and reported it to the DMS project manager – while that particular dam appears to have been successfully removed, several more have become established within the past two months. One large dam occurs at approximately Sta. 44+00 near VP 17 and is backing up water to at least XS's 10 and 11, where fresh beaver chew is evident. A second set of dams occurs further downstream near approximately Sta. 52+00. The larger of these two dams occurs at 50' downstream of XS 15 is creating a backwater effect up to XS 14. The smaller of these dams is located directly at XS 14. The locations of all active and remnant dams are denoted on the CCPV. Due to ongoing beaver activity on the site, first noted in the year 4 spring assessment, the site has been added to the APHIS contract and quarterly site visits will be mandatory. Traps have been set for current residents and dam removal will follow.

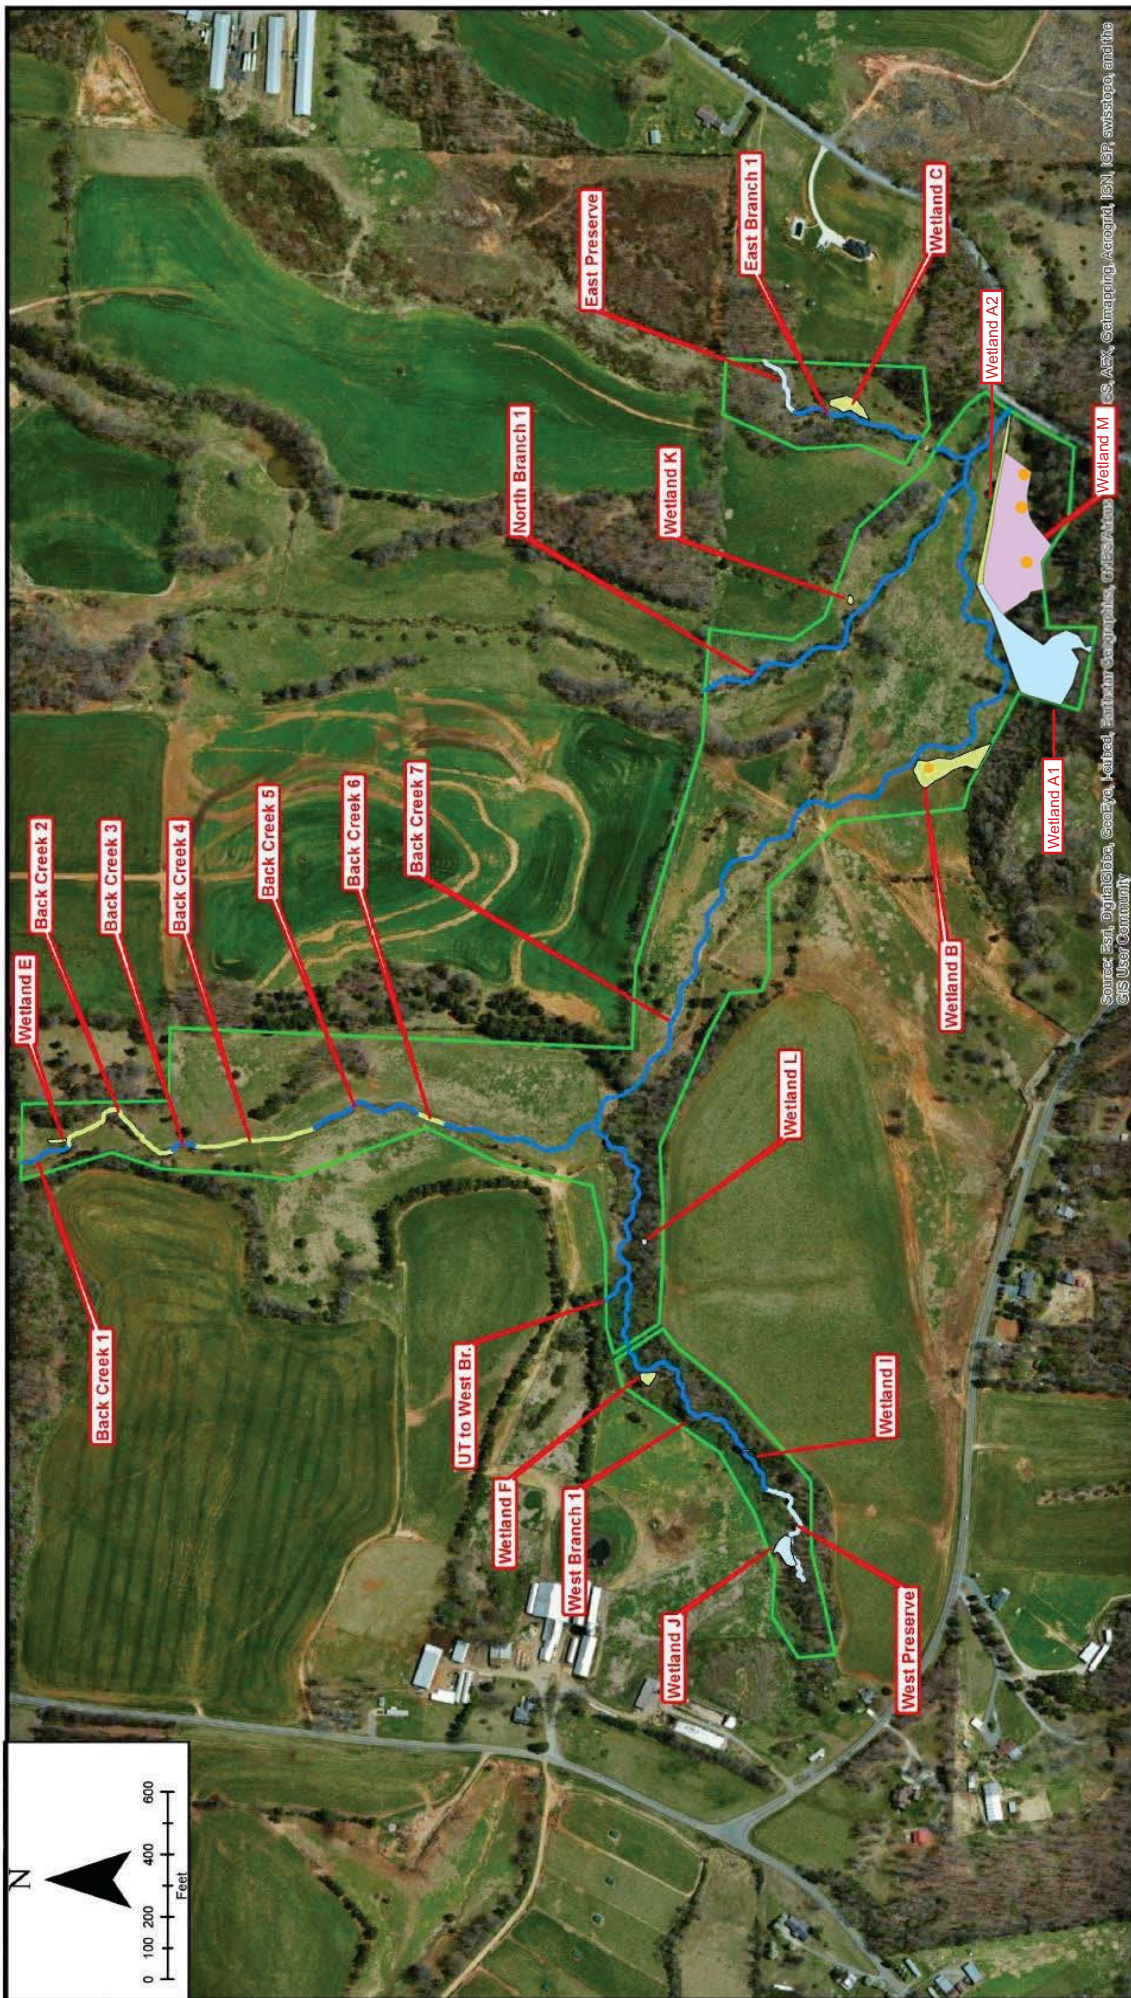
Standing water and obviously saturated soils were observed in many of enhanced and preserved wetlands on site (i.e. Wetlands "A" through "L"; Figure 2.9) during the Spring MY4 site visit while all but the wettest of these areas were visibly dry during the fall MY4 site visit. Consistent with previous
