Heath Dairy Road Stream Restoration Site Randolph County, North Carolina

DMS Project #170

MY – 05 Fall Monitoring Report

Mogensen Mitigation, Inc.

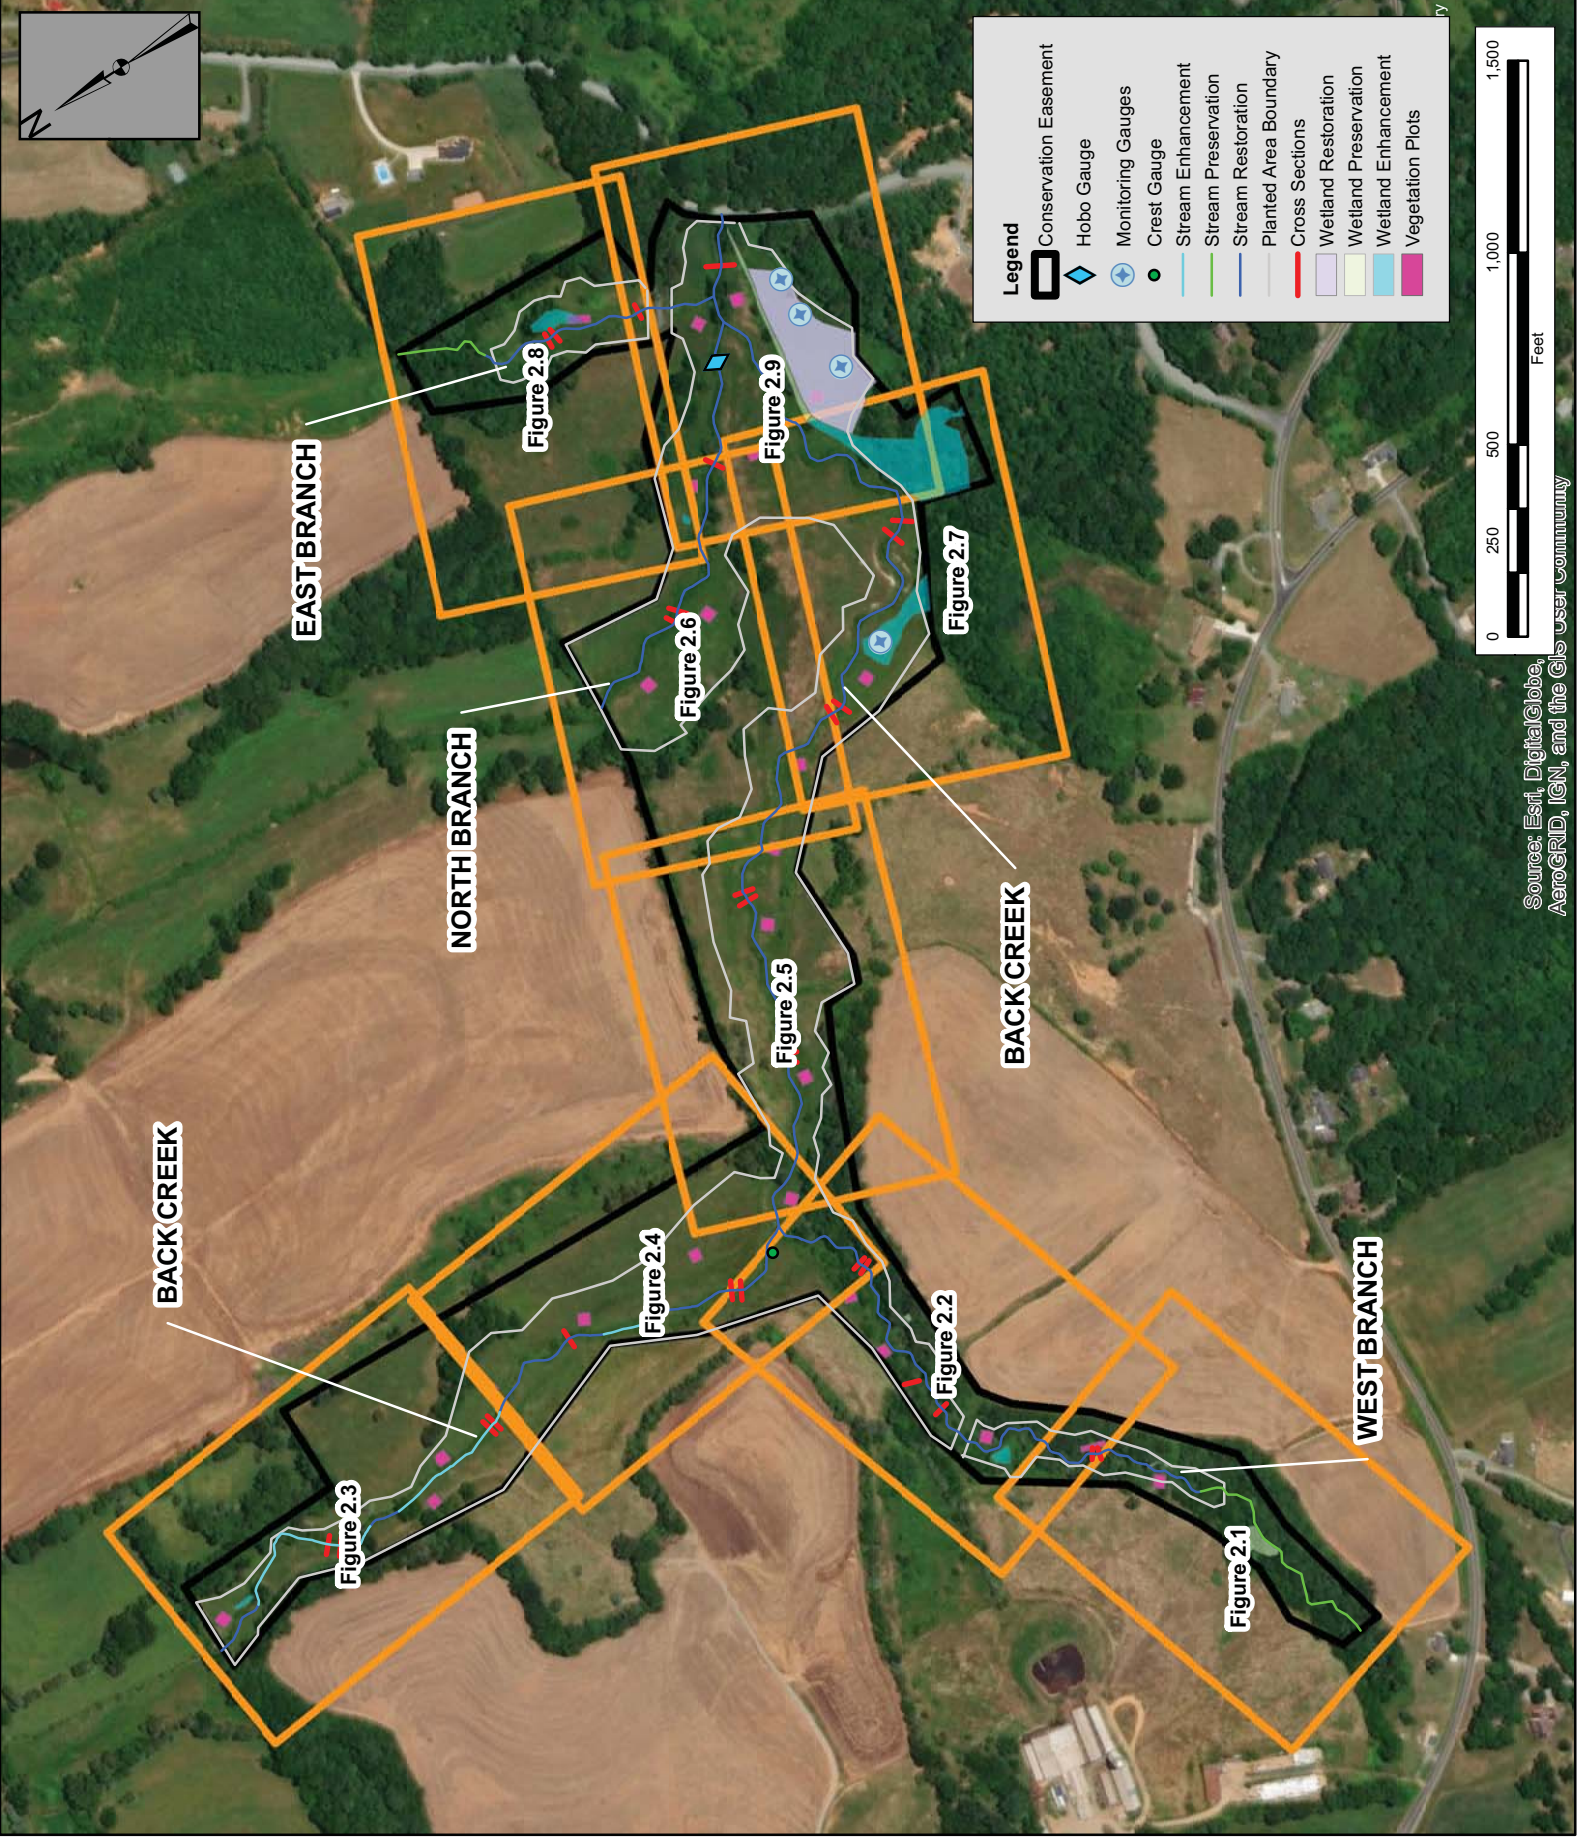
HEATH DAIRY MONITORING YEAR 5
CURRENT CONDITIONS PLAN VIEW OVERVIEW
DMS #170
Randolph County, North Carolina

Four areas of “low woody stem density” totaling 0.79 acre remain on the current CCPV figures; other areas have achieved success due to growth of planted and volunteer stems. The majority of the 0.79 acres of low woody stem density areas exist beyond the required 50 ft stream buffer zones. Numerous invasive plant areas (mostly multiflora rose and Chinese privet) mapped in April 2018 at scattered locations throughout the site do not appear to have been treated recently, and remain the same as shown in the spring 2018 report. Other invasives noted at scattered sites include Japanese honeysuckle, porcelainberry, ailanthus, and callery pear. The NC DMS is currently contracting additional invasive species treatment to address invasives on the entire 58-acre site.
