**UT to Dutch Buffalo Creek
Stream and Wetland Enhancement Project
Project No. 172
2009 Baseline/Monitoring Report: Year 0/1 of 5**

November 2009 (Revised April 2010)

Prepared for: NCDENR-EEP
1652 Mail Service Center
Raleigh, NC 27699-1652

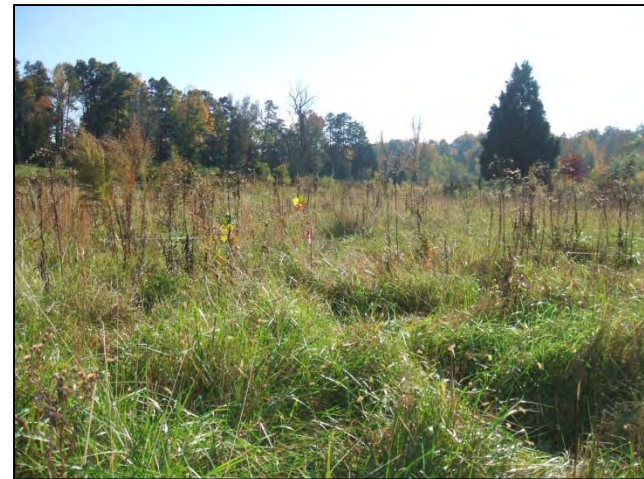
Monitoring Plot 4 (10/2009)

Vegetation Plot ID	Vegetation Survival Threshold Met (Y/N)
Plot 1	Y
Plot 2	Y
Plot 3	Y
Plot 4	N
Total Mean Density (stems/acre)	445
Total Planted Density (stems/acre)	425
