**Helms Site (UT to Dutch Buffalo Creek)
Stream and Wetland Enhancement Project
EEP Project No. 172
2010 Monitoring Report: Year 2 of 5**

**Construction Completed: April 2009
Submission Date: February 2011**

Jordan, Jones and Goulding
309 East Morehead Street, Suite 110
Charlotte, NC 28202

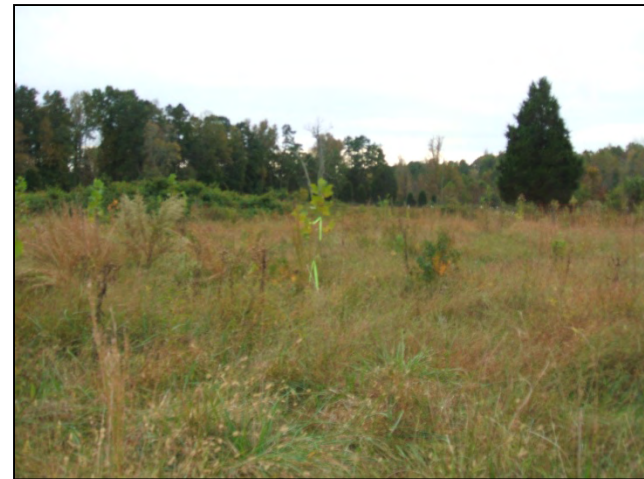
Vegetation Plot 4
(10/2010)

Vegetation Plot ID	Vegetation Survival Threshold
	Met (Y/N)
Plot 1	Y
Plot 2	Y
Plot 3	Y
Plot 4	N
Total Mean Density (stems/acre)	547
Total Planted Density (stems/acre)	385

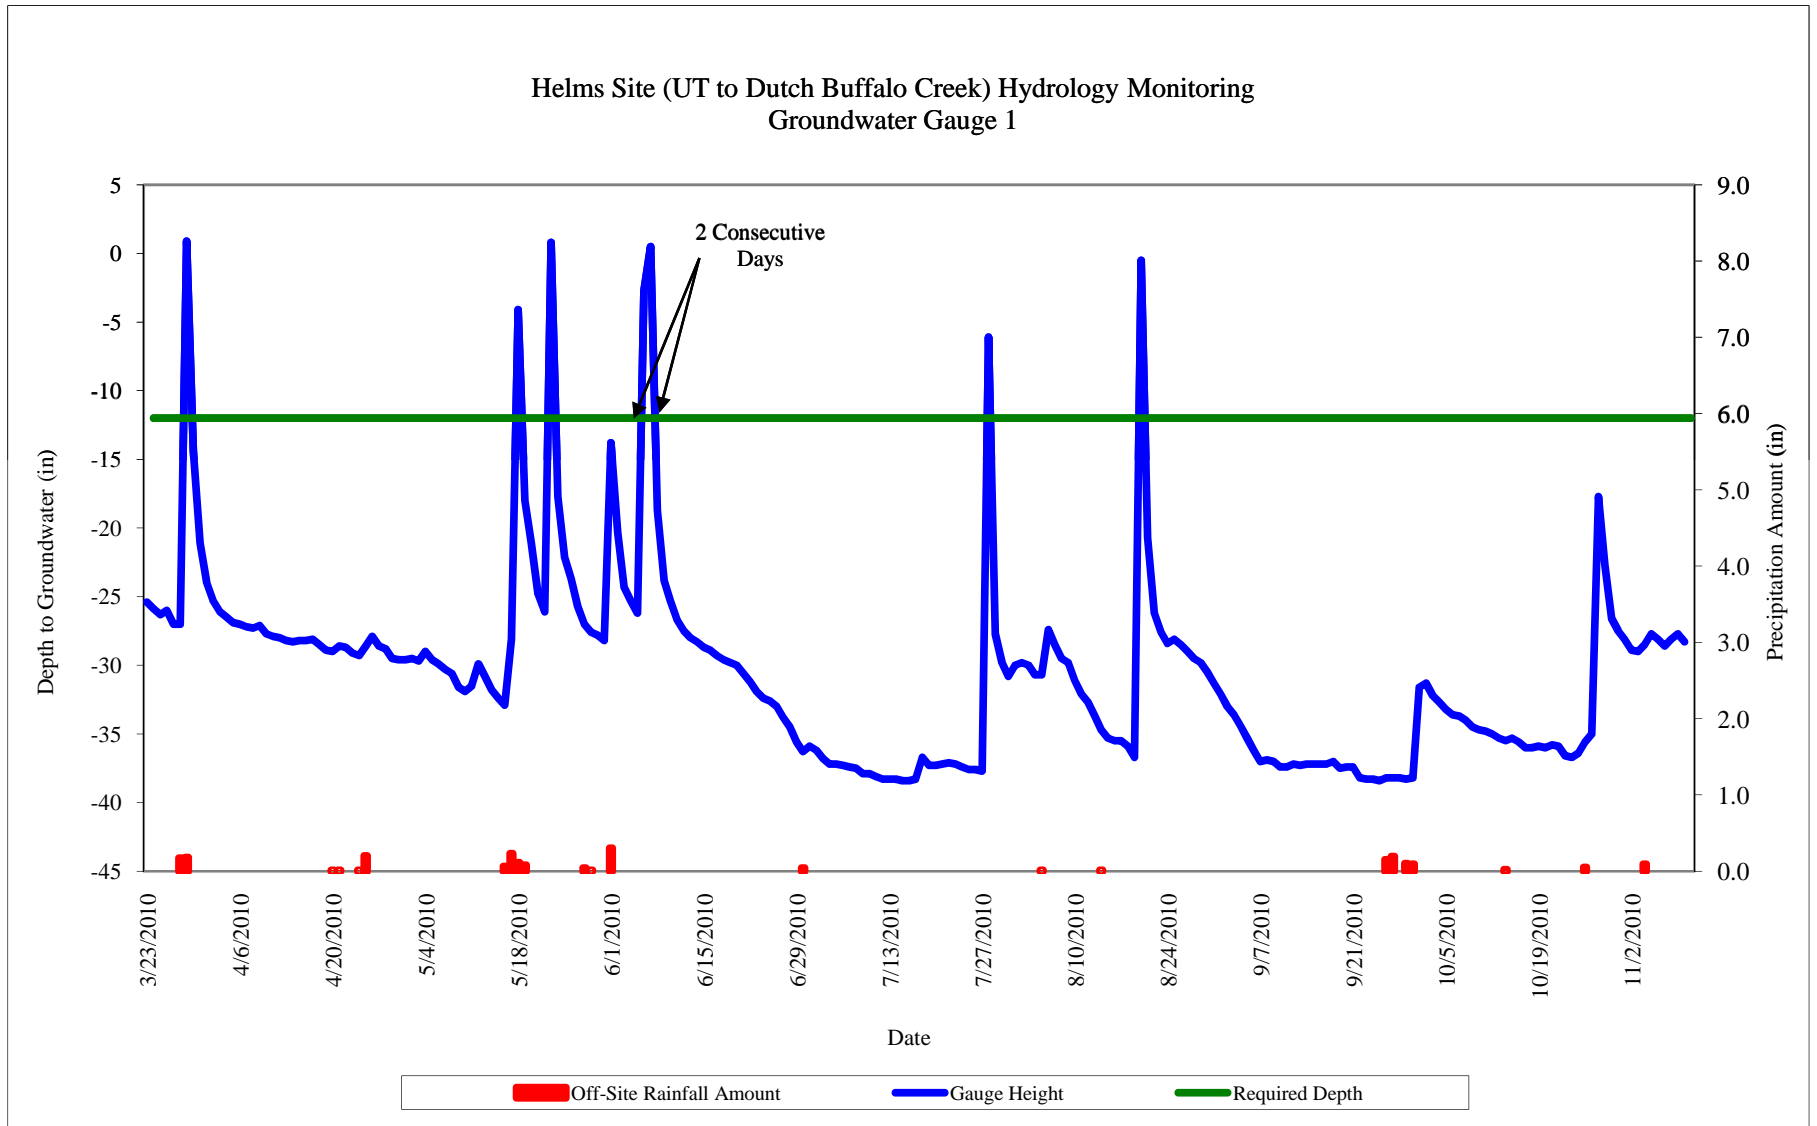
**Appendix 5.1 Precipitation - Water Level Plots for Gauges
Helms Site (UT to Dutch Buffalo Creek)/EEP Project No. 172
Monitoring Year 2 of 5**

Neither groundwater gauge achieved the wetland success criterion of soil saturation within the upper 12 inches for 29 consecutive days during the growing season. Groundwater gauge 1 is not located in a wetland restoration area but has been installed to monitor groundwater elevations in a potential wetland area. Therefore, this area is not a high concern and is not needed for the Site to meet the wetland success criteria. However, groundwater gauge 2 is located within the wetland restoration area and is needed for determining wetland success. Due to unforeseen circumstances, data from groundwater gauge 2 was not available during the 2010 growing season. The groundwater gauge has been replaced to avoid this situation from reoccurring in future monitoring years. Within the wetland restoration area, hydrophytic vegetation and hydrology indicators have developed. Surface inundation to ground saturation was observed throughout the wetland area; therefore, appropriate hydrological conditions for the wetland zones appeared to be present. Since the wetland restoration area appears to be functioning as anticipated, the lack of data from groundwater gauge 2 in MY 2010 is not expected to cause any delay in the monitoring schedule for this project, barring any other issues.

**GW2 was installed in 7/2010, however no data was retrieved for the 2010 monitoring due to an incorrect calibration that occurred in 7/2010 and 8/2010 and a gauge malfunction in 9/2010.
