# Helms Site (UT to Dutch Buffalo Creek) Stream and Wetland Enhancement Project

**EEP Project No. 172**  
**2011 Final Monitoring Report: Year 3 of 5**

**Construction Completed: April 2009**  
**Submission Date: May 2012**

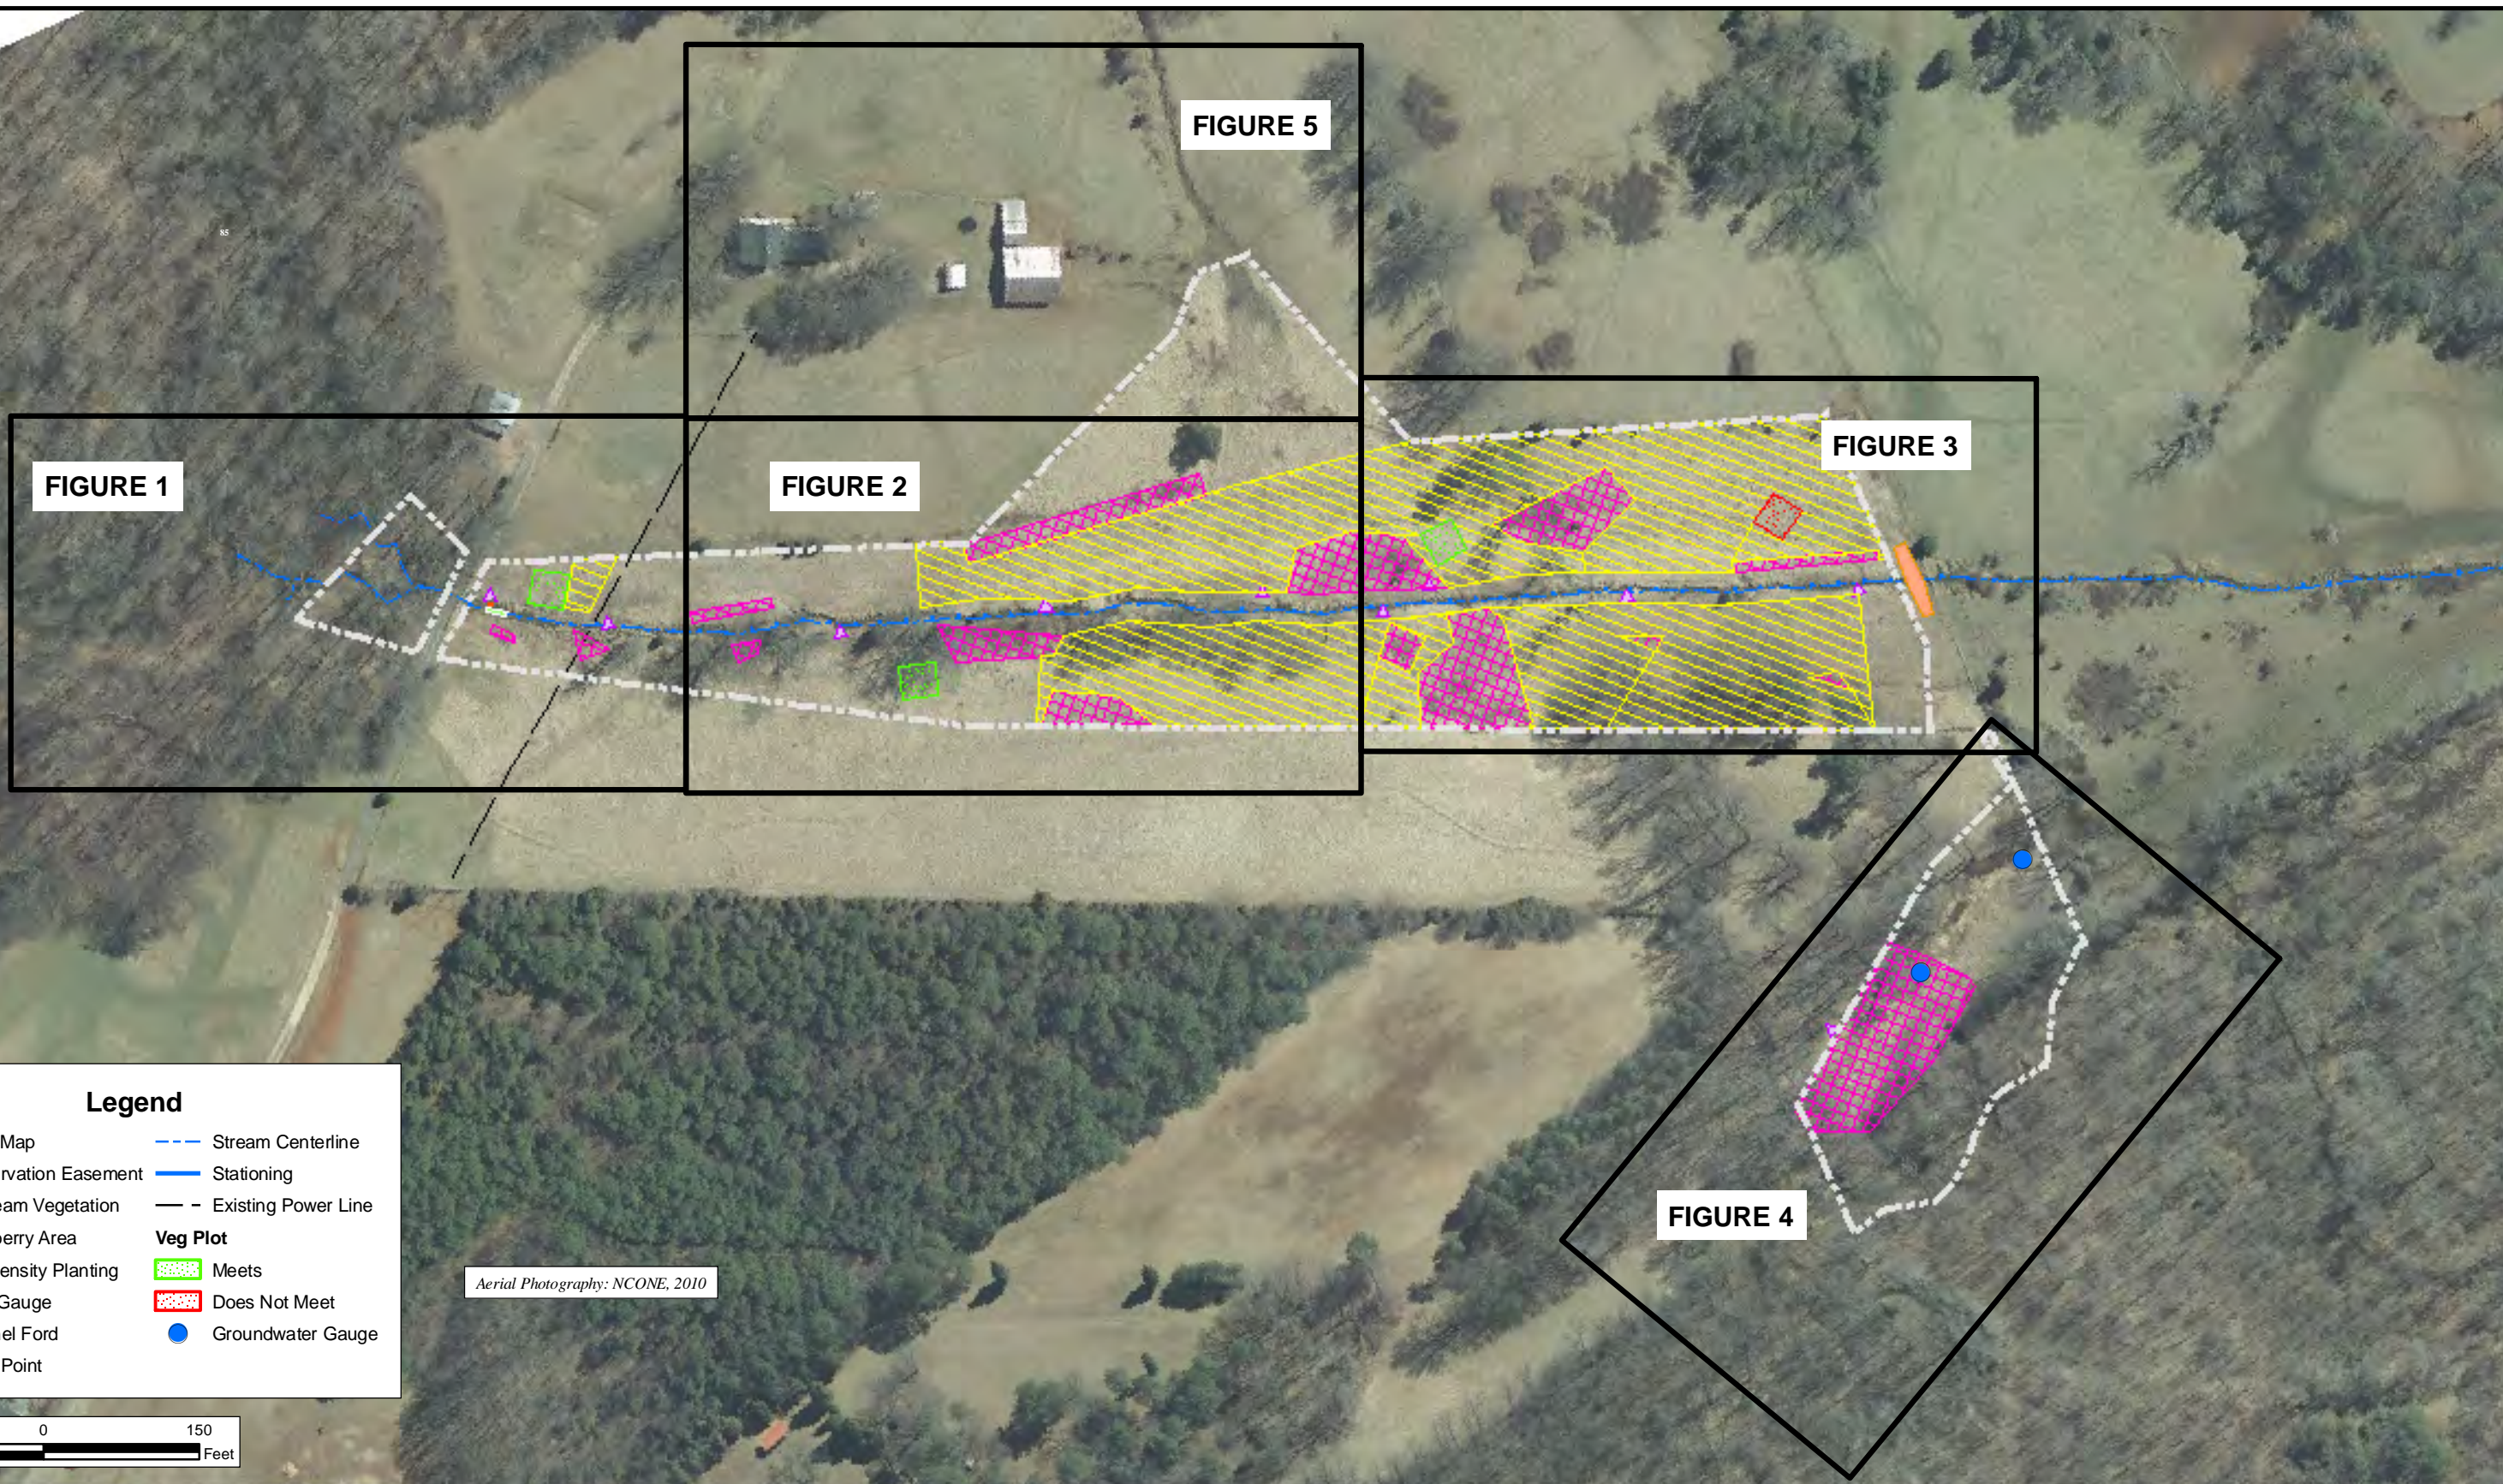
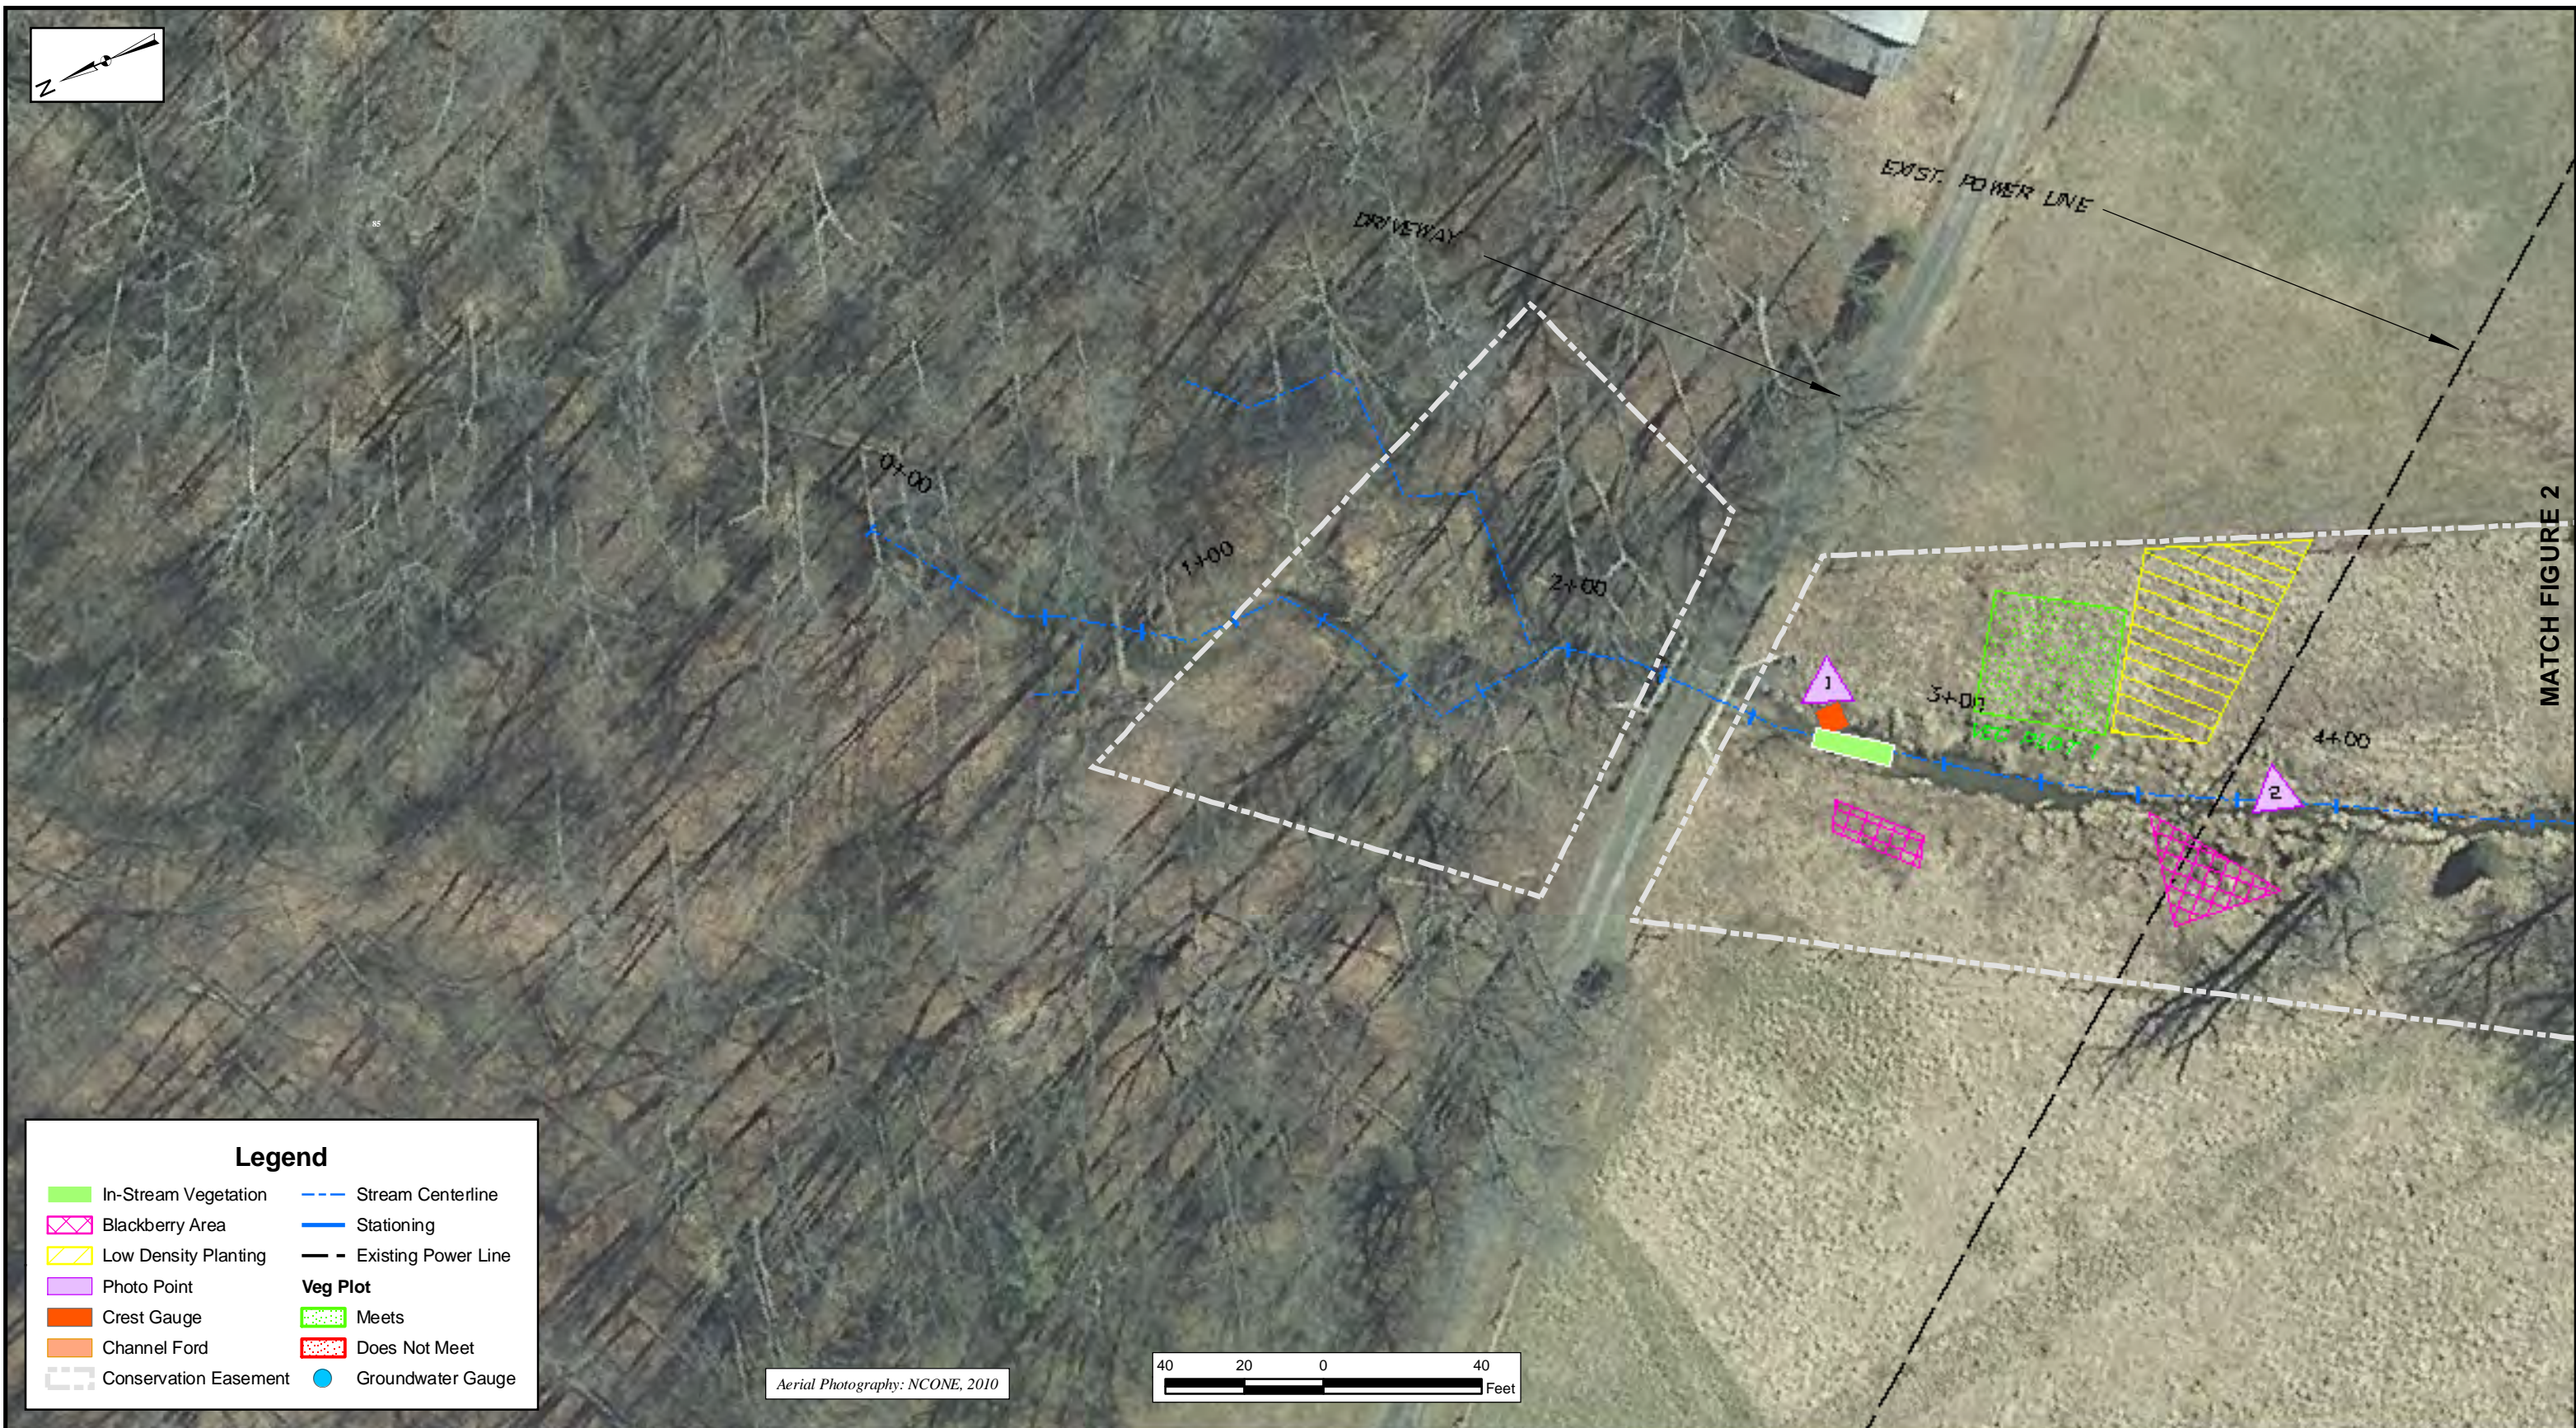
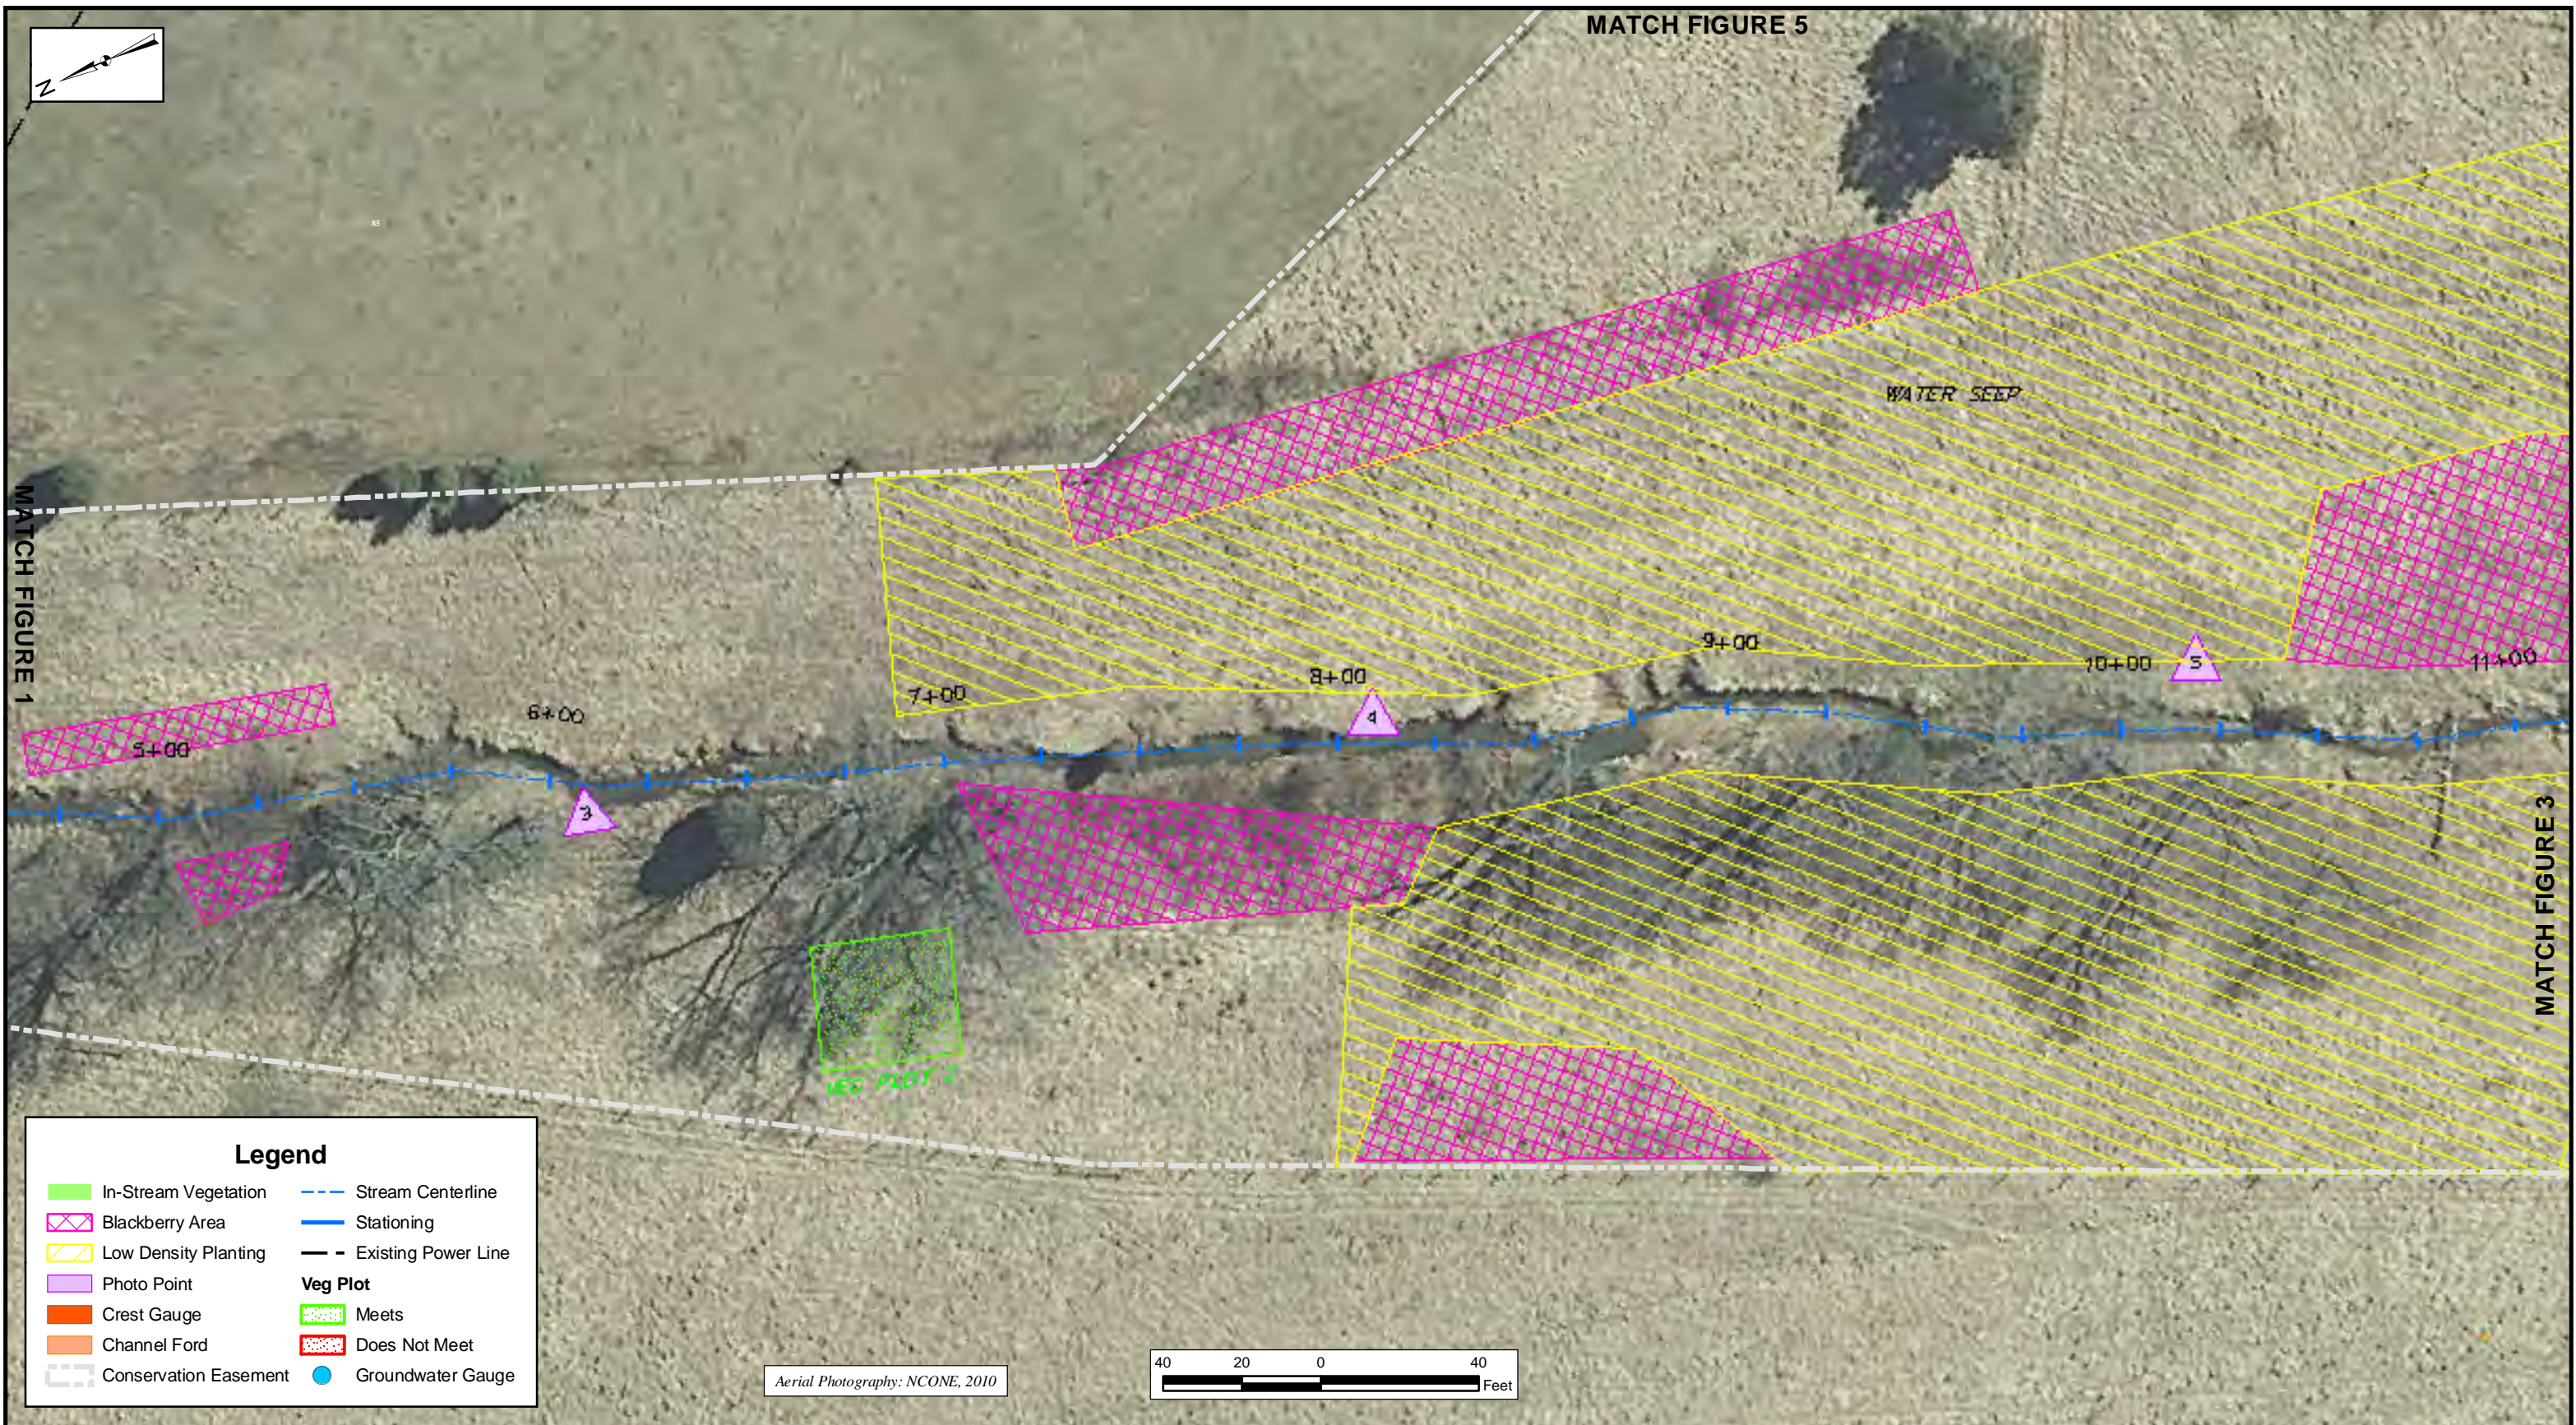
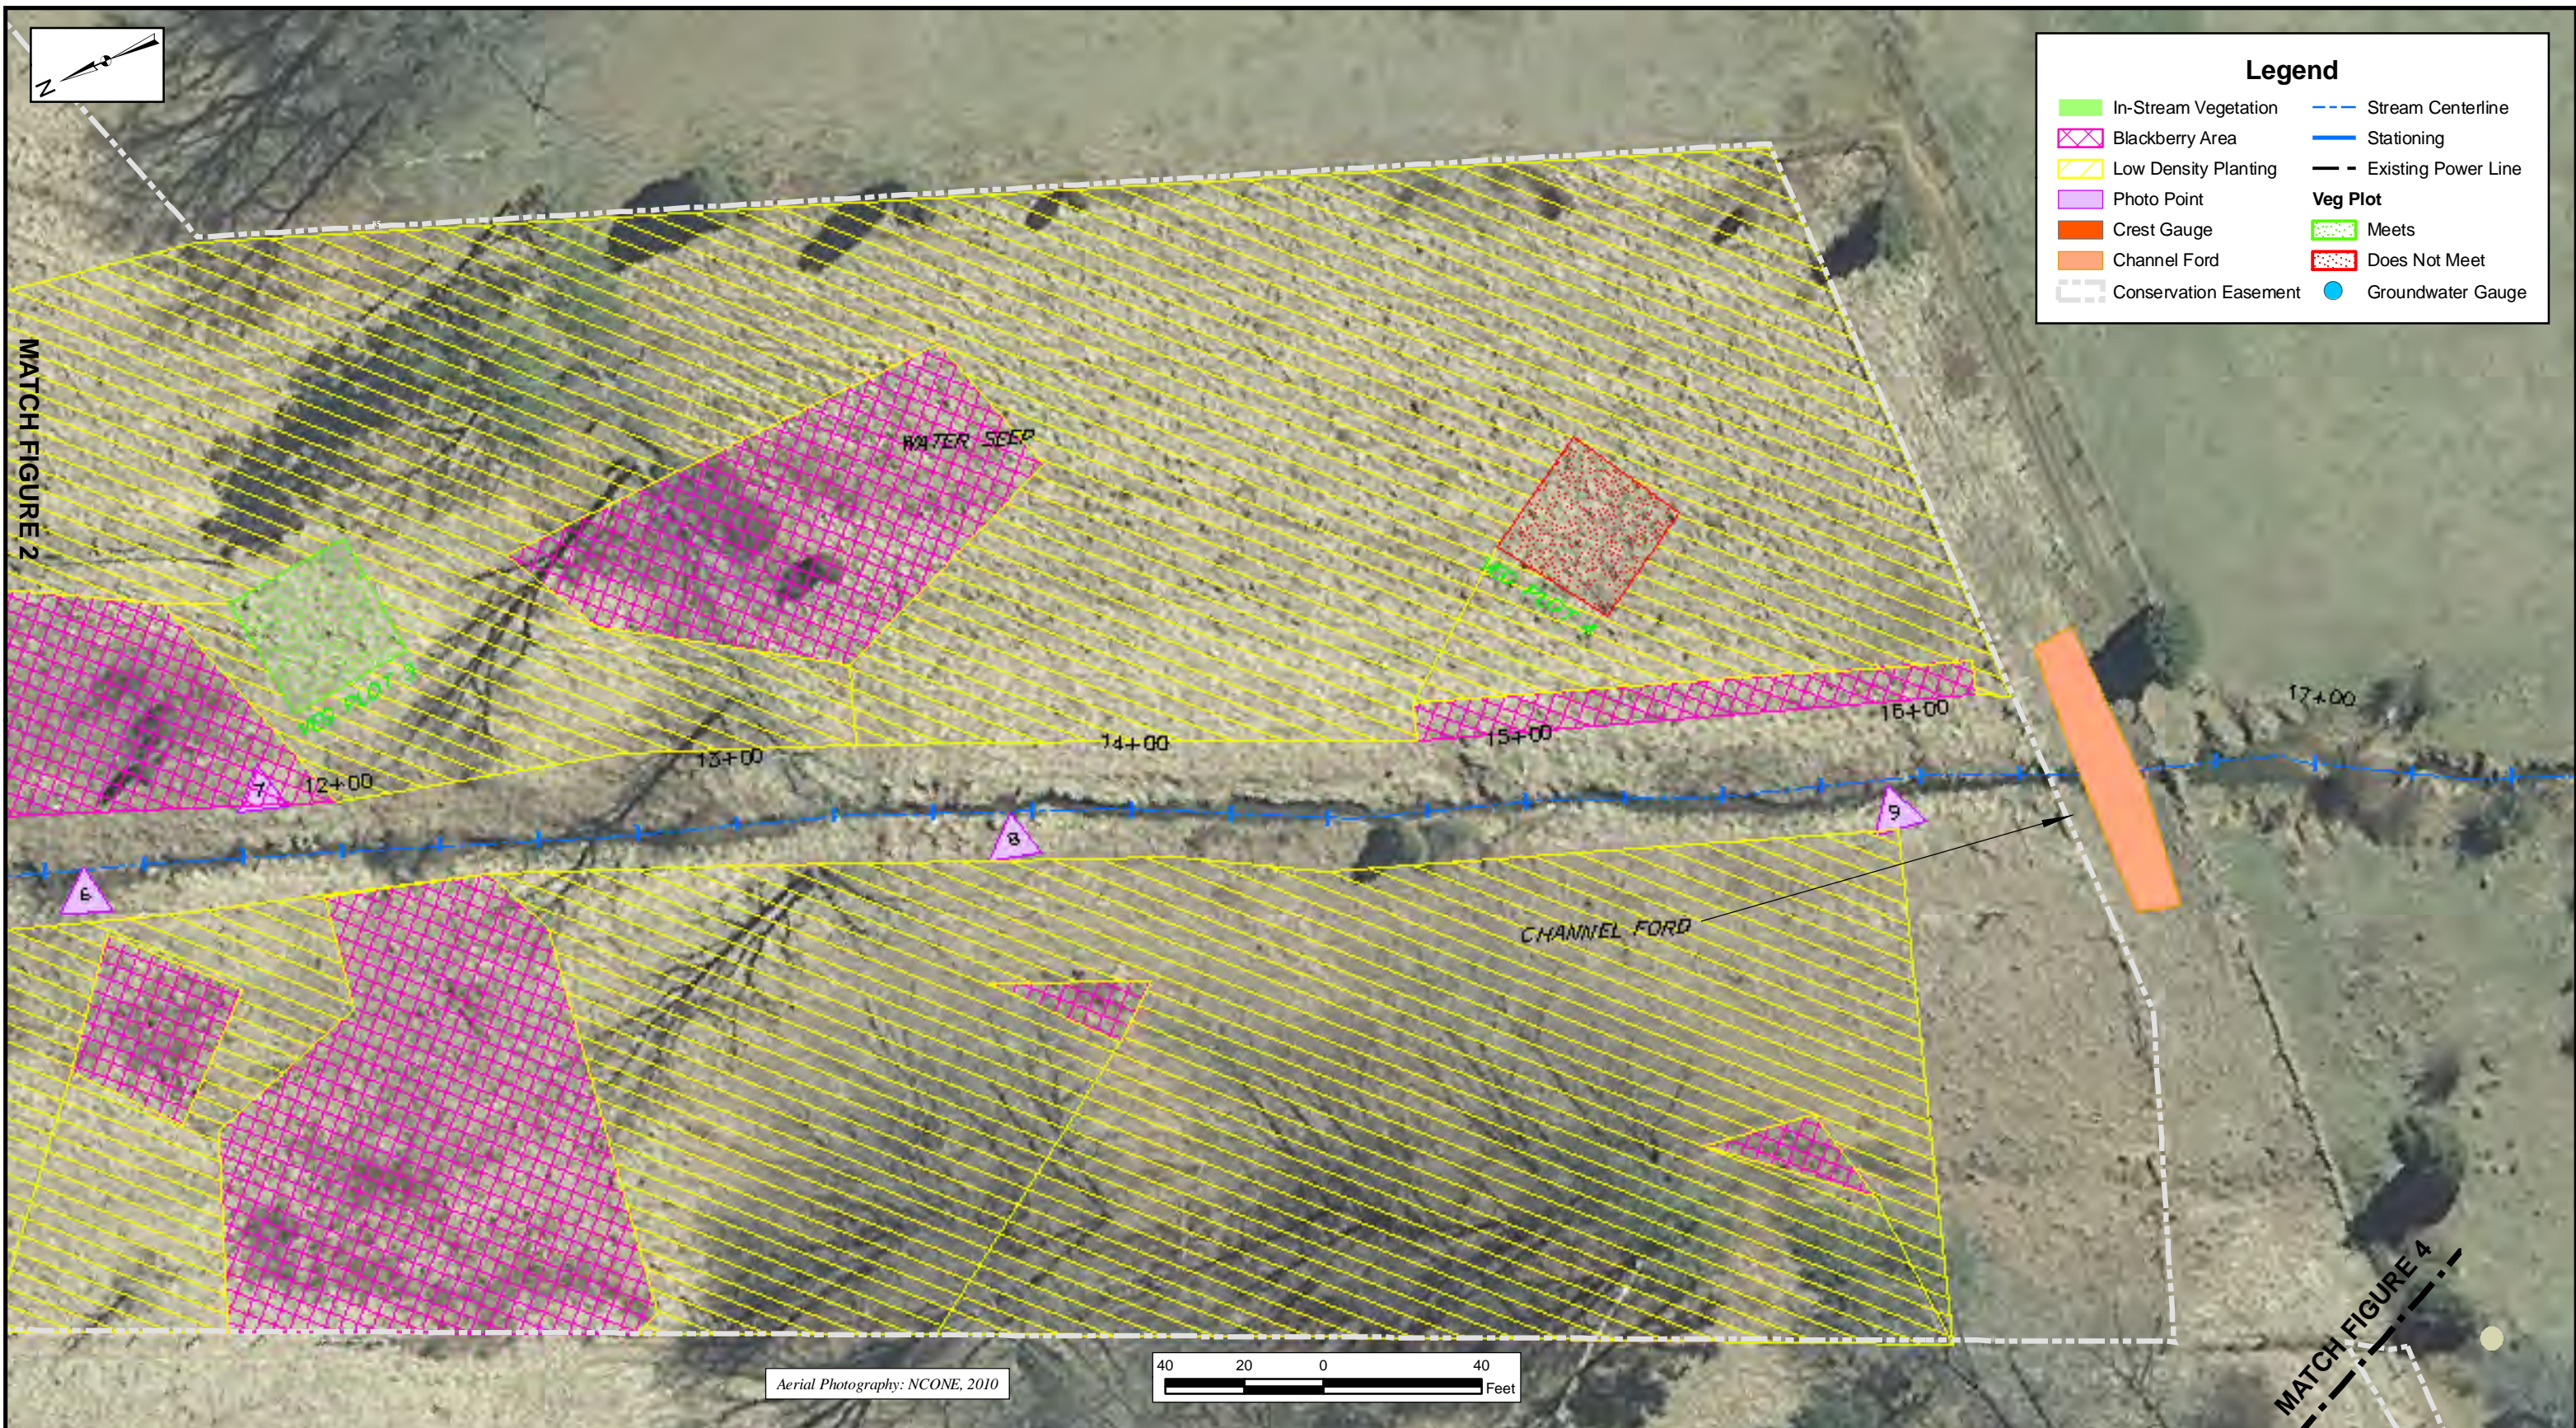
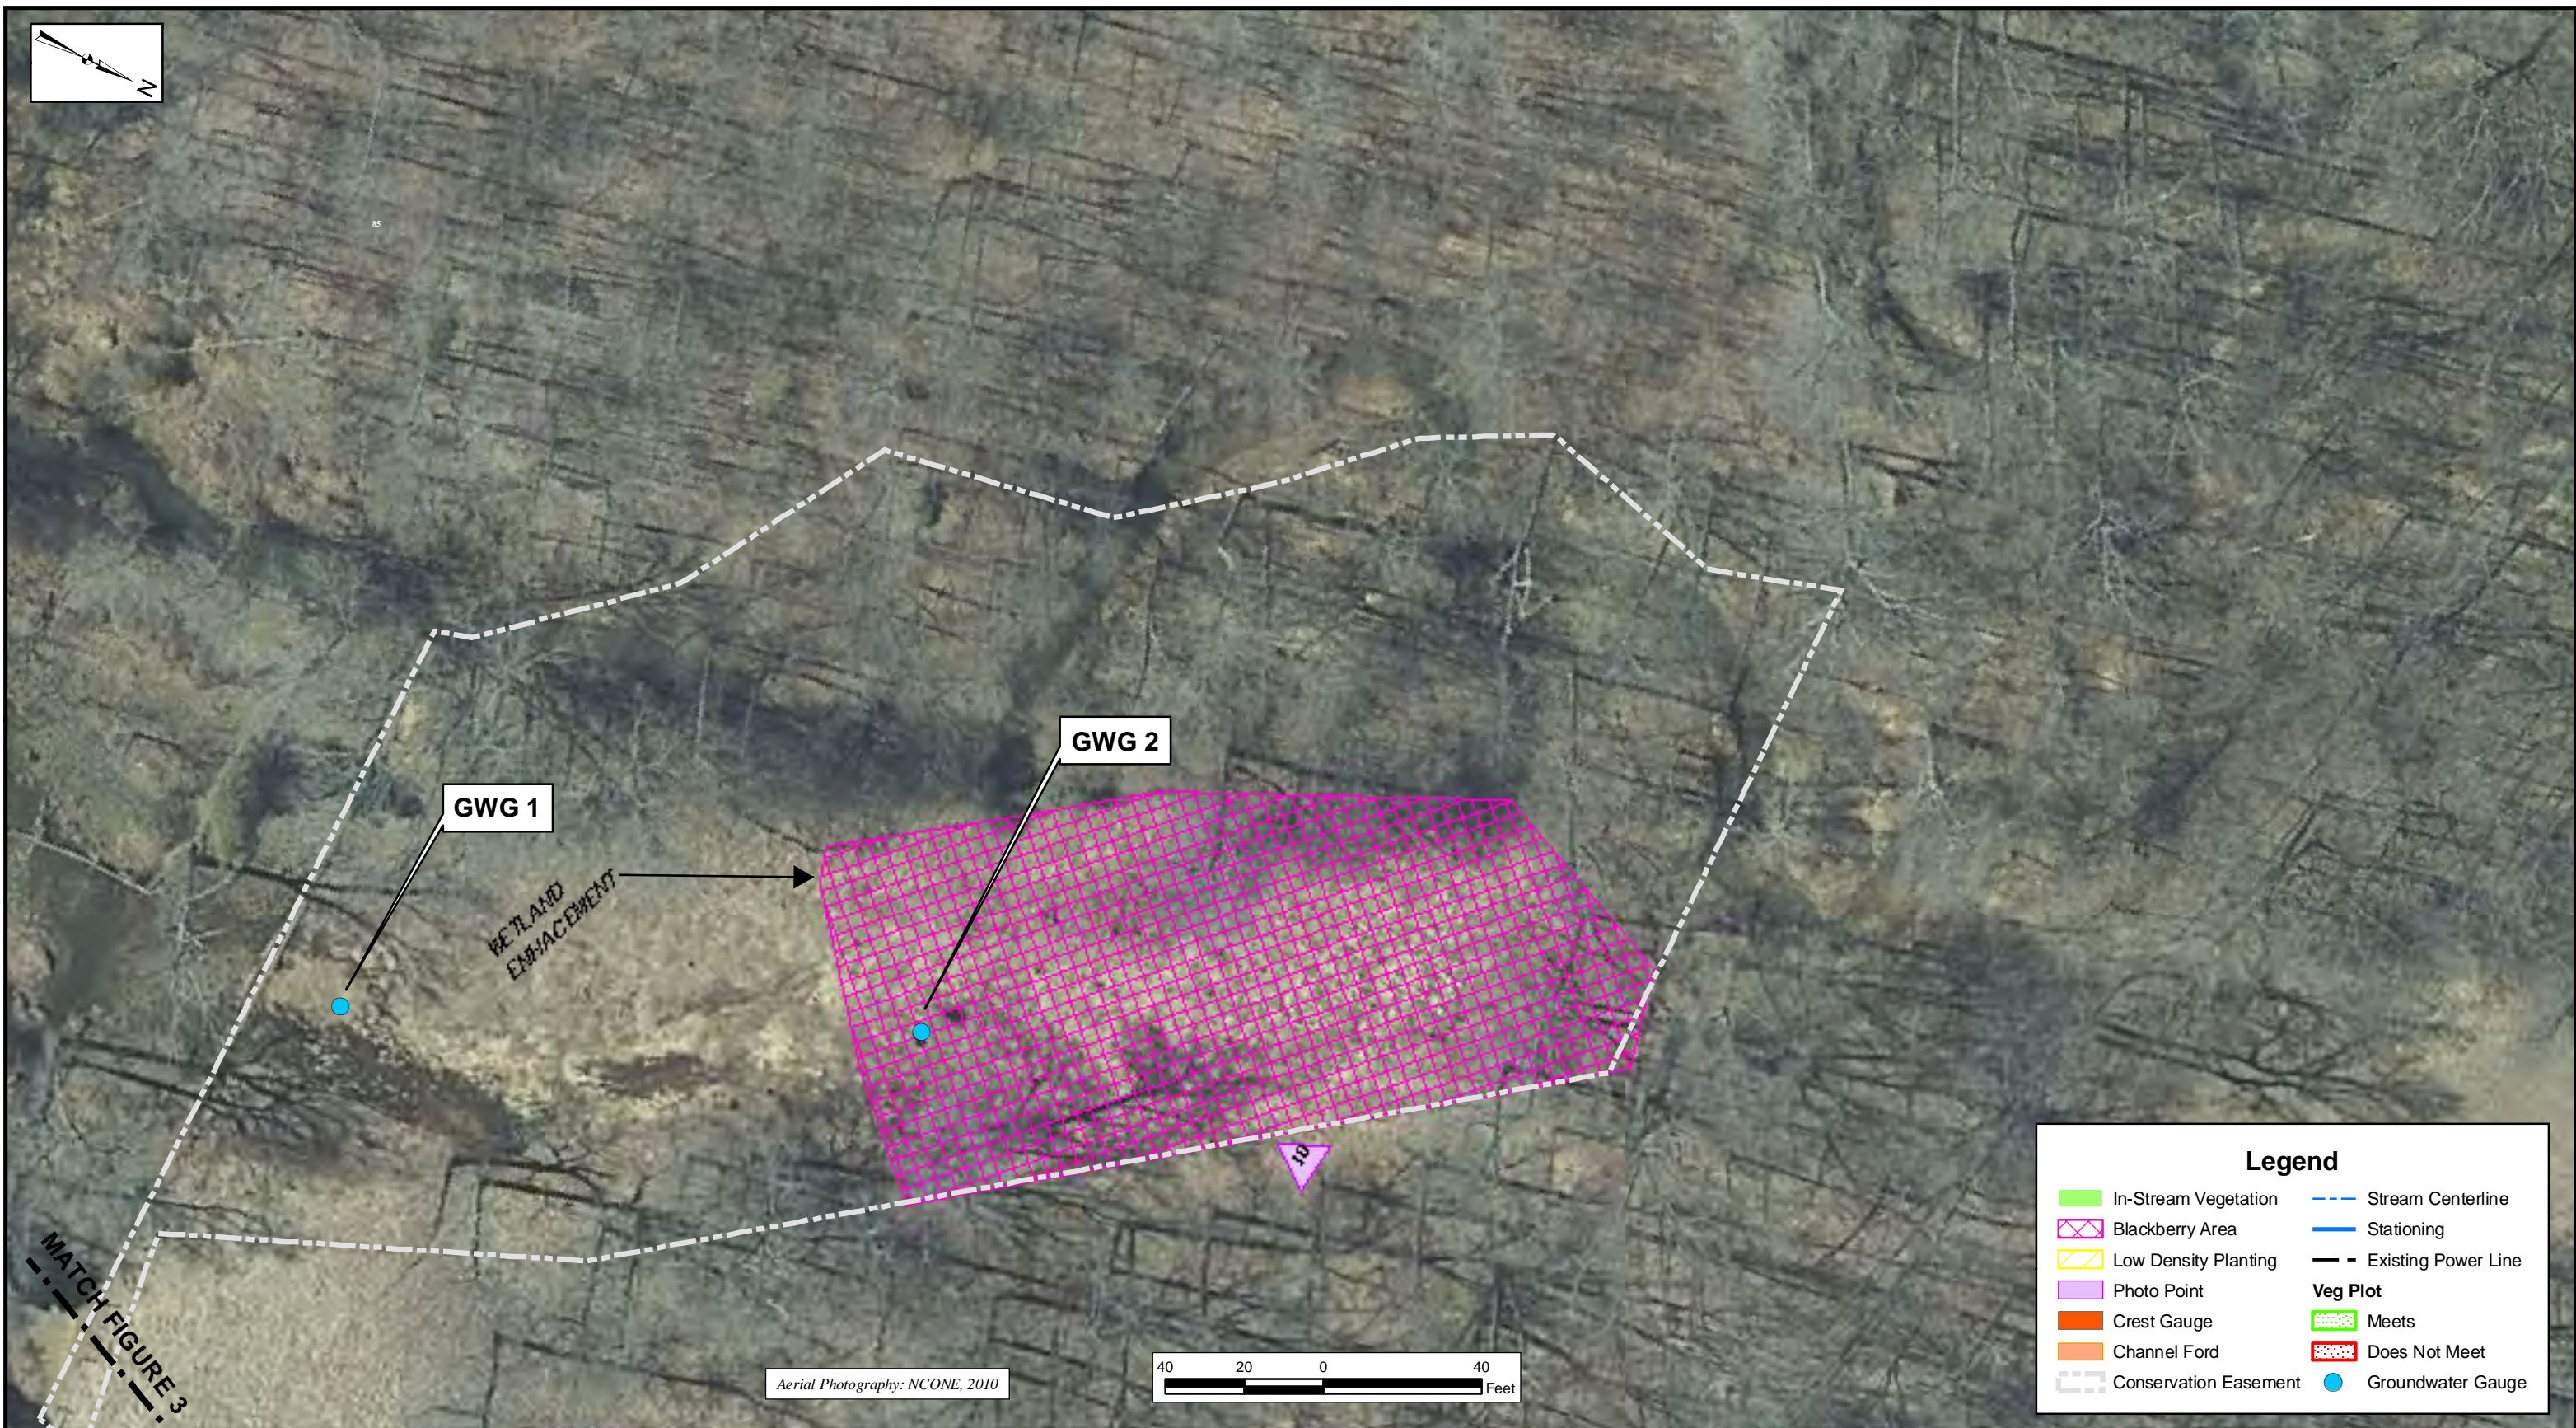
**CURRENT CONDITION PLAN VIEW**

Stream dimension, pattern, profile, and substrate were visually evaluated along 1393.81 linear feet of the UT to Dutch Buffalo Creek. Results from the 2011 stream monitoring effort indicate that stream pattern, profile, and dimension of UT to Dutch Buffalo Creek is maintaining vertical and lateral stability with minimal problem areas. A few areas were noted with in-stream vegetation growth (in association with aggradation) and bank scour. In-stream vegetation does not appear to have affected channel flow but has been associated with mid and transverse channel bars. The channel bars are located near the northernmost portion of the project (near the driveway bridge crossing) and within the vicinity of station 06+00. Low flow conditions have also exacerbated the complications with in-stream vegetation growth. Bank scour is likely a pre-existing condition as a result of previous land use. Currently, sections of the reach exhibiting scour appear to be limited to historically eroded areas and have maintained or slightly decreased in size and prevalence throughout. These problem areas will continue to be monitored during subsequent assessments.

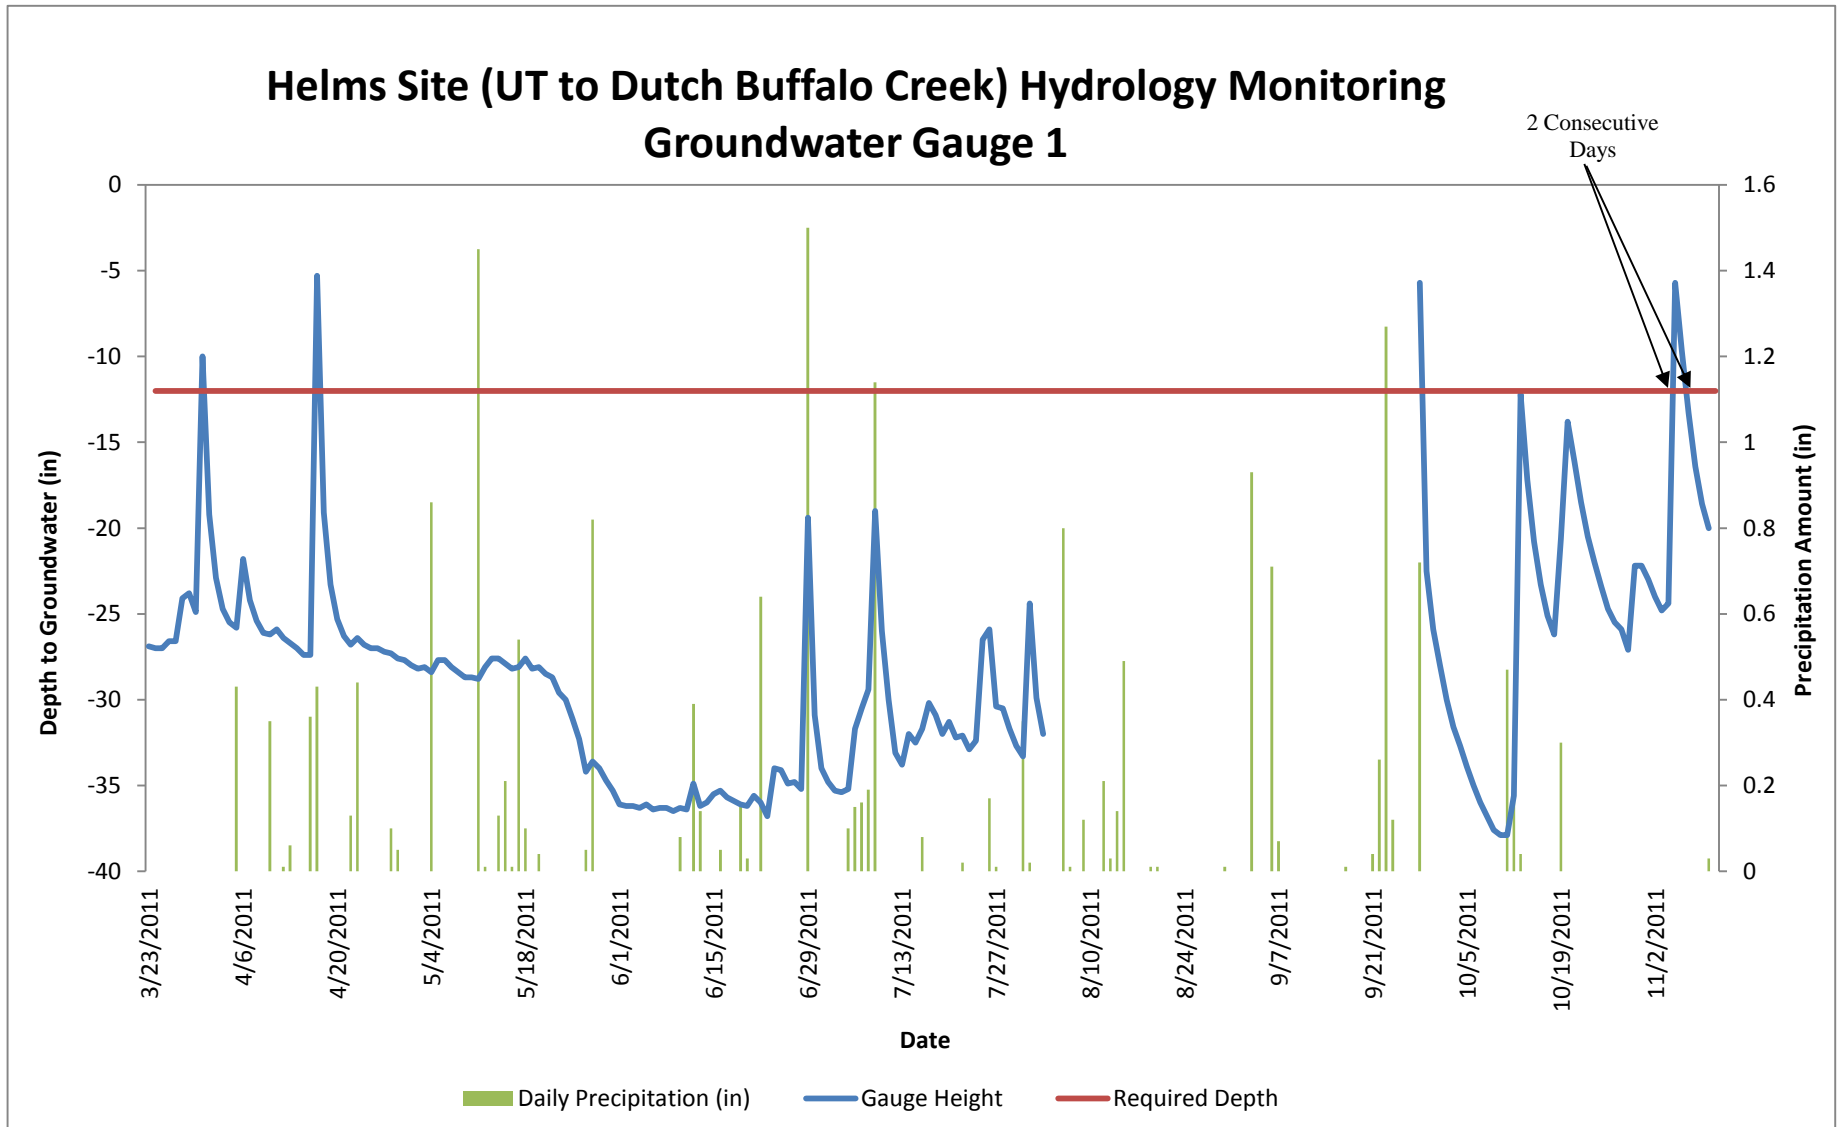
**Figure 7a: Precipitation and Water Level Plots for Gauges  
Helms Site (UT to Dutch Buffalo Creek)/EEP Project No. 172  
Monitoring Year 3 of 5**

Two groundwater gauges are located on Site. The original groundwater gauge (Gauge 1) installed by EcoScience malfunctioned and was replaced by JJG after the first (2009) monitoring season. Groundwater gauge 2 was installed late in the 2010 monitoring season and experienced multiple malfunctions throughout the growing season. The gauges are programmed to download groundwater levels daily in order to capture hydrological data during the growing season. The target wetland hydrological success criterion is saturation or inundation for at least 12.5 percent of the growing season in the lower landscape (floodplain) positions. To achieve the stated hydrologic success criterion, groundwater levels must be within 12 inches of the ground surface for 29 consecutive days of the March 23 to November 7 (229 days) growing season.

Neither groundwater gauge achieved the wetland success criterion of soil saturation within the upper 12 inches for 29 consecutive days during the growing season. Groundwater gauge 1 is not located in a wetland restoration area but has been installed to monitor groundwater elevations in a potential wetland area. Therefore, this area is not a high concern and is not needed for the Site to meet the wetland success criteria. However, groundwater gauge 2 is located within the wetland restoration area and is needed for determining wetland success. Due to unforeseen circumstances, data from groundwater gauge 2 was not available during the 2010 growing season. The groundwater gauge was replaced after the 2010 growing season to prevent this situation from reoccurring in future monitoring years, but, the gauge continually malfunctioned throughout the 2011 monitoring year. Therefore, hydrologic data was not collected from groundwater gauge 2 during the growing season. However, within the wetland restoration area, hydrophytic vegetation and hydrology indicators have continued to develop in 2011. Surface inundation to ground saturation was observed throughout the wetland area; therefore, appropriate hydrological conditions for the wetland zones appeared to be present. Since the wetland restoration area appears to be functioning as anticipated, the lack of data from groundwater gauge 2 in MY 2011 is not expected to cause any delay in the monitoring schedule for this project, barring any other issues.
