FINAL
ANNUAL MONITORING REPORT
YEAR 4 (2014)
HELMS SITE (UT to DUTCH BUFFALO CREEK)
STREAM/WETLAND ENHANCEMENT SITE
ROWAN COUNTY, NORTH CAROLINA
(EEP Project No. 172, Contract No. 5767)
Construction Completed April 2009

October 2014

Prepared by:
Axiom Environmental, Inc.
218 Snow Avenue
Raleigh, North Carolina 27603

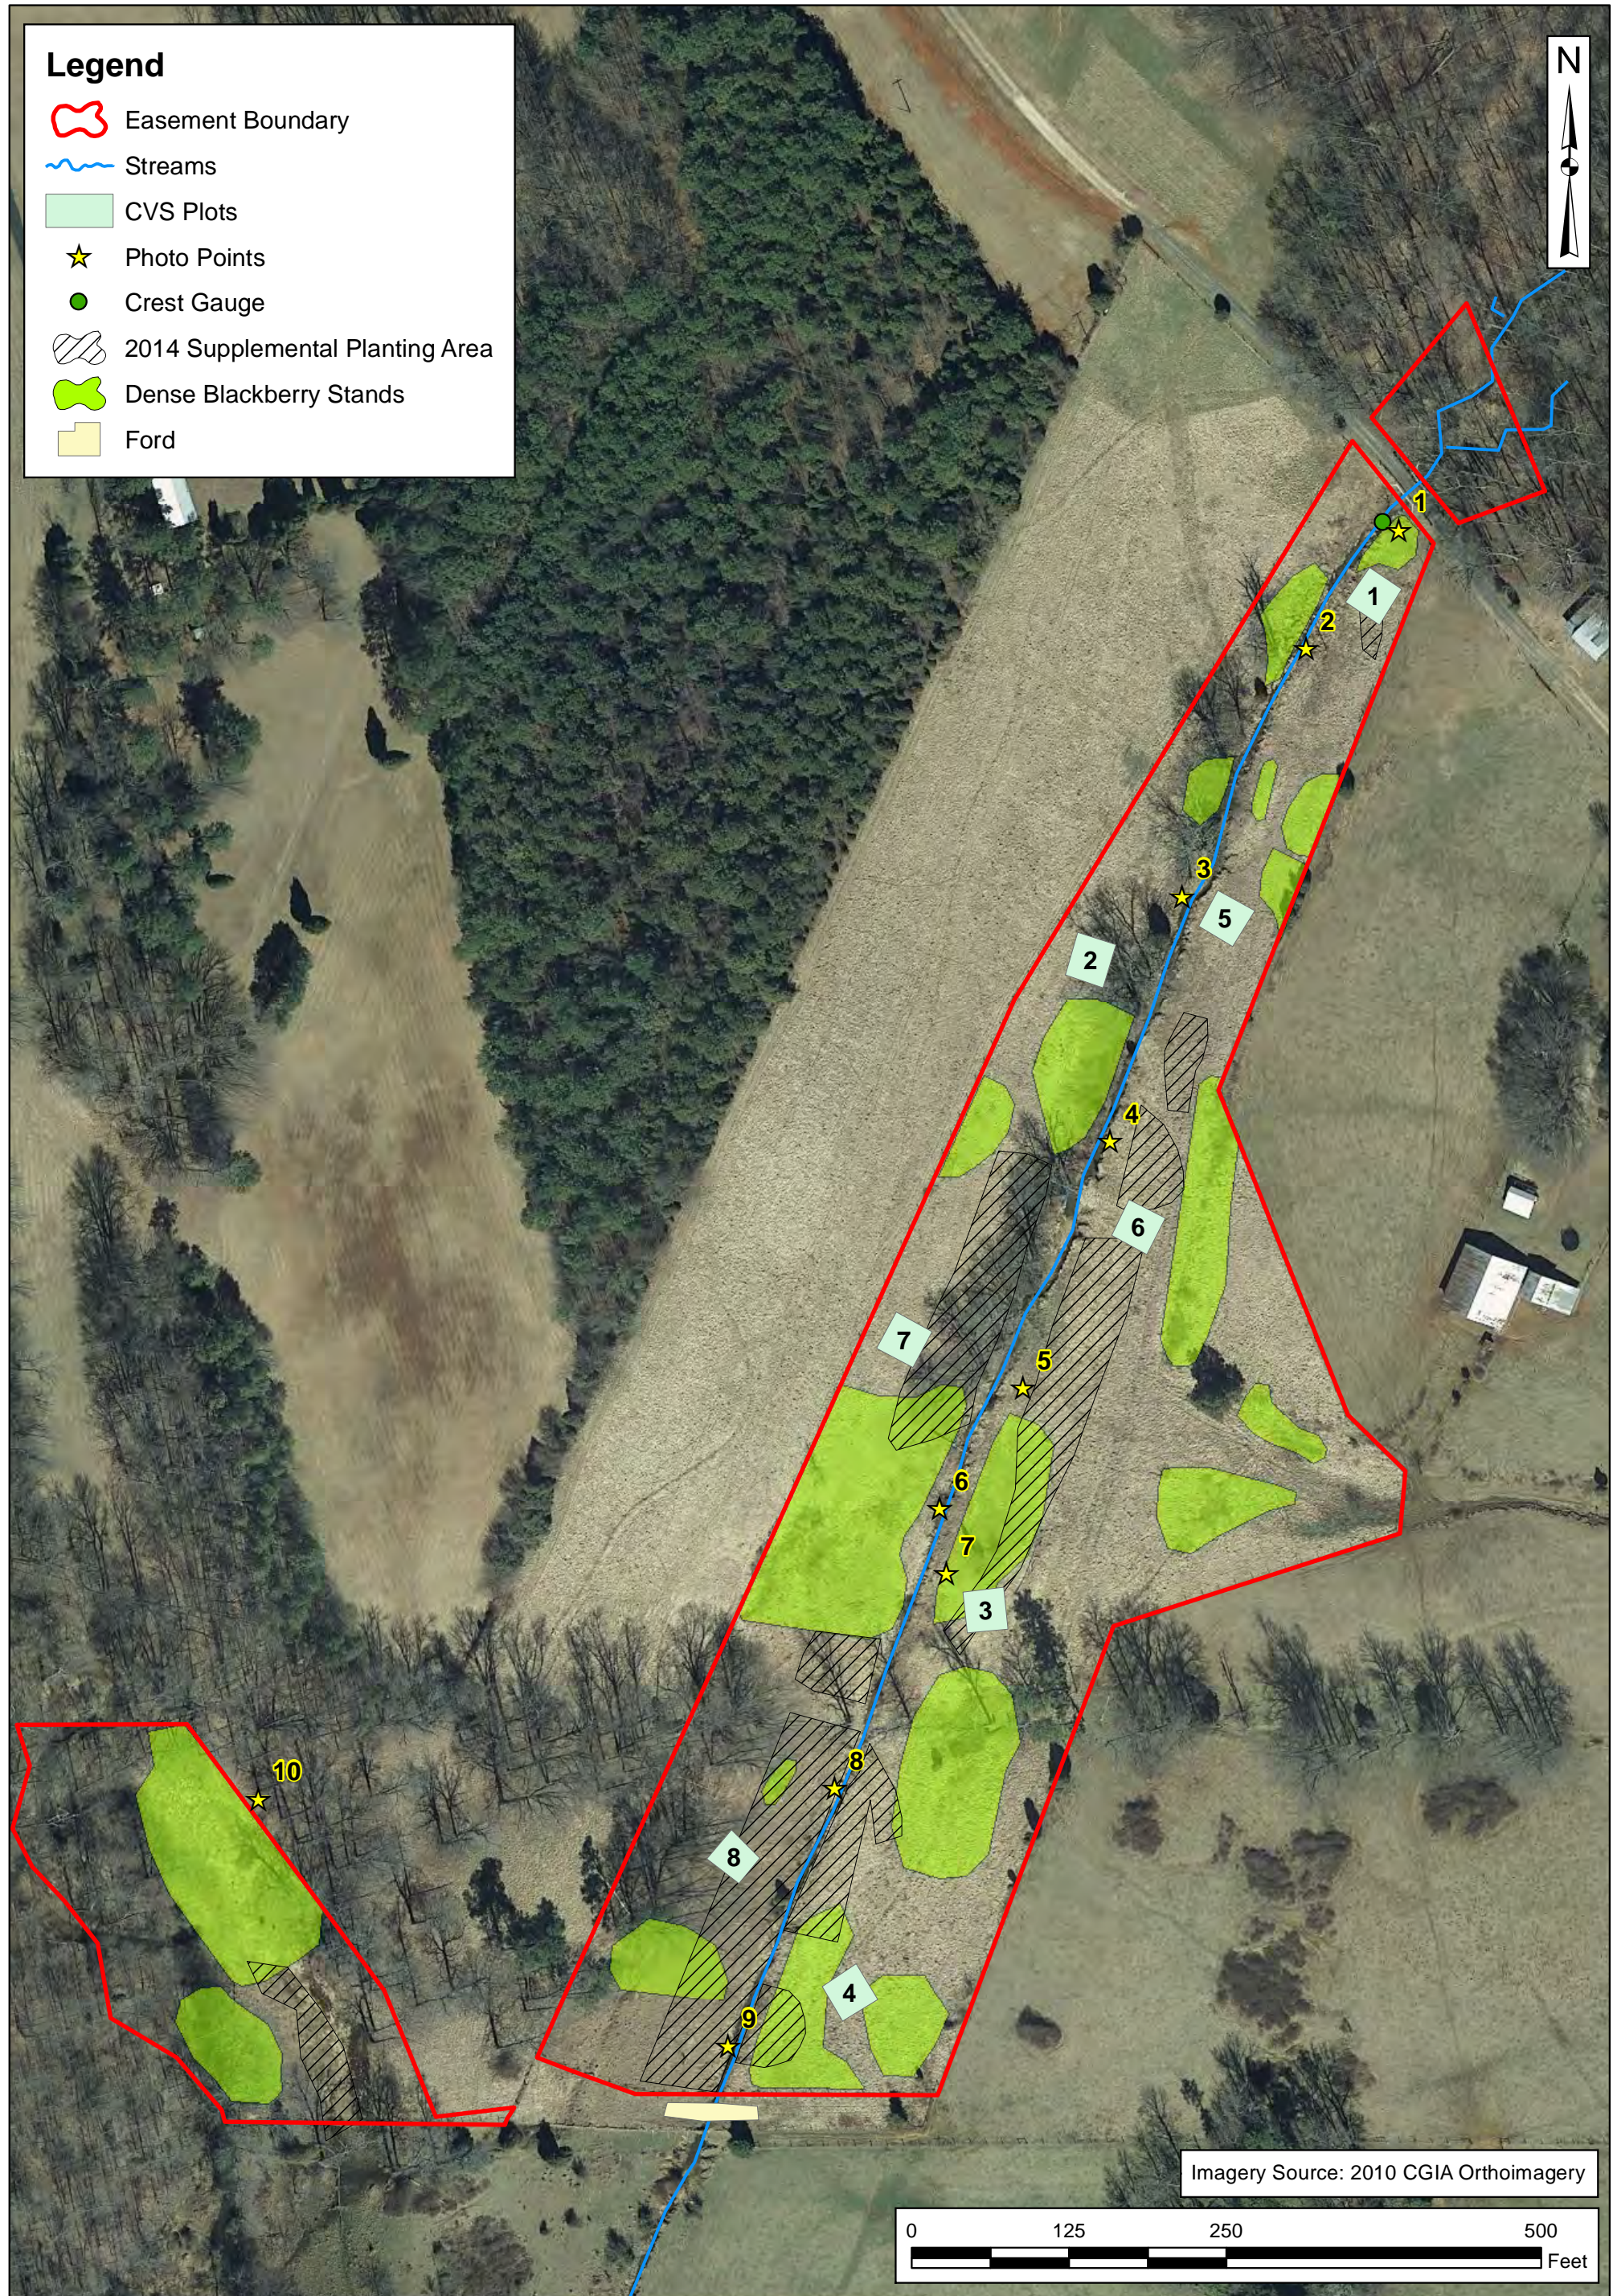
**FIGURE
2**

Several dense patches of blackberry had been identified onsite in previous monitoring years; blackberry continues to thrive in these areas, and several have expanded during the 2014 growing season (Figure 2, Appendix B). In addition, several stems of trifoliolate orange (*Poncirus trifoliolate*) and Tree of Heaven (*Ailanthus altissima*) are scattered throughout the Site. These are not currently posing any threat to success, but they will continue to be closely monitored over the next year.

A supplemental planting occurred on February 19 and 24, 2014. This planting area spanned the majority of the site and consisted of 850 containerized stems of native character species (Figure 2, Appendix B). The planting list is as follows.
