FINAL
ANNUAL MONITORING REPORT
YEAR 5 (2015)
HELMS SITE (UT to DUTCH BUFFALO CREEK)
STREAM/WETLAND ENHANCEMENT SITE
ROWAN COUNTY, NORTH CAROLINA
(DMS Project No. 172, Contract No. 5767)
Construction Completed April 2009

December 2015

Prepared by:
Axiom Environmental, Inc.
218 Snow Avenue
Raleigh, North Carolina 27603

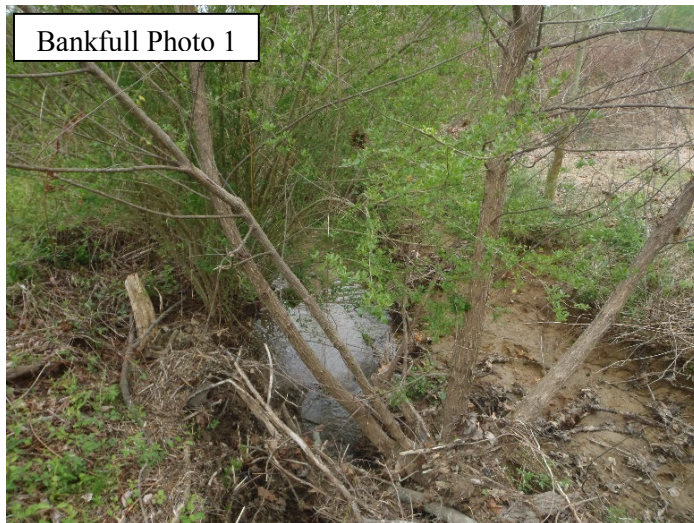
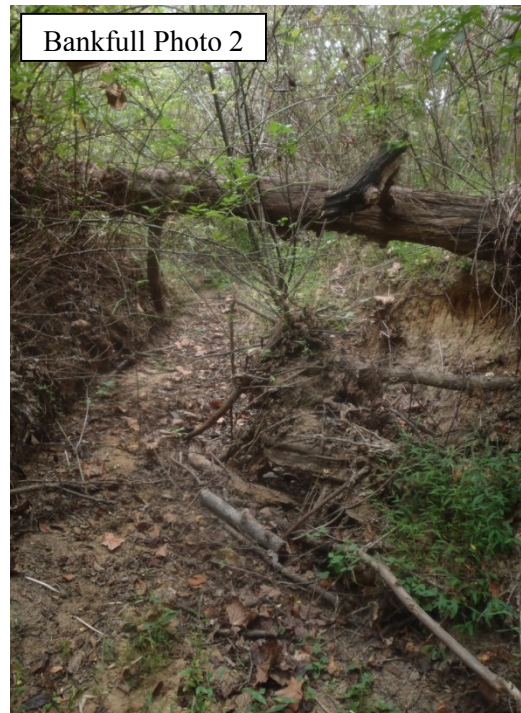
Date of Data Collection	Date of Occurrence	Method	Photo (if available)
November 18, 2009	November 11-12, 2009	Visual observations	--
October 1, 2010	Unknown	Visual observations, crest gauge	--
April 2011	April 19, 2011	Visual observations, crest gauge, discussions with landowner	--
May 2011	May 19, 2011	Visual observations, crest gauge, discussions with landowner	--
July 2011	July 2011	Visual observations, crest gauge, discussions with landowner	--
May 2014	August 17, 2013	2.36 inches* of rain in one day indicate that a bankfull event likely occurred.	--
May 2014	March 7, 2014	Wrack observed in floodplain as well as crest gauge observations after 2.08 inches* of rain in one day indicate a bankfull event occurred.	1
September 25, 2014	August 1, 2014	Crest gauge data indicates a bankfull event occurred after 1.75 inches* of rain in one day.	--
September 21, 2015	July 19, 2015	Wrack observed in floodplain along the right bank, just downstream of PP-06, after 1.53 inches* of rain in one day.	2
