MONITORING YEAR 1 ANNUAL REPORT

HENRY FORK MITIGATION SITE

Catawba County, NC
DEQ Contract No. 005782
DMS ID No. 96306

Final Submission Date: January 13, 2017

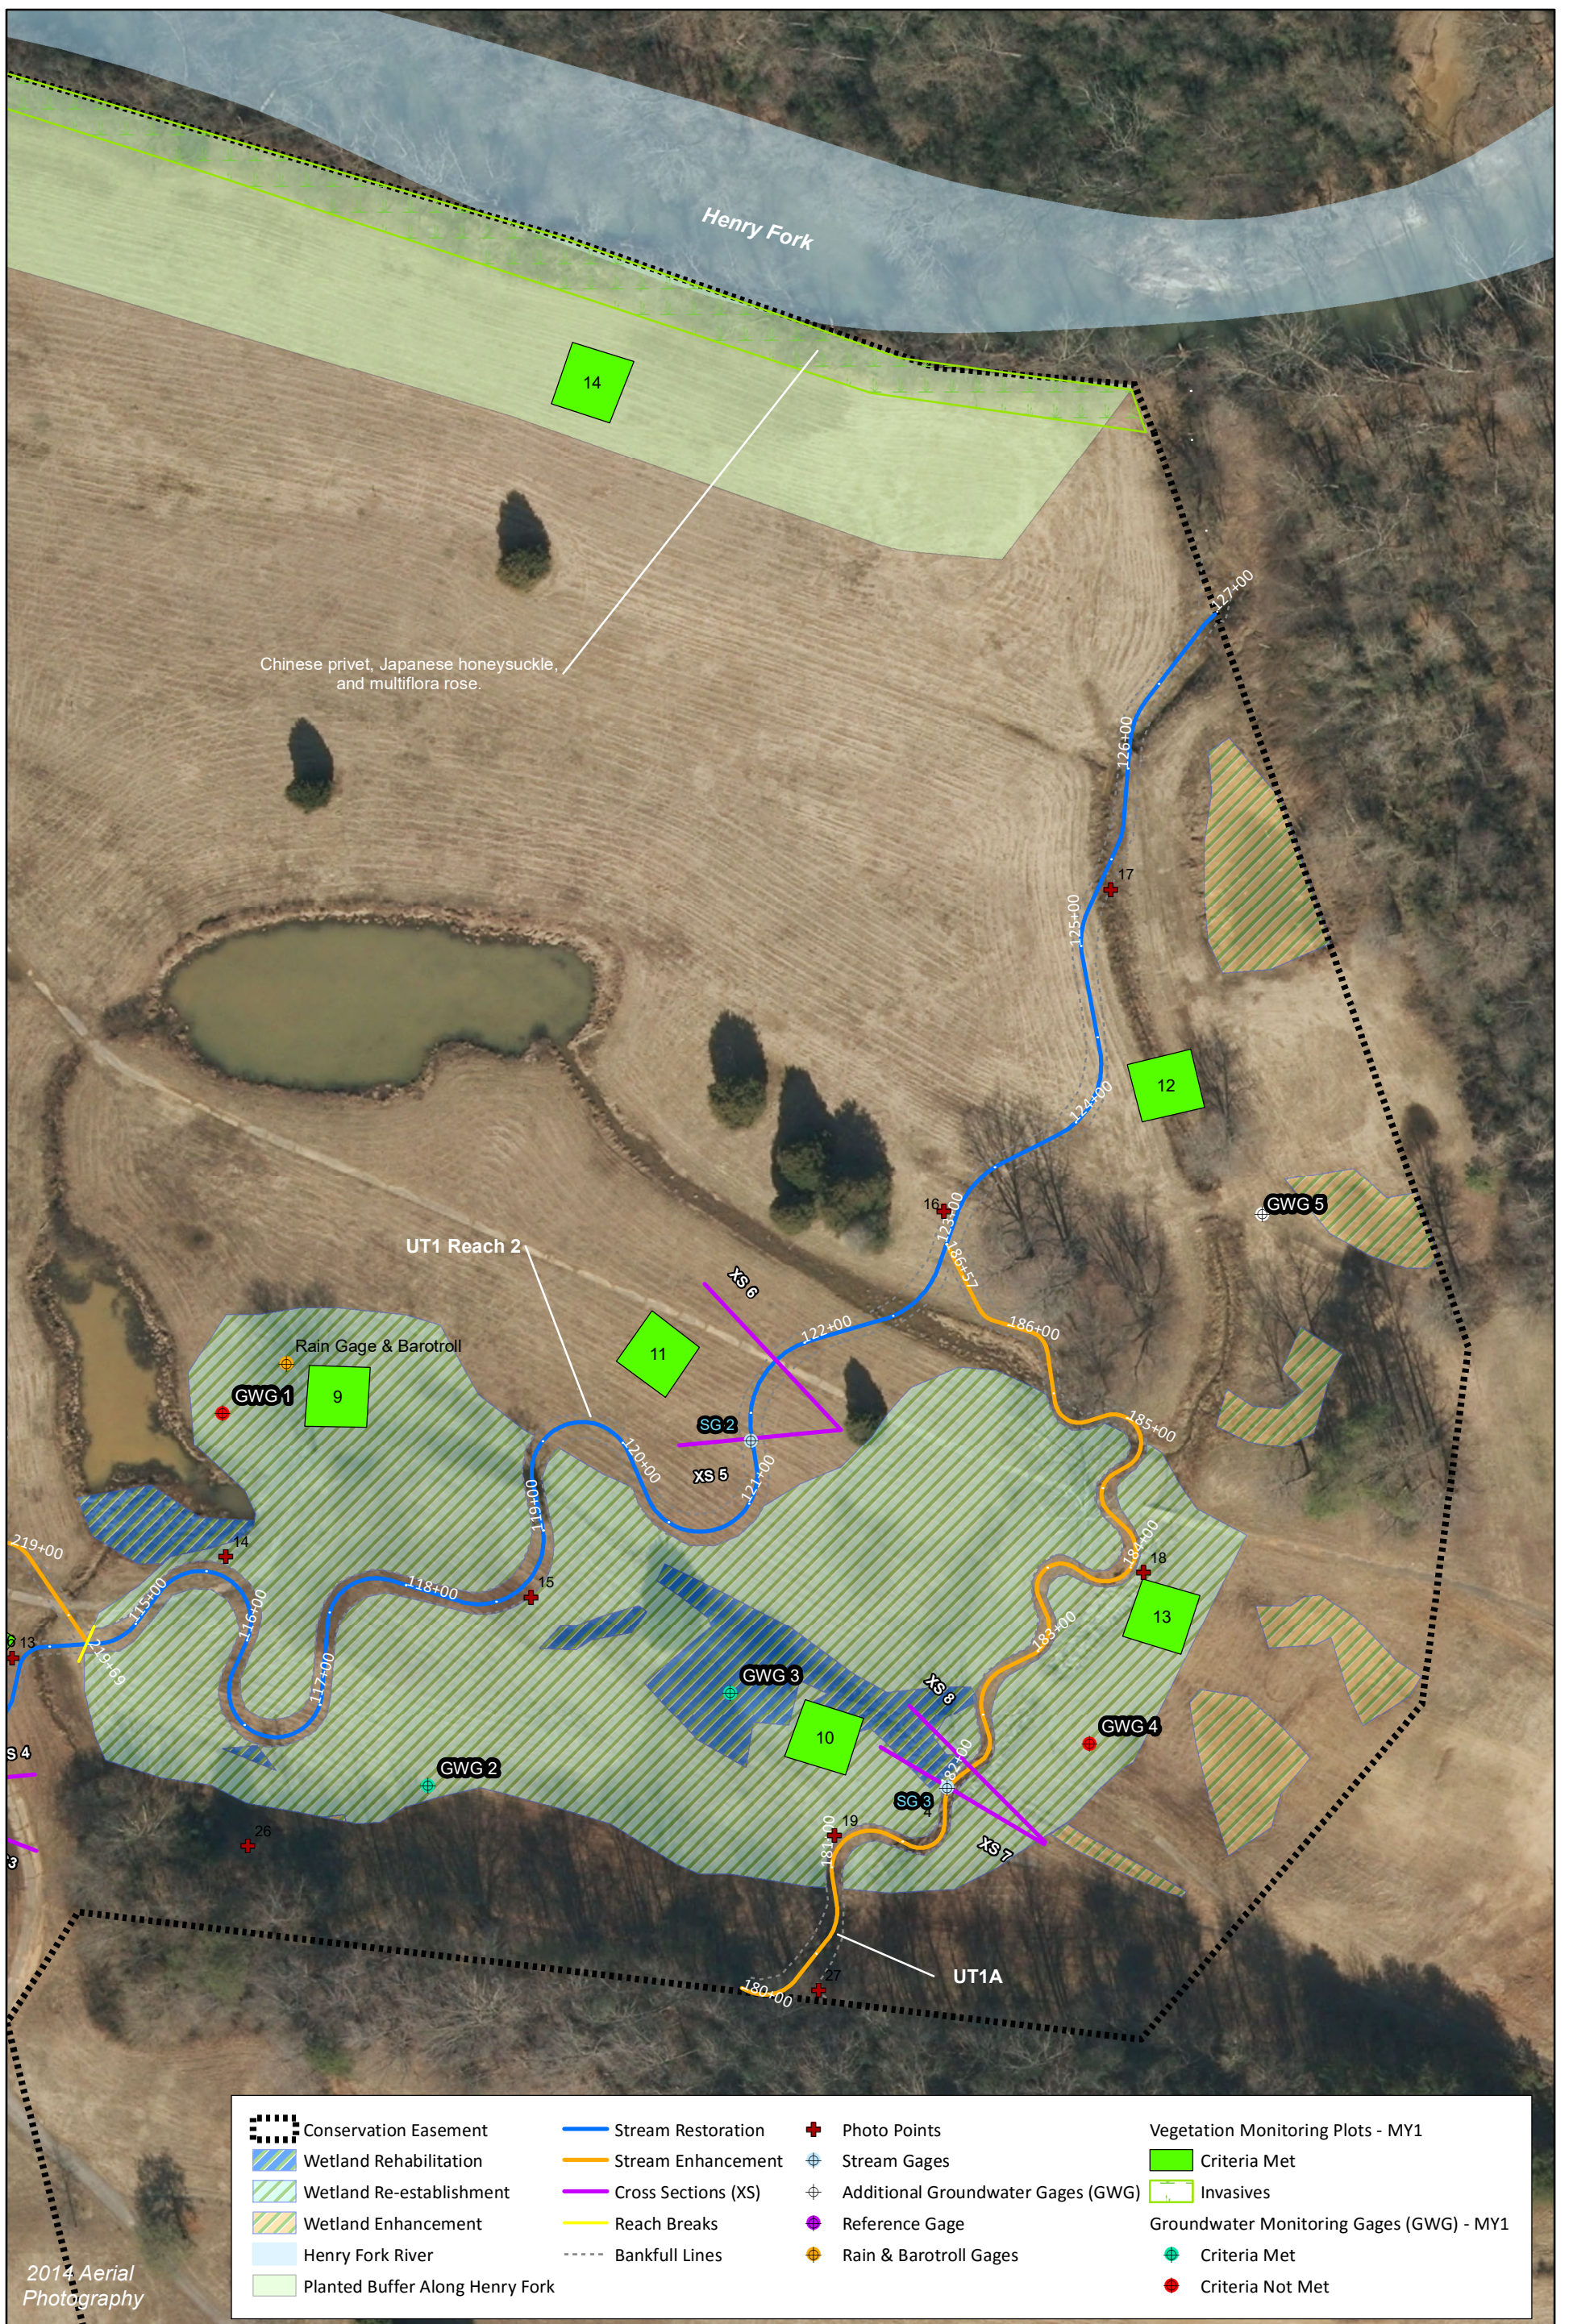
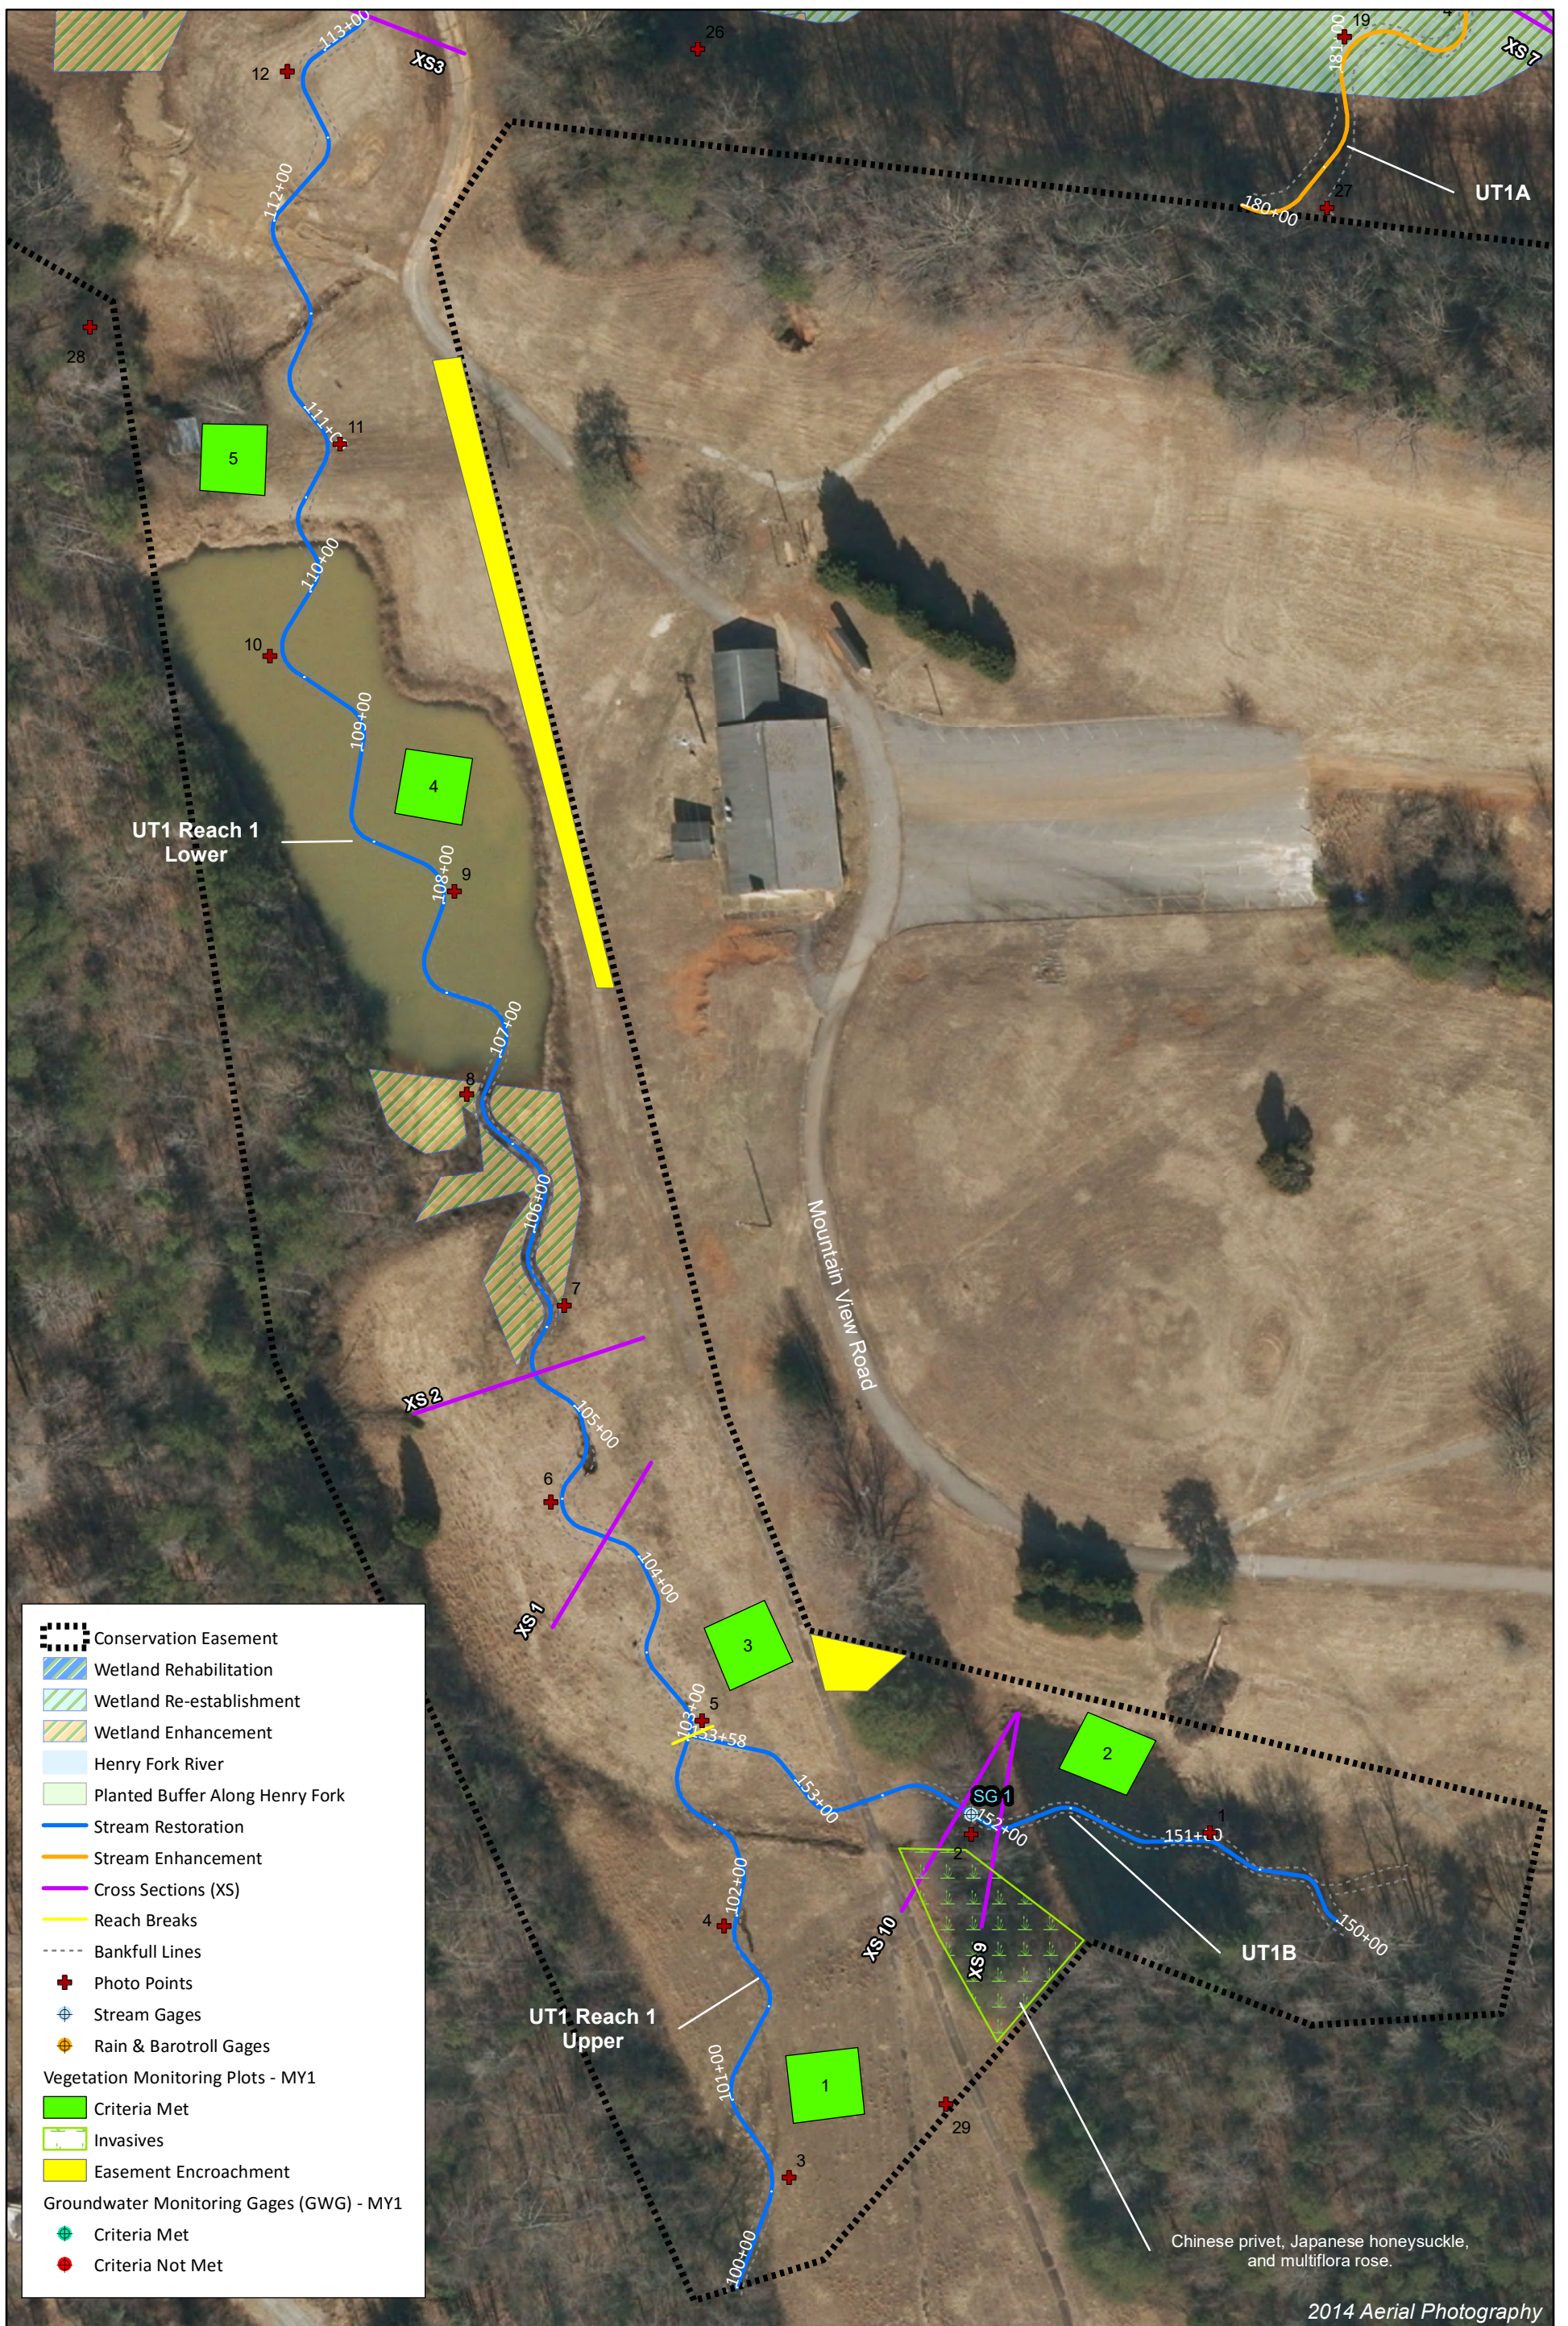
Figure 3.4 Integrated Current Condition Plan View (Sheet 4)
Henry Fork Mitigation Site
DMS Project No. 96306
Monitoring Year 1 - 2016

Chinese privet, Japanese honeysuckle, and multiflora rose.

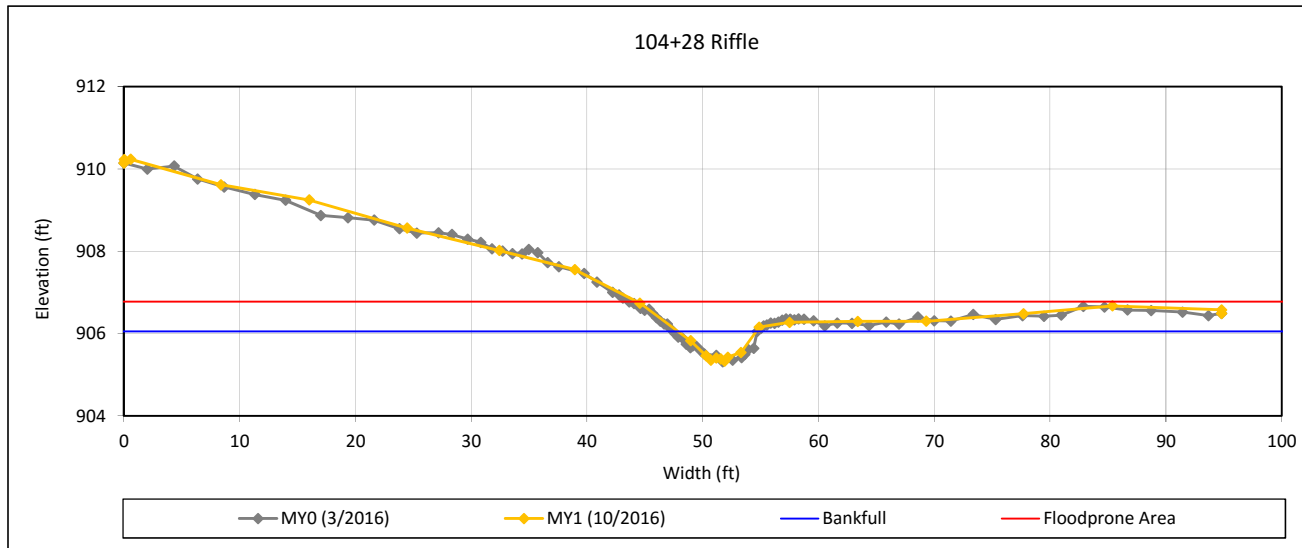
Cross Section 1-UT1 R1

2.9	x-section area (ft.sq.)
6.8	width (ft)
0.4	mean depth (ft)
0.7	max depth (ft)
7.0	wetted perimeter (ft)
0.4	hydraulic radius (ft)
15.7	width-depth ratio
50.5	W flood prone area (ft)
7.5	entrenchment ratio
1.0	low bank height ratio

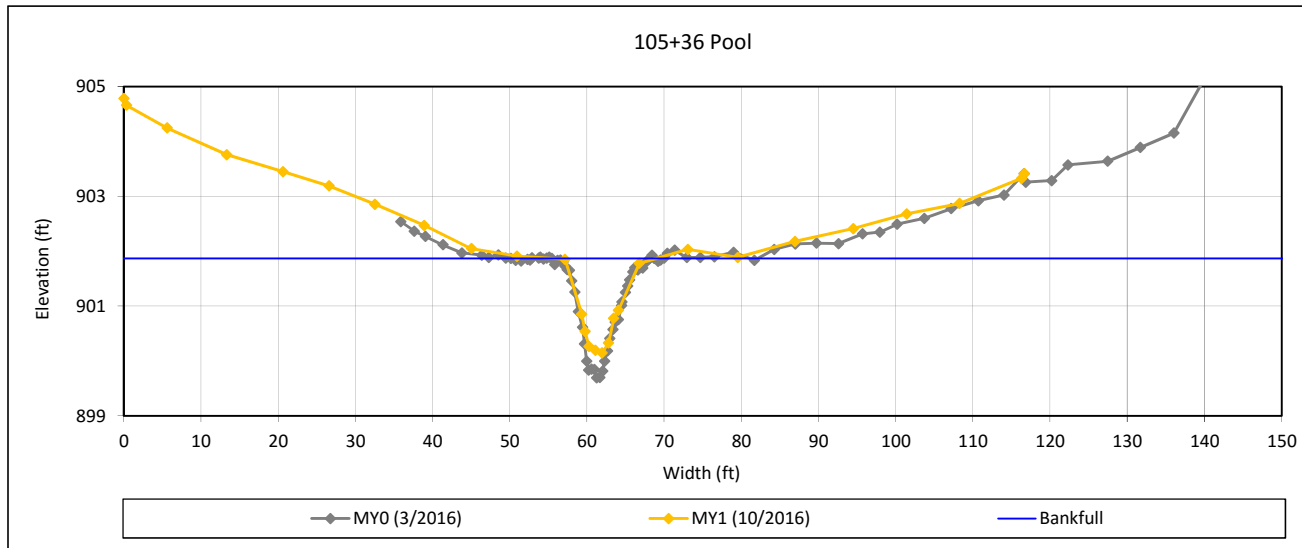
Cross Section 2-UT1 R1

9.5	x-section area (ft.sq.)
9.6	width (ft)
1.0	mean depth (ft)
1.7	max depth (ft)
10.3	wetted perimeter (ft)
0.9	hydraulic radius (ft)
9.7	width-depth ratio

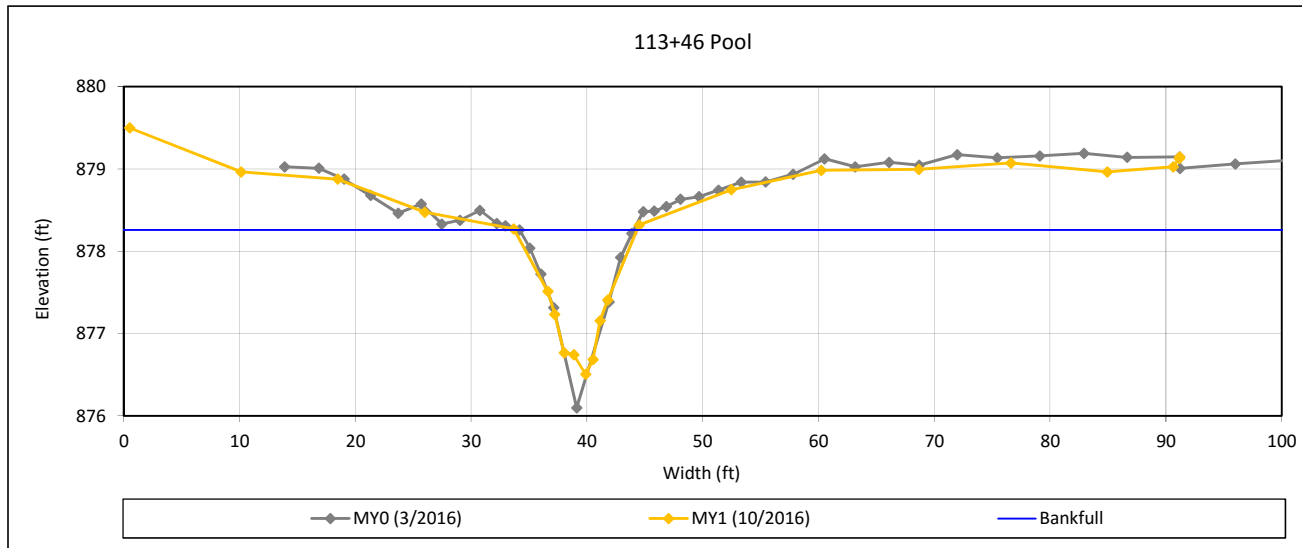
Cross Section 3-UT1 R1

8.1	x-section area (ft.sq.)
7.7	width (ft)
1.0	mean depth (ft)
1.8	max depth (ft)
8.3	wetted perimeter (ft)
1.0	hydraulic radius (ft)
7.3	width-depth ratio

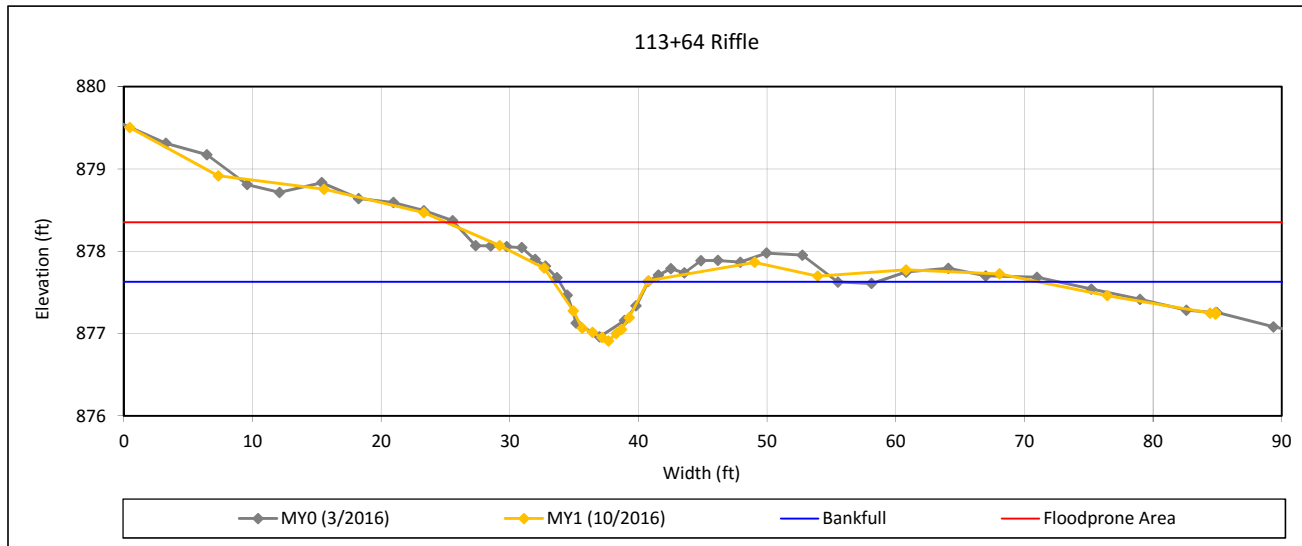
Cross Section 4-UT1 R1

3.2	x-section area (ft.sq.)
7.4	width (ft)
0.4	mean depth (ft)
0.7	max depth (ft)
7.5	wetted perimeter (ft)
0.4	hydraulic radius (ft)
17.1	width-depth ratio
118+	W flood prone area (ft)
16.0	entrenchment ratio
1.0	low bank height ratio

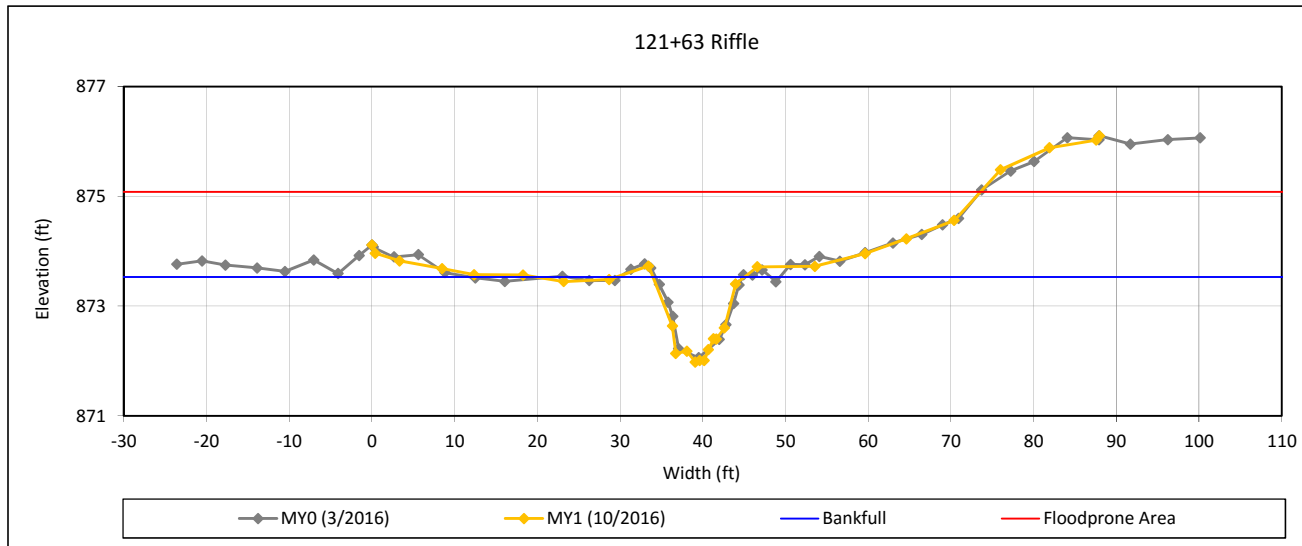
Cross Section 5-UT1 R2

10.1	x-section area (ft.sq.)
11.1	width (ft)
0.9	mean depth (ft)
1.5	max depth (ft)
11.8	wetted perimeter (ft)
0.9	hydraulic radius (ft)
12.1	width-depth ratio
96.7+	W flood prone area (ft)
8.7	entrenchment ratio
1.0	low bank height ratio

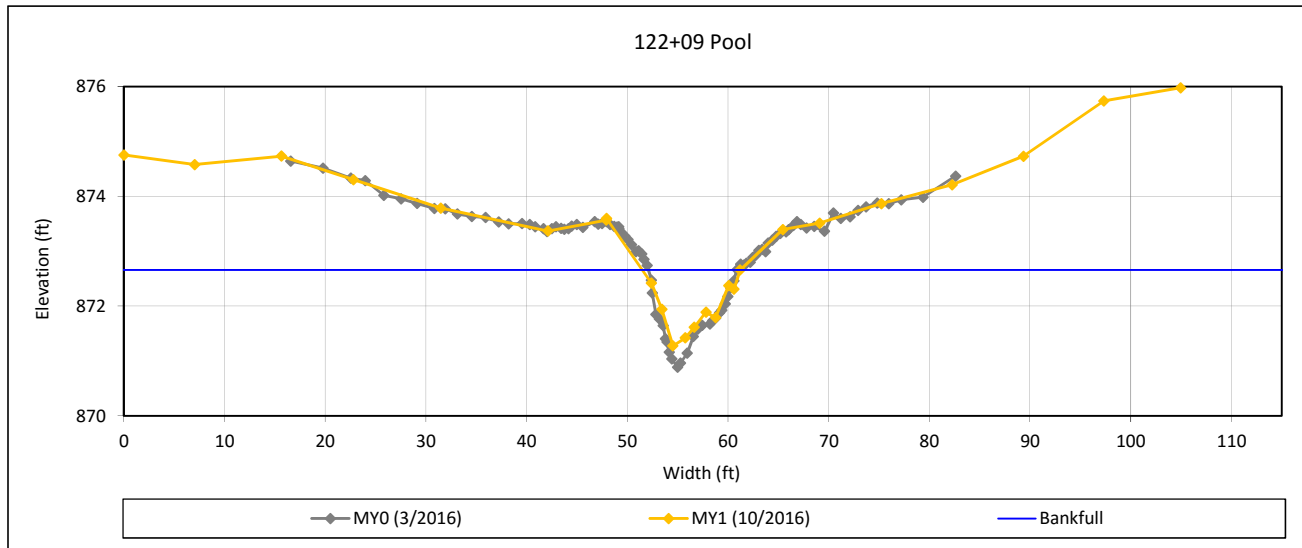
Cross Section 6-UT1 R2

7.2	x-section area (ft.sq.)
8.8	width (ft)
0.8	mean depth (ft)
1.4	max depth (ft)
9.4	wetted perimeter (ft)
0.8	hydraulic radius (ft)
10.8	width-depth ratio

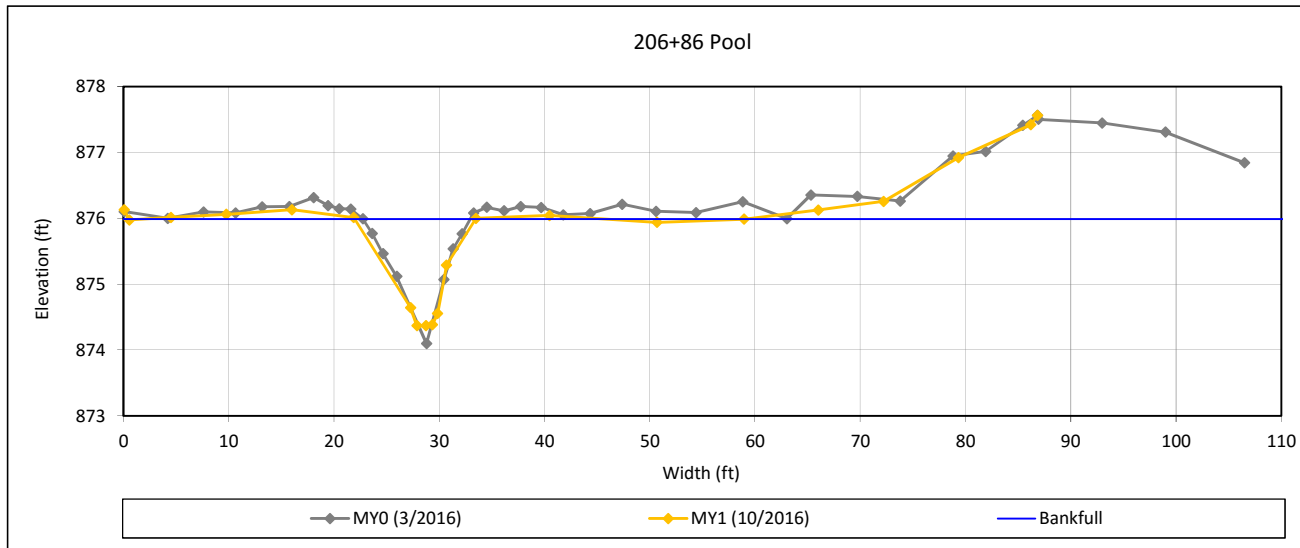
Cross Section 11-UT2

9.5	x-section area (ft.sq.)
11.5	width (ft)
0.8	mean depth (ft)
1.6	max depth (ft)
12.1	wetted perimeter (ft)
0.8	hydraulic radius (ft)
13.9	width-depth ratio

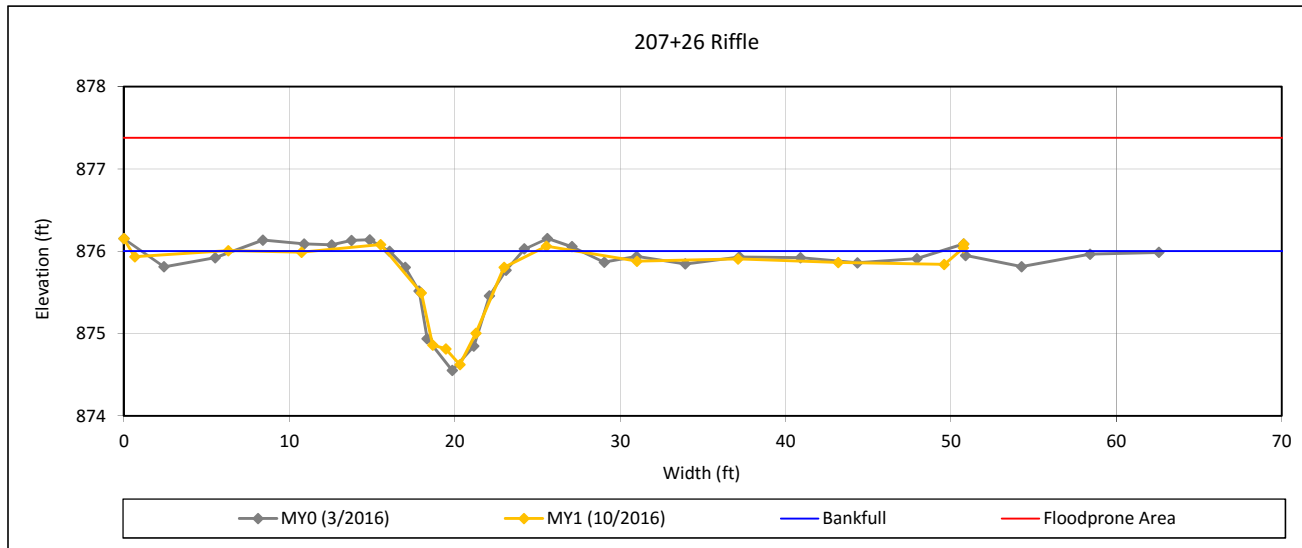
Cross Section 12-UT2

5.5	x-section area (ft.sq.)
9.1	width (ft)
0.6	mean depth (ft)
1.4	max depth (ft)
9.7	wetted perimeter (ft)
0.6	hydraulic radius (ft)
15.0	width-depth ratio
50.8+	W flood prone area (ft)
5.6	entrenchment ratio
1.1	low bank height ratio

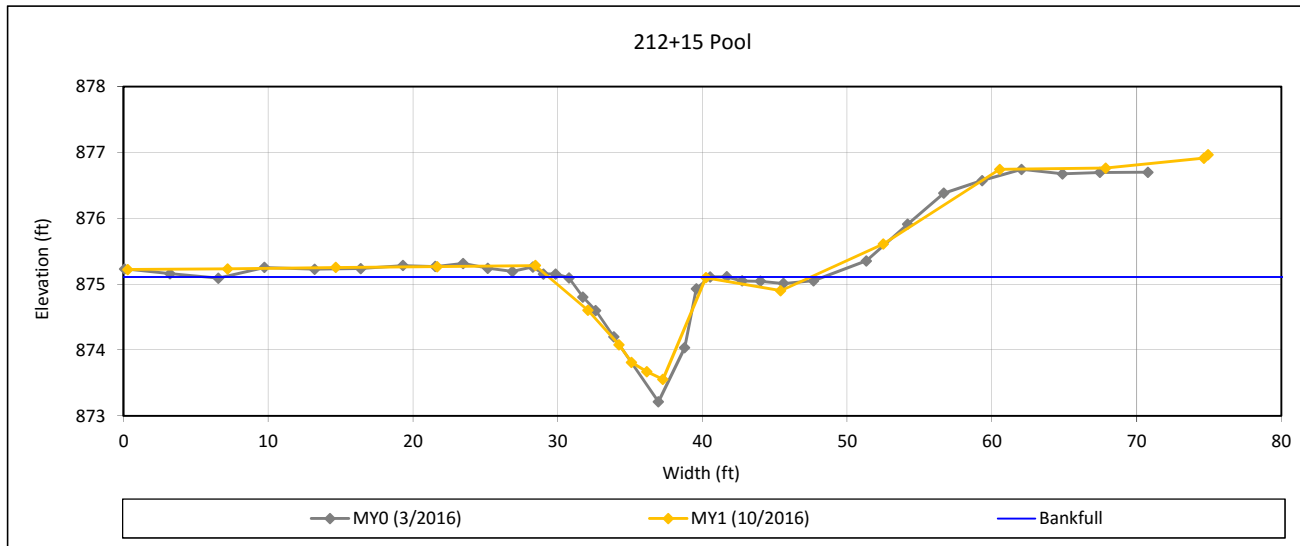
Cross Section 13-UT2

8.1	x-section area (ft.sq.)
8.2	width (ft)
1.0	mean depth (ft)
1.6	max depth (ft)
8.7	wetted perimeter (ft)
0.9	hydraulic radius (ft)
8.2	width-depth ratio

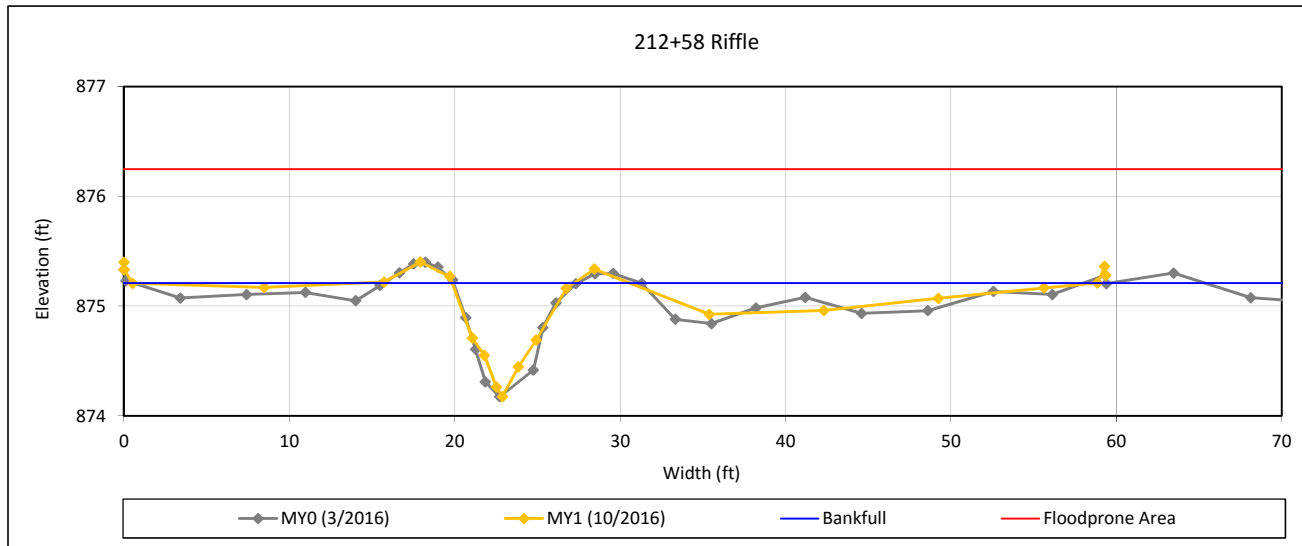
Cross Section 14-UT2

3.8	x-section area (ft.sq.)
6.9	width (ft)
0.5	mean depth (ft)
1.0	max depth (ft)
7.2	wetted perimeter (ft)
0.5	hydraulic radius (ft)
12.7	width-depth ratio
150+	W flood prone area (ft)
21.8	entrenchment ratio
1.1	low bank height ratio
