MONITORING YEAR 2 ANNUAL REPORT

HENRY FORK MITIGATION SITE

Catawba County, NC
DEQ Contract No. 005782
DMS Project No. 96306

Data Collection Period: April 2017 - November 2017
Draft Submission Date: November 30, 2017
Final Submission Date: December 20, 2017

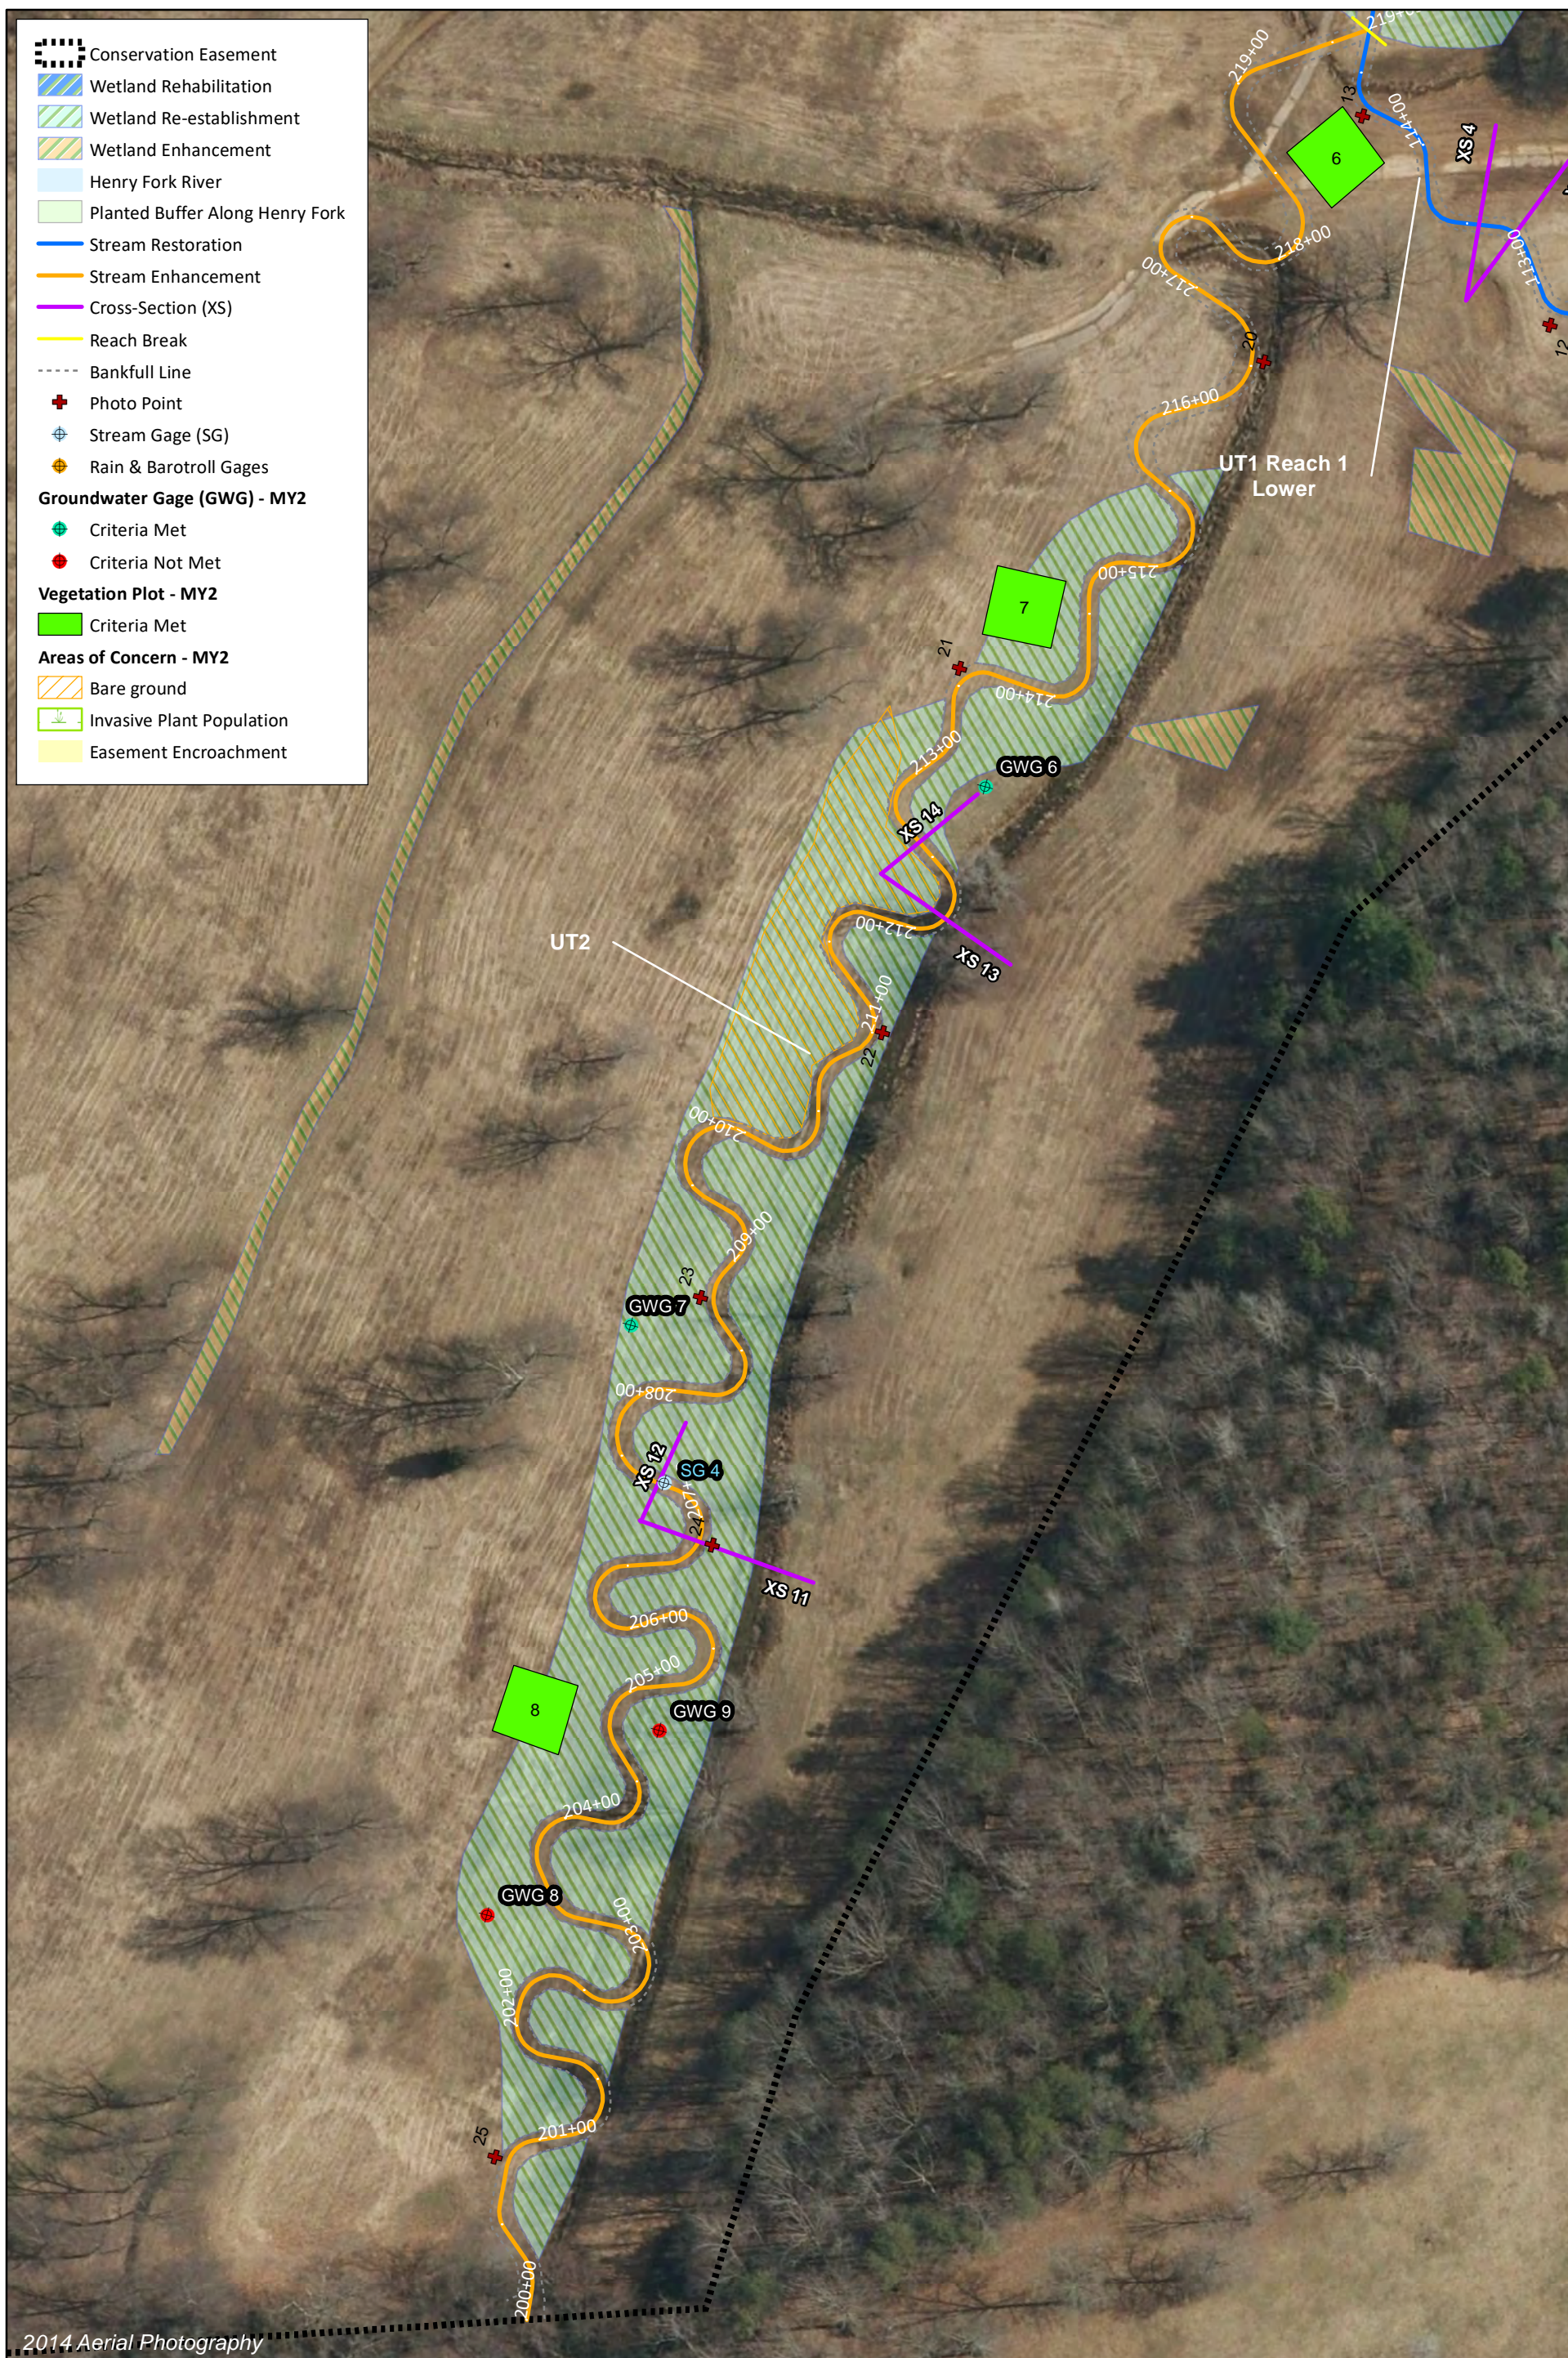
Figure 3.2 Integrated Current Condition Plan View (Sheet 2)
Henry Fork Mitigation Site
DMS Project No. 96306
Monitoring Year 2 - 2017

The minor mowing encroachments of the easement has continued along the eastern edge of UT1 Reach 1, as shown in the CCPV (Appendix 2). The adjacent landowner has been notified that the activities are in violation of the easement.

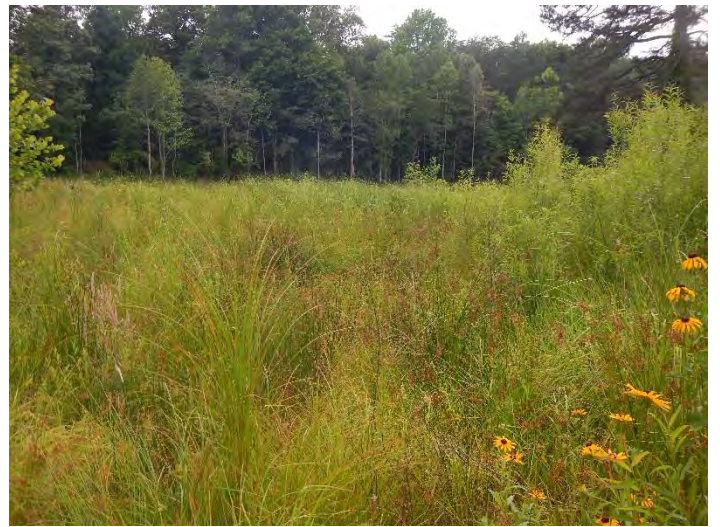
Photo Point 1 – view upstream UT1B (06/16/2017)

Photo Point 1 – view downstream UT1B (06/16/2017)

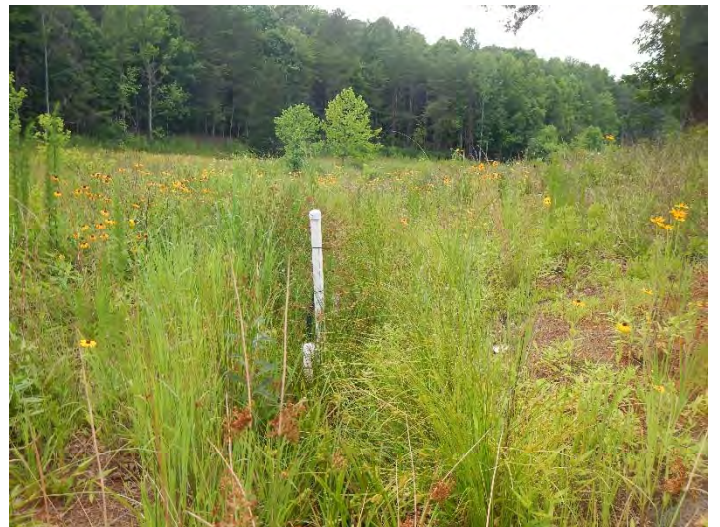
Photo Point 2 – view upstream UT1B (06/16/2017)

Photo Point 2 – view downstream UT1B (06/16/2017)

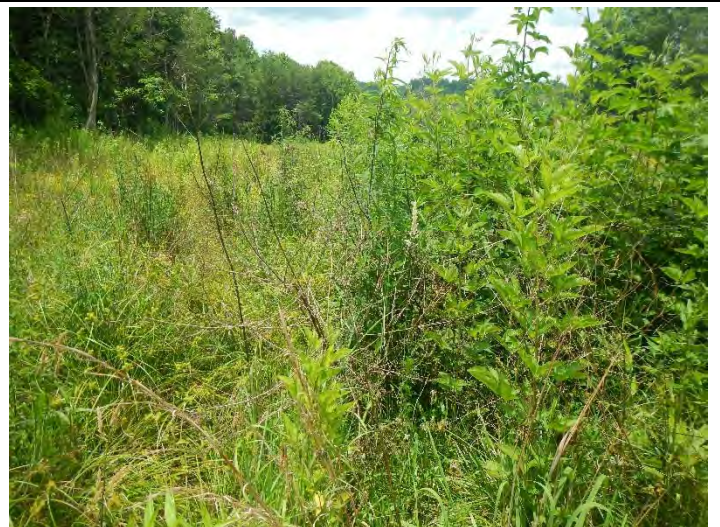
Photo Point 3 – view upstream UT1 R1 Upper (06/16/2017)

Photo Point 3 – view downstream UT1 R1 Upper (06/16/2017)
