# MONITORING YEAR 4 ANNUAL REPORT

## HENRY FORK MITIGATION SITE

Catawba County, NC  
DEQ Contract No. 005782  
DMS Project No. 96306

Data Collection Period: February 2019 - November 2019  
Final Submission Date: December 23, 2019

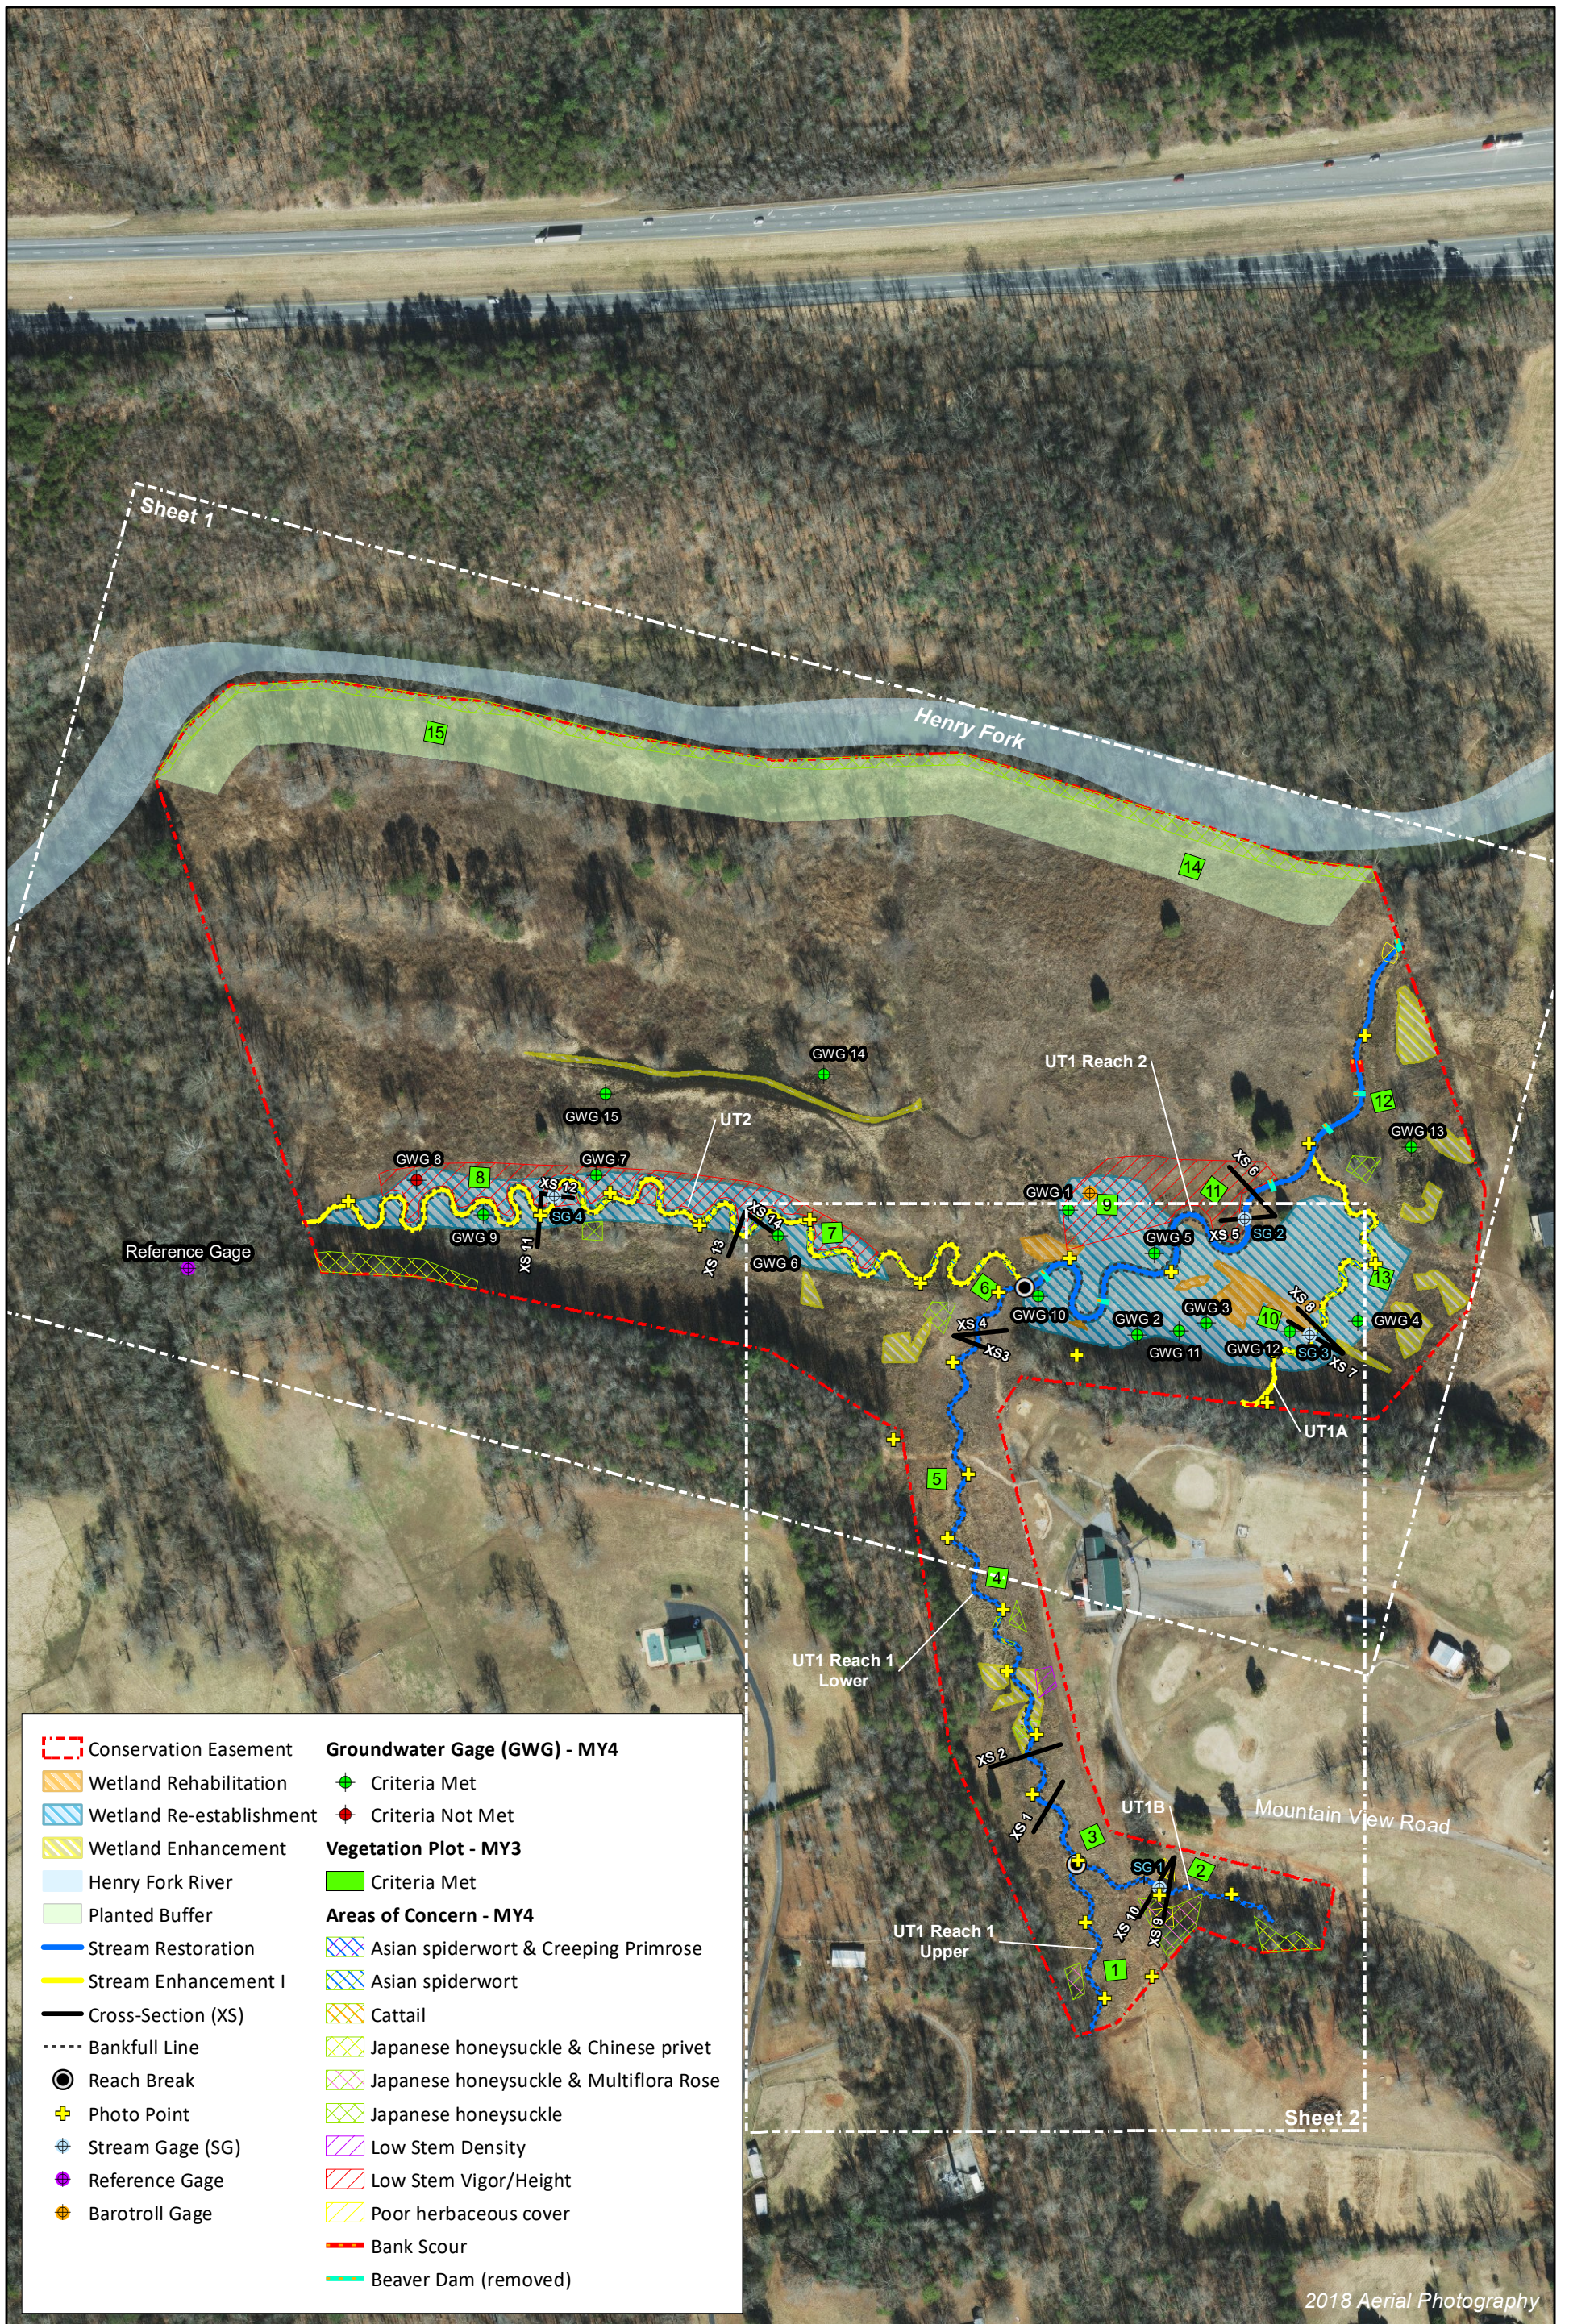
Figure 3.0 Integrated Current Condition Plan View (KEY)  
Henry Fork Mitigation Site  
DMS Project No. 96306  
Monitoring Year 4 - 2019

Conservation Easement	<b>Groundwater Gage (GWG) - MY4</b>
Wetland Rehabilitation	Criteria Met
Wetland Re-establishment	Criteria Not Met
Wetland Enhancement	<b>Vegetation Plot - MY3</b>
Henry Fork River	Criteria Met
Planted Buffer	<b>Areas of Concern - MY4</b>
Stream Restoration	Asian spiderwort & Creeping Primrose
Stream Enhancement I	Asian spiderwort
Cross-Section (XS)	Cattail
Bankfull Line	Japanese honeysuckle & Chinese privet
Reach Break	Japanese honeysuckle & Multiflora Rose
Photo Point	Japanese honeysuckle
Stream Gage (SG)	Low Stem Density
Reference Gage	Low Stem Vigor/Height
Barotroll Gage	Poor herbaceous cover
	Bank Scour
	Beaver Dam (removed)

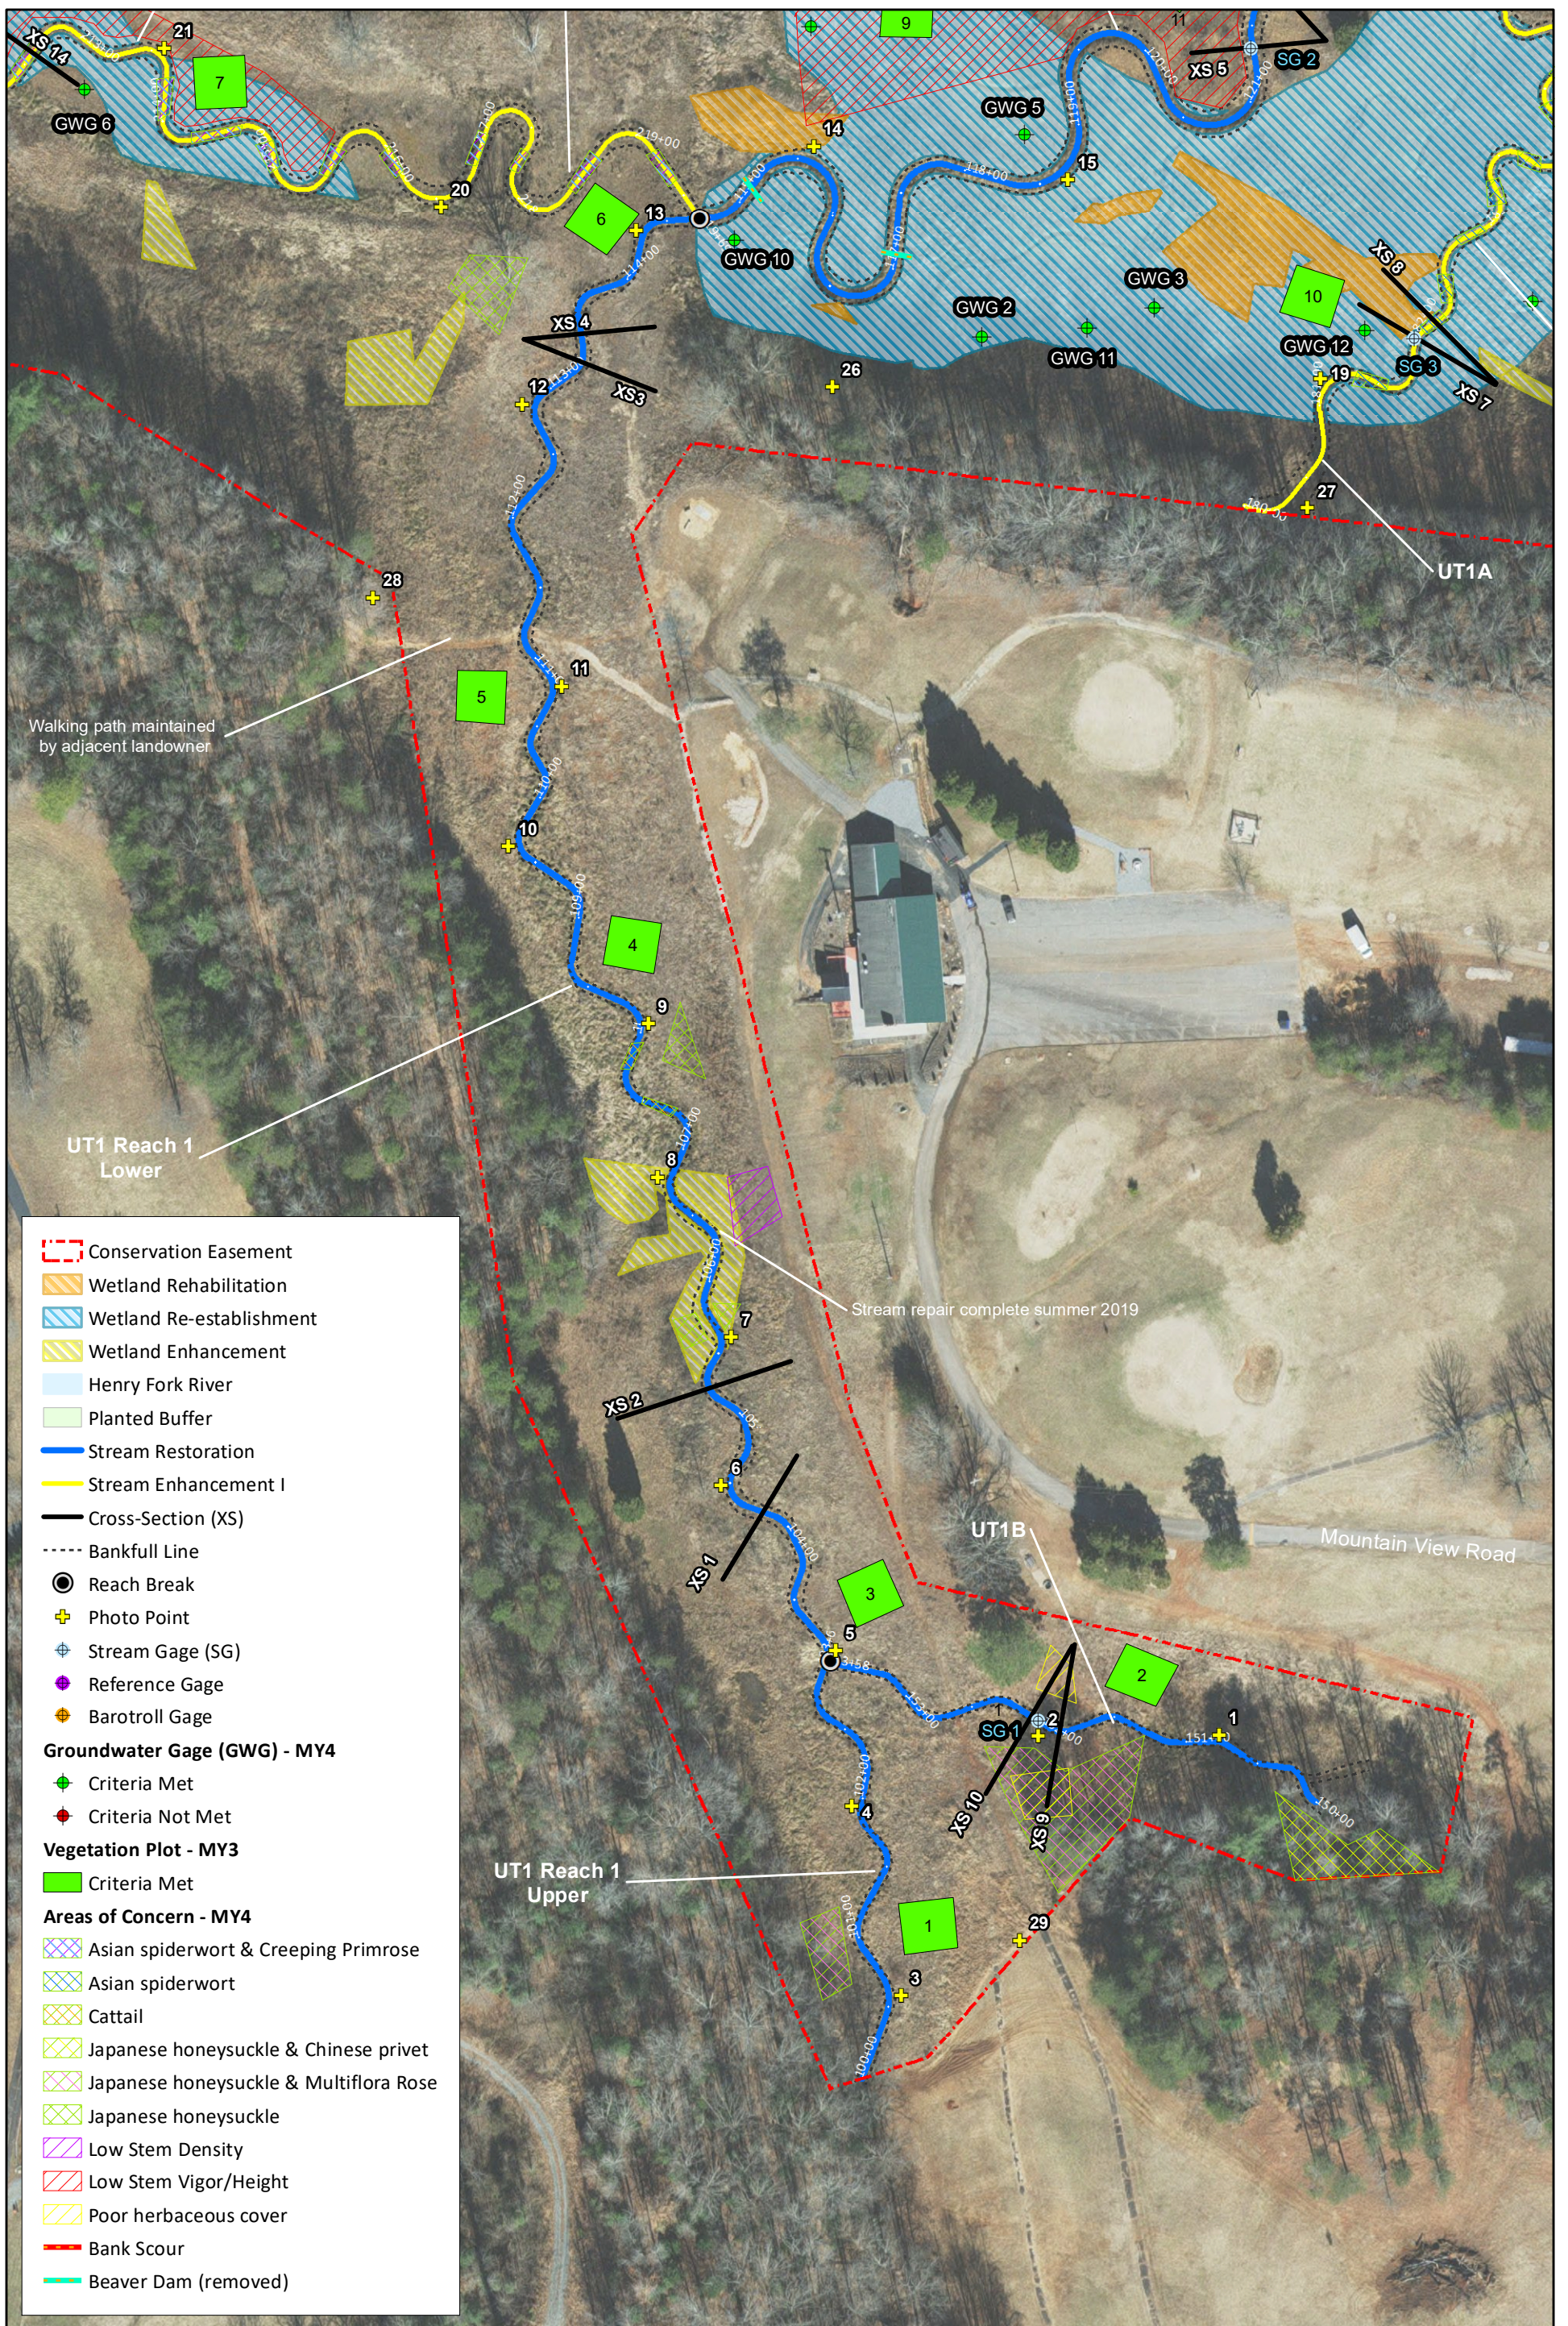
Figure 3.2 Integrated Current Condition Plan View (Sheet 2)  
 Henry Fork Mitigation Site  
 DMS Project No. 96306  
 Monitoring Year 4 - 2019

Following a large storm event in June 2019, isolated areas of bank scour were noted along UT1. In August 2019, minor repairs were performed on UT1 Reach 1 on the pool near station 106+00 consisting of regrading the outside meander bend and replanting the banks with established vegetation transplanted from the floodplain. Additional minor bank repairs, in part related to beaver activity, are planned for an area of bank scour on UT1 Reach 2 near station 124+75 and to be completed in the winter of 2019/2020.

*Wildlands response; A callout has been added to CCPV Figure 3.2 to note the location of the bank repair on UT1.*
