MONITORING YEAR 7 ANNUAL/CLOSEOUT REPORT

HENRY FORK MITIGATION SITE

Catawba County, NC
DEQ Contract No. 005782
DMS Project No. 96306
USACE No. 2014-00538
DWR No. 20140193

Data Collection Period: January – November 2022
Draft Submission Date: November 30, 2022
Final Submission Date: January 17, 2023

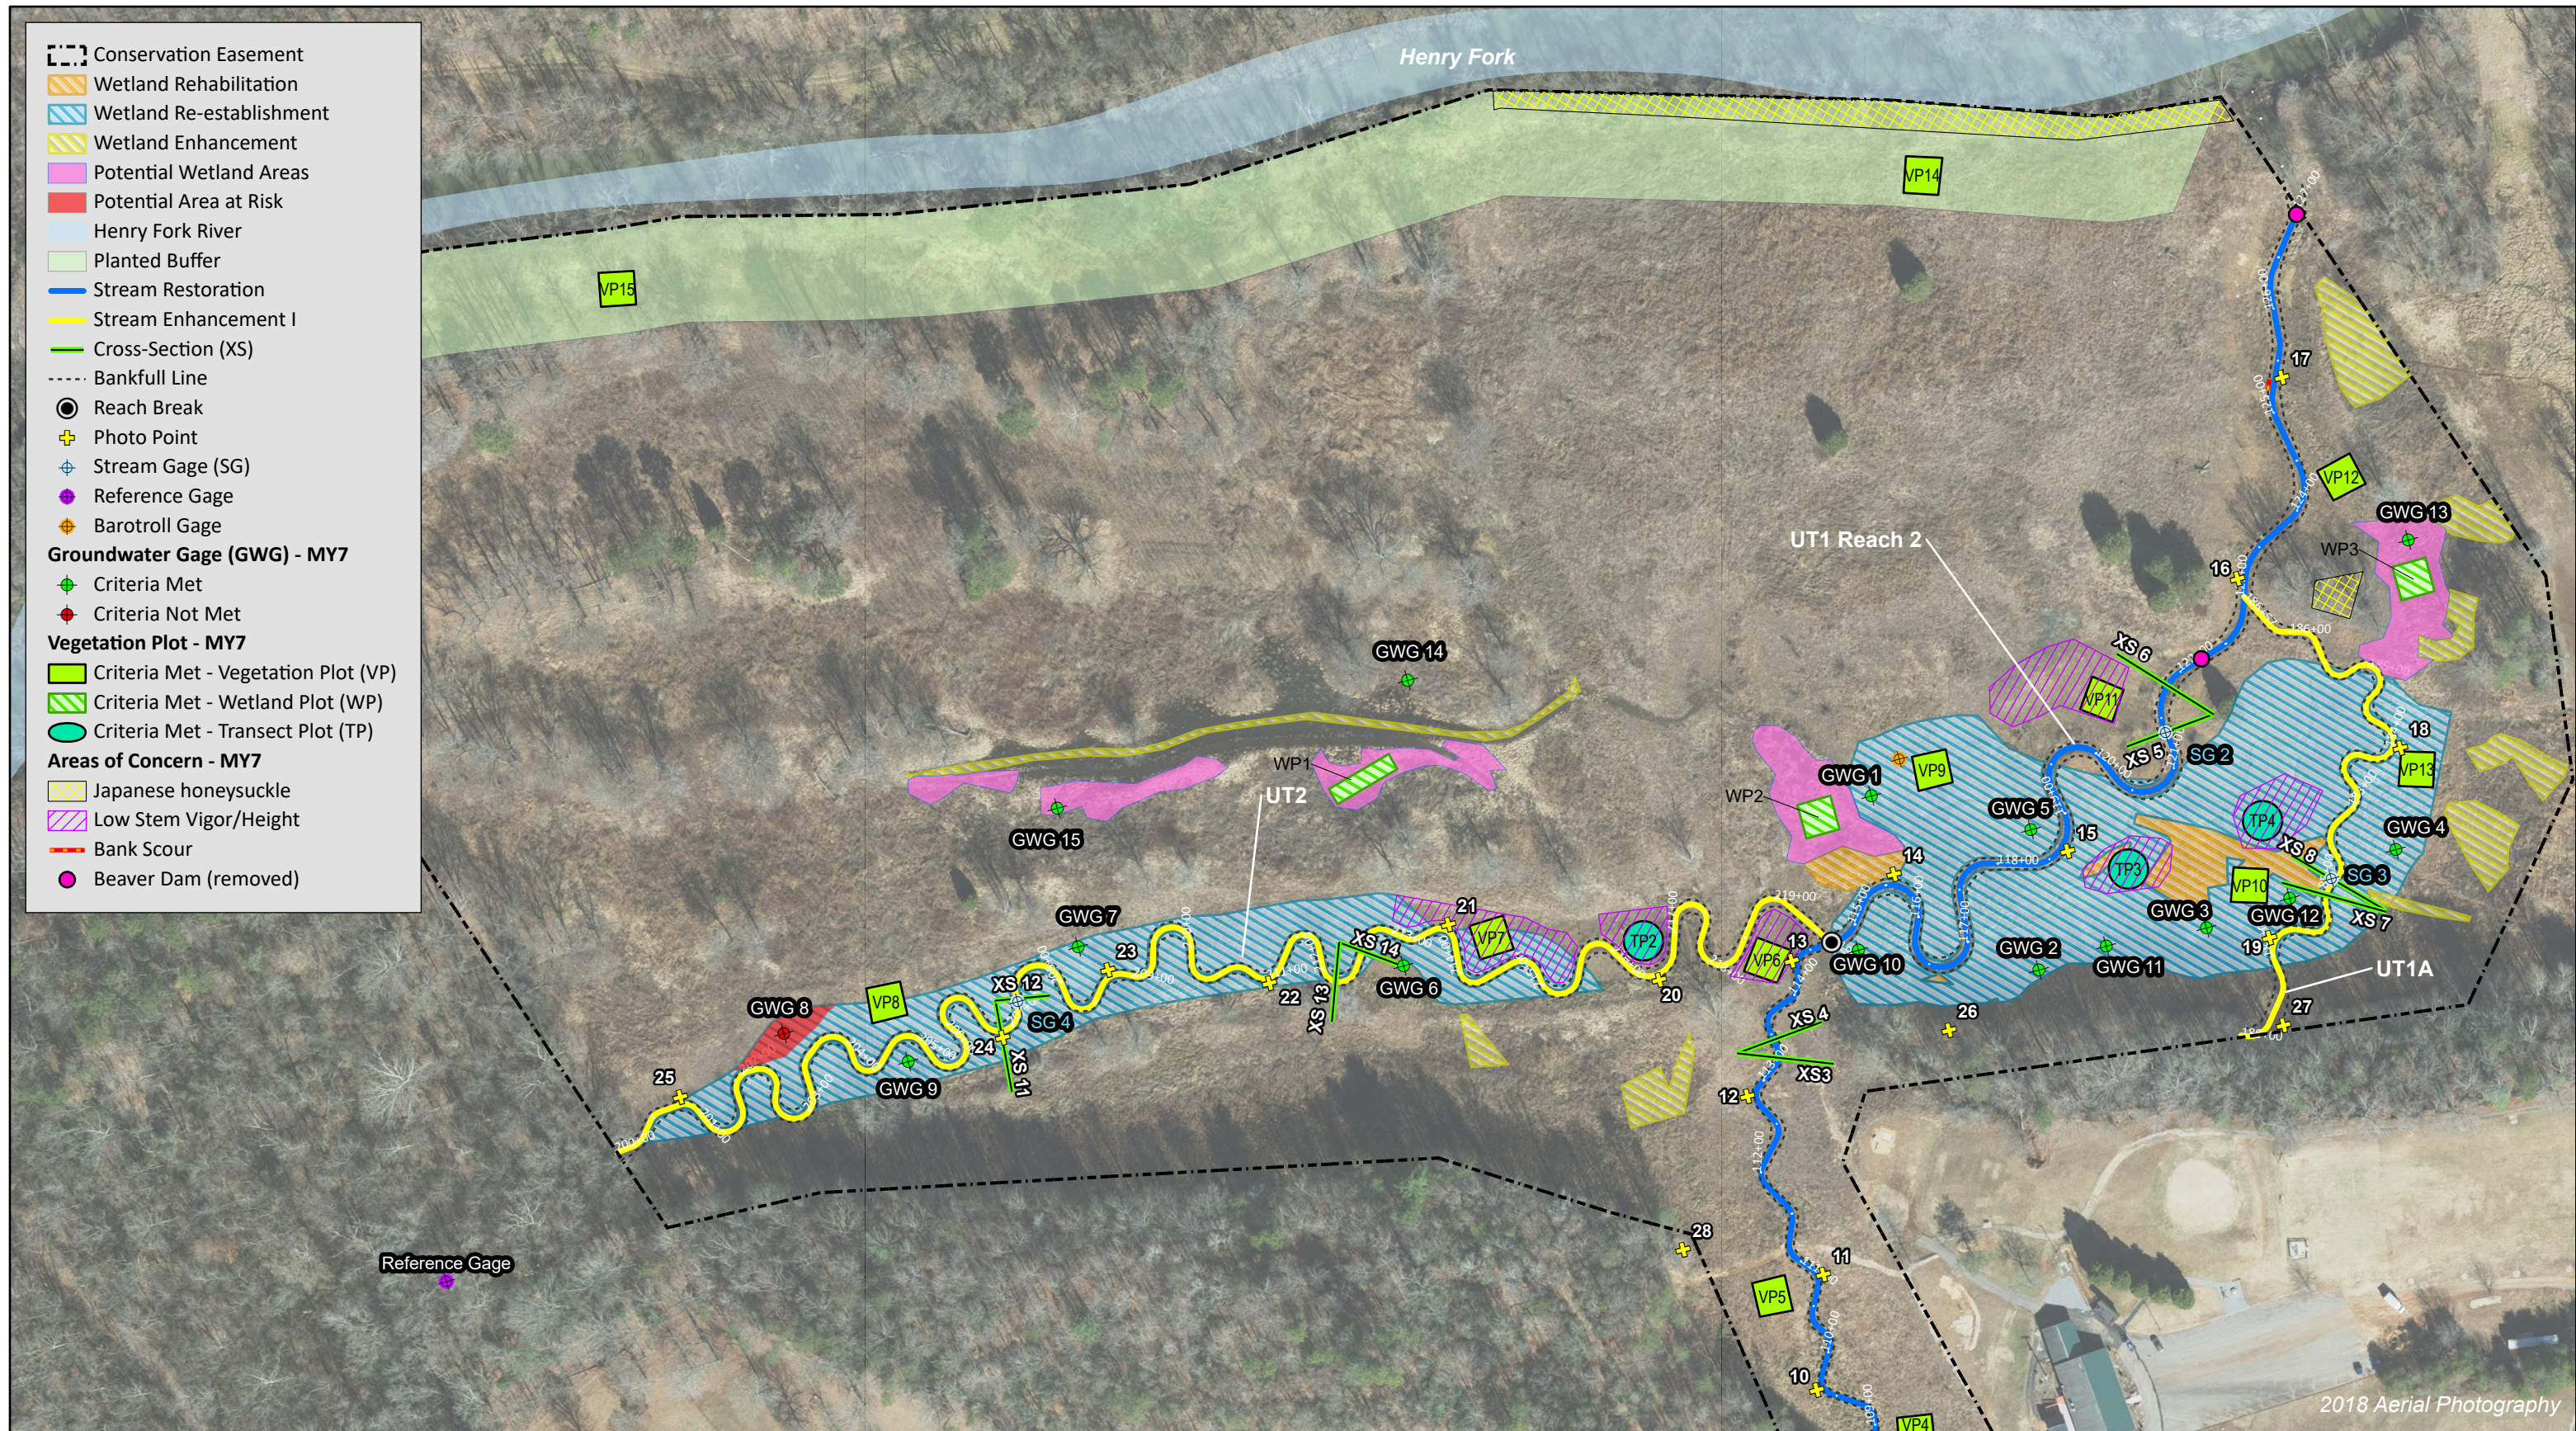
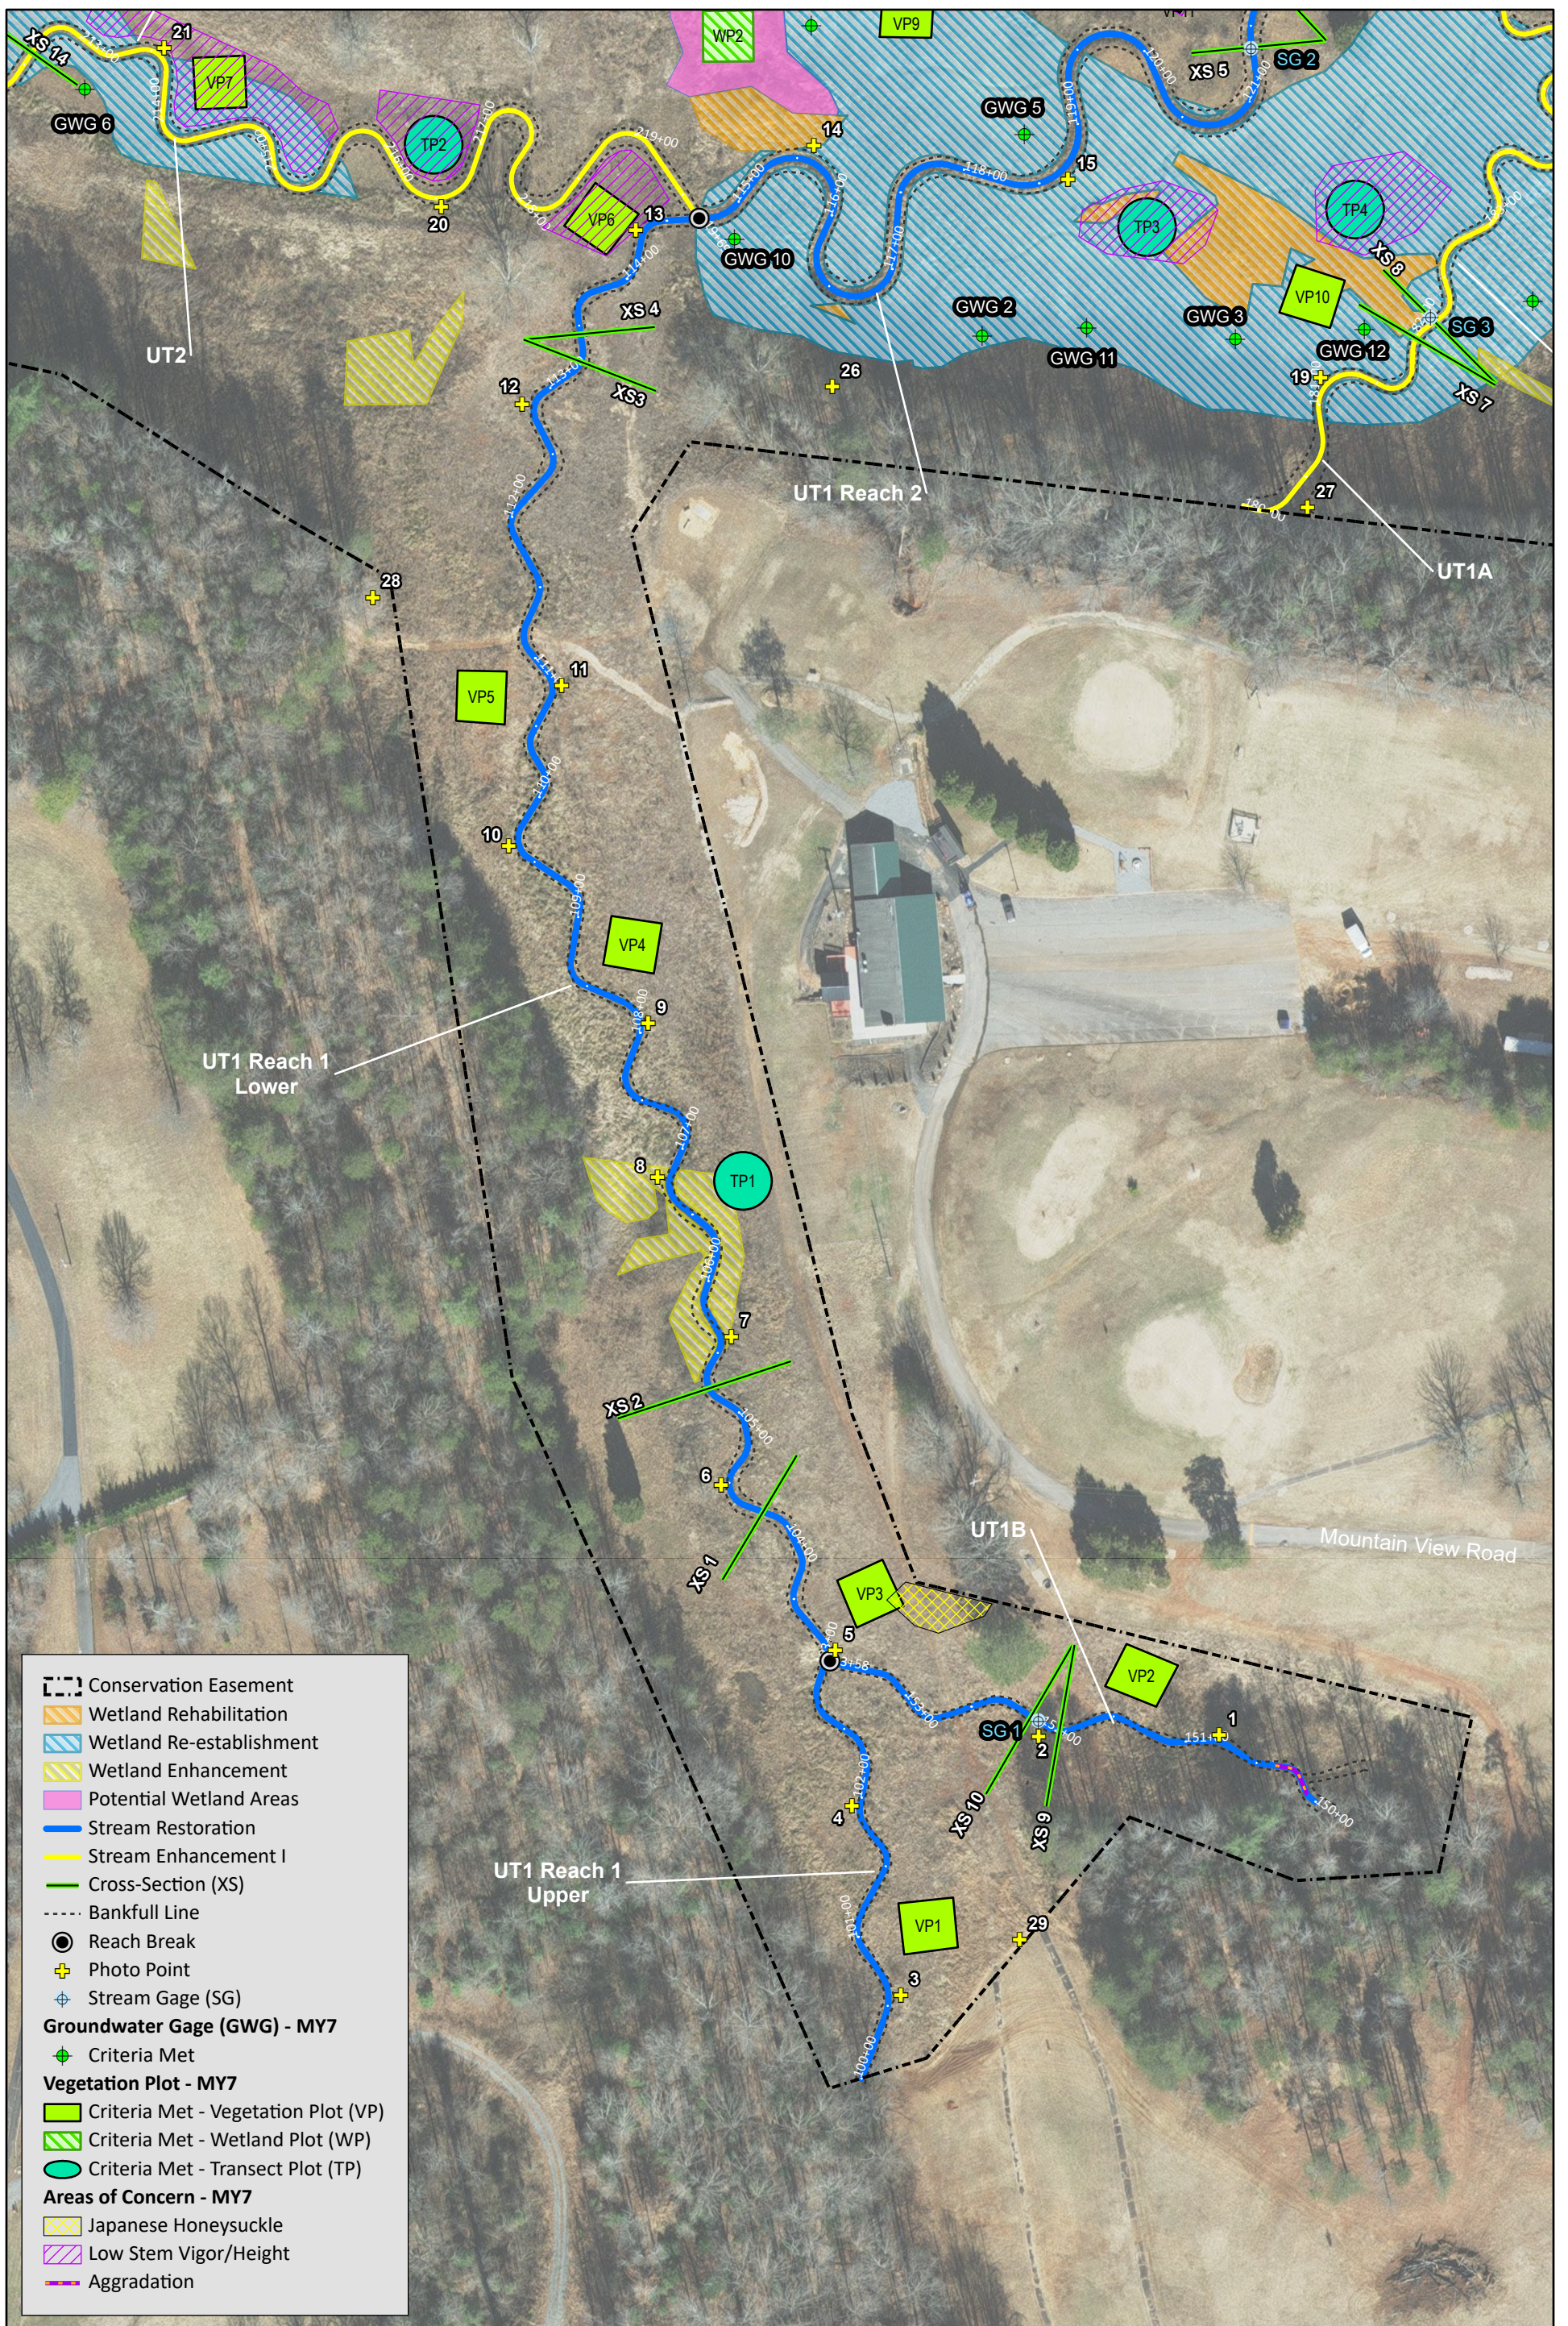
Bank repairs were previously completed in MY5 along UT1 near station 106+00 and 124+75, and in MY6 along UT1 near station 124+25. Visual assessments in MY7 reveal that these repair areas continue to appear stable and are functioning as designed.

A few beaver dams were removed in the spring 2022 throughout the lower portion of UT1 Reach 2. Prolonged periods of inundation were not observed or recorded by stream gages on the Site in MY7 which suggests beaver activity has significantly decreased. Refer to Appendix 5 for the UT1 Reach 2 stream gage plot. The less frequent beaver impoundments have permitted regular flow of tributaries (UT1A and UT2) into UT1, thus allowing floodplain vegetation to continue to become established in previously inundated areas. Due to beaver activity, a small gully formed along the right floodplain of UT1 Reach 2 below the wetland enhancement area. In spring 2022, matting, livestock, and seed were added to this area and vegetation has become well established which has stabilized the area. Beaver activity will continue to be monitored and managed until closeout.

Quarterly site visits will continue to be conducted until closeout to monitor and address areas of concern. If necessary, adaptive management will be implemented to improve the conditions of the Site. Please refer to Appendix 2 for CCPV Figures 3.0-3.2 for mapped areas of concern.

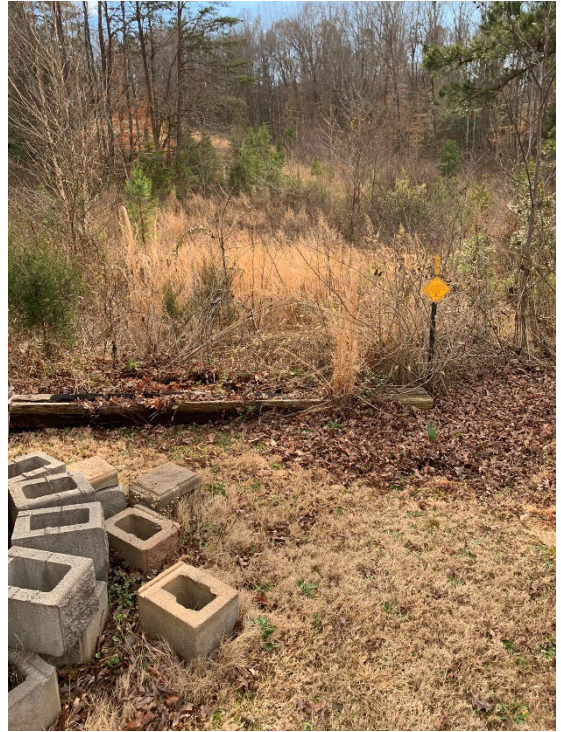
- 1. Cement blocks were placed within the conservation easement on UT1B near VP2. Blocks must be removed from inside the easement.**
 - Resolution required by Stewardship: Please submit georeferenced photo documenting removal of blocks from the easement area.**
- 2. Discontinue access through trail utilized by Disc Golf Course.**
 - Resolution required by Stewardship: Submit georeferenced photos to document physical barrier to the trail has been established on both ends of trail. Physical barriers may include t-posts/u-channels with signage, logs placed across the trail, fencing, etc. Please include correspondence from Disc Golf Course acknowledging discontinued use of trail.**

Action Item 1: Cement blocks removed from the easement on UT1B near VP2 - (01/06/2023)
