**YEAR 2 of 7 (2013)**  
**ANNUAL MONITORING REPORT**  
**HERMAN DAIRY STREAM AND WETLAND RESTORATION SITE**

Alexander County, North Carolina  
Full Delivery Contract No. 003271

Catawba River Basin  
Cataloging Unit and Targeted Local Watershed  
03050101120030

NOVEMBER 2013

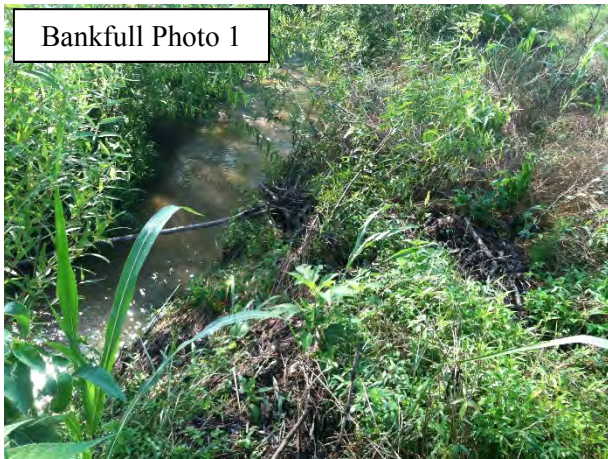
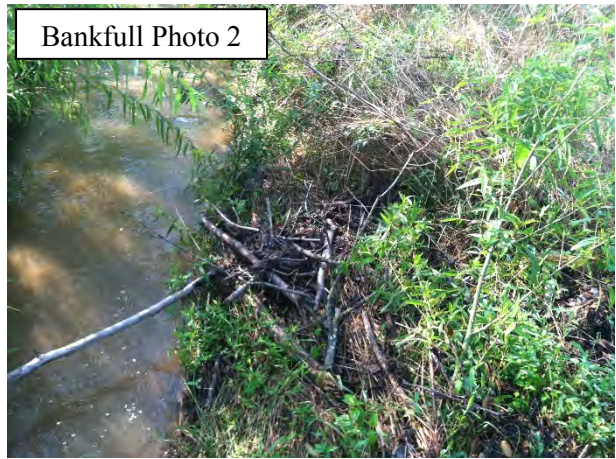
Date of Data Collection	Date of Occurrence	Method	Photo (if available)
May 11, 2013	May 6, 2013	Sediment deposits observed on top of banks after 3.00 inches of rain was documented* over a two-day period.	--
July 18, 2013	June 6, 2013	Wrack observed on top of bank and throughout floodplain after 4.27 inches of rain was documented* over a two-day period.	1-2
