YEAR 3 of 7 (2014)
ANNUAL MONITORING REPORT
HERMAN DAIRY STREAM AND WETLAND RESTORATION SITE

Alexander County, North Carolina

EEP Project No. 94642

JANUARY 2015

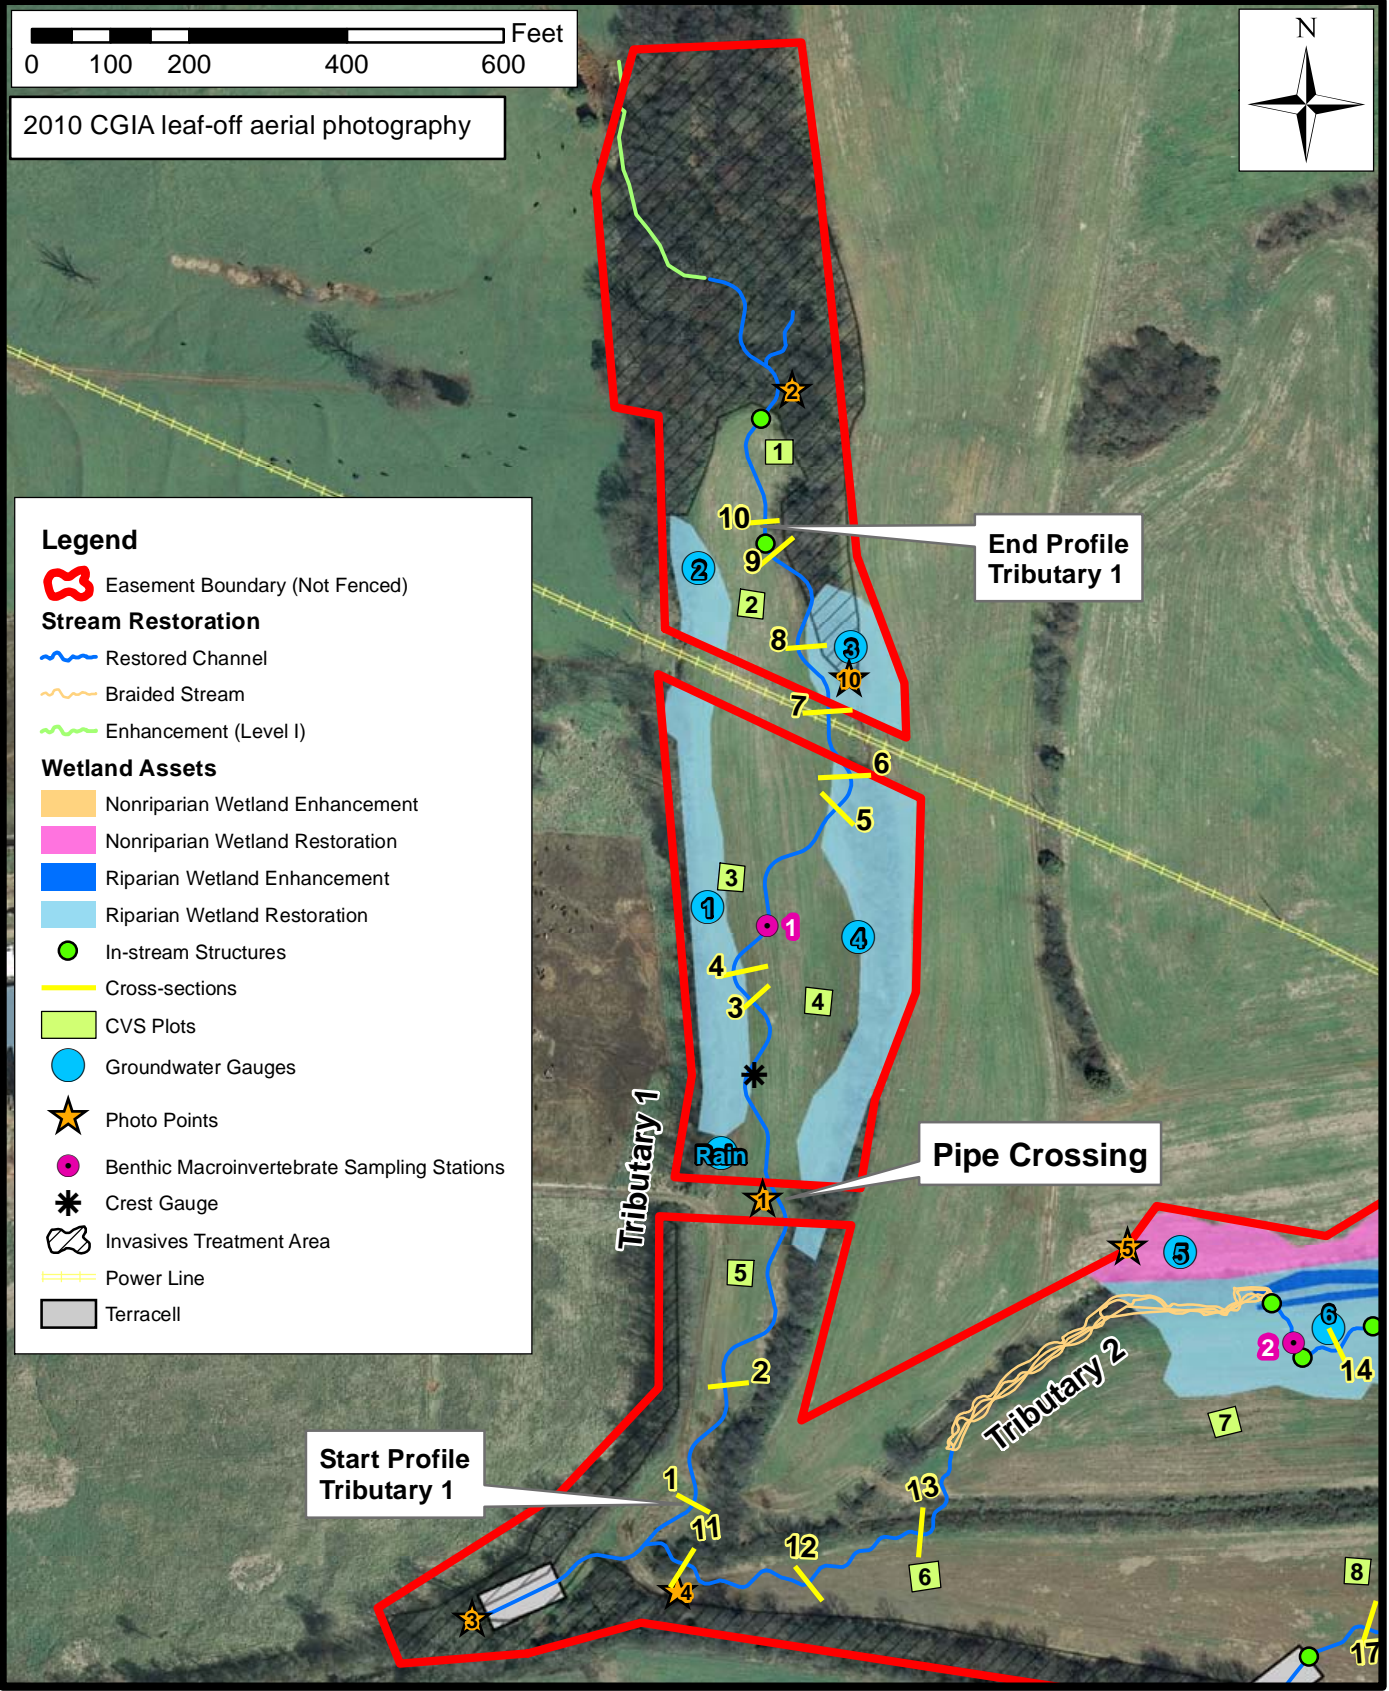
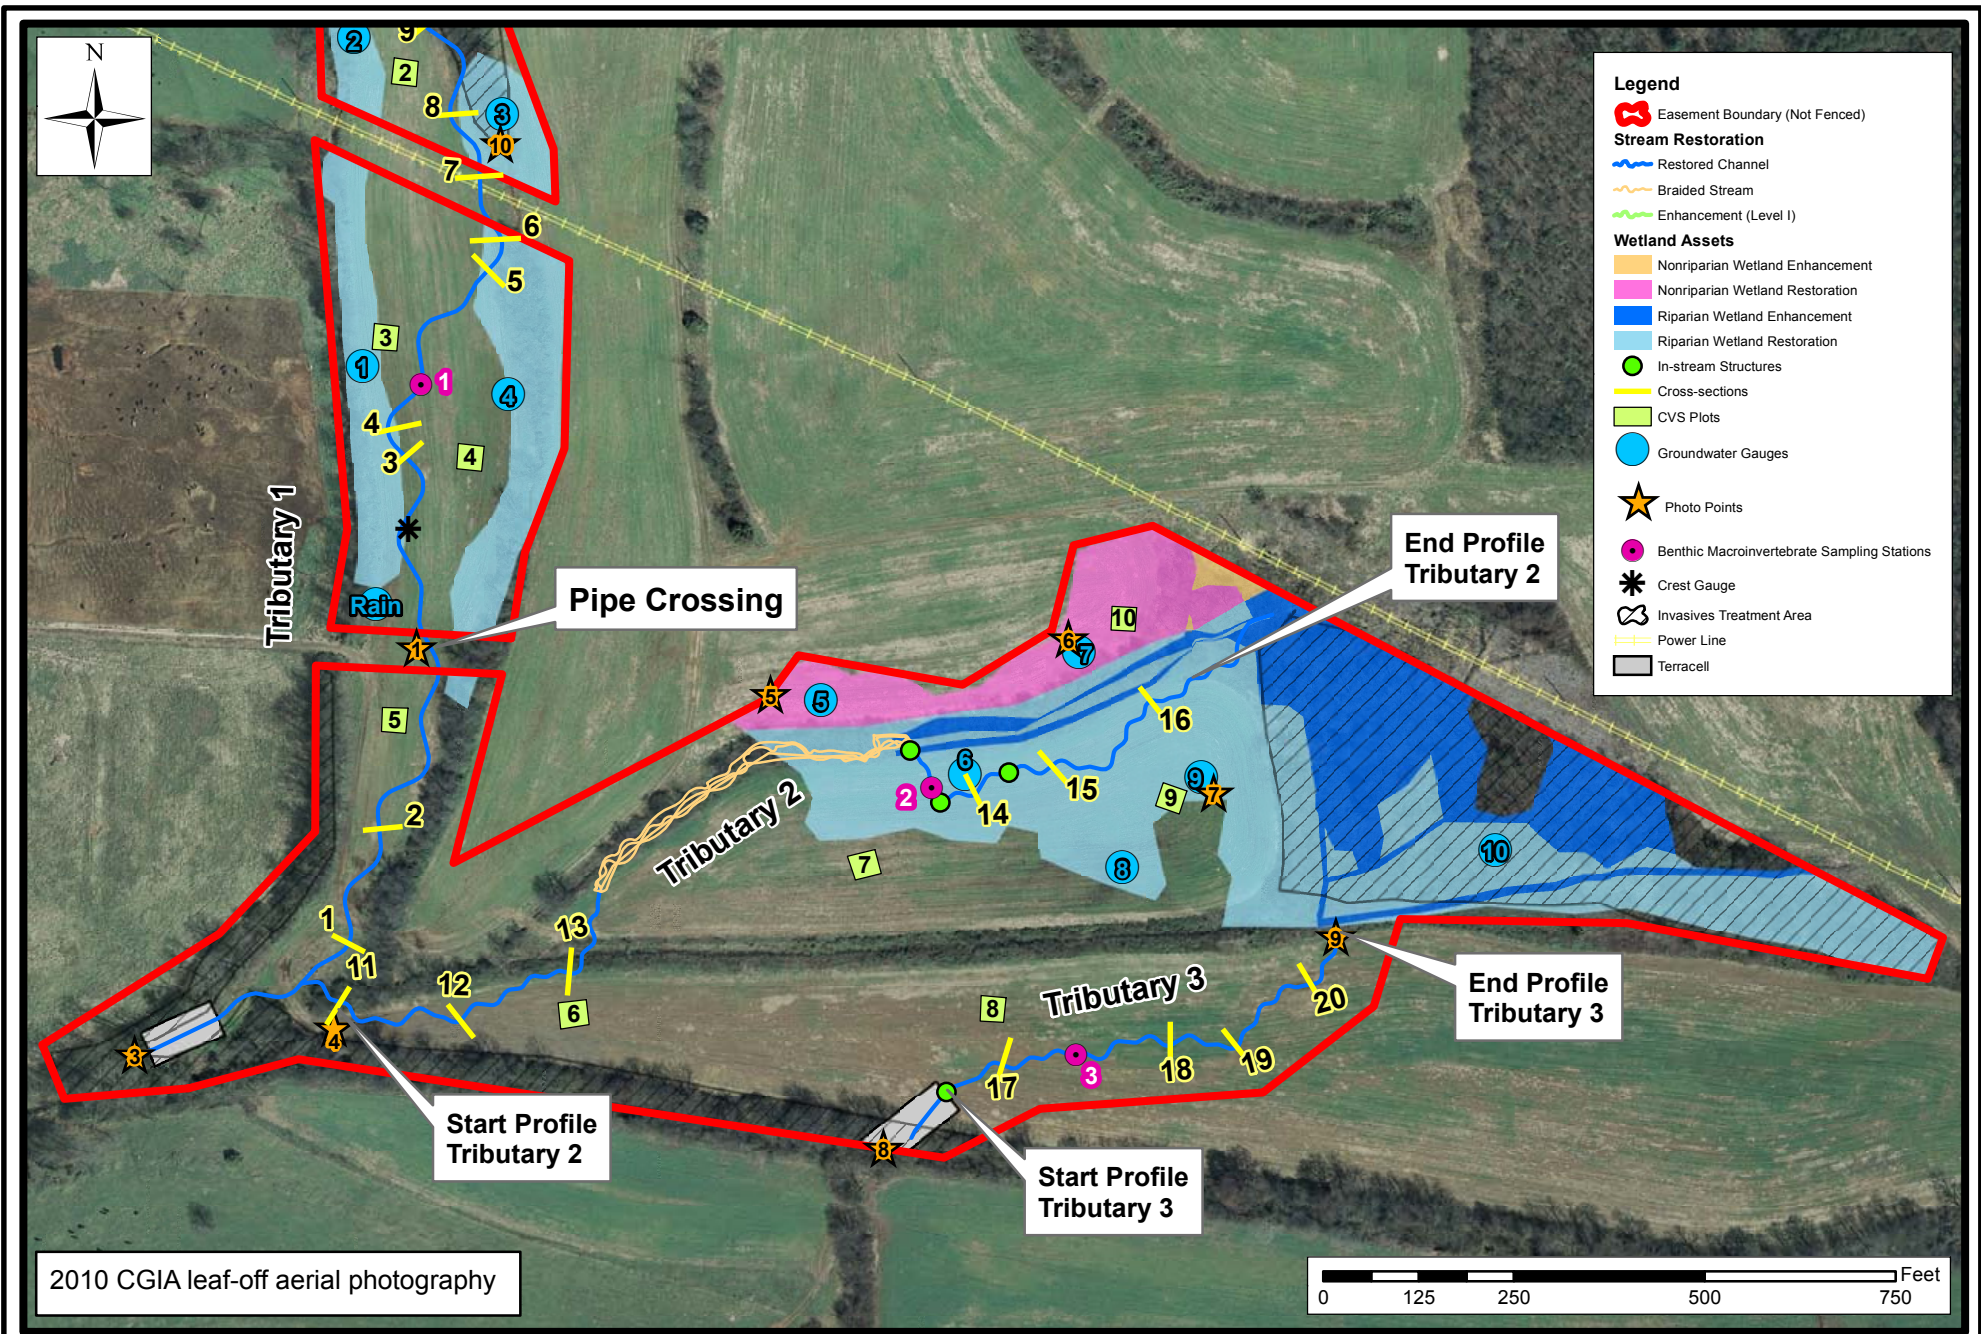
FIGURE
2A

Vegetation Results: Vegetation sampling across the Site was above the required average density with 465 planted stems per acre surviving. In addition, 9 out of 10 individual plots exceeded success criteria, with plot 4 being only one stem shy of the required stem density. The number of native tree and shrub species observed in plots ranged from three (Plot 4) to seven (Plot 5), with 16 total native species observed. Treatment for invasive species, primarily Chinese privet (*Ligustrum sinense*) was initiated prior to construction and will continue as necessary, primarily within areas denoted on Figures 2 and 2A-2B (Appendix A).
