YEAR 5 (2016)
ANNUAL MONITORING REPORT
HERMAN DAIRY STREAM AND WETLAND RESTORATION SITE

Alexander County, North Carolina

DMS Project No. 94642

YEAR 5 of 7 (2016)
ANNUAL MONITORING REPORT
HERMAN DAIRY STREAM AND WETLAND RESTORATION SITE

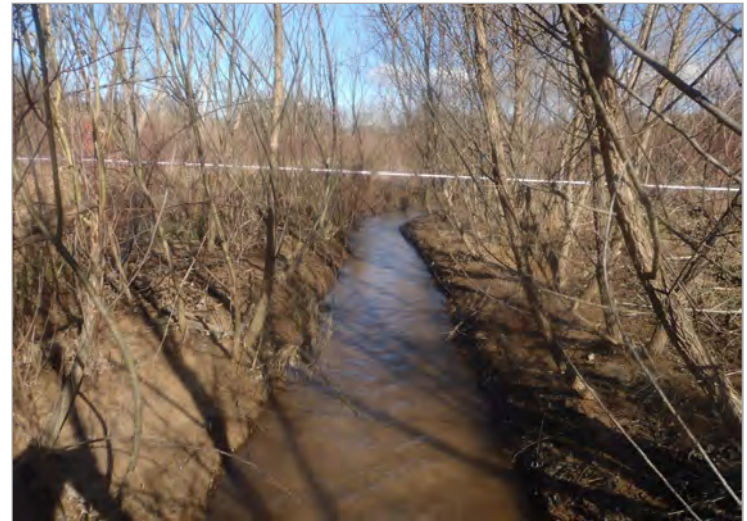
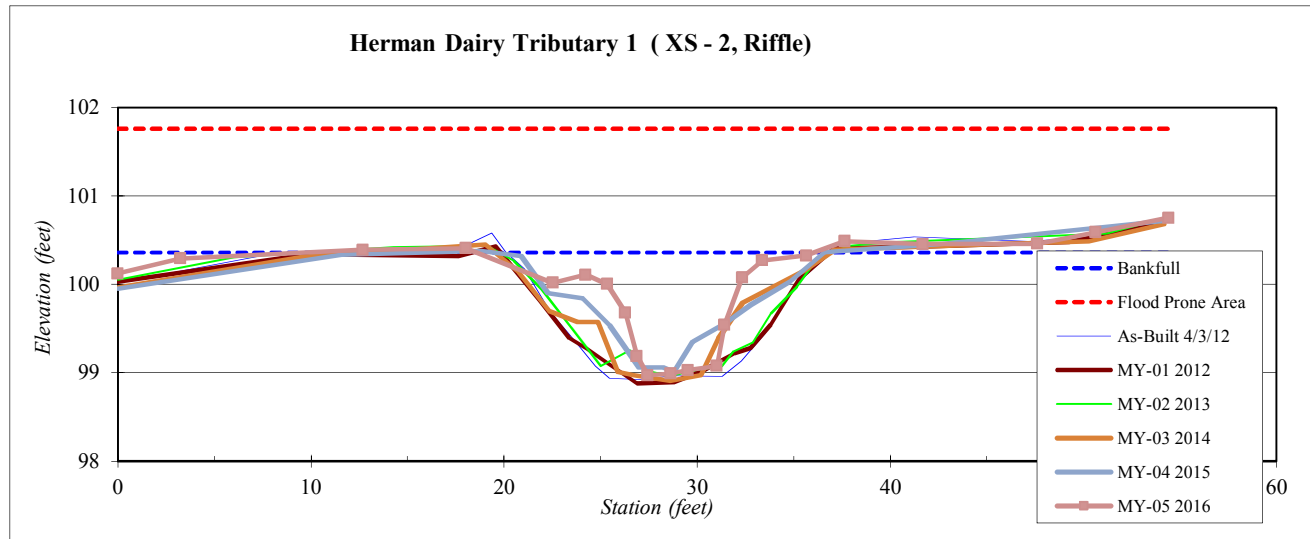
Site Name:	Herman Dairy
Watershed:	30501001120030
XS ID	Tributary 1 (XS - 2, Pool)
Drainage Area (sq mi):	1.01
Date:	2/20/2016
Field Crew:	Perkinson, Jernigan

SUMMARY DATA	
Bankfull Elevation:	100.4
Bankfull Cross-Sectional Area:	9.3
Bankfull Width:	17.5
Flood Prone Area Elevation:	101.8
Flood Prone Width:	>80
Max Depth at Bankfull:	1.4
Mean Depth at Bankfull:	0.5
W / D Ratio:	32.9
Entrenchment Ratio:	>5
Bank Height Ratio:	1.0

Stream Type E

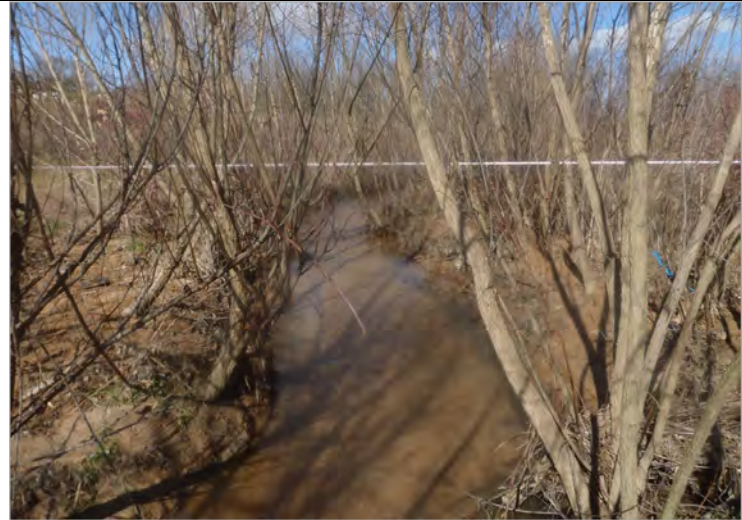
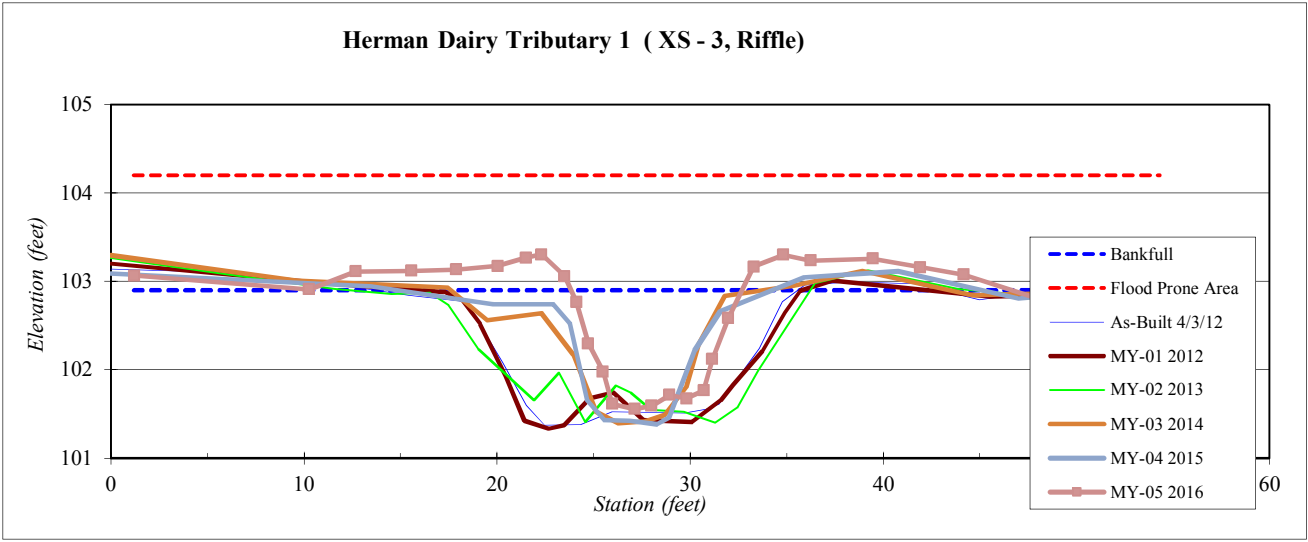
Site Name:	Herman Dairy
Watershed:	30501001120030
XS ID	Tributary 1 (XS - 3, Riffle)
Drainage Area (sq mi):	1.01
Date:	2/20/2016
Field Crew:	Perkinson, Jernigan

Stream Type E/C

SUMMARY DATA	
Bankfull Elevation:	102.9
Bankfull Cross-Sectional Area:	8.3
Bankfull Width:	8.9
Flood Prone Area Elevation:	104.2
Flood Prone Width:	>80
Max Depth at Bankfull:	1.3
Mean Depth at Bankfull:	0.9
W / D Ratio:	9.5
Entrenchment Ratio:	>5
Bank Height Ratio:	1.0
