FINAL
AS-BUILT BASELINE
MONITORING REPORT (MY0)

HERON STREAM AND WETLAND MITIGATION SITE
Alamance County, North Carolina

DMS Project ID No. 100014
Full Delivery Contract No. 7192
USACE Action ID No. SAW-2017-01471
DWR No. 17-0290
RFP No. 16-006990

Data Collection: February – May 2019
Submission: May 2019

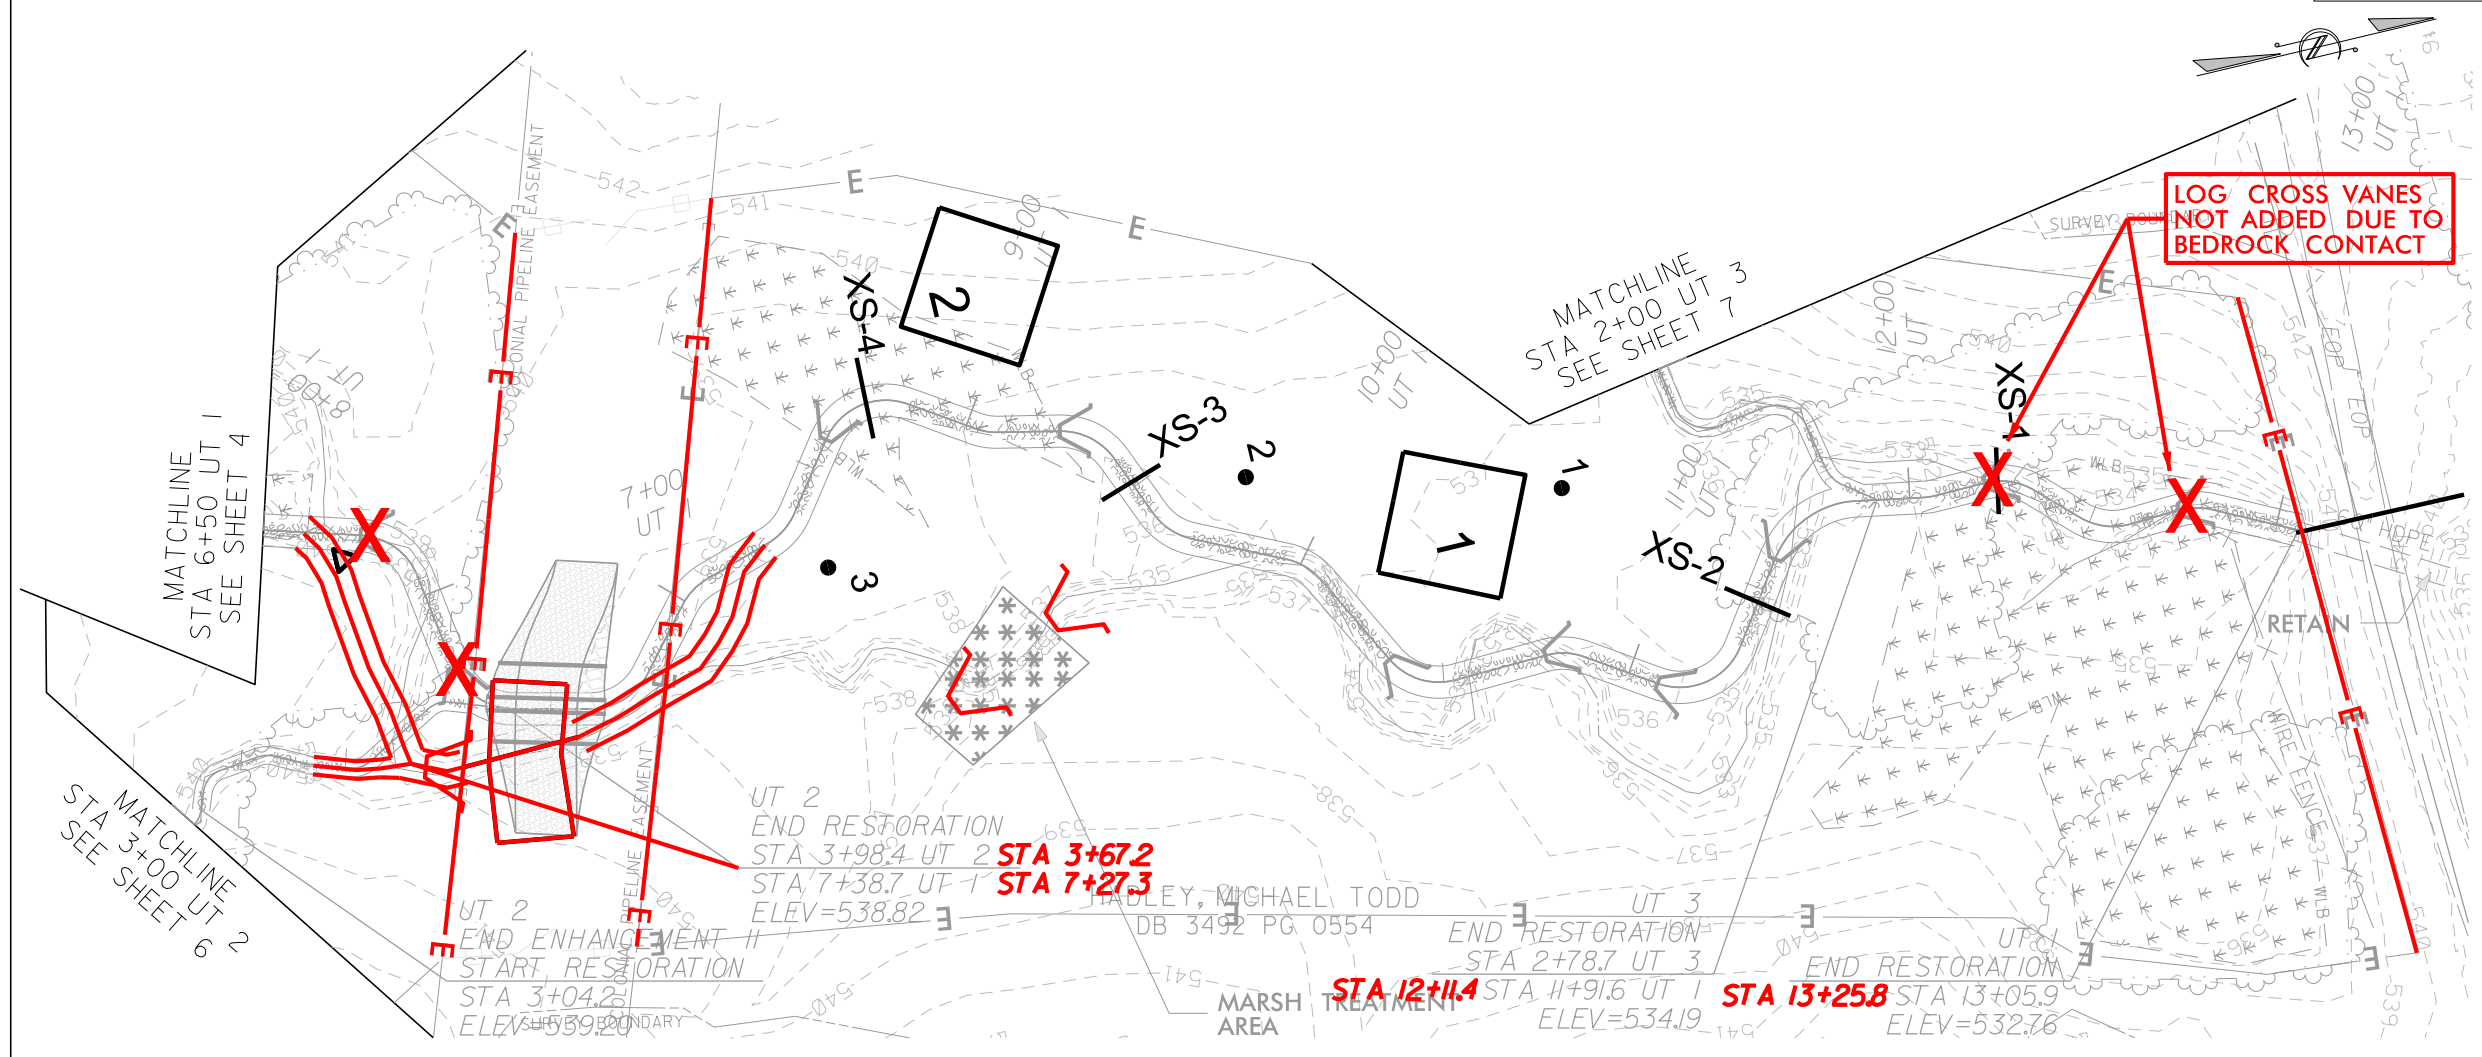
-UT1-, -UT2- STREAM ALIGNMENT, STRUCTURE LOCATIONS AND STREAM CROSSING ADJUSTED DUE TO GAS LINE CONFLICT. EXISTING STREAM ELEVATIONS USED FOR AREA INSIDE OF COLONIAL PIPELINE EASEMENT

LOG CROSS VANES NOT ADDED DUE TO BEDROCK CONTACT
