FINAL MONITORING REPORT
2021 (Year 3)

HERON STREAM AND WETLAND MITIGATION SITE

Alamance County, North Carolina

DMS Project ID No. 100014
Full Delivery Contract No. 7192
USACE Action ID No. SAW-2017-01471
DWR No. 17-0290
RFP No. 16-006990

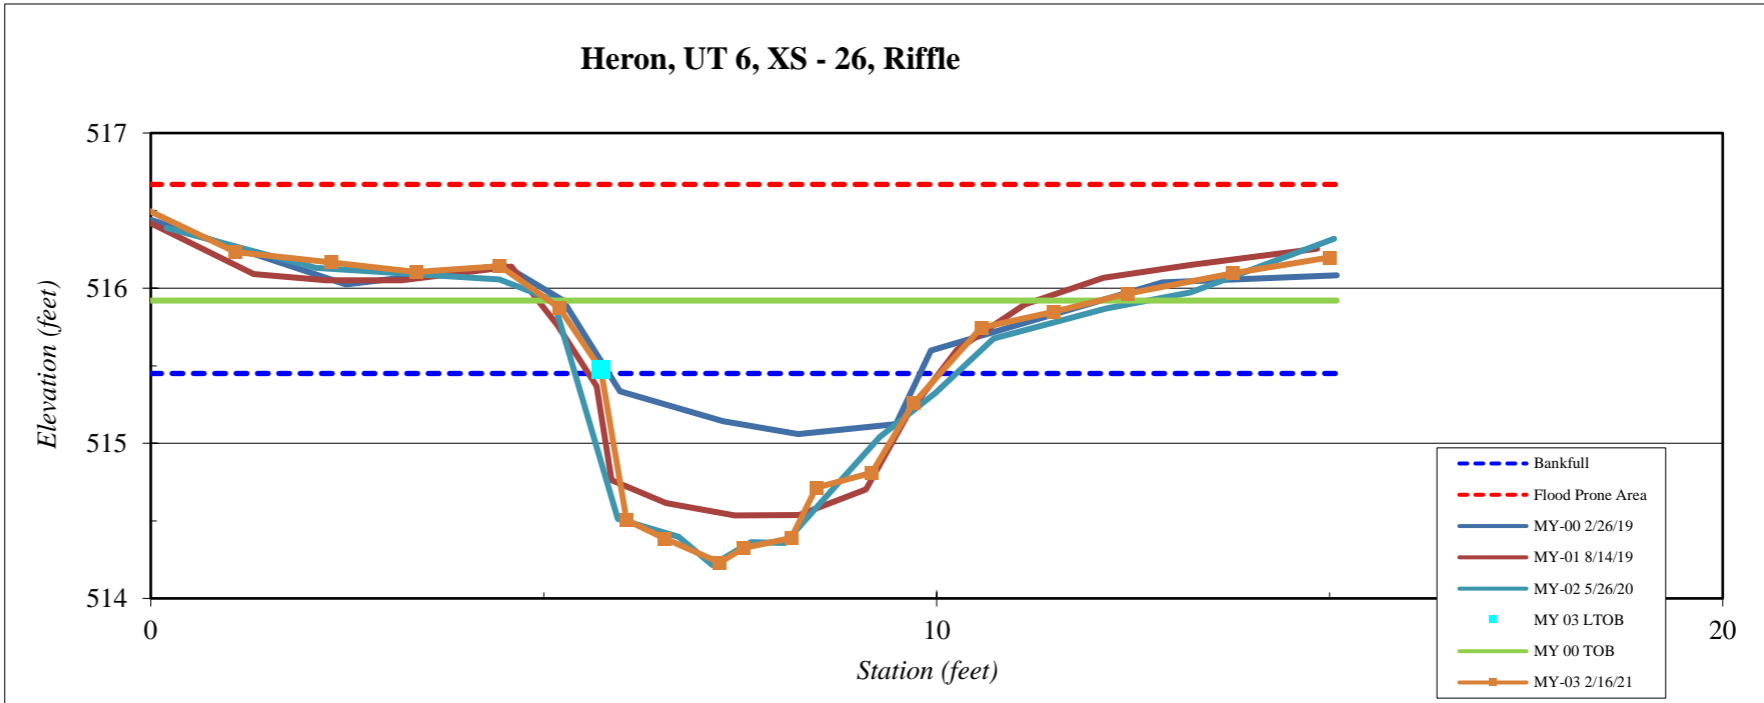
The degradation in XS-26 is likely a result of upstream land-use causing more direct, flashy flows during heavy rain events prior to the streambed fully settling post-construction. The majority of the degradation occurred between MY0 and MY1, and MY2 and MY3 data are virtually the same. This indicates stability, although RS will continue to monitor this reach for additional degradation through the remainder of the monitoring period. XS-27 aggradation occurred shortly after construction, likely from fines being flushed out of riffle bed material upstream and settling in this lower energy reach of stream. Virtually no additional aggradation has occurred since MY1, and the pool appears to have stabilized. The notes on these cross-sections were revised for clarity.

Note: Riffle degradation is likely a result of direct, flashy flows from upstream land-use just after construction. It appears to have stabilized during years 2-3.

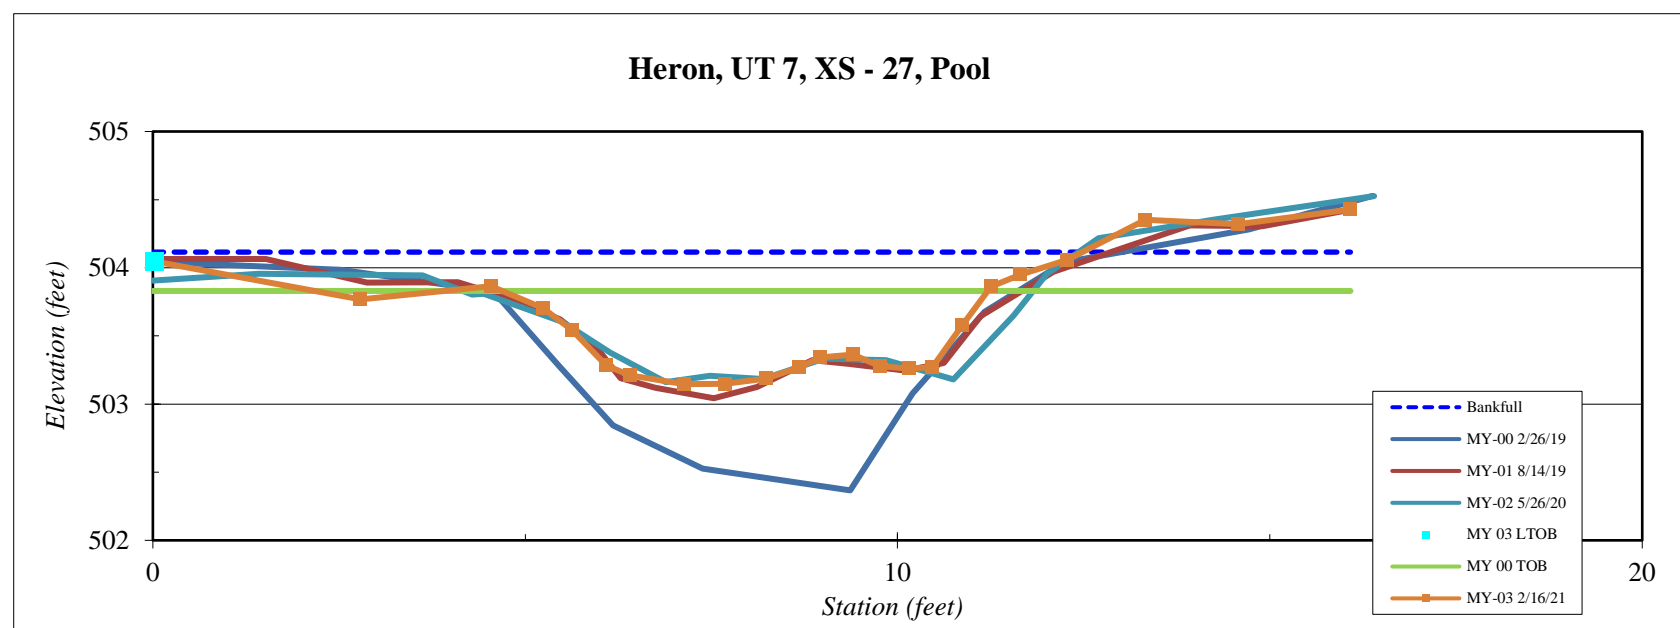
Note: The sediment deposition in this pool occurred shortly after construction and has stabilized during Years 1-3. It is not expected to lead to further instability.

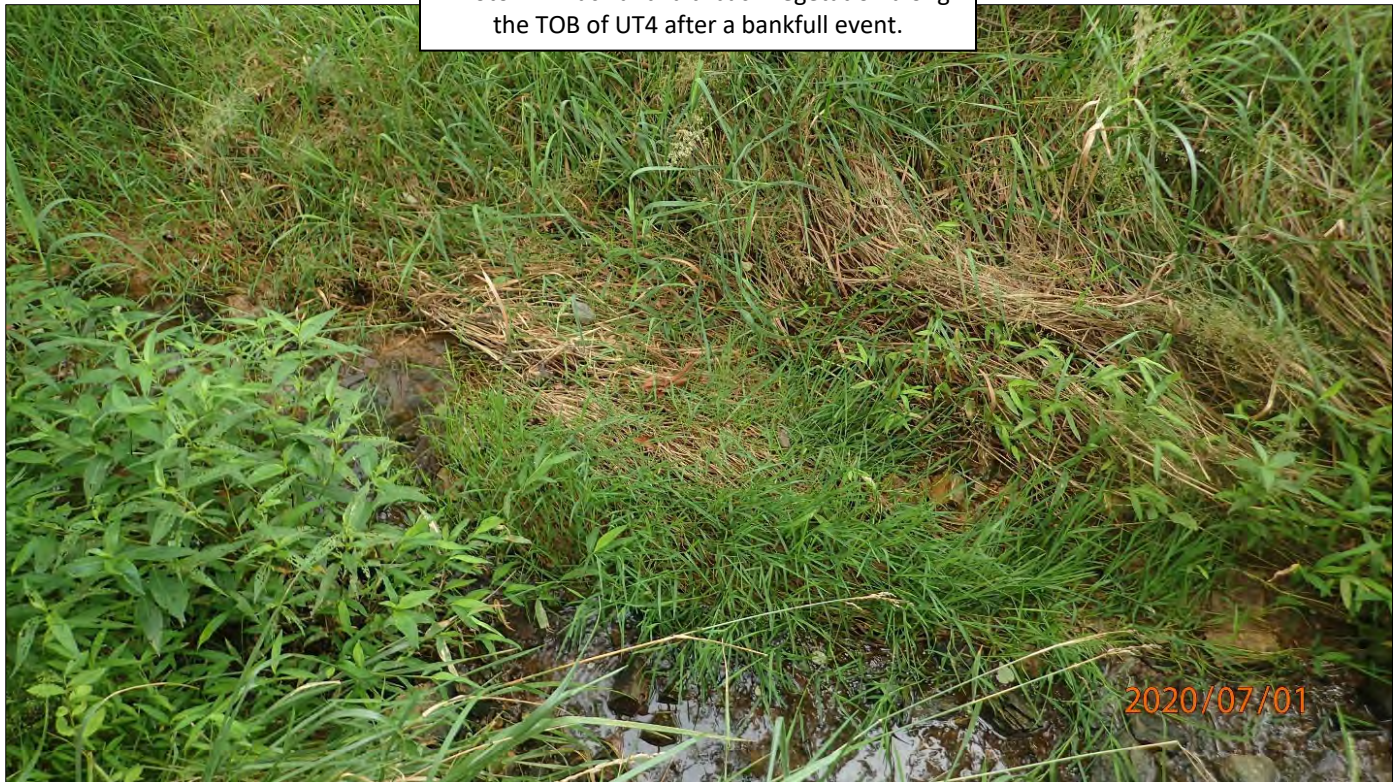
Photo 1: Wrack and laid-back vegetation along the TOB of UT4 after a bankfull event.

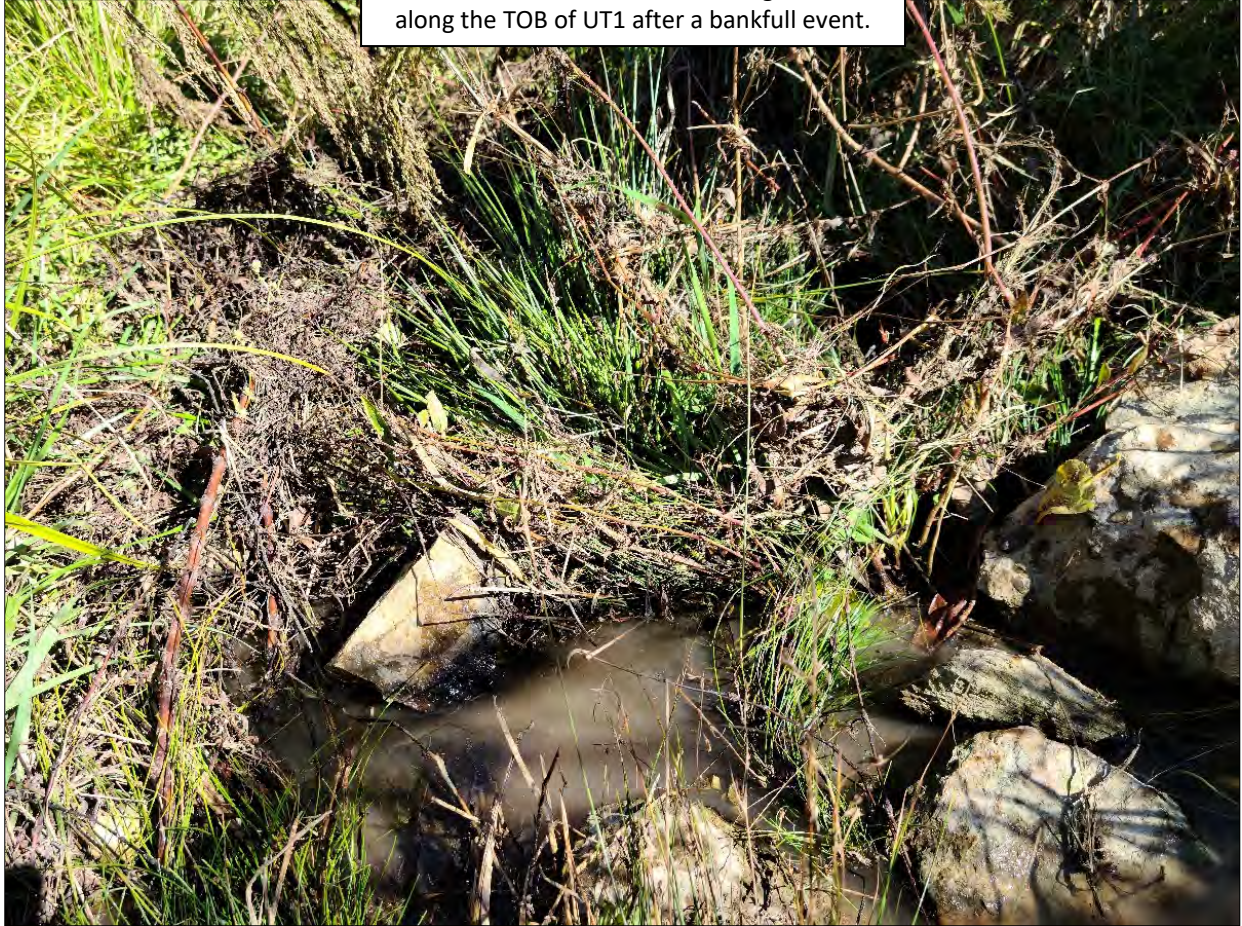
Photo 2: Wrack and laid-back vegetation along the TOB of UT1 after a bankfull event.

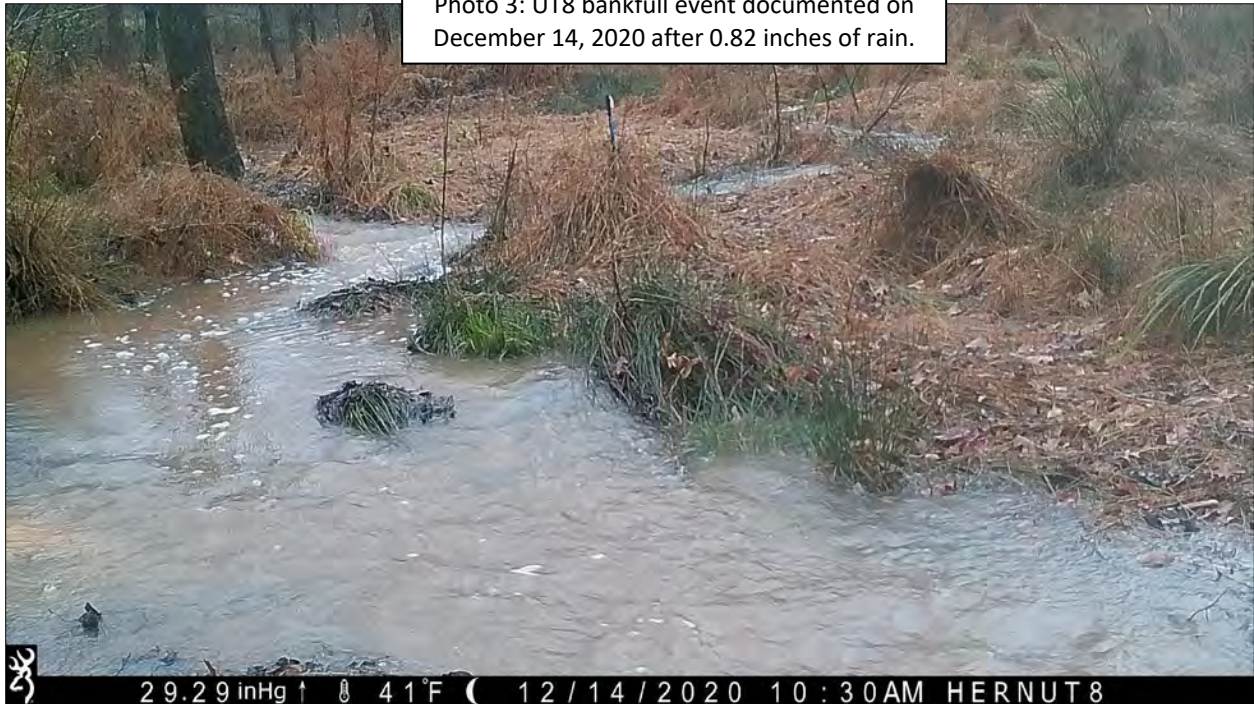
Photo 3: UT8 bankfull event documented on December 14, 2020 after 0.82 inches of rain.

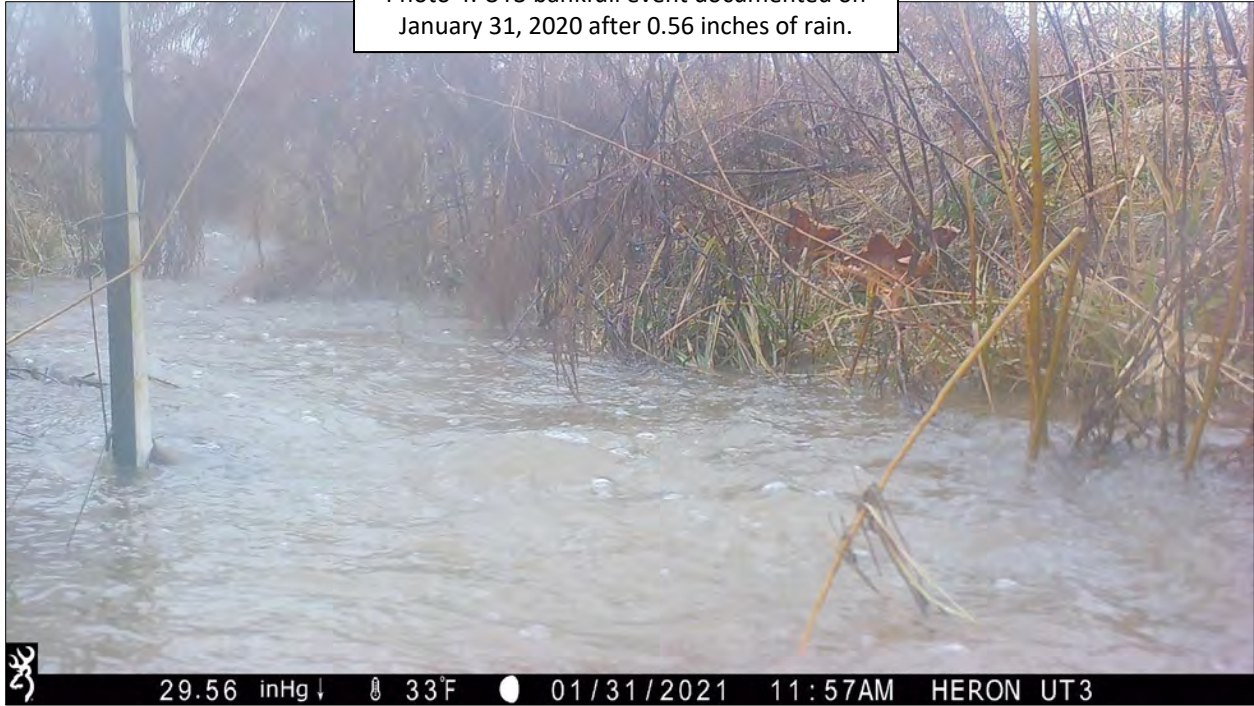
Photo 4: UT3 bankfull event documented on January 31, 2020 after 0.56 inches of rain.

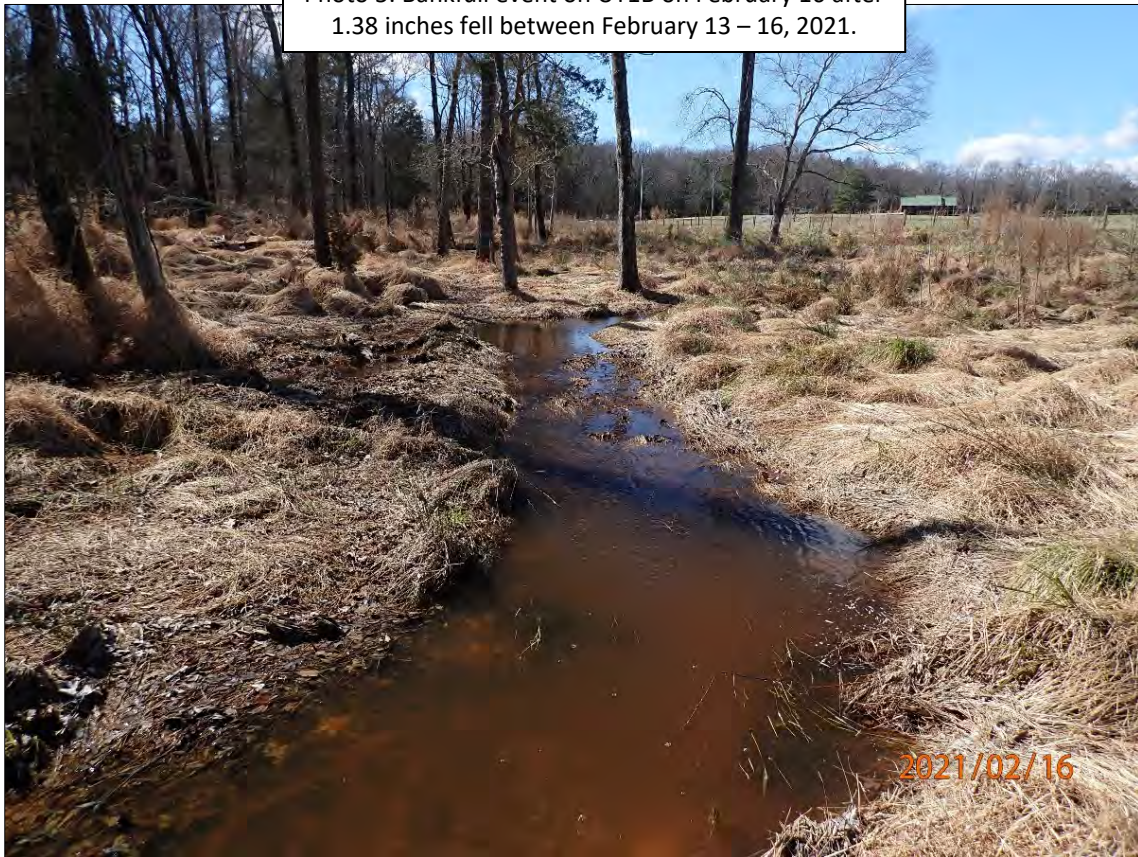
Photo 5: Bankfull event on UT1B on February 16 after 1.38 inches fell between February 13 – 16, 2021.

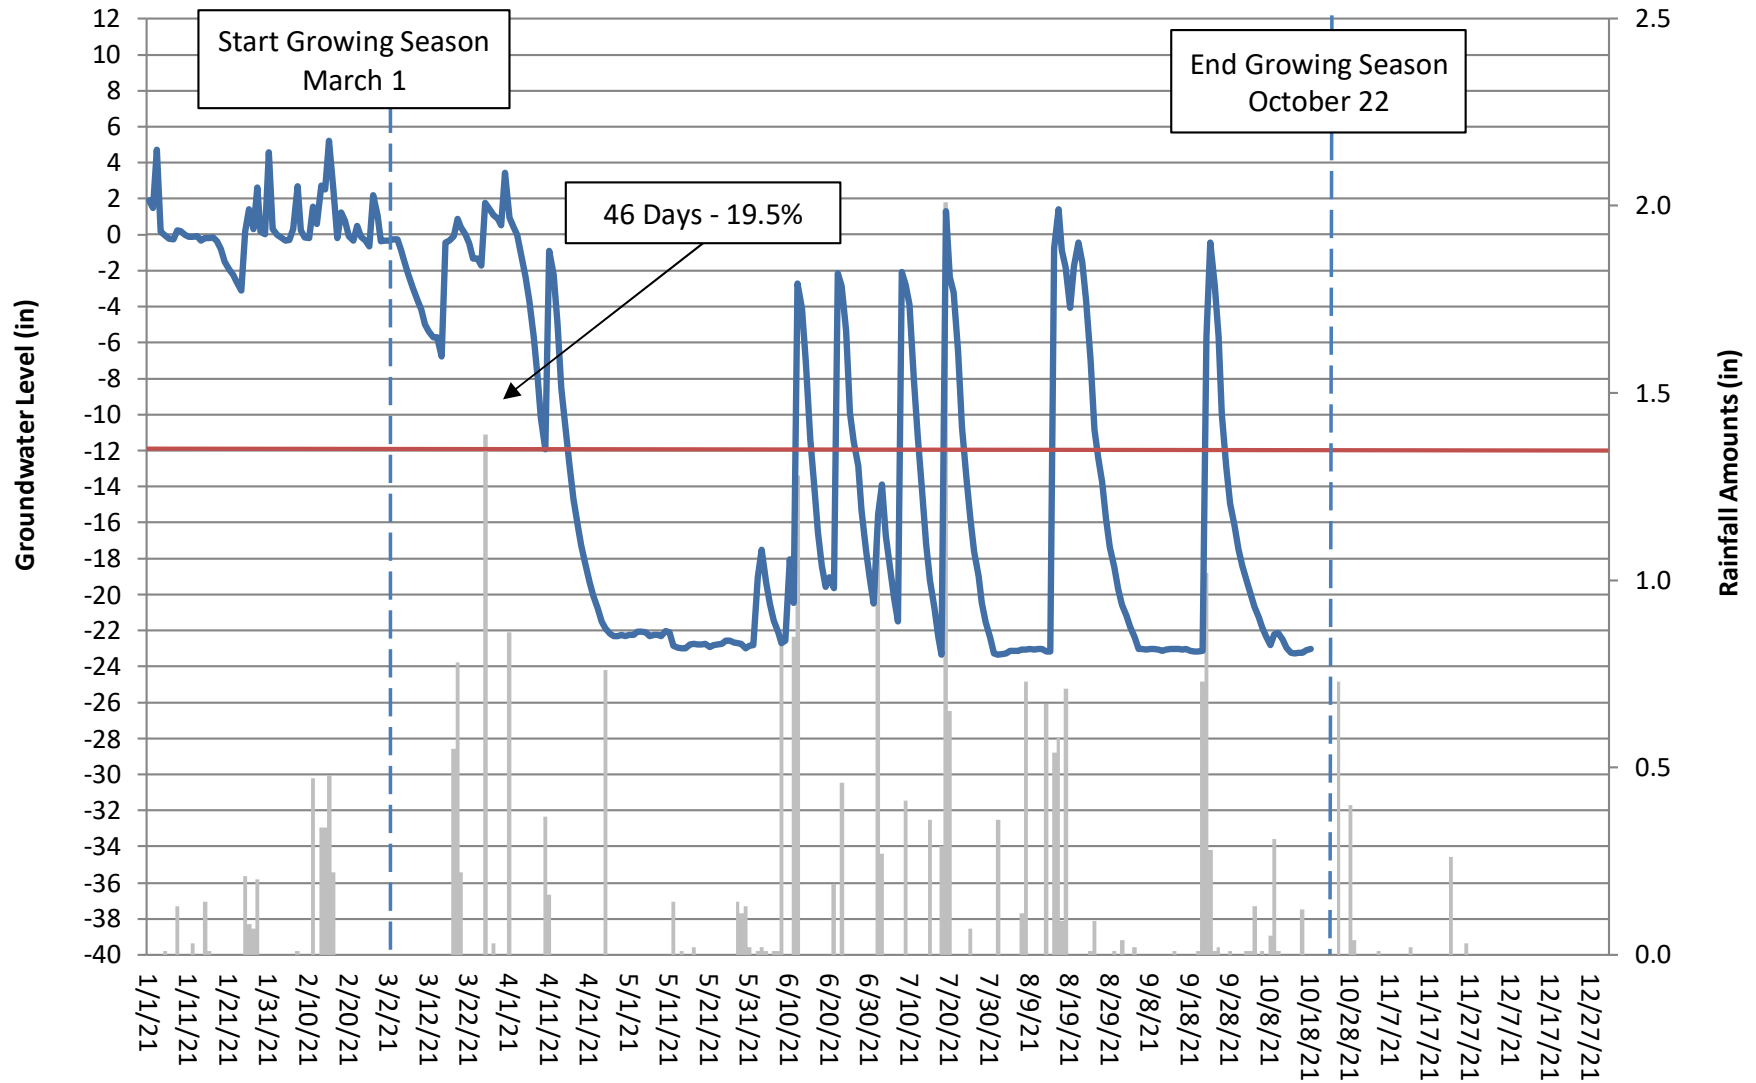
Heron Groundwater Gauge 1 Year 3 (2021 Data)

8. GW gage 1 is missing the label that includes # continuous days and % hydroperiod like the other graphs.

The label was added to the graph.
