FINAL MONITORING REPORT
2022 (Year 4)

HERON STREAM AND WETLAND MITIGATION SITE

Alamance County, North Carolina

DMS Project ID No. 100014
Full Delivery Contract No. 7192
USACE Action ID No. SAW-2017-01471
DWR No. 17-0920
RFP No. 16-006990

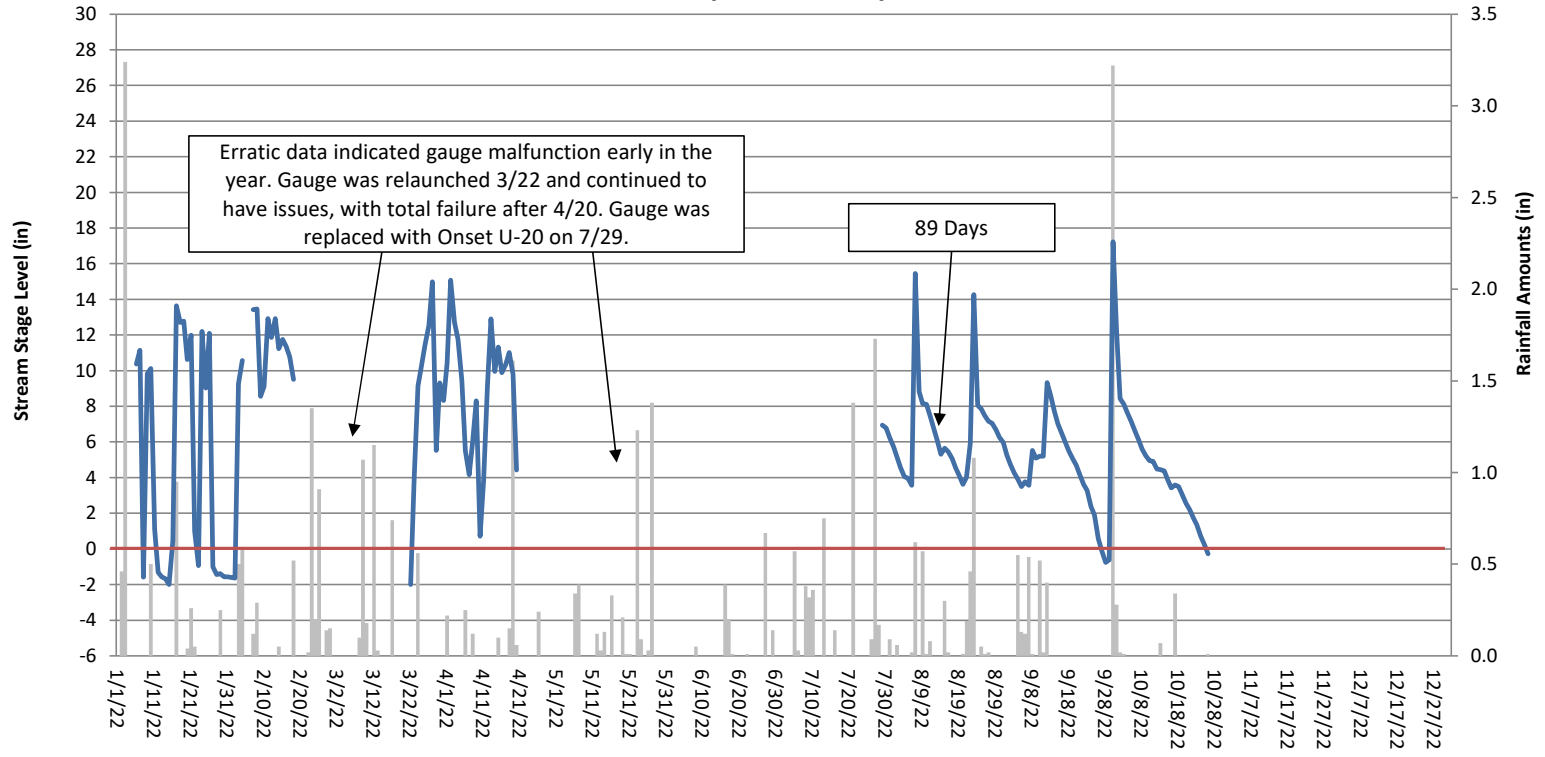
Heron Stream Flow Gauge UT1 Year 4 (2022 Data)

Channel formation was evident in all site tributaries during year 4 (2022). The UT1 streamflow gauge malfunctioned twice during MY4 (2022). After it was replaced in July, it captured 89 days of consecutive flow. The UT2 and UT3 stream gauges captured 61 days and 131 days respectively. The UT5 upstream and downstream gauges captured 201 and 130 days respectively. UT6 exhibited 118 consecutive days of flow prior to its failure in July. The upstream and downstream gauges on UT7 both failed resulting in data loss between April and July; however, they captured 36 days and 59 days respectively prior to the failures. The UT7 middle gauge captured 209 days of flow. The UT8 gauge also malfunctioned between April and July, but it captured 108 consecutive days of flow prior to its failure. All stream gauges were replaced with Onset U-20 gauges in July, and no additional malfunctions or failures are anticipated. Channel formation tables and graphs are in Appendix E.

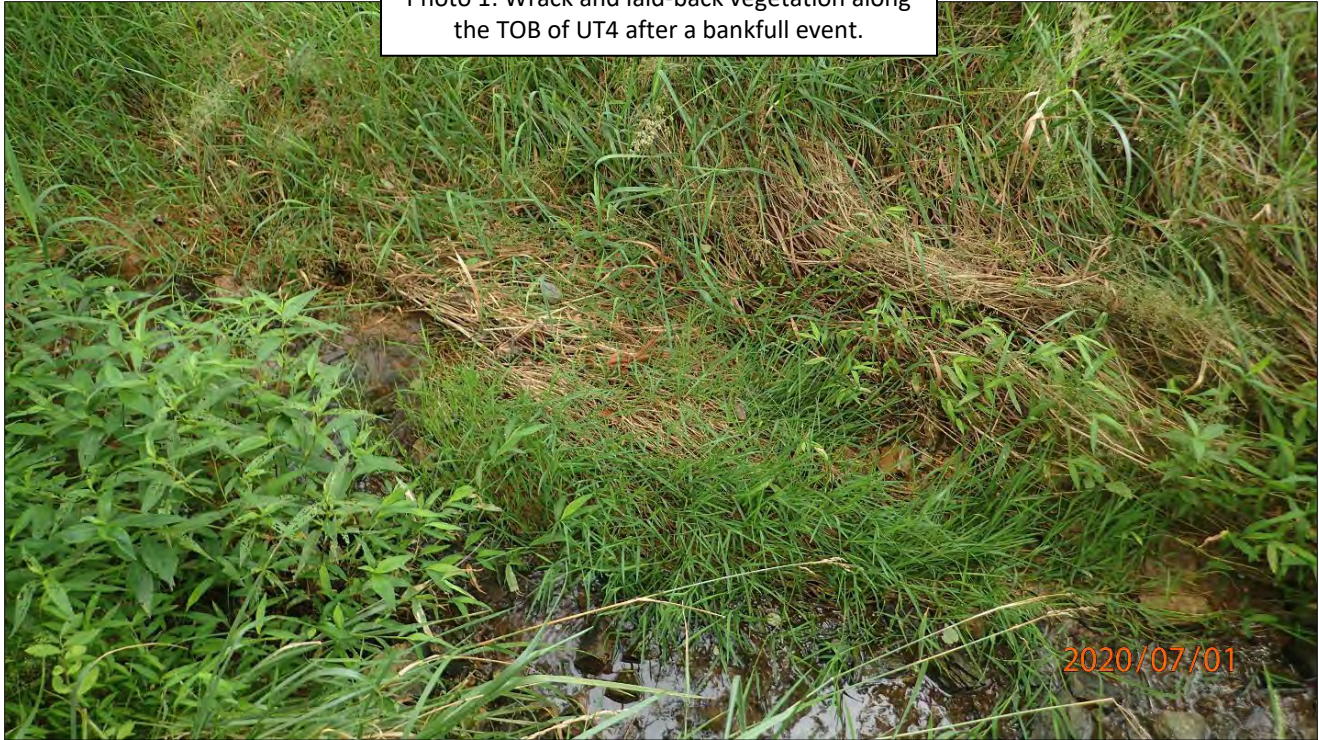
Photo 1: Wrack and laid-back vegetation along the TOB of UT4 after a bankfull event.

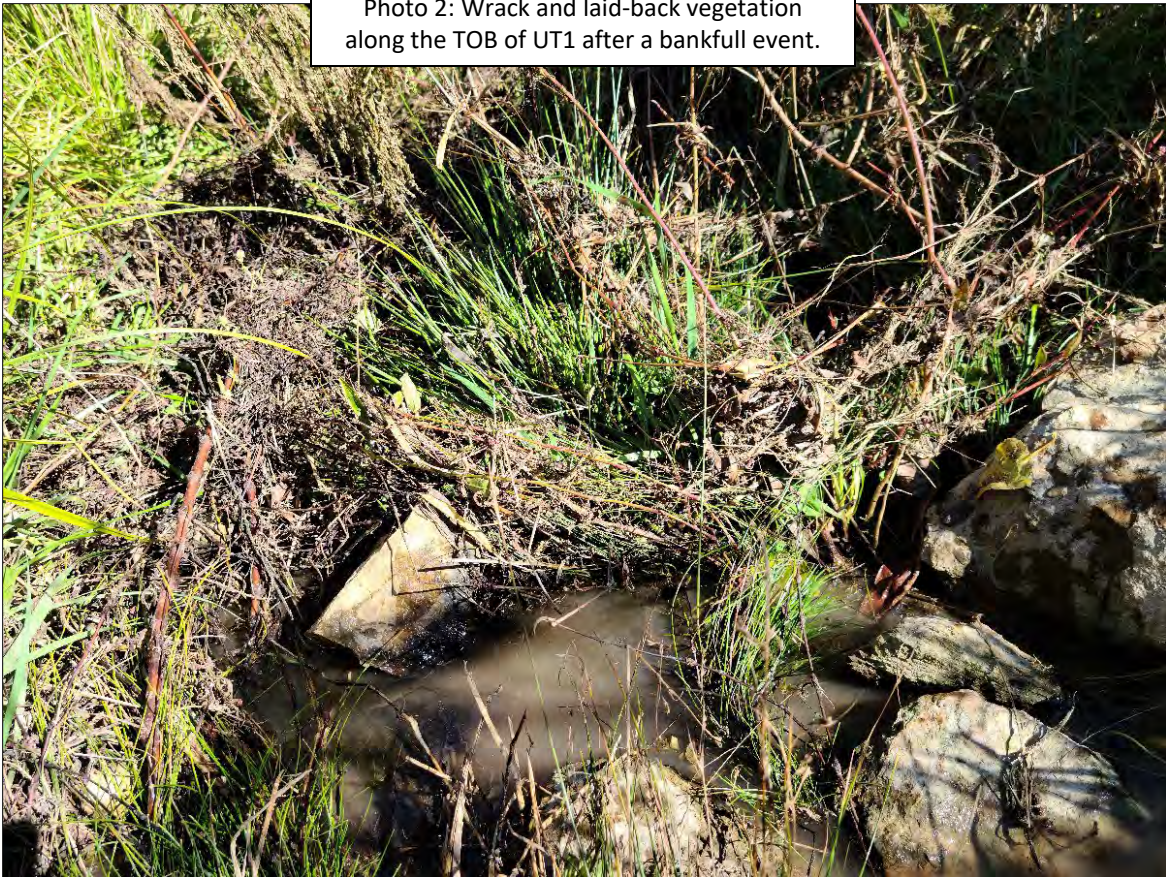
Photo 2: Wrack and laid-back vegetation along the TOB of UT1 after a bankfull event.

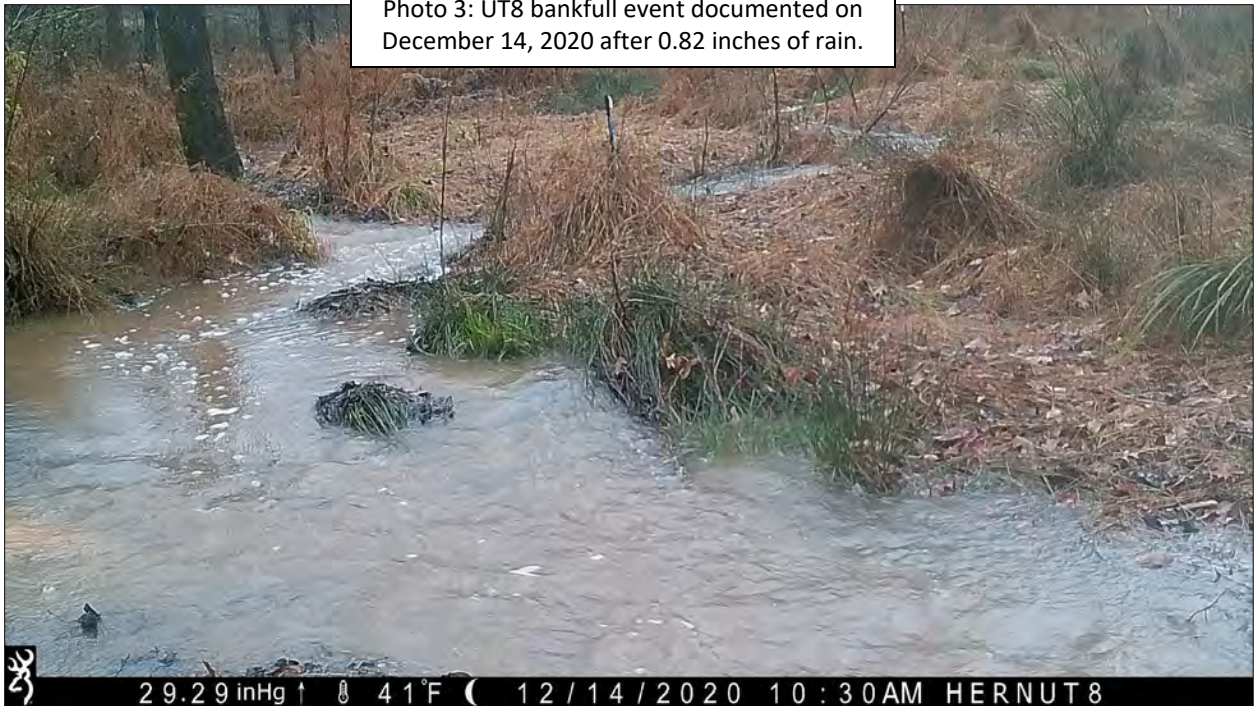
Photo 3: UT8 bankfull event documented on December 14, 2020 after 0.82 inches of rain.

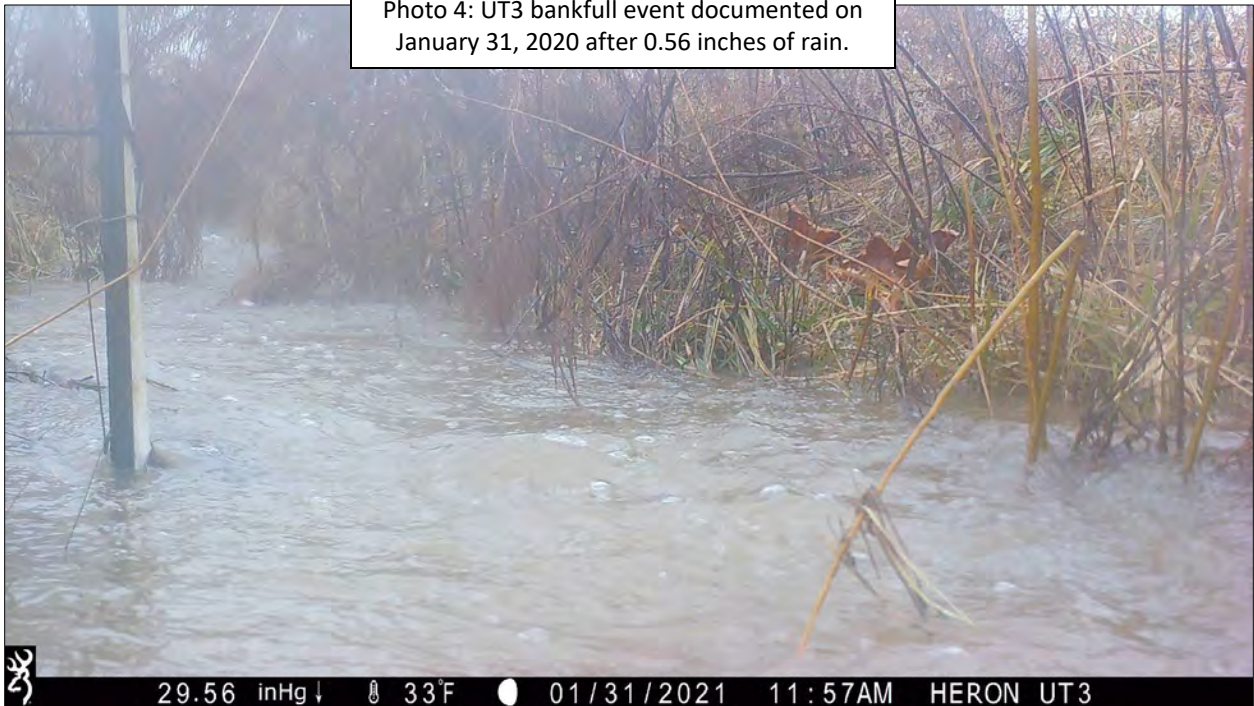
Photo 4: UT3 bankfull event documented on January 31, 2021 after 0.56 inches of rain.

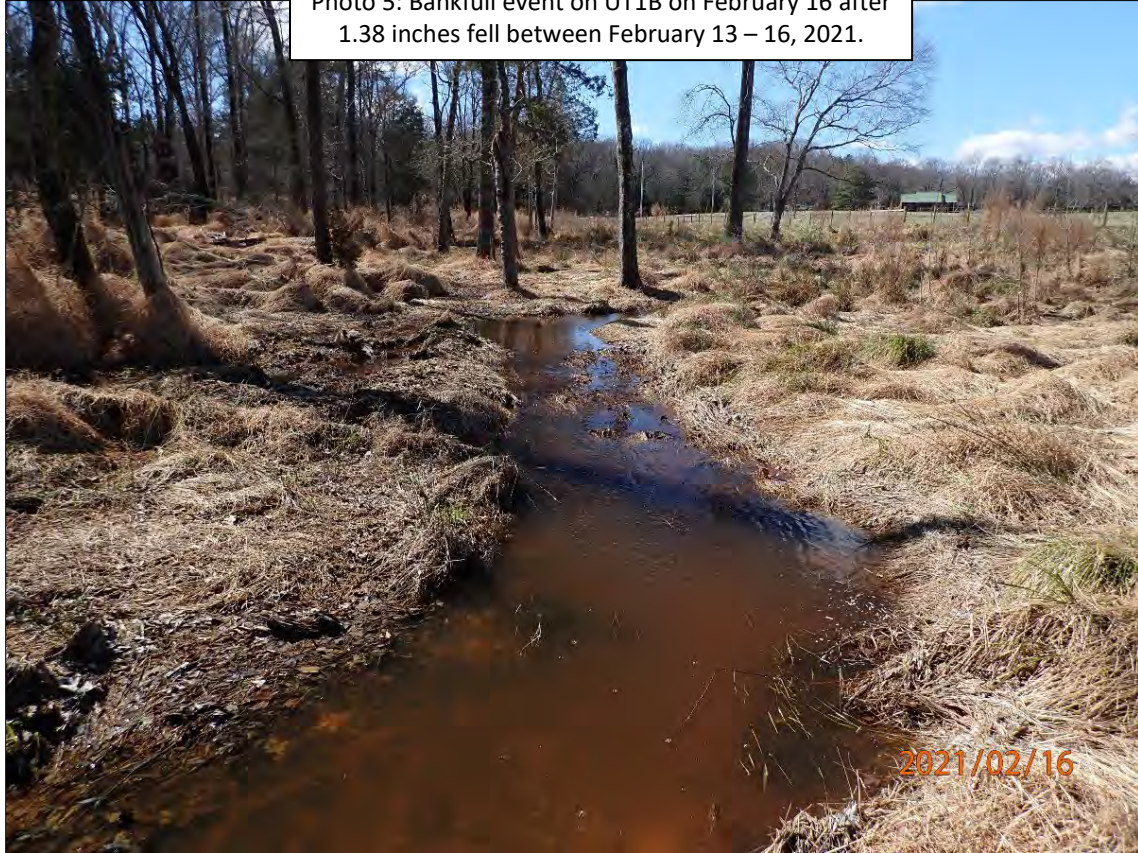
Photo 5: Bankfull event on UT1B on February 16 after 1.38 inches fell between February 13 – 16, 2021.

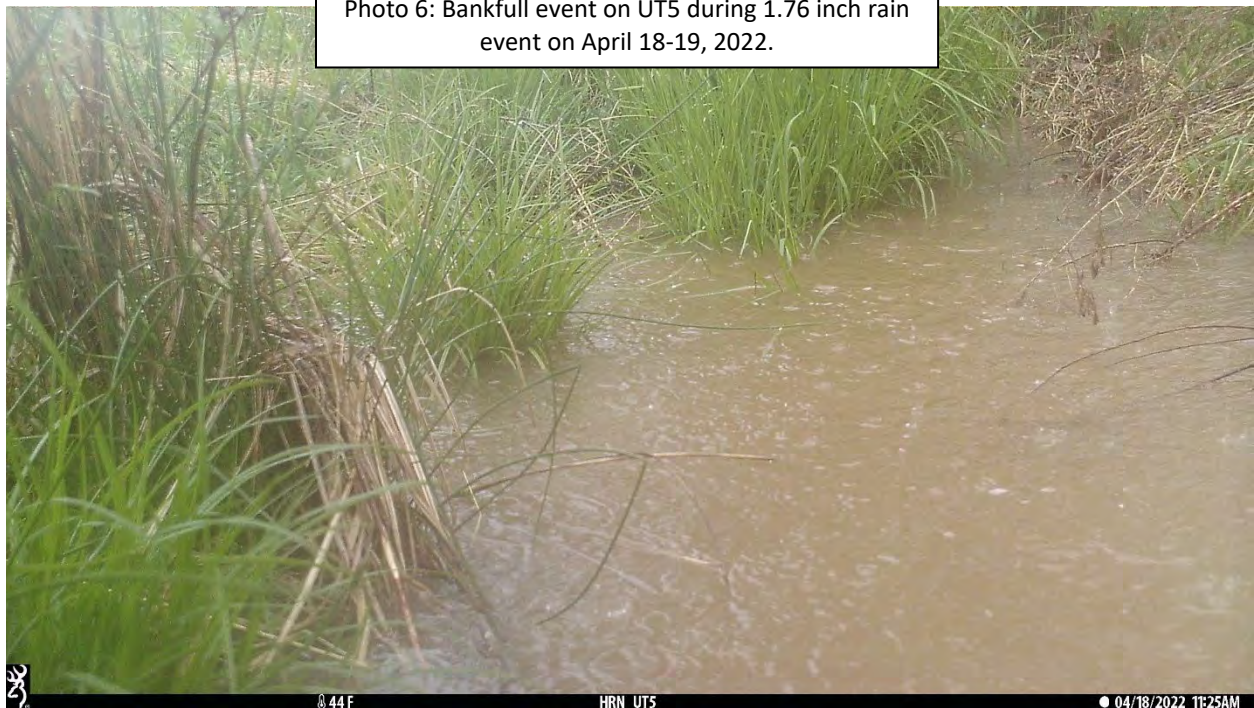
Photo 6: Bankfull event on UT5 during 1.76 inch rain event on April 18-19, 2022.

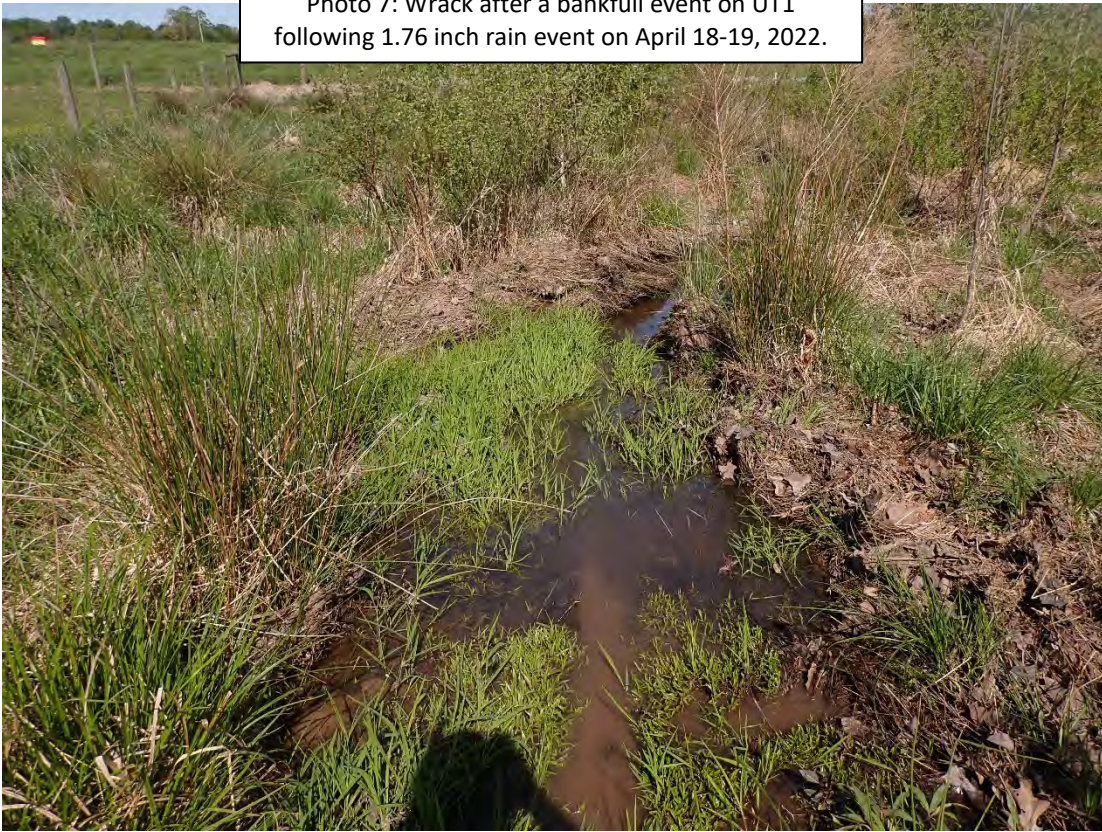
Photo 7: Wrack after a bankfull event on UT1 following 1.76 inch rain event on April 18-19, 2022.

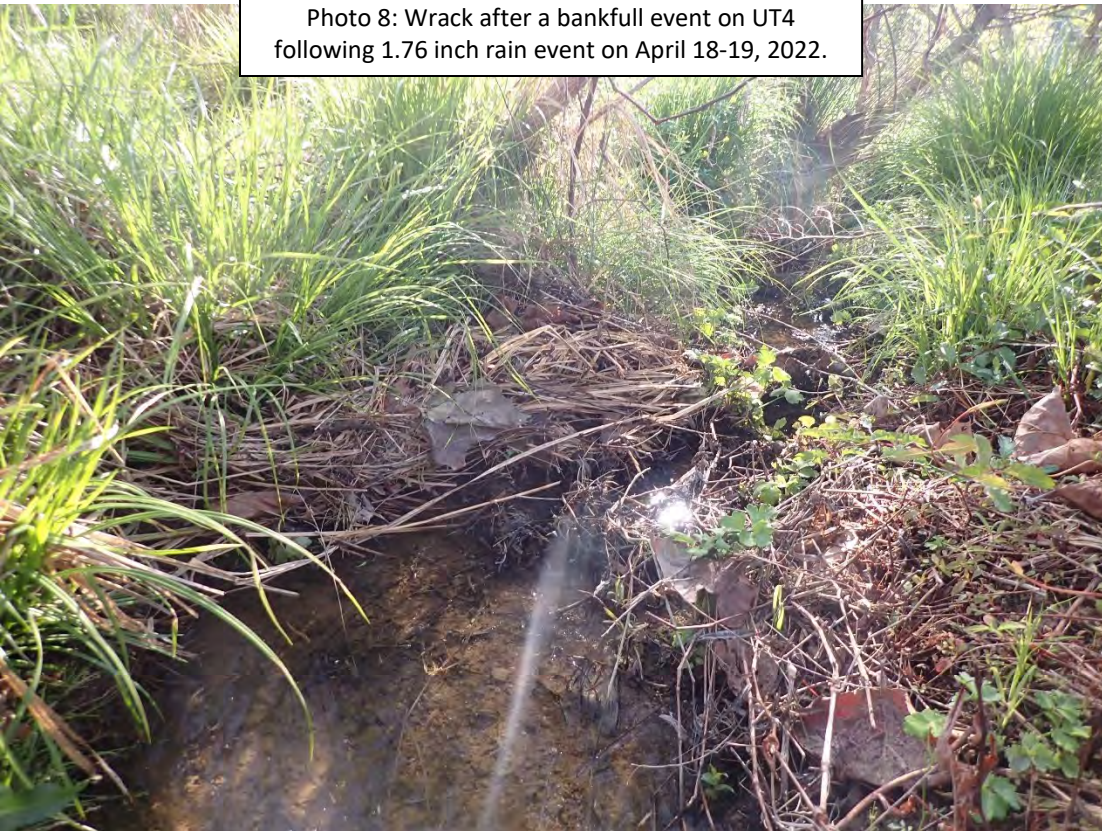
Photo 8: Wrack after a bankfull event on UT4 following 1.76 inch rain event on April 18-19, 2022.

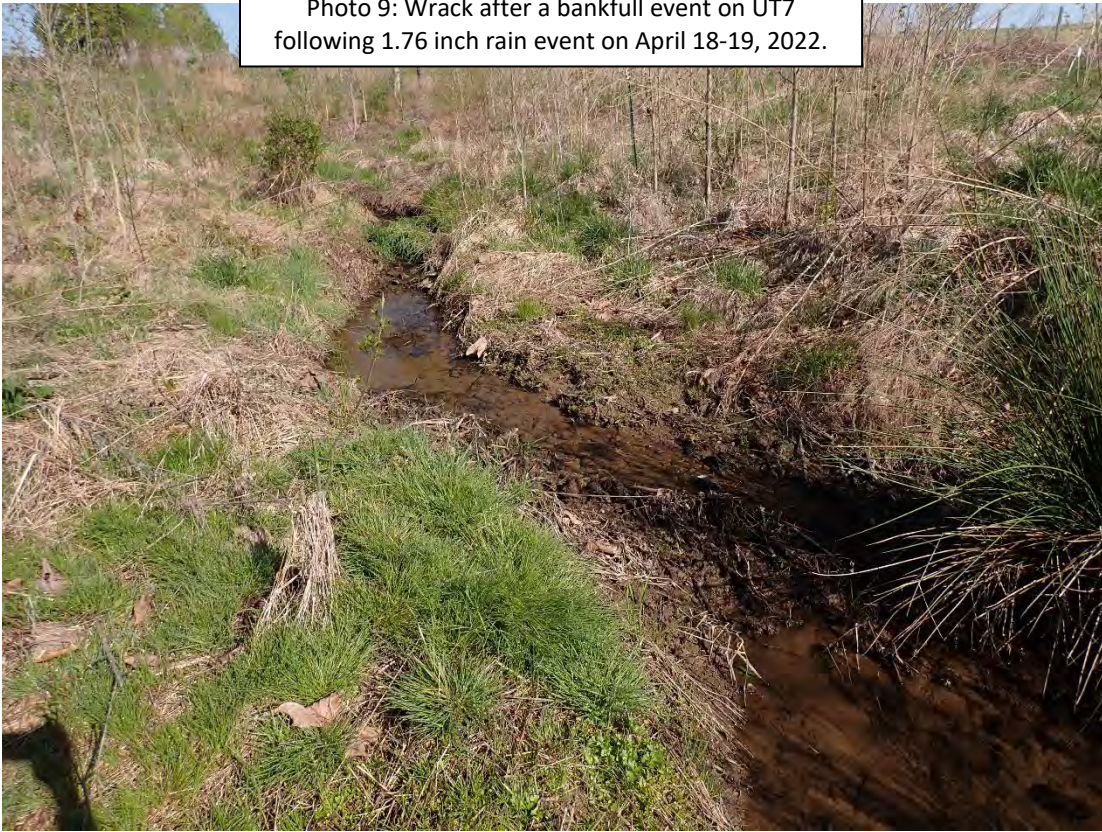
Photo 9: Wrack after a bankfull event on UT7 following 1.76 inch rain event on April 18-19, 2022.

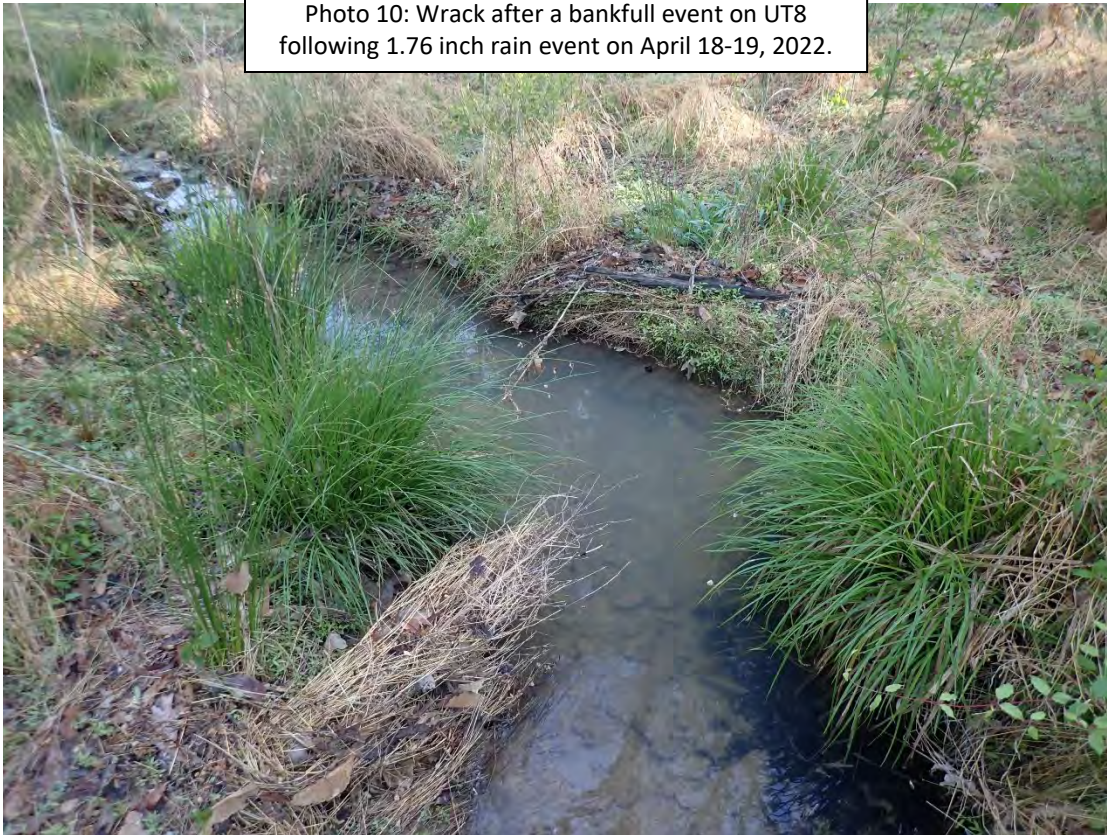
Photo 10: Wrack after a bankfull event on UT8 following 1.76 inch rain event on April 18-19, 2022.

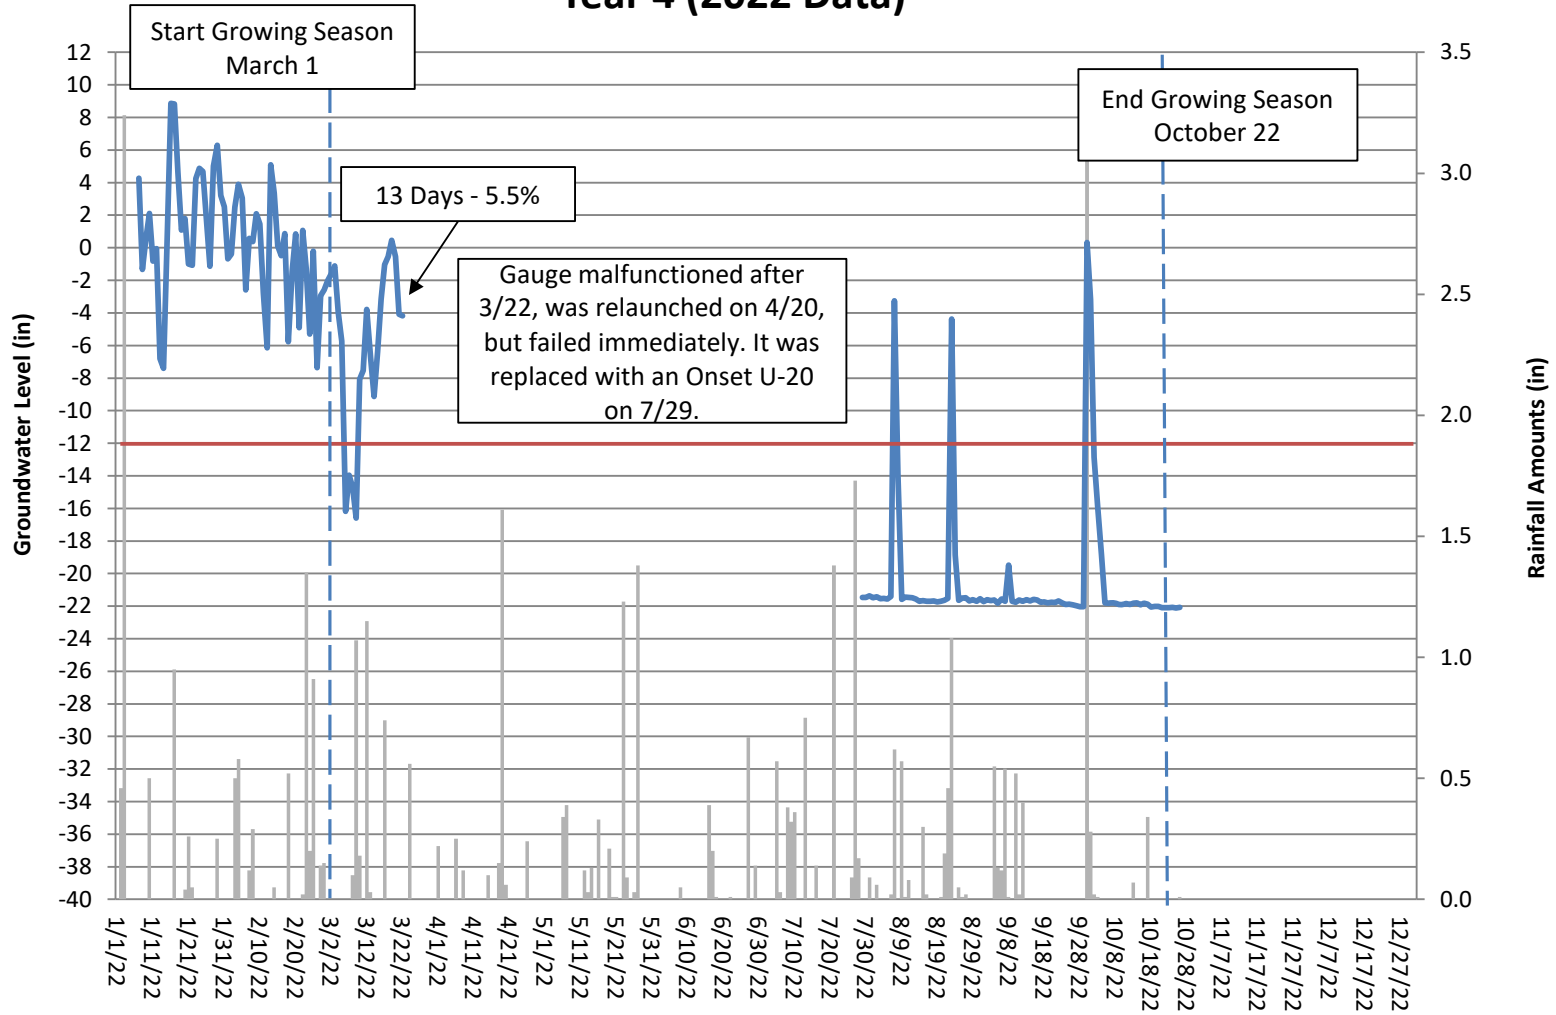
Heron Groundwater Gauge 6 Year 4 (2022 Data)

* Gauge 6 malfunctioned 3/22/22, was relaunched on 4/20/22, and failed immediately after. This resulted in data loss during this time-period. It is expected that gauge 6 would have met success criteria during the time of the data loss. All gauges were replaced with new Onset U-20 gauges on 7/29/22.

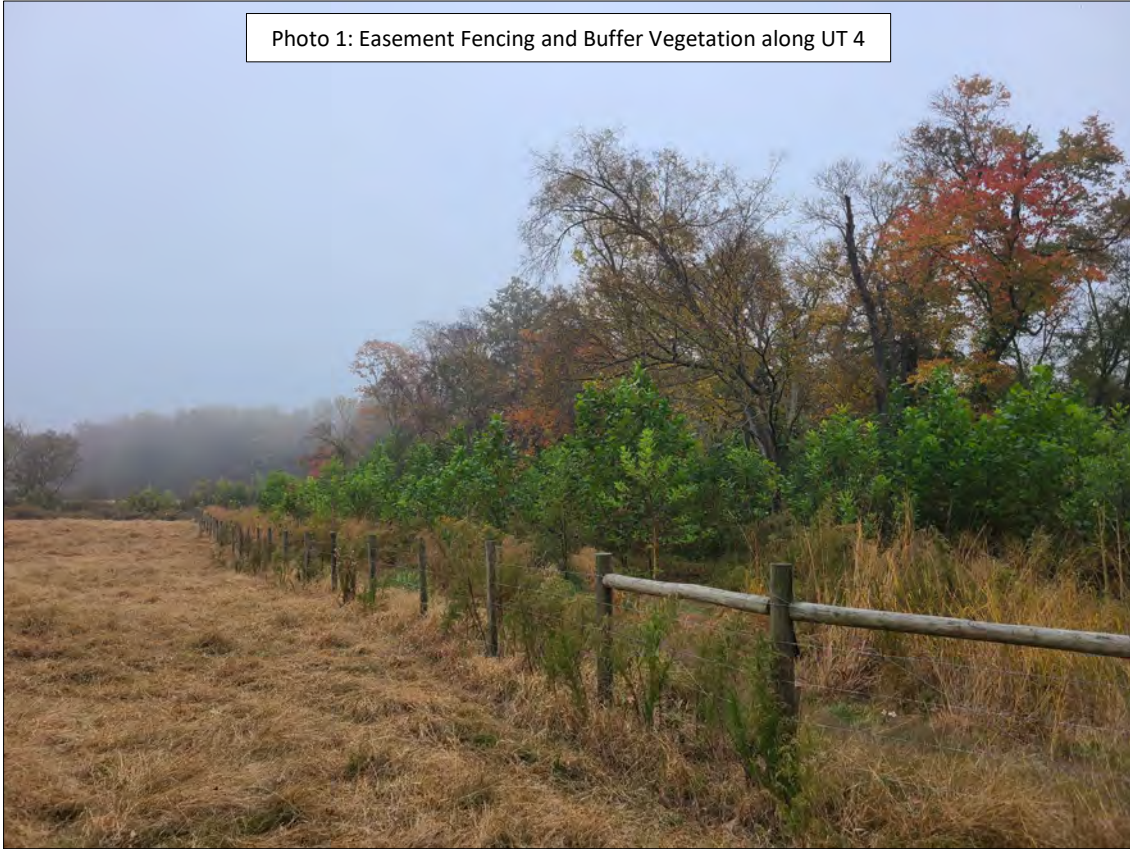
Photo 1: Easement Fencing and Buffer Vegetation along UT 4

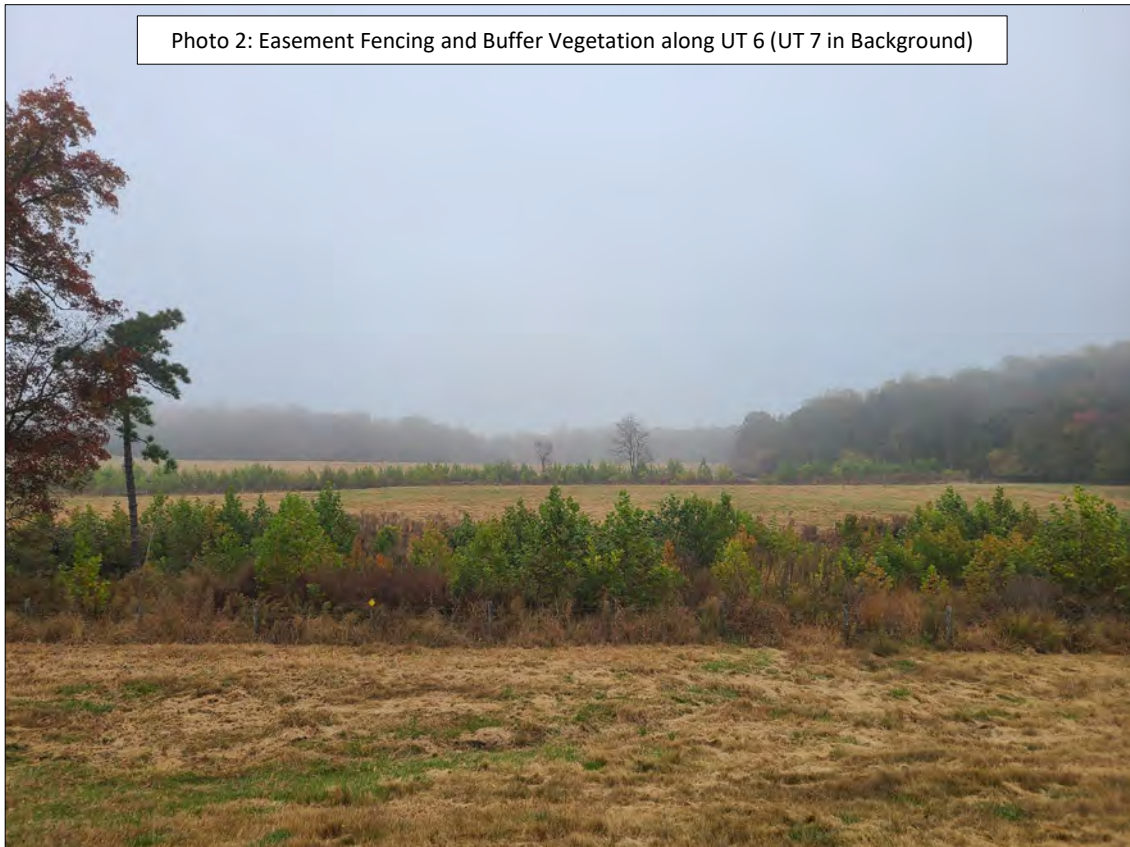
Photo 2: Easement Fencing and Buffer Vegetation along UT 6 (UT 7 in Background)

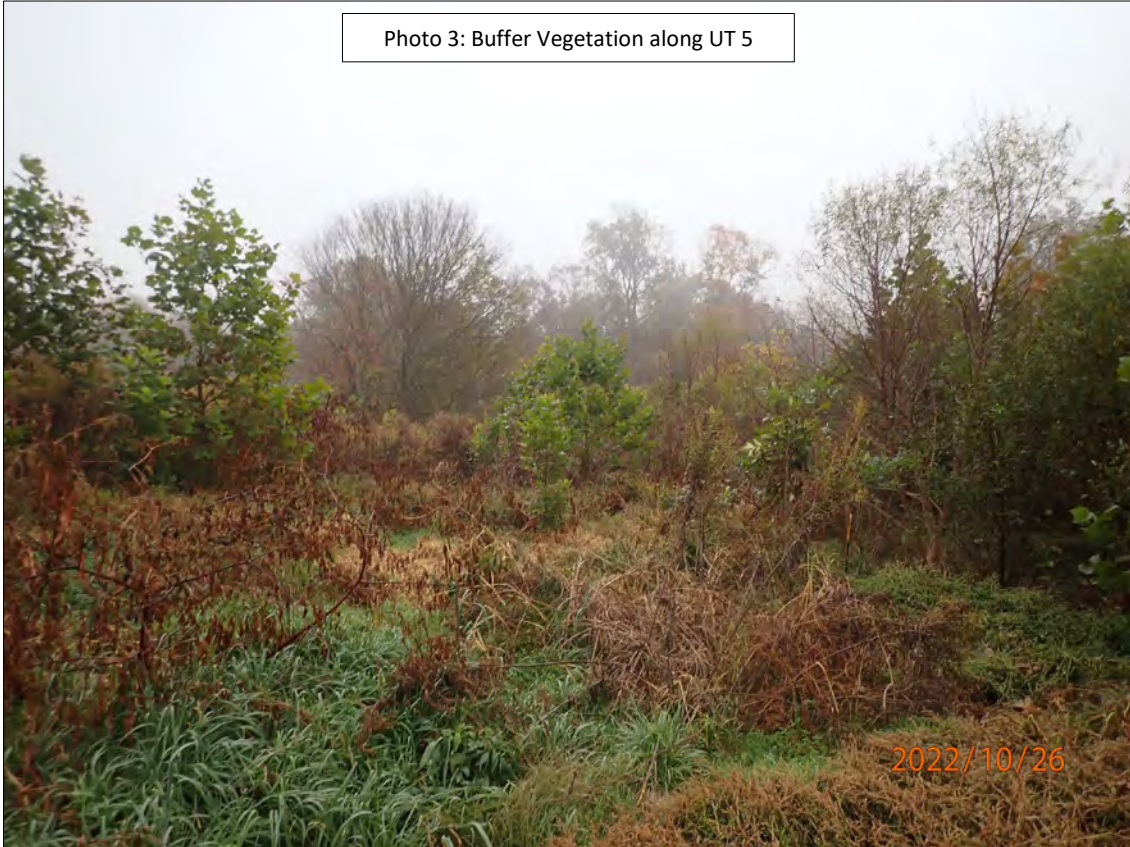
Photo 3: Buffer Vegetation along UT 5

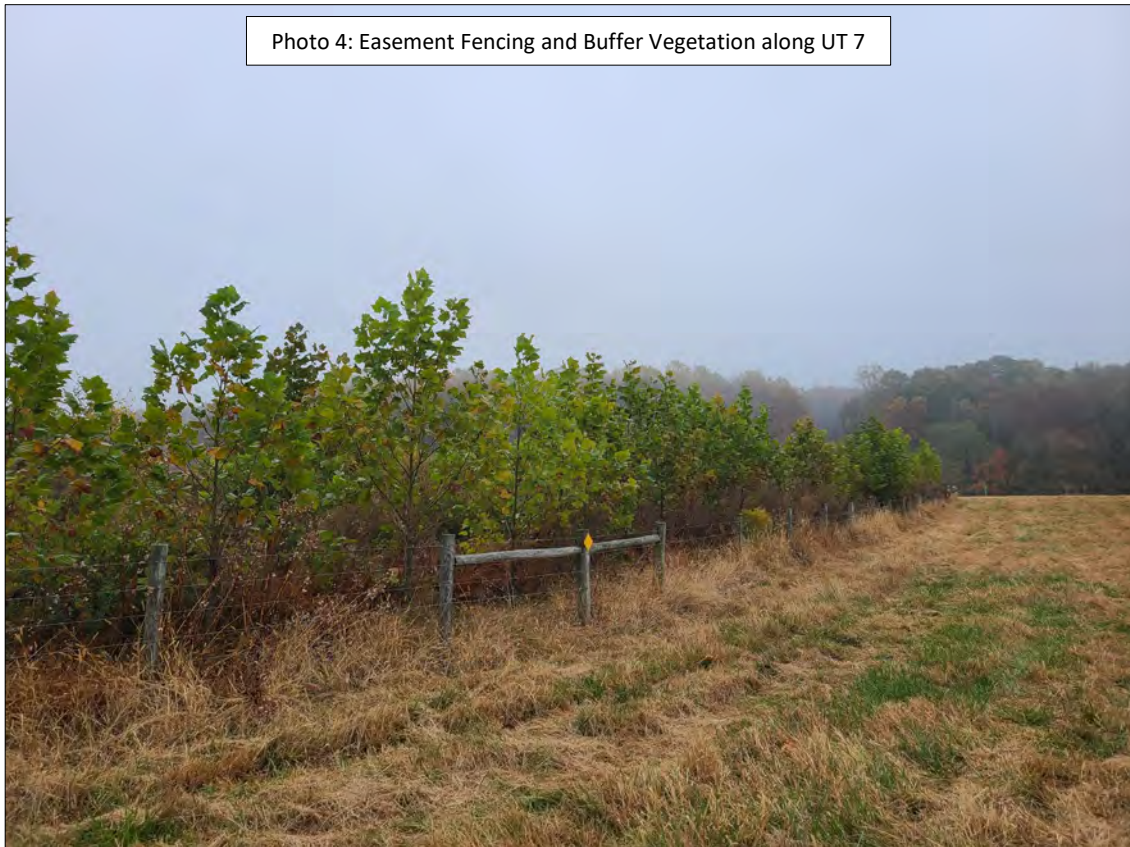
Photo 4: Easement Fencing and Buffer Vegetation along UT 7

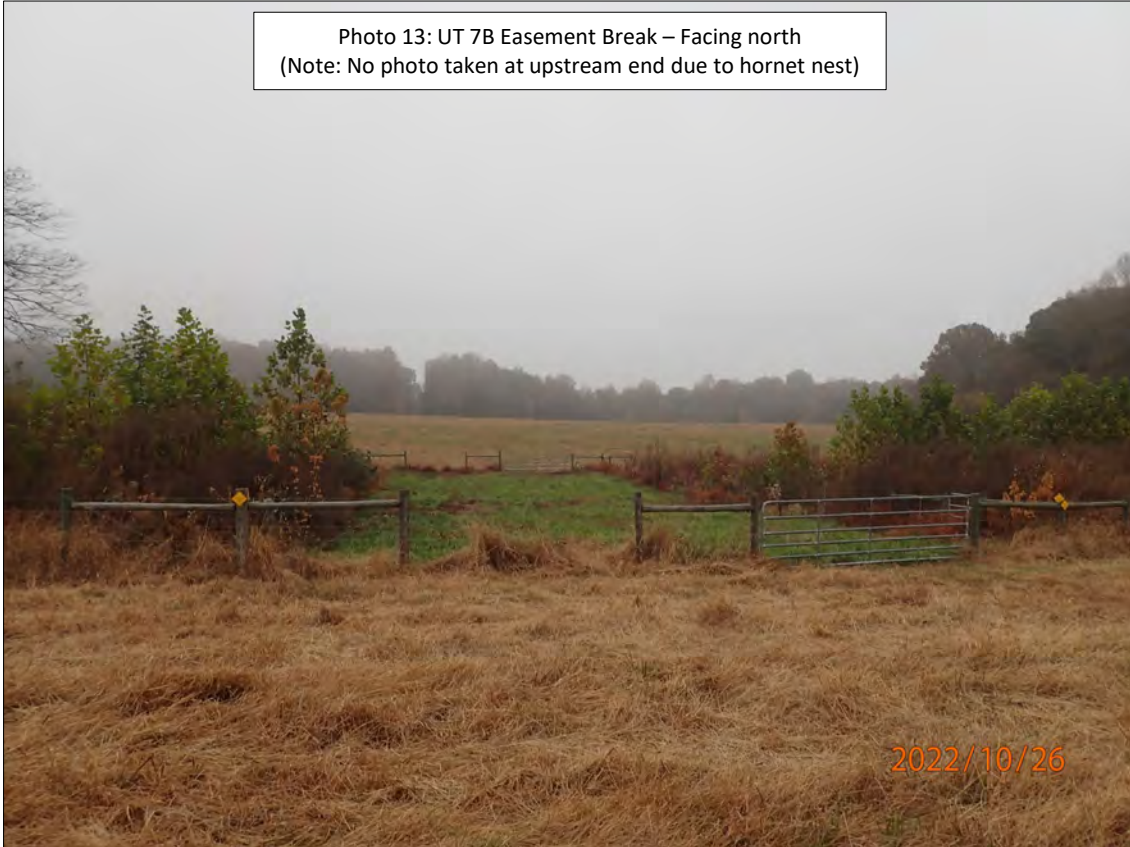
Photo 13: UT 7B Easement Break – Facing north
(Note: No photo taken at upstream end due to hornet nest)

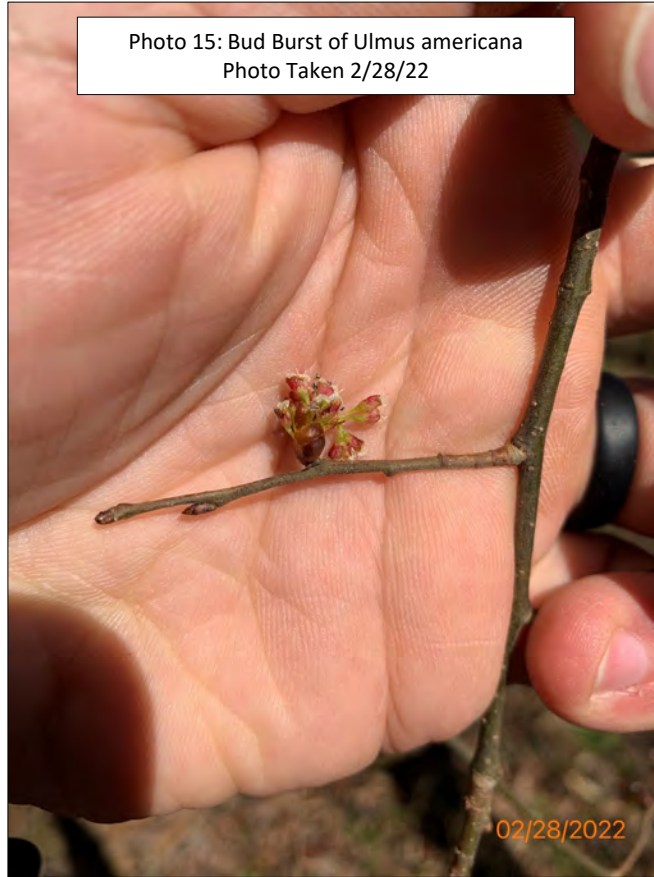
Photo 15: Bud Burst of *Ulmus americana*
Photo Taken 2/28/22

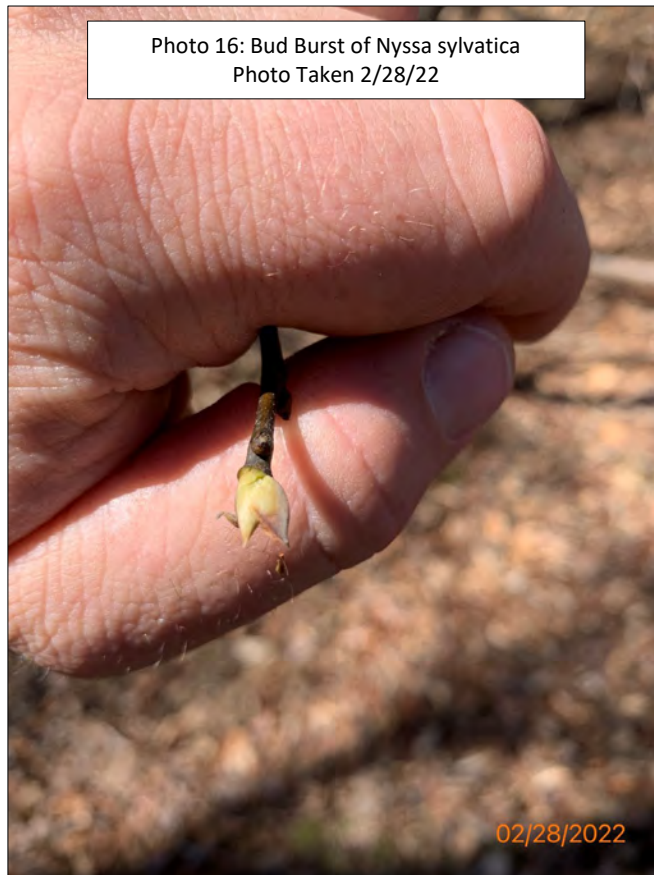
Photo 16: Bud Burst of *Nyssa sylvatica*
Photo Taken 2/28/22
