**FINAL
MY5 (2023) MONITORING REPORT**

HERON STREAM AND WETLAND MITIGATION SITE

Alamance County, North Carolina
Cape Fear River Basin
Cataloging Unit 03030002

DMS Project ID No. 100014
Full Delivery Contract No. 7192
RFP No. 16-006990
USACE Action ID No. SAW-2017-01471
DWR Project No. 17-0920

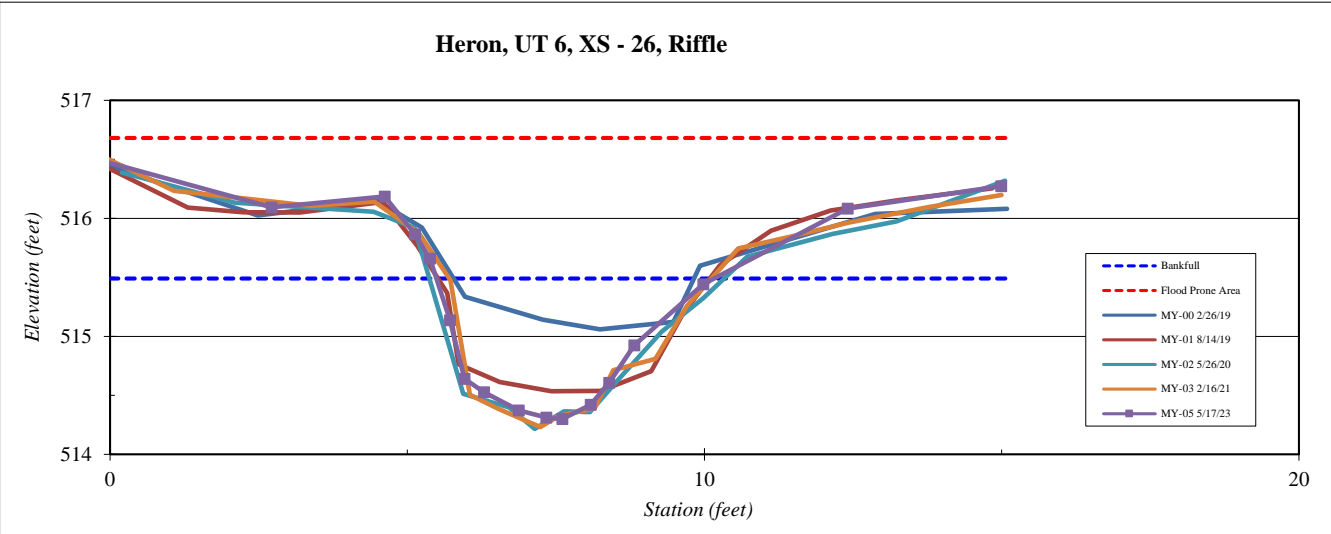
Note: Riffle degradation is likely a result of direct, flashy flows from upstream land-use just after construction. It appears to have stabilized during years 2-5.

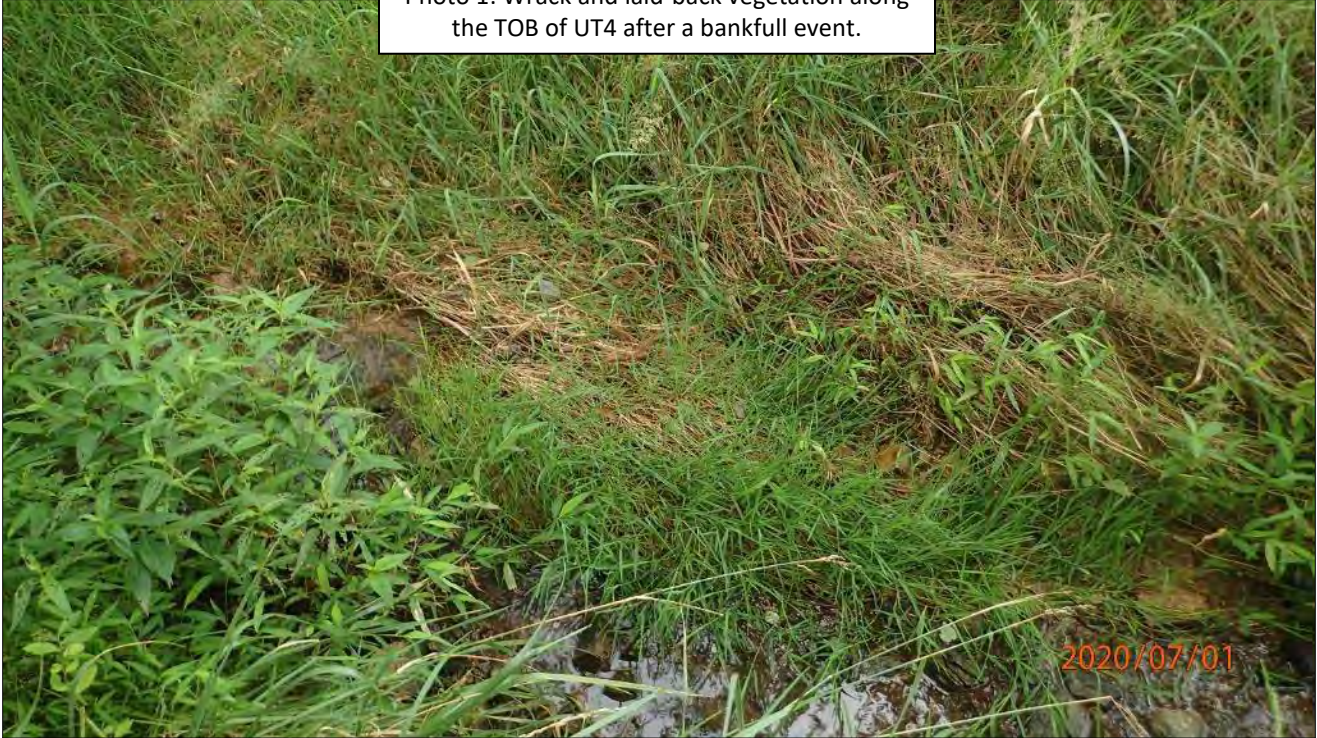
Photo 1: Wrack and laid-back vegetation along the TOB of UT4 after a bankfull event.

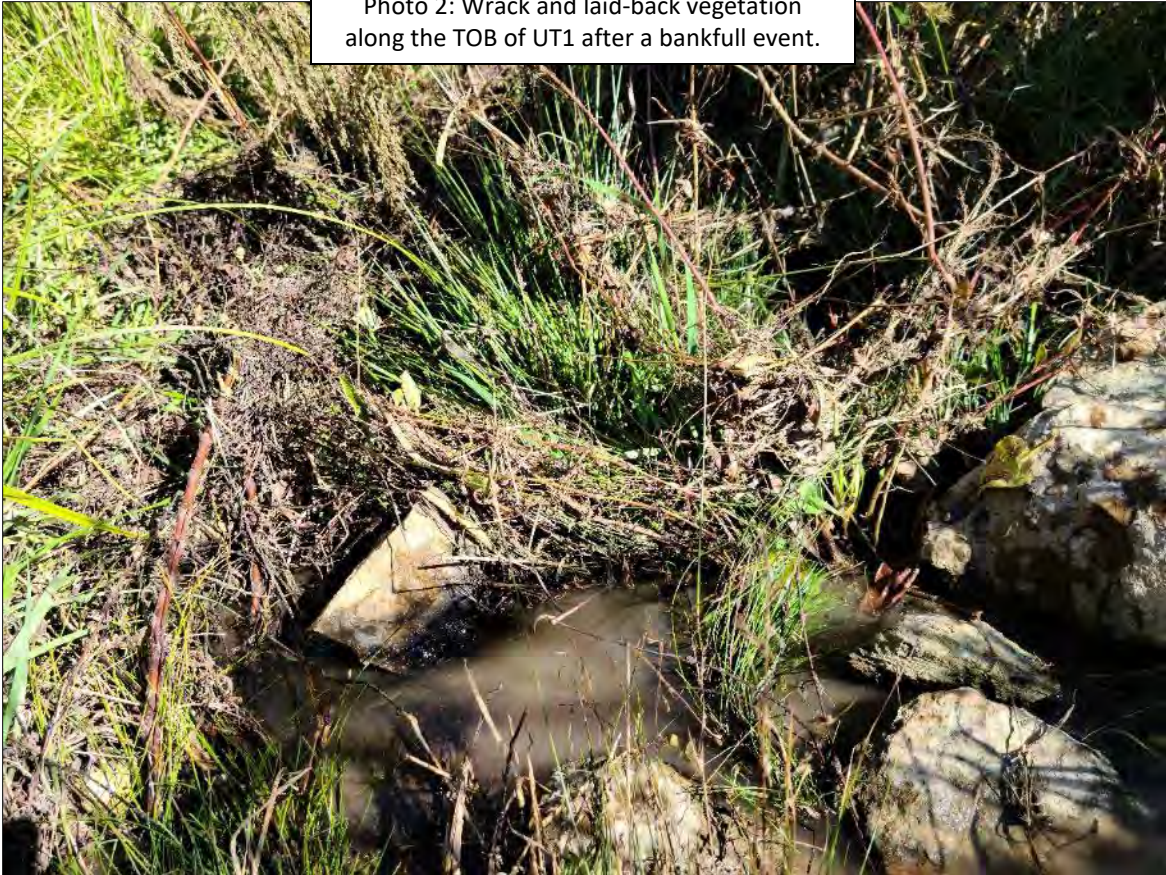
Photo 2: Wrack and laid-back vegetation along the TOB of UT1 after a bankfull event.

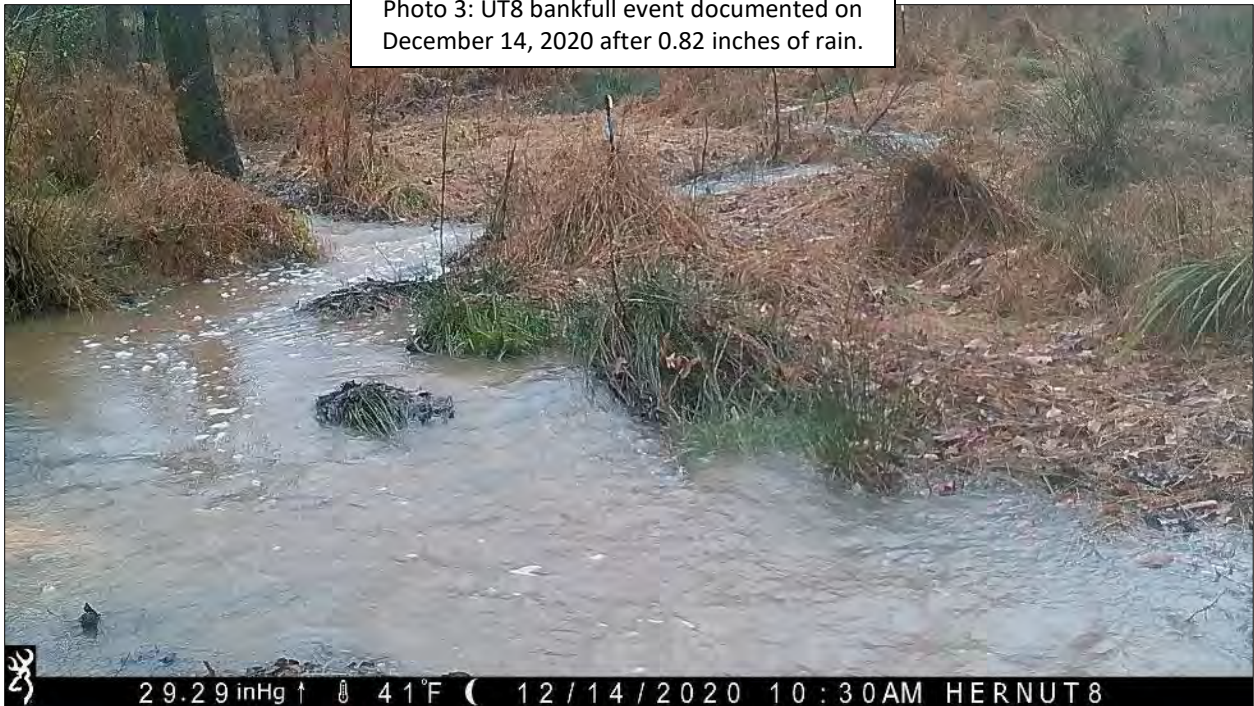
Photo 3: UT8 bankfull event documented on December 14, 2020 after 0.82 inches of rain.

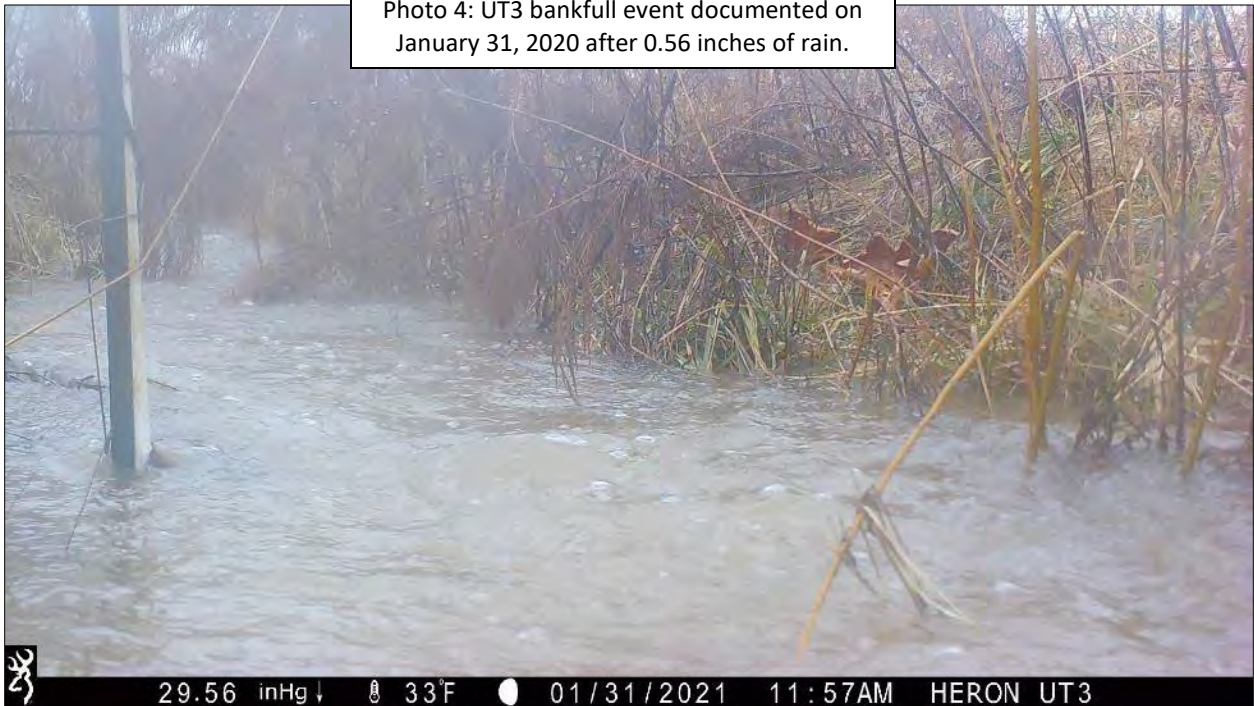
Photo 4: UT3 bankfull event documented on January 31, 2021 after 0.56 inches of rain.

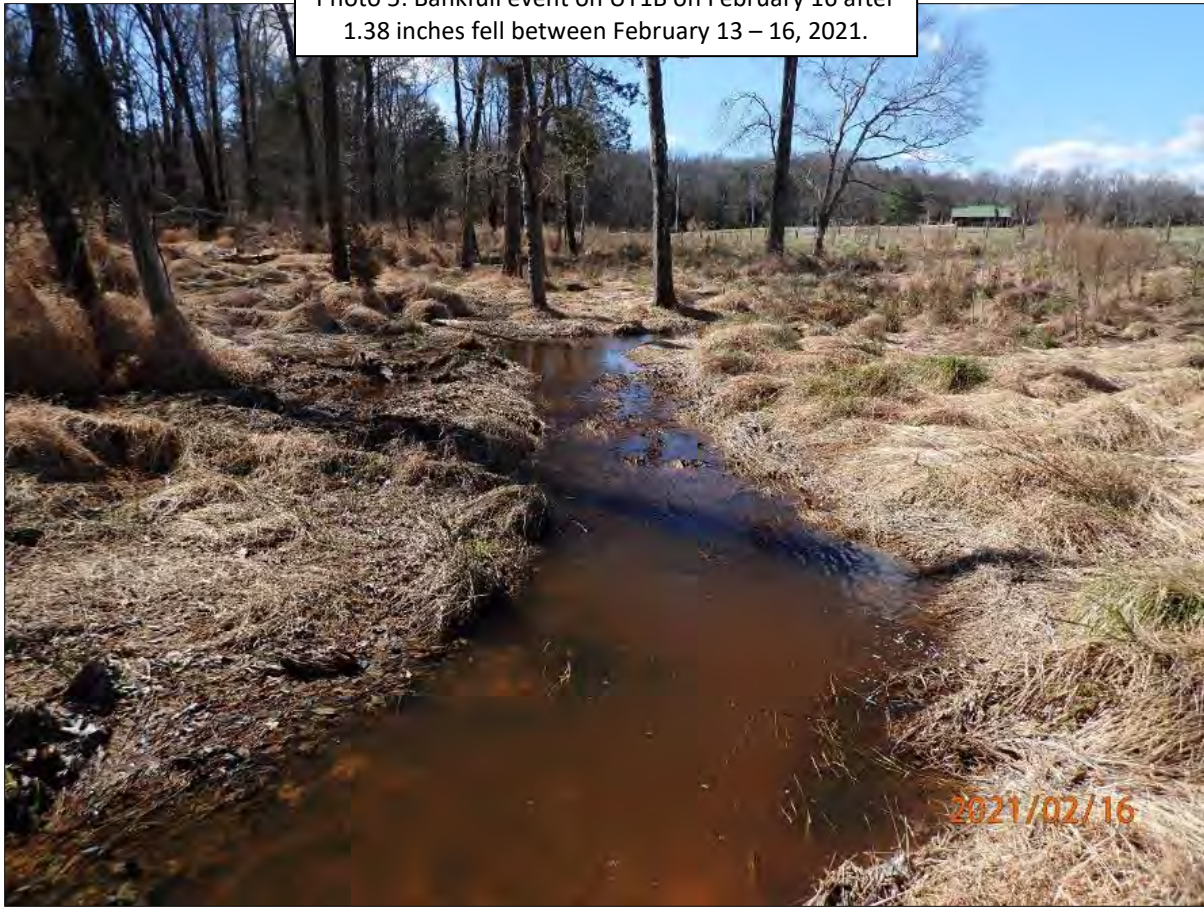
Photo 5: Bankfull event on UT1B on February 16 after 1.38 inches fell between February 13 – 16, 2021.

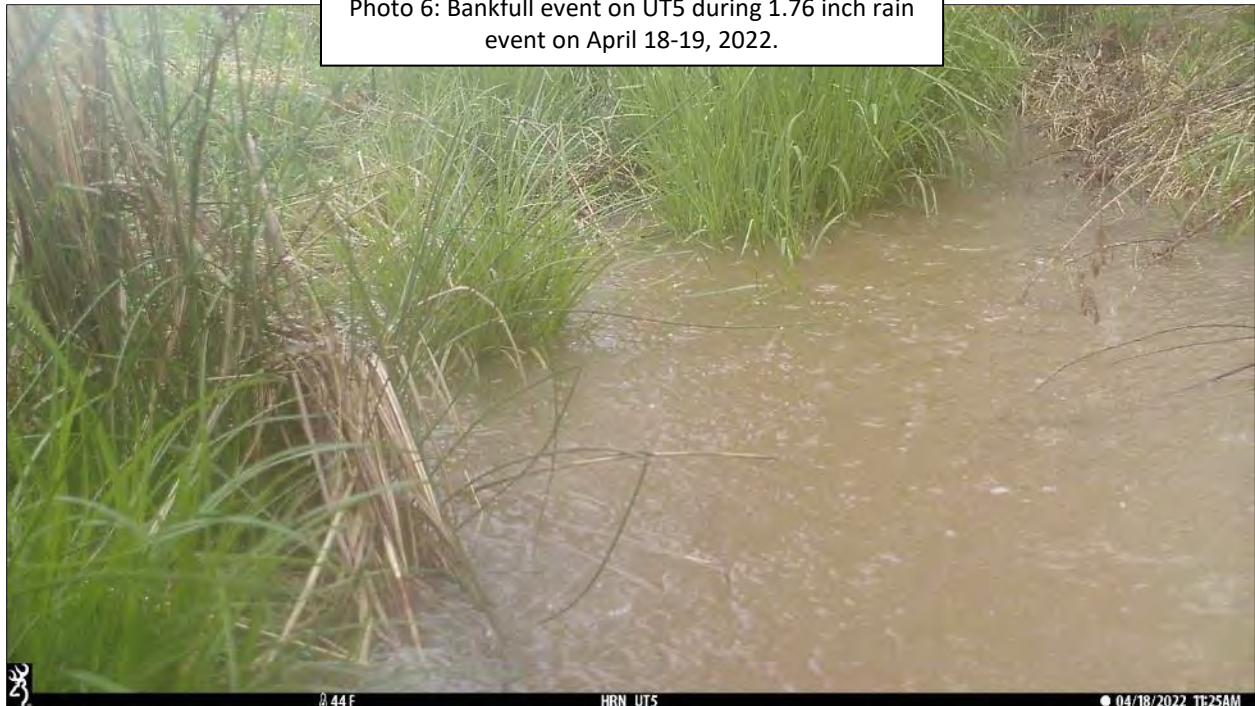
Photo 6: Bankfull event on UT5 during 1.76 inch rain event on April 18-19, 2022.

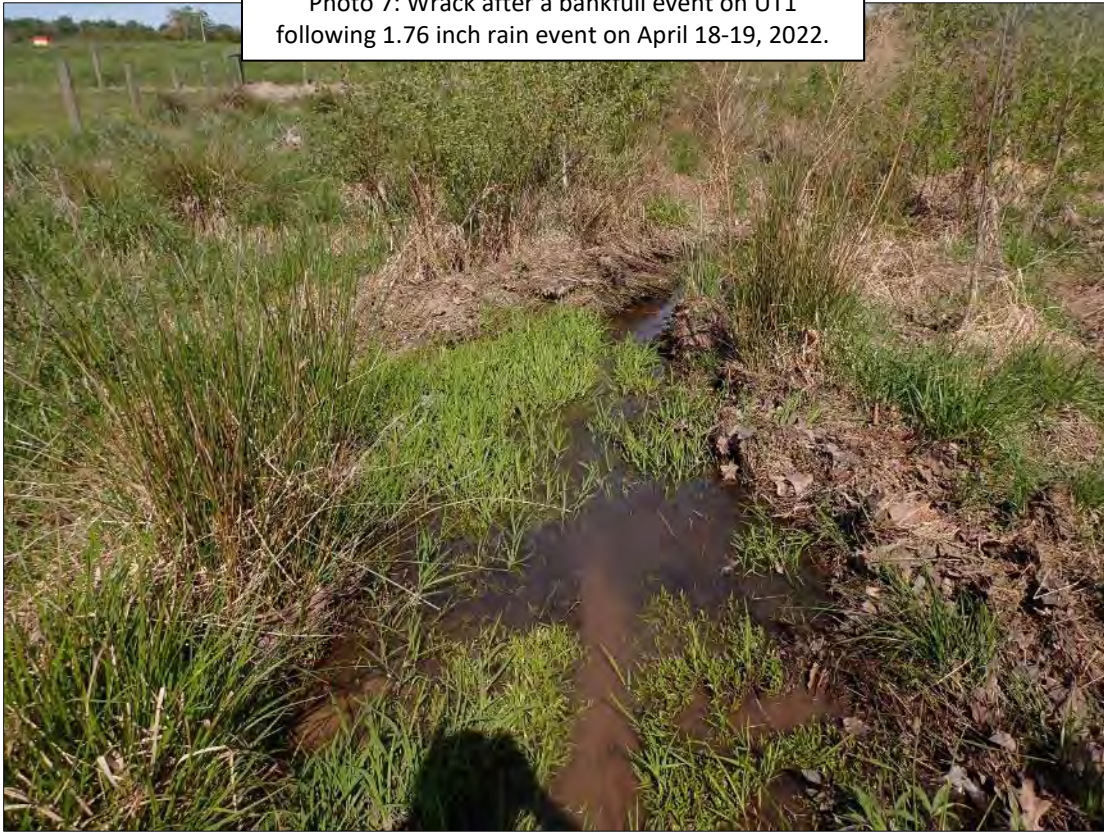
Photo 7: Wrack after a bankfull event on UT1 following 1.76 inch rain event on April 18-19, 2022.

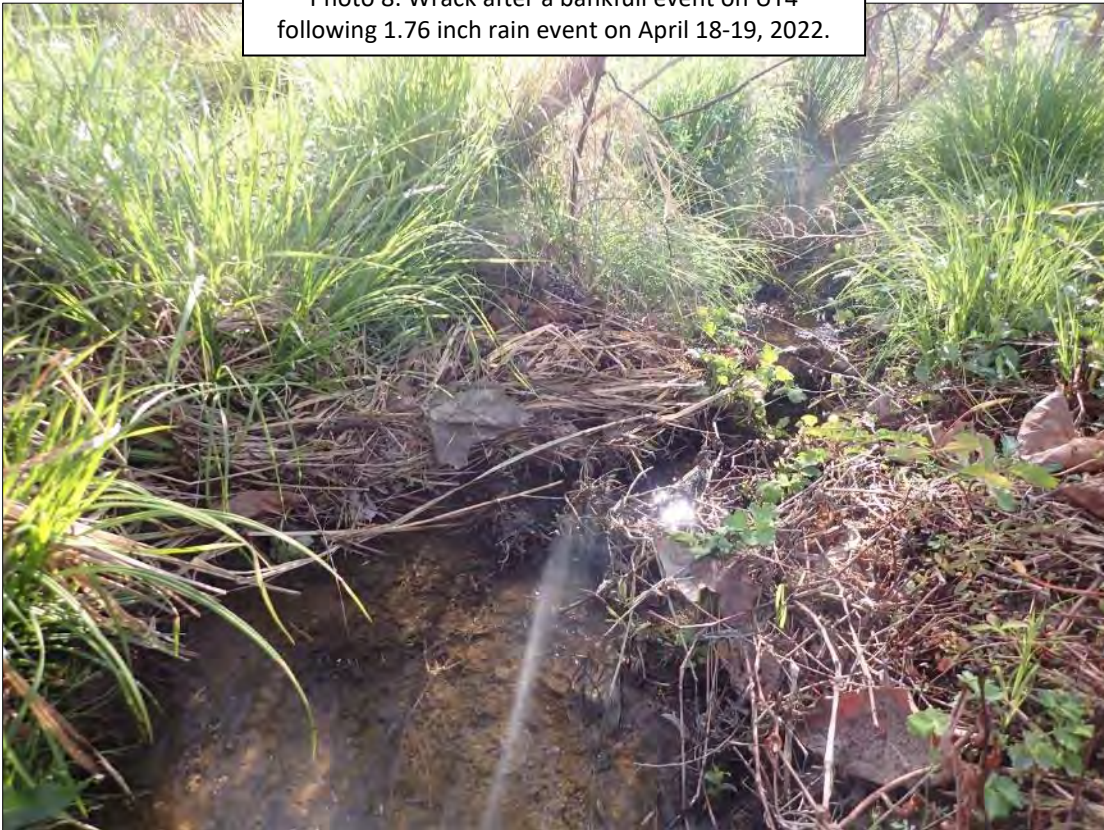
Photo 8: Wrack after a bankfull event on UT4 following 1.76 inch rain event on April 18-19, 2022.

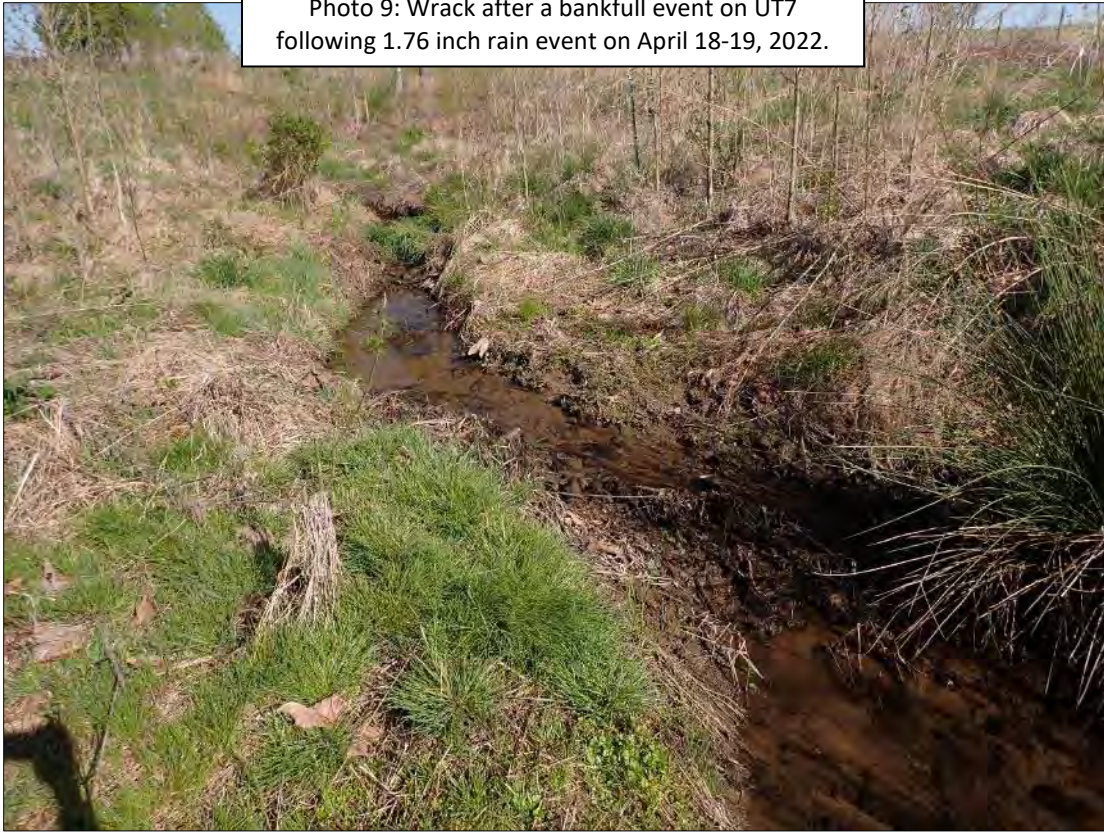
Photo 9: Wrack after a bankfull event on UT7 following 1.76 inch rain event on April 18-19, 2022.

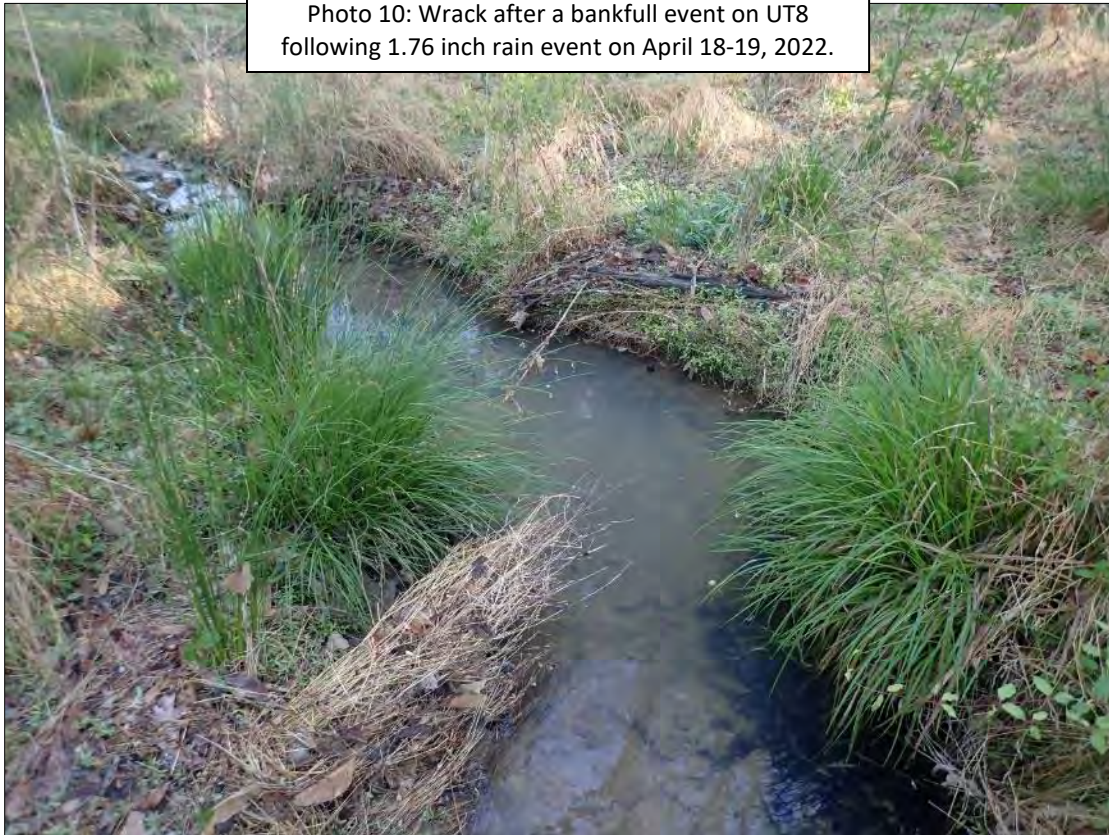
Photo 10: Wrack after a bankfull event on UT8 following 1.76 inch rain event on April 18-19, 2022.

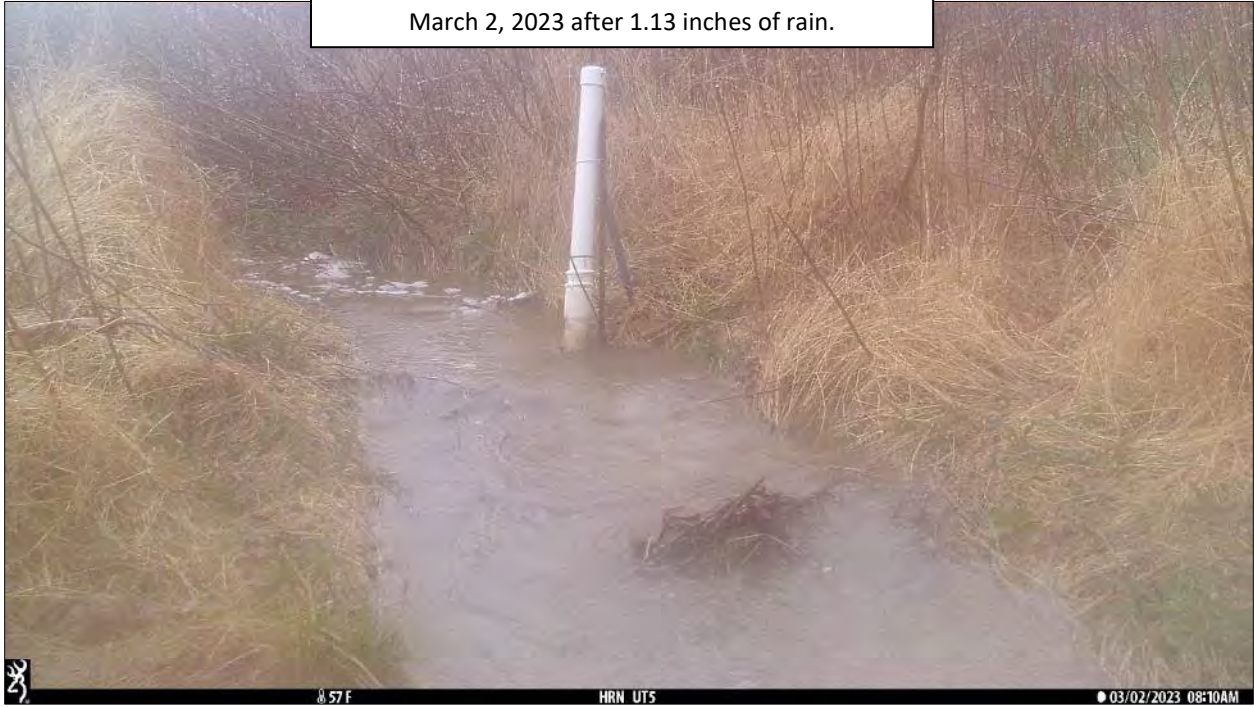
Photo 11: Bankfull event on UT5 documented on March 2, 2023 after 1.13 inches of rain.

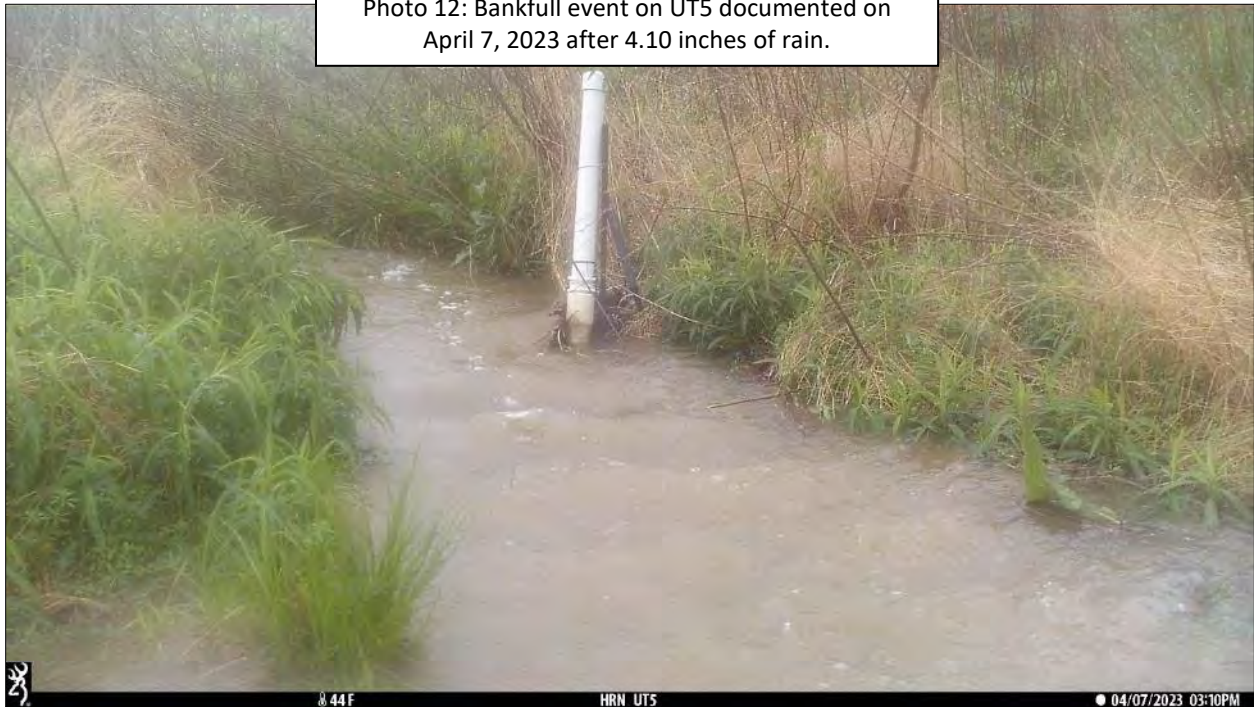
Photo 12: Bankfull event on UT5 documented on April 7, 2023 after 4.10 inches of rain.

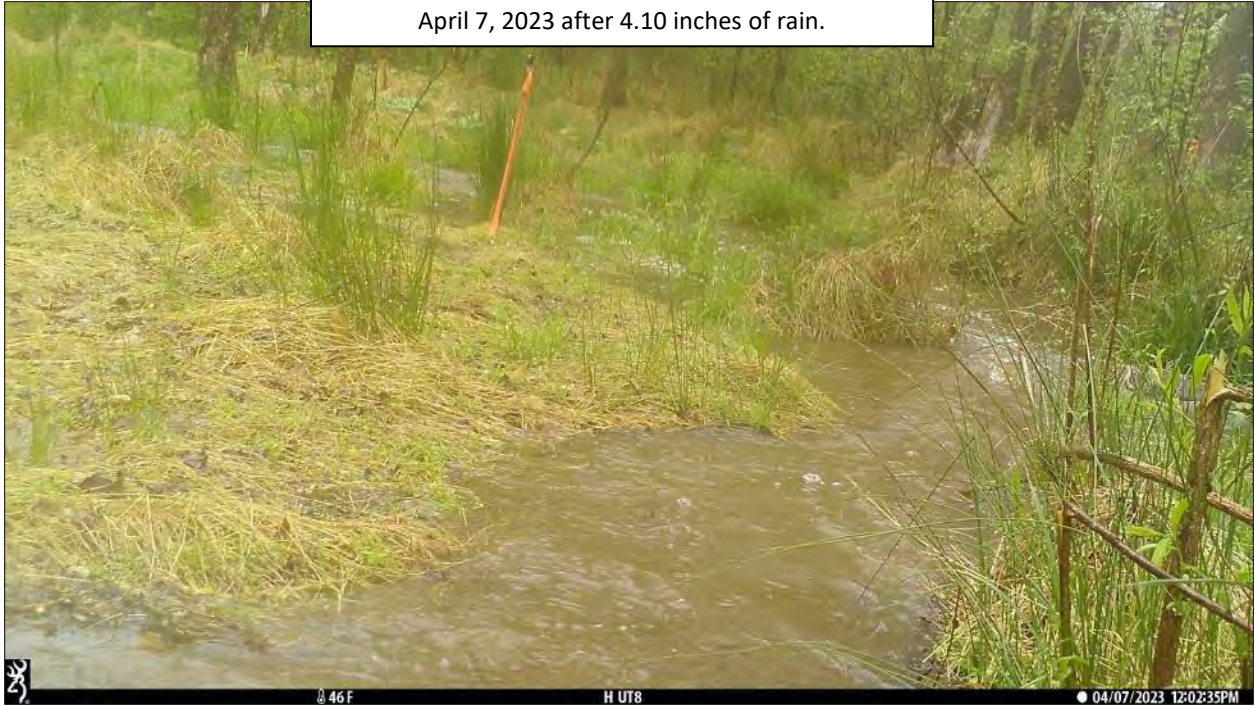
Photo 13: Bankfull event on UT8 documented on April 7, 2023 after 4.10 inches of rain.

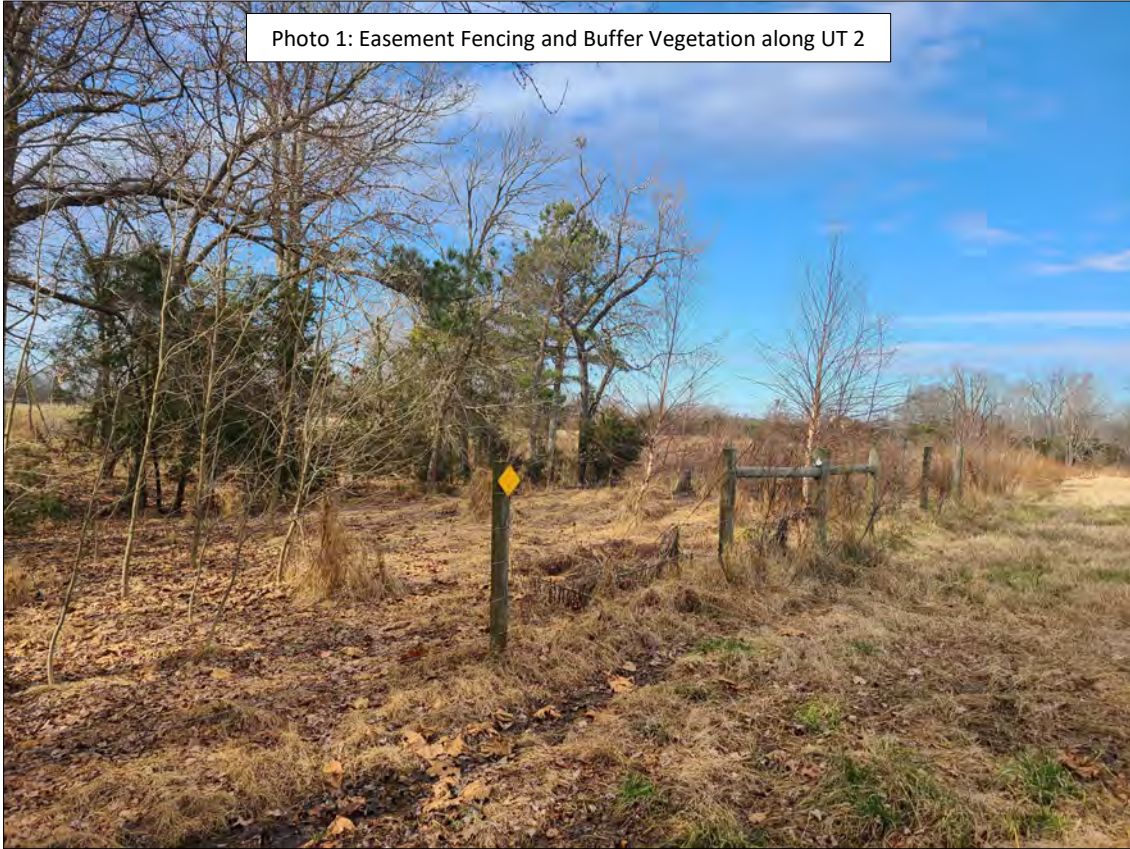
Photo 1: Easement Fencing and Buffer Vegetation along UT 2

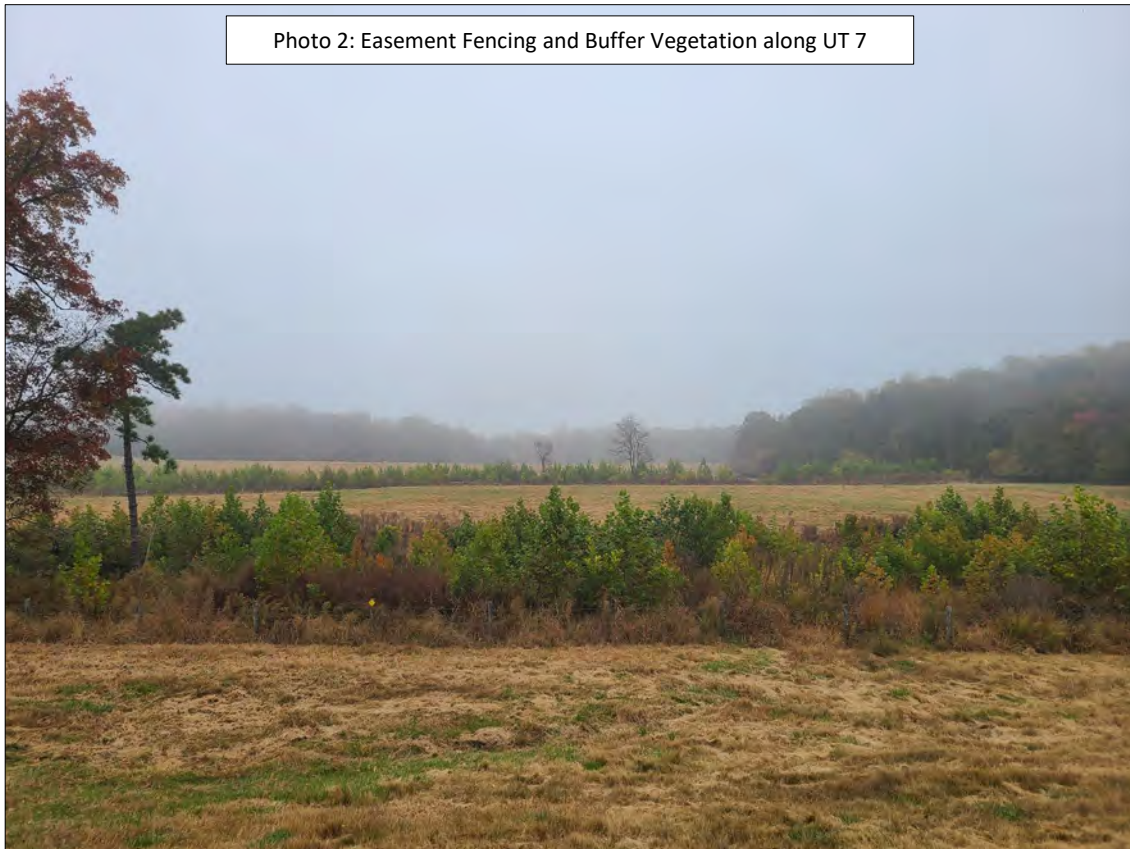
Photo 2: Easement Fencing and Buffer Vegetation along UT 7

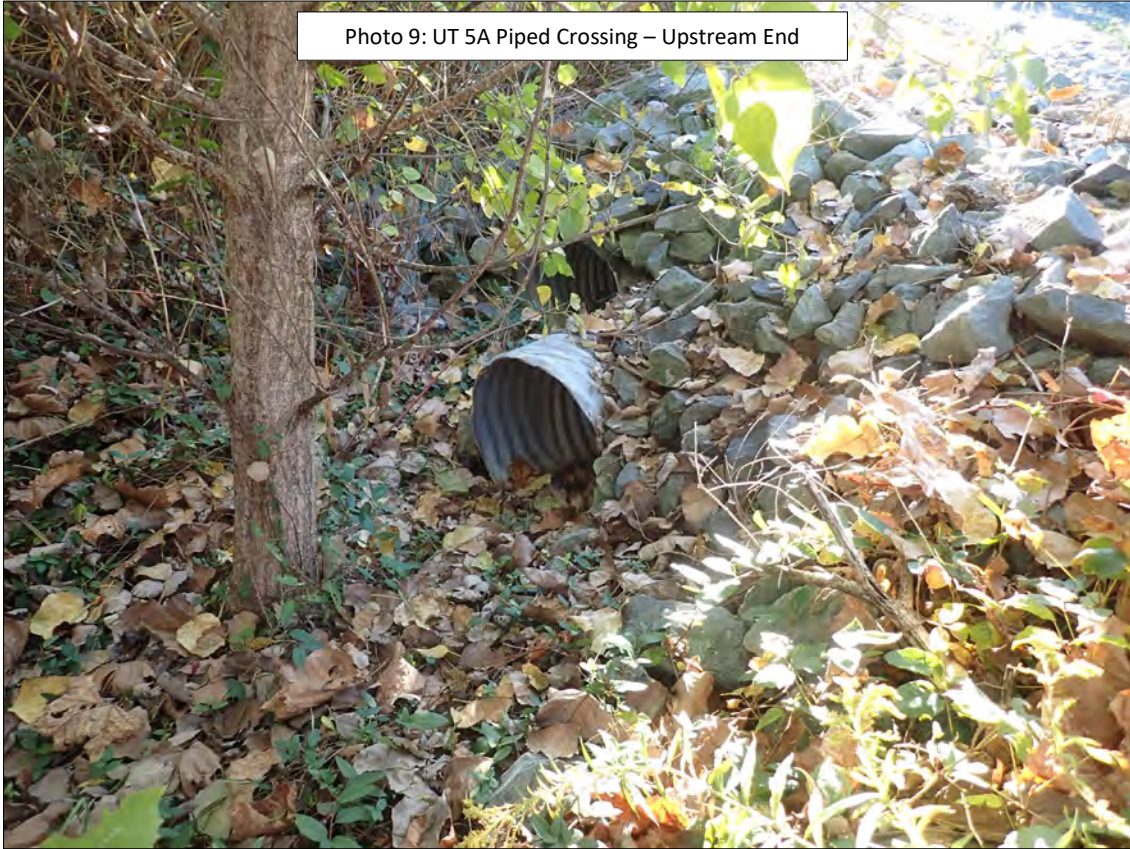
Photo 9: UT 5A Piped Crossing – Upstream End

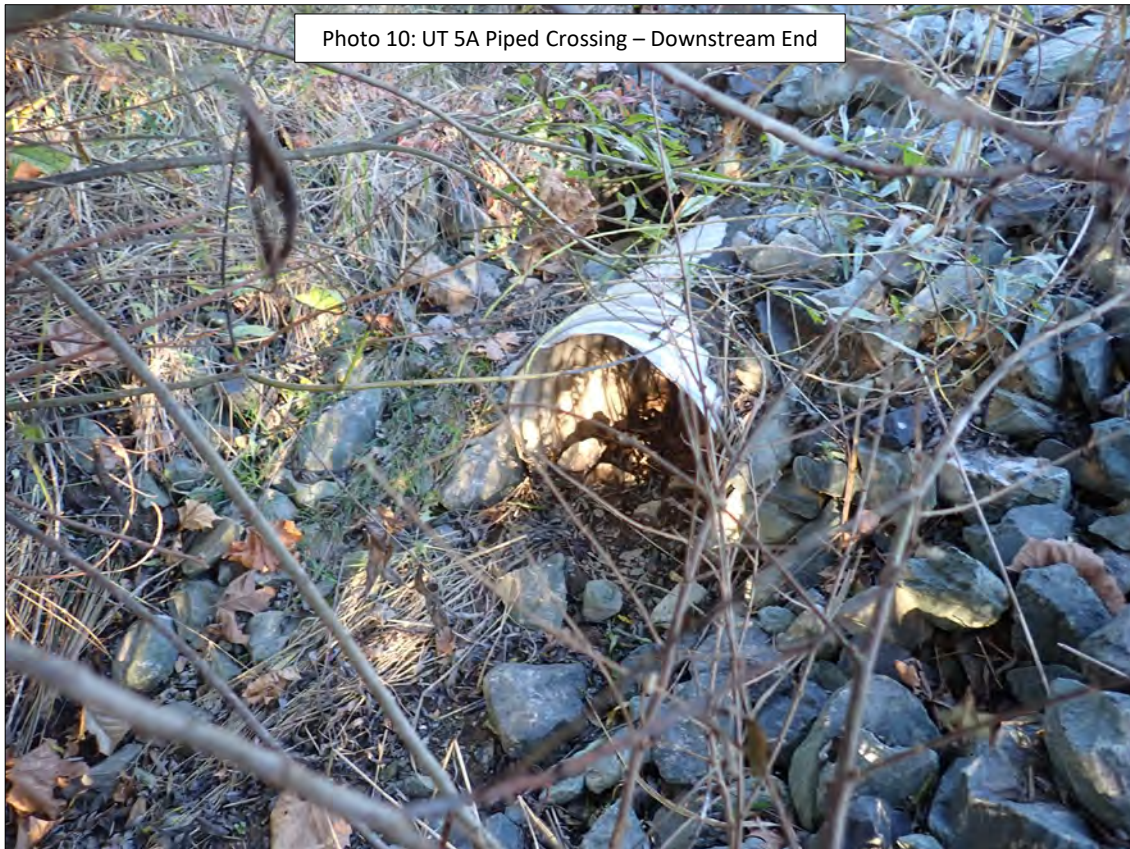
Photo 10: UT 5A Piped Crossing – Downstream End
