Buffalo Creek Watershed Phase I Year 1 Monitoring Report Greensboro, North Carolina

North Carolina Department of Environment and Natural Resources
Ecosystem Enhancement Program

April 2005

Buffalo Creeks Phase I Hillsdale Park and Gillespie Golf Course Year 1 Monitoring Report Greensboro, North Carolina

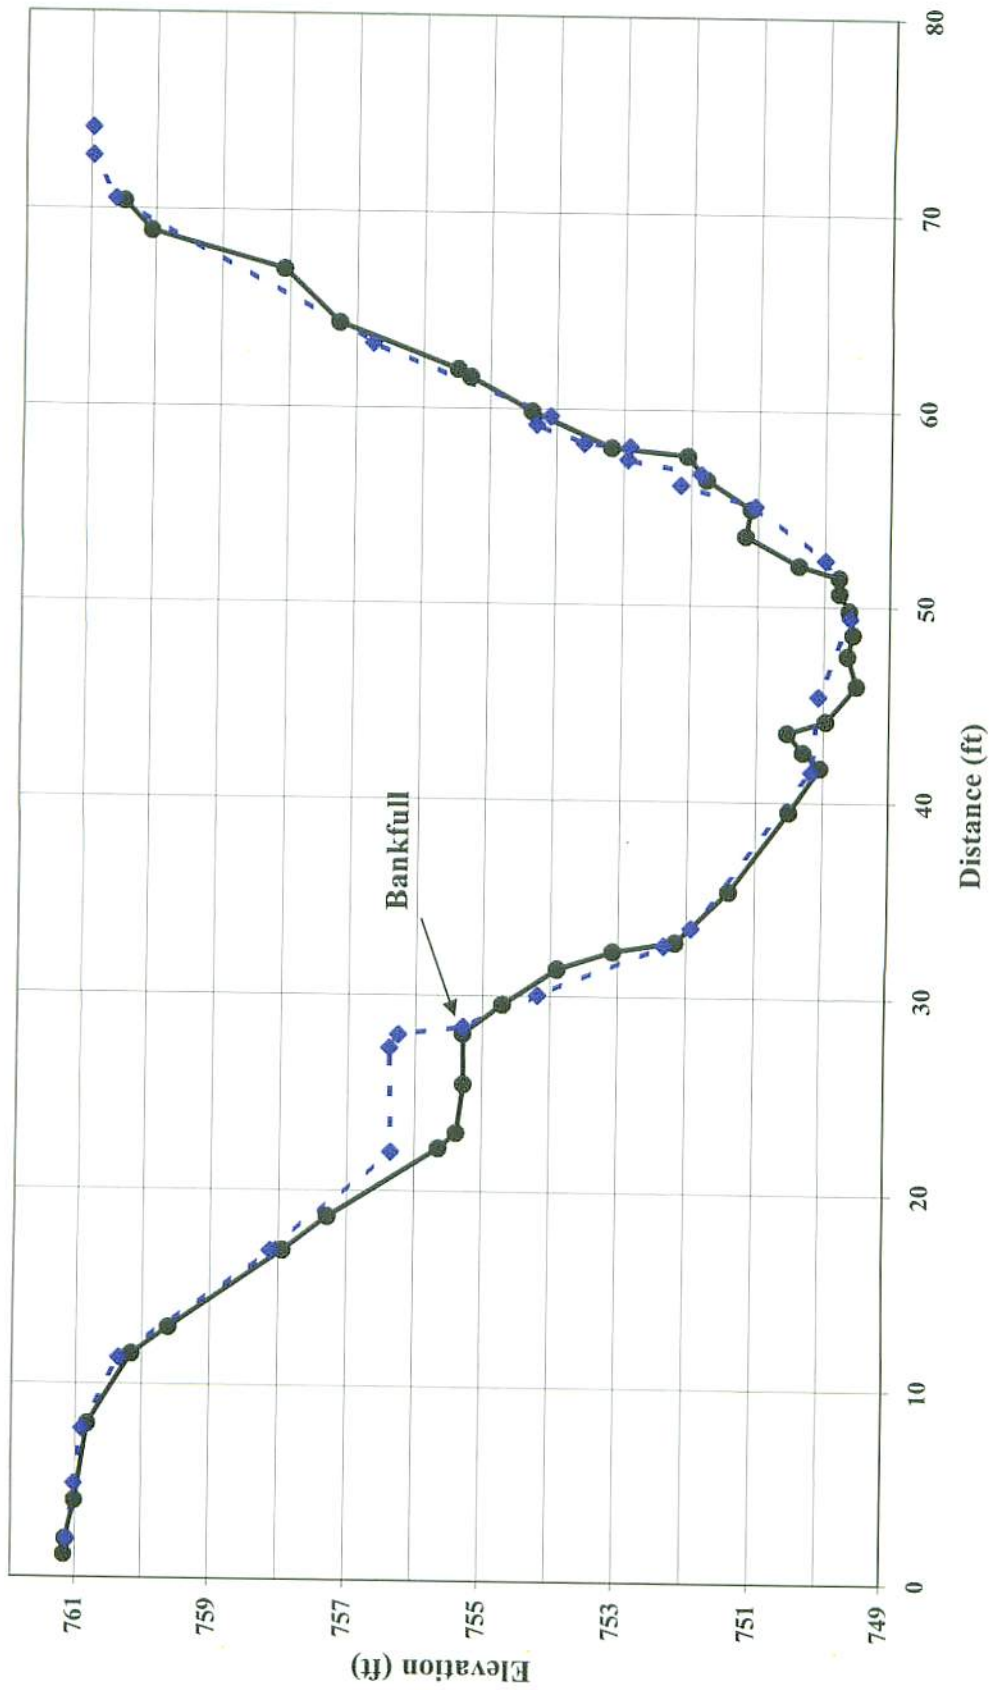
Hillsdale - R1A
Cross Section 1 -- Pool

Cross sections 1 through 8 are located in Reach 1 a/b. These cross sections are all stable. Minor bed and/or bank deposition is evident in cross sections 1, 2, 3, 4, 5, 6, and 8. Cross section 7 has had some slight scour on the left and right bench, which probably occurred shortly after construction, but it has good vegetative cover. Cross sections 1, 2, 3, 5, 6, 7, and 8 have all had decreases in their width/depth (w/d) ratios. The w/d ratio for cross section 7 remained static. Cross section 4 had a slight increase in its w/d ratio due to minor erosion on its left bank, which occurred shortly after construction. Currently it has good vegetative cover and should remain stable. The pool at cross section 6 has deepened, with a corresponding increase in the bankfull area.

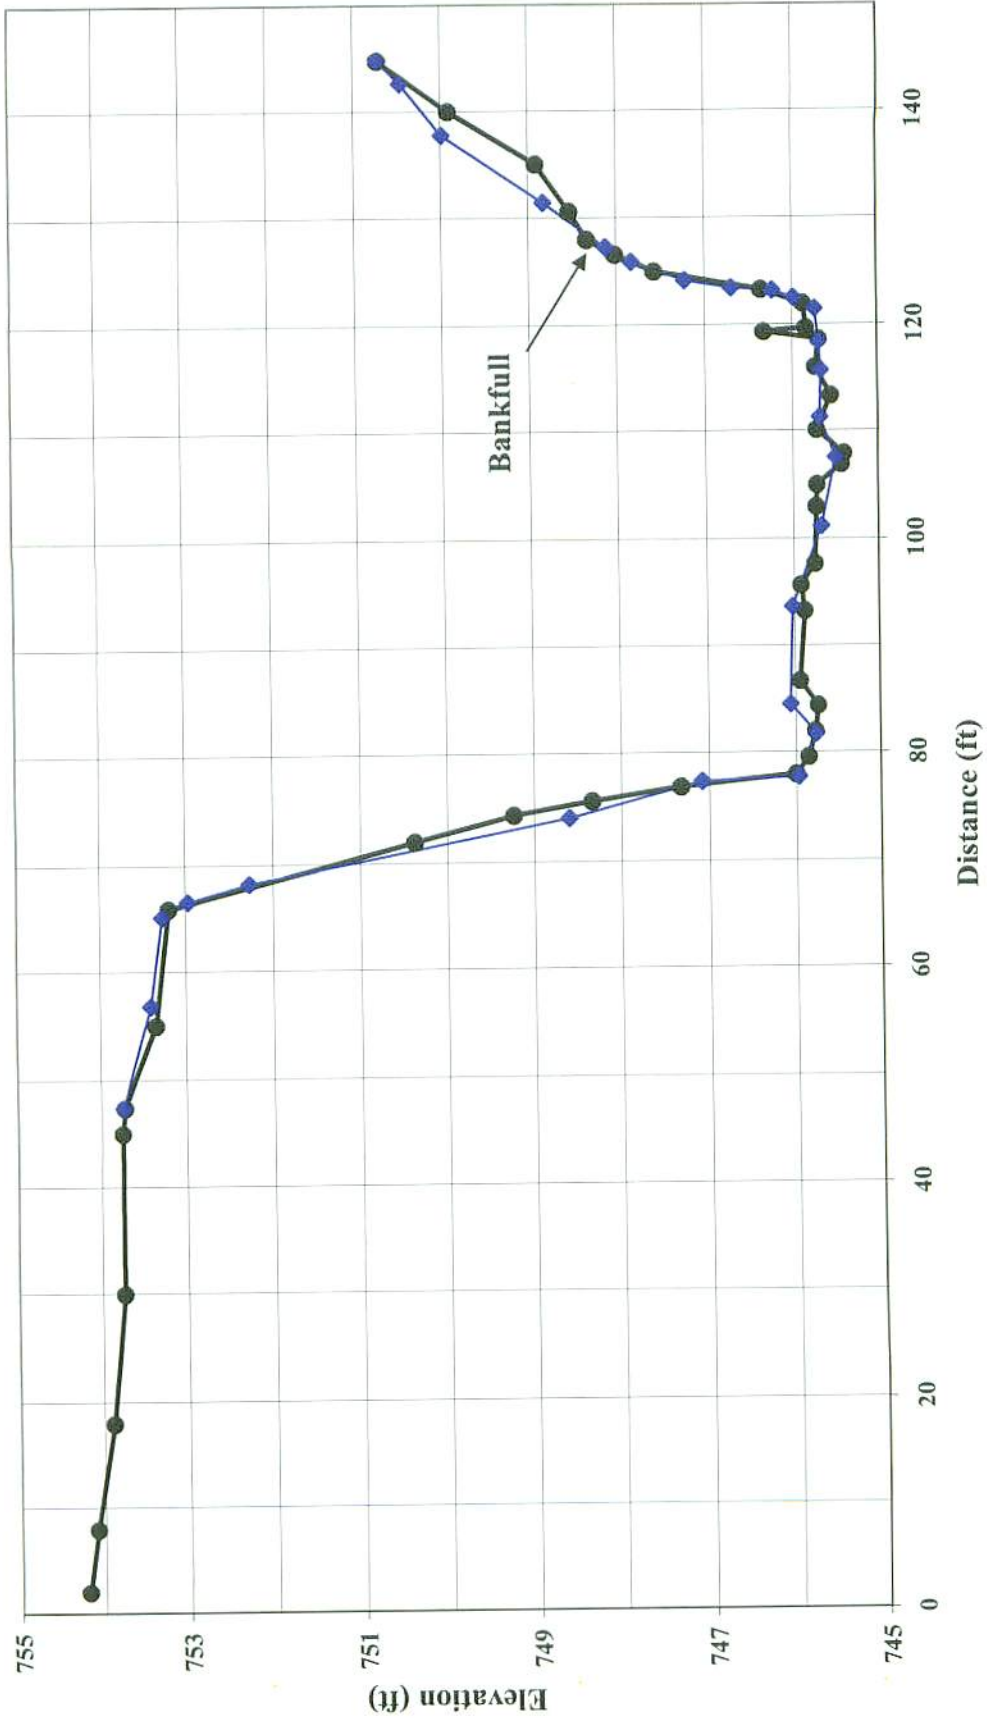
Hillsdale - R2
Cross Section 9 Riffle

Cross sections 9 through 12 are located in Reach 2. As with the cross sections in Reach 1 a/b, these are all in a stable state. The riffles in cross section 9 and 11 have had nominal change, due primarily to settling, and there has been no change in thalweg

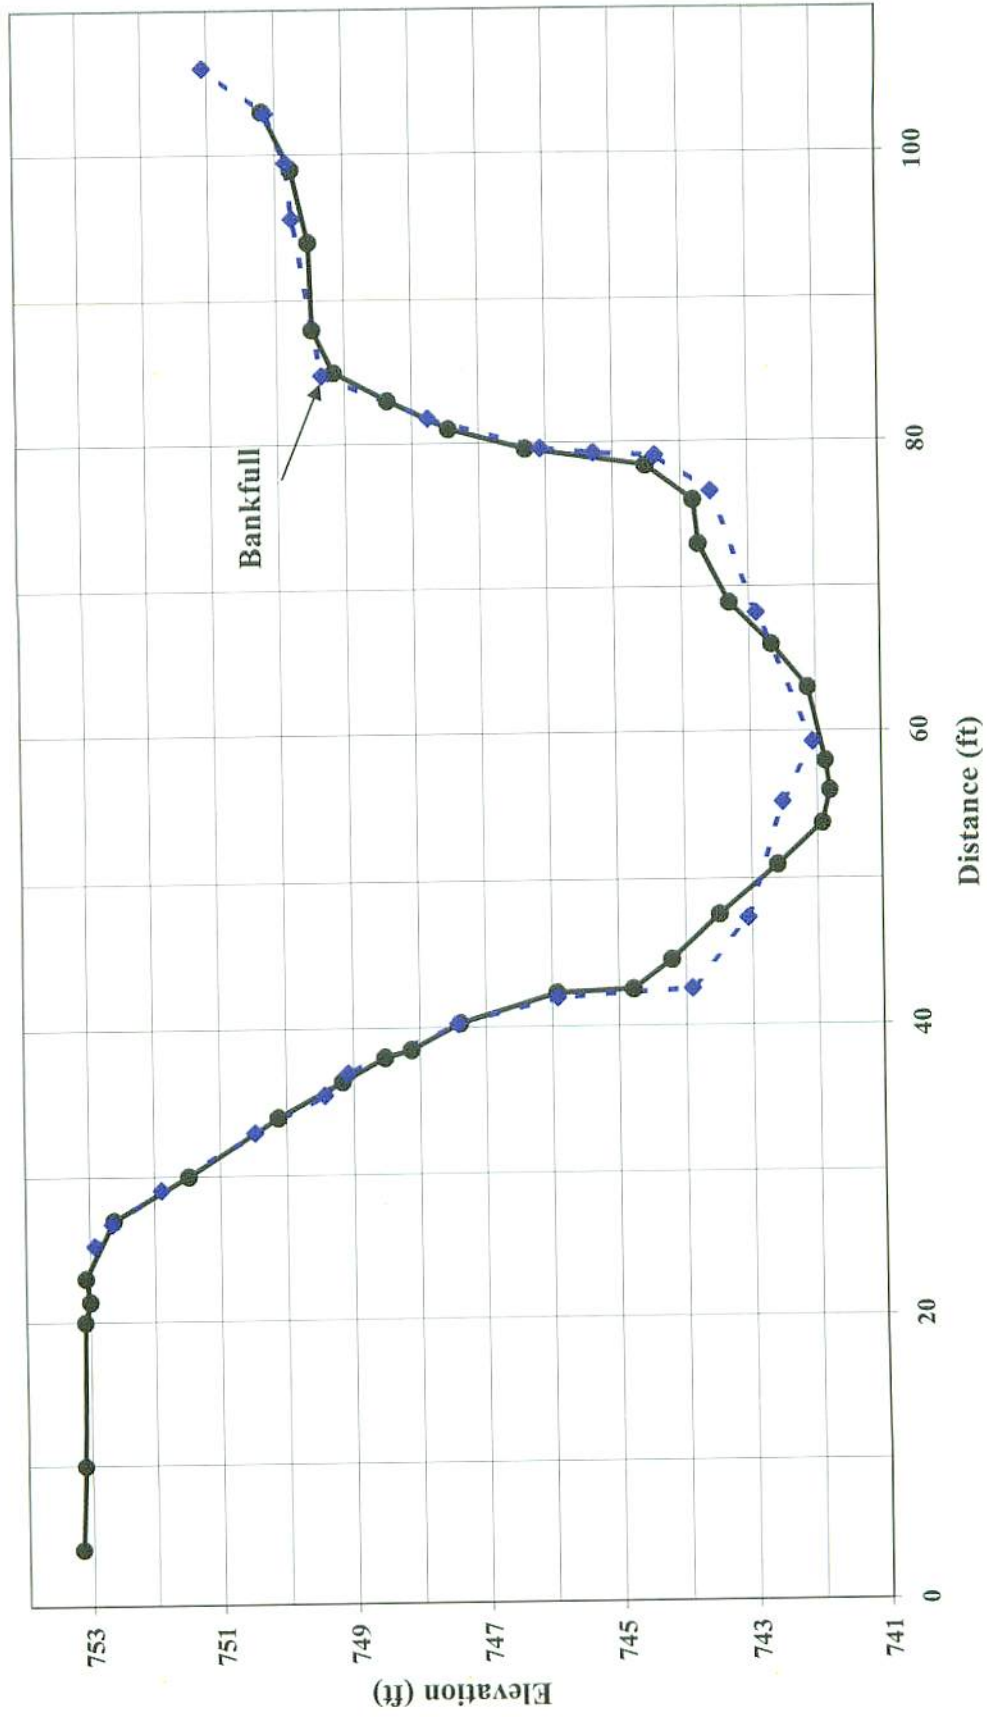
Hillsdale R2
Cross Section 10 Pool

location or elevation. The pools in cross sections 10 and 12 have both had a decrease in their w/d ratios and the pool in 12 has deepened. All four cross sections have good vegetative cover providing bank stabilization.

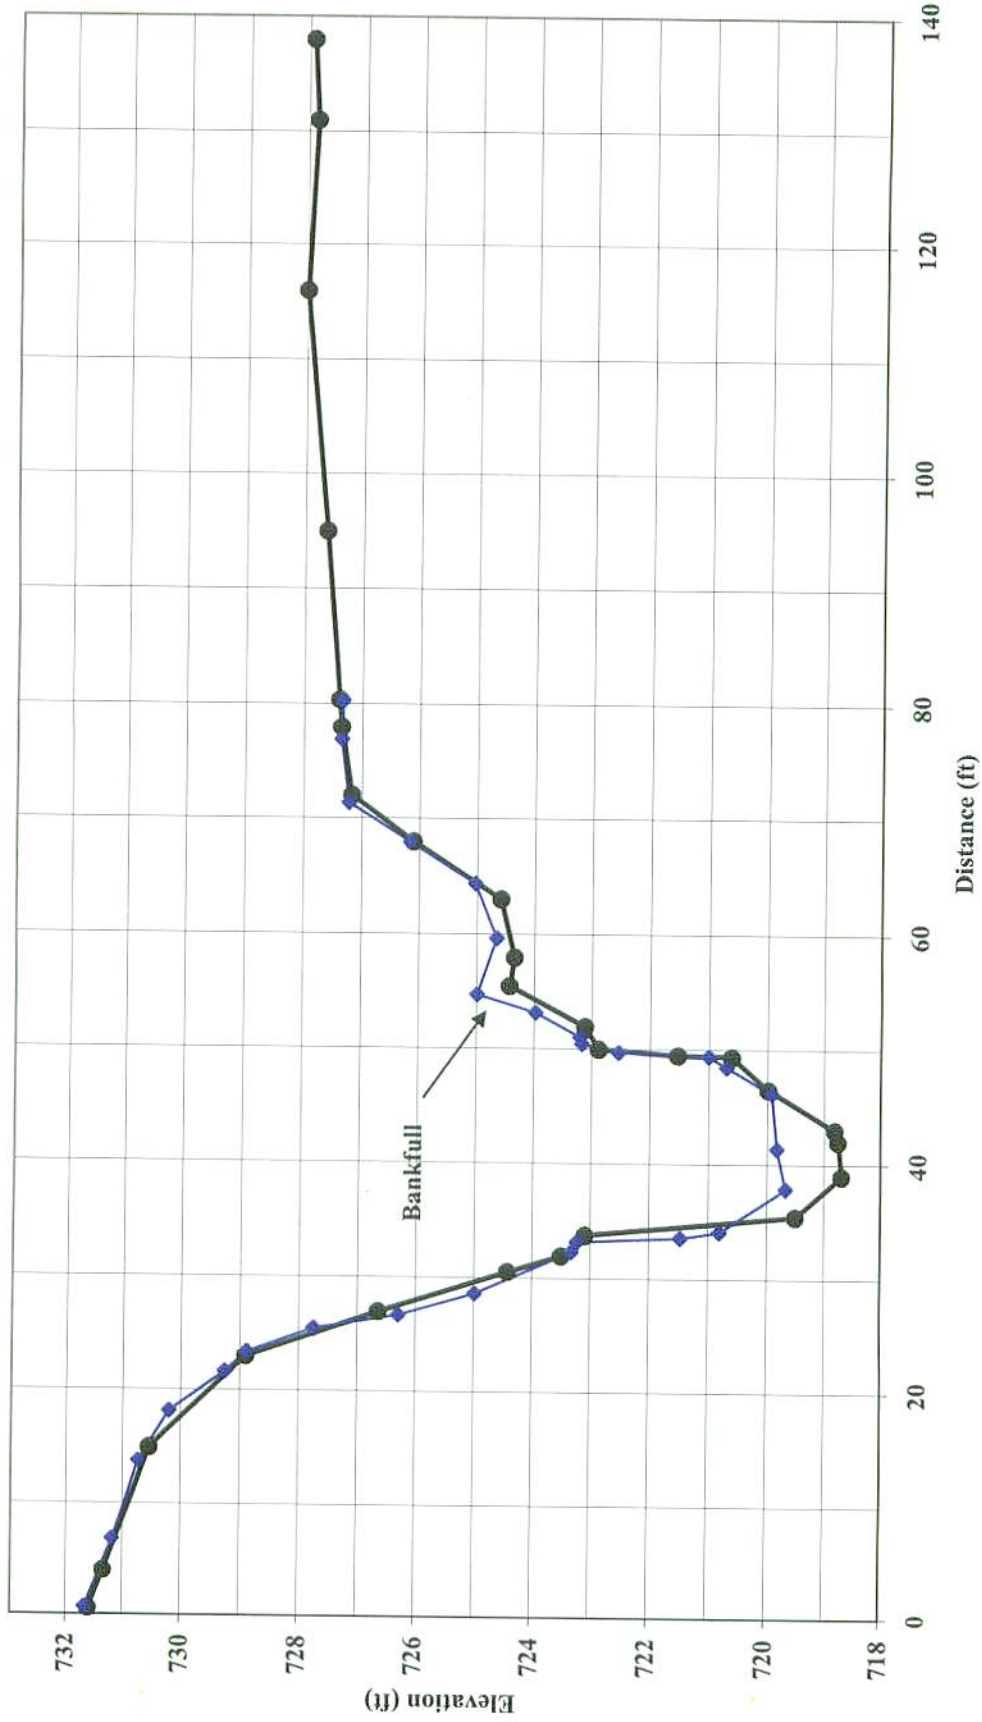
Gillespie R1A
Cross Section 1 Pool

Cross sections 1, 2 and 3 are stable with minor changes (settling, deposition on the banks, decrease in width depth ratio) indicating a positive change in channel evolution. The pool in cross section 1 shows minor deposition on the right bank and in the pool, along with very minor erosion of the left and right toe. The riffle in cross section 2 has had moderate deposition on the left bench and more substantial deposition on the right bench and the right wing of the double wing deflector. The thalweg in cross section has moved from the center of the riffle to the right toe, with minimal down-cutting. All three have stable banks with good vegetative cover and functioning bankfull benches.

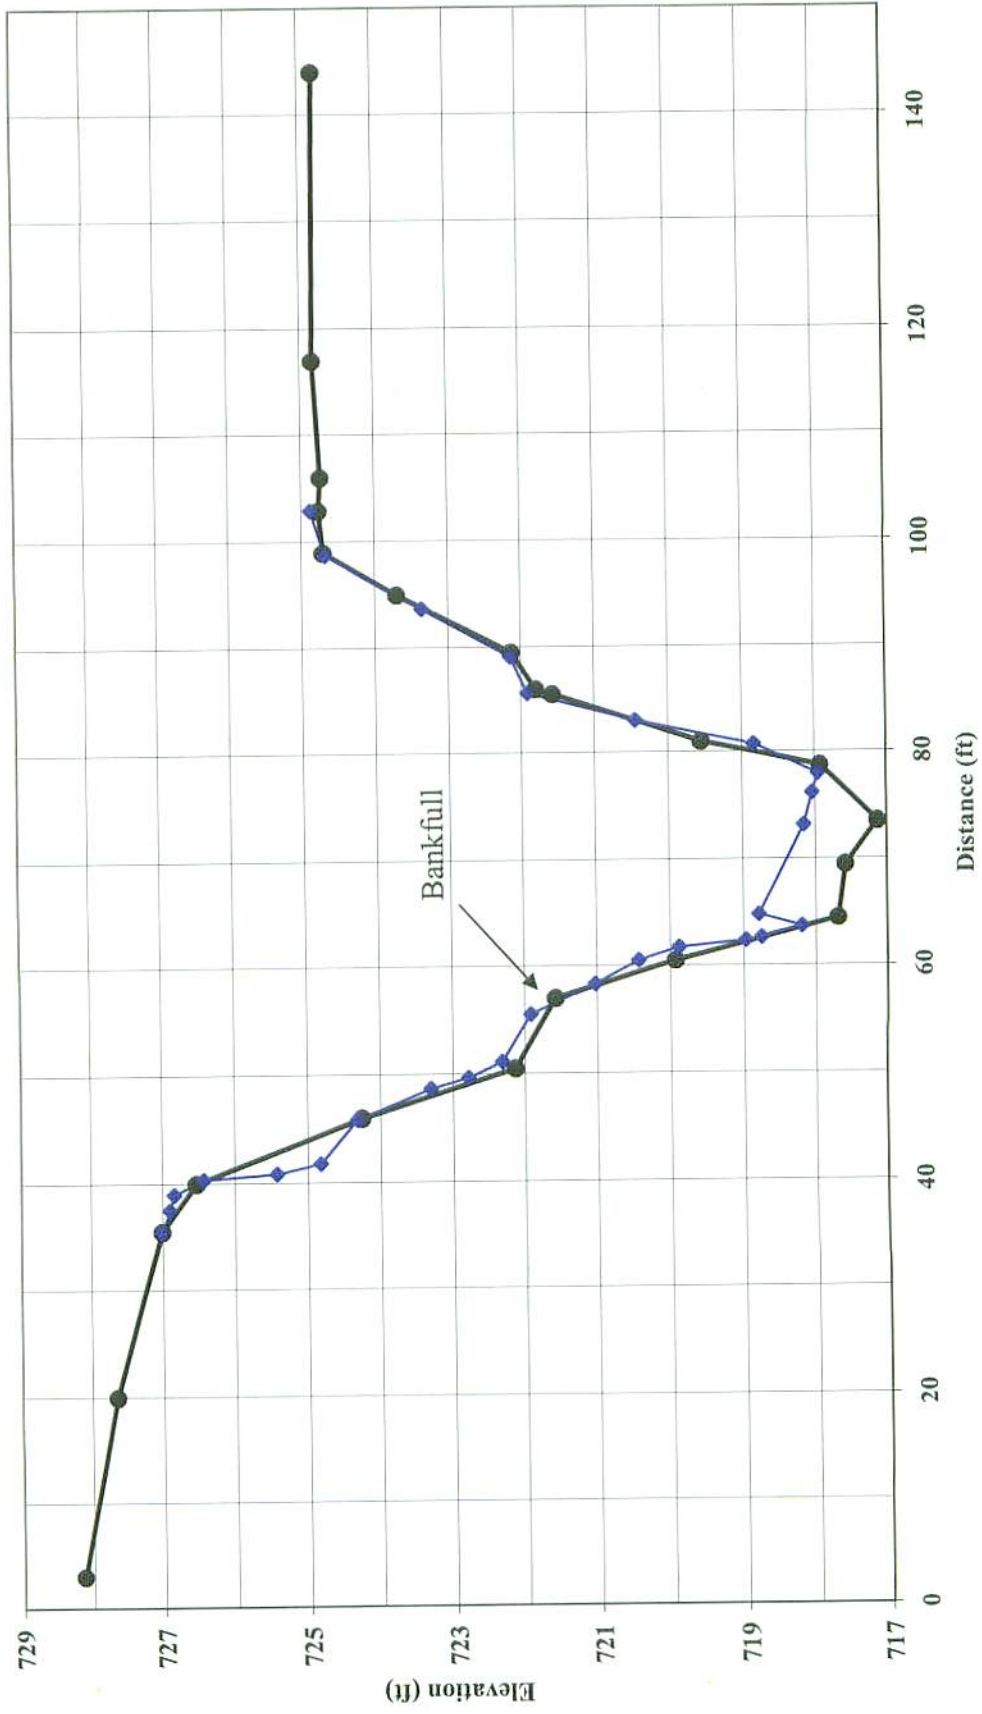
Gillespie RIC
Cross Section 4 Pool

Cross section 4 has had some minor erosion near the top of the left terrace from surface flow during storm events, along with minor deposition on its bench. However, both banks have good vegetative cover and are stable. There has been deposition of fines in the pool, and the thalweg has moved slightly over to the right toe, resulting in a slight increase of the w/d ratio and a slight decrease (2.7 square feet) in the bankfull area. Cross section 5 is a stable riffle, with a minimal change in its thalweg from the left toe to the right toe. At J-hook #1 (Photo point 17 in photo log) a large tree has fallen over and is suspended above the structure. The tree is low enough to present an obstacle to channel flow during substantial rain events and should be removed. The tree's root mass may be left in place to provide bank protection.

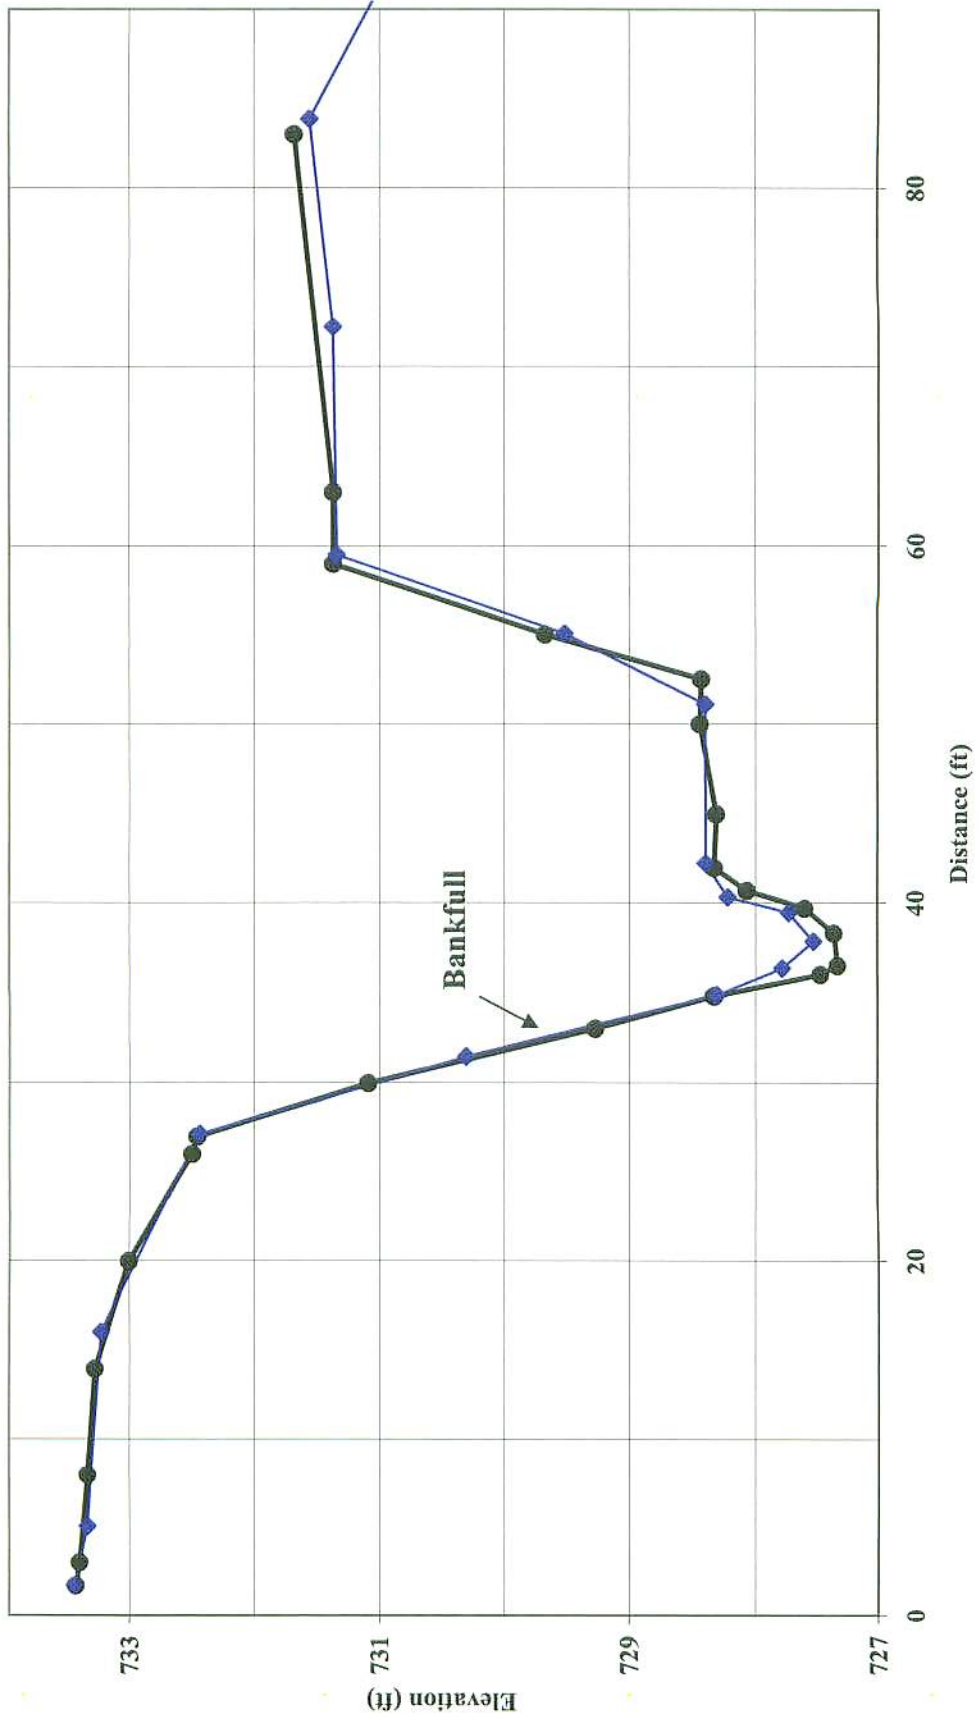
Gillespie R2
Cross Section 6 Rifle

Cross section 6 has remained stable and has slight deposition in its riffle. Of note is the ongoing construction of a new city truck wash rack at the top of Reach GR2. The impact of this construction is unknown and will need to be assessed in future monitoring.
