**Hillsdale Park (Buffalo Creek) Stream Restoration
Greensboro, North Carolina
Annual Monitoring Report
Monitoring Year 2005**

Monitoring Year: 2005
Measurement Year 2
As-Built Date: 2004
NCEEP Project Number 177

February 2006

**HILLSDALE PARK (BUFFALO CREEK) STREAM RESTORATION
2005 MONITORING REPORT**

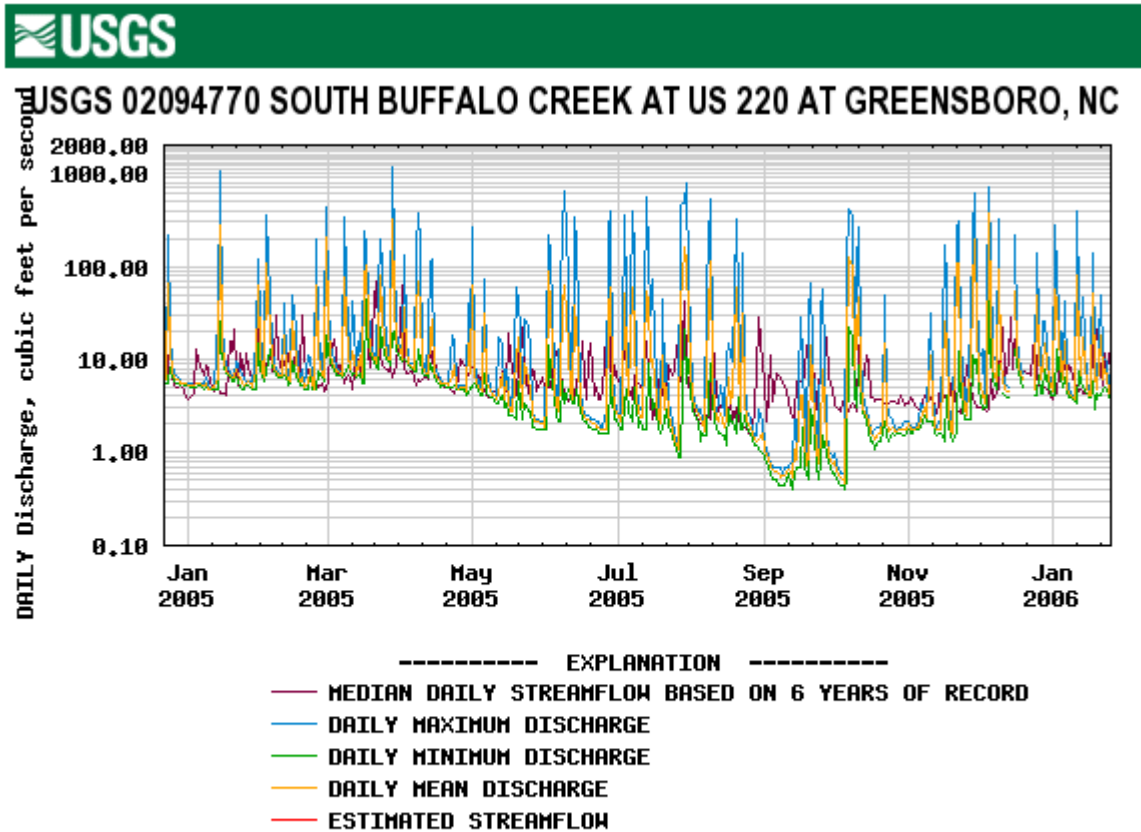
Figure 3. USGS Stream gauge data for South Buffalo Creek at US 220.

No crest gauges are installed at this site to document bankfull events. Therefore, potential occurrence was extrapolated based on USGS stream gauge discharge data for South Buffalo Creek at US 220 (approximately 2 miles downstream of project site) with a drainage area of 15.4 square miles. Bankfull events were determined by comparing the stream discharge cubic feet per second (cfs) against the drainage area on the urban piedmont regional curve. According to the urban piedmont regional curve a bank full event occurs on a stream with a 15.4 mi² drainage area when the discharge is between 1,538 and 1,704 cfs. Based on USGS data and the piedmont-

urban regional curves, no bankfull events occurred in 2005. However, there may have been one bankfull event on December 10, 2004 when the maximum discharge reached 1,700 cfs for one day. Two high flow events were recorded for 2005. On January 14 and March 28 maximum discharge was recorded at 1,040 and 1,140 cfs respectively.
