**Hillsdale Park (South Buffalo Creek) Stream Restoration  
Greensboro, North Carolina  
Final Annual Monitoring Report  
Monitoring Year 2008**

**Monitoring Year: 2008  
Measurement Year 5  
As-Built Date: 2004  
NCEEP Project Number 177**

**March 2009**

WK Dickson and Co., Inc.  
720 Corporate Center Drive  
Raleigh, NC 27607  
(919) 782-0495

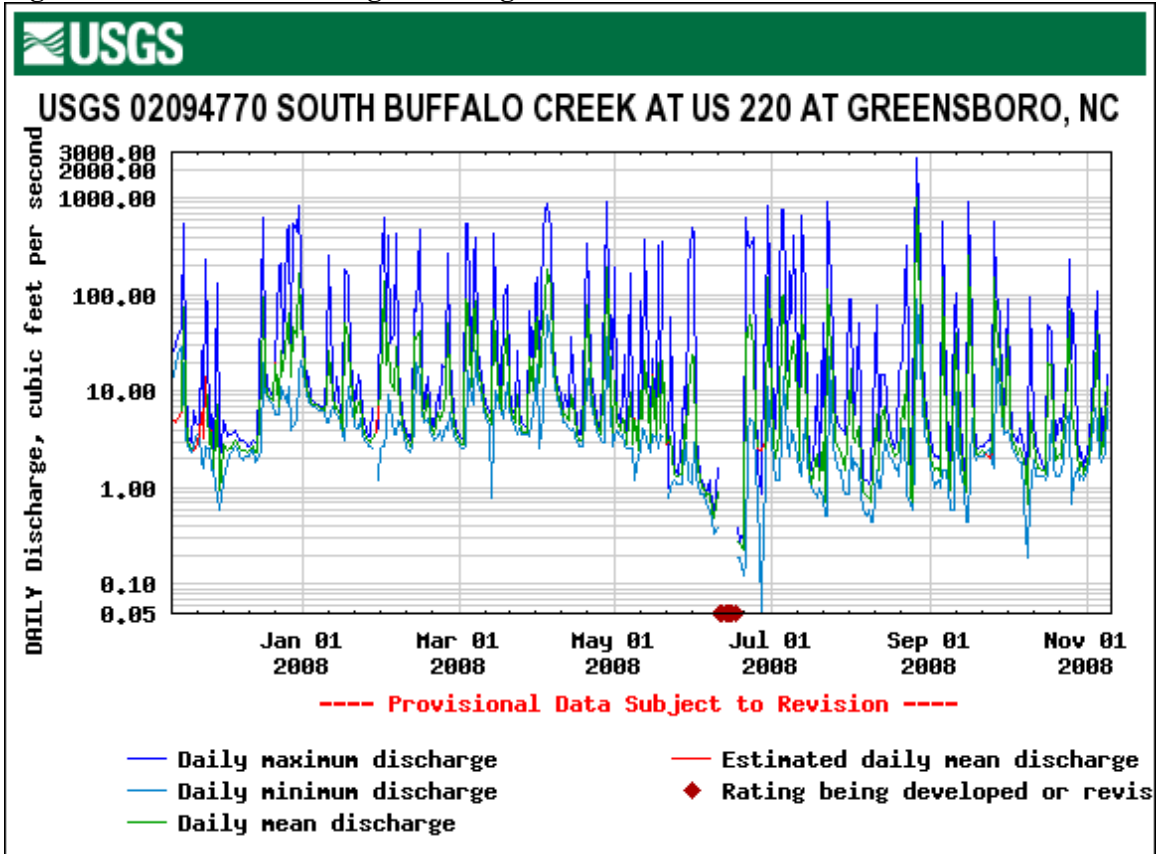
Figure 3. USGS Stream Gauge Discharge Data for South Buffalo Creek at US 220.

Although this technique has been used to establish the occurrence of bankfull events for the history of this project, it should be used as a proxy estimator. The idealized approach would be to transfer the discharge to the project reach from the gauge site, and then run a step-backwater or other flow model to predict slope and water surface elevation. The event captured by the USGS gauge was the result of Tropical Storm Fay, which produced 6-10 inches of rain in central Guilford County, and at least 6 inches throughout the Buffalo Creek drainage basin, with reports of widespread flooding in Greensboro.
