MY02 MONITORING REPORT

Hip Bone Creek Restoration Site

DMS Project #100059

Date: February 9, 2023
To: Jeremiah Dow, DMS Project Manager
From: Adam Spiller, Project Manager
KCI Associates of North Carolina, PA
Subject: MY-02 Monitoring Report Comments
Hip Bone Creek DMS#100059, Contract 007528
Cape Fear River Basin CU 03040101
Chatham County, North Carolina

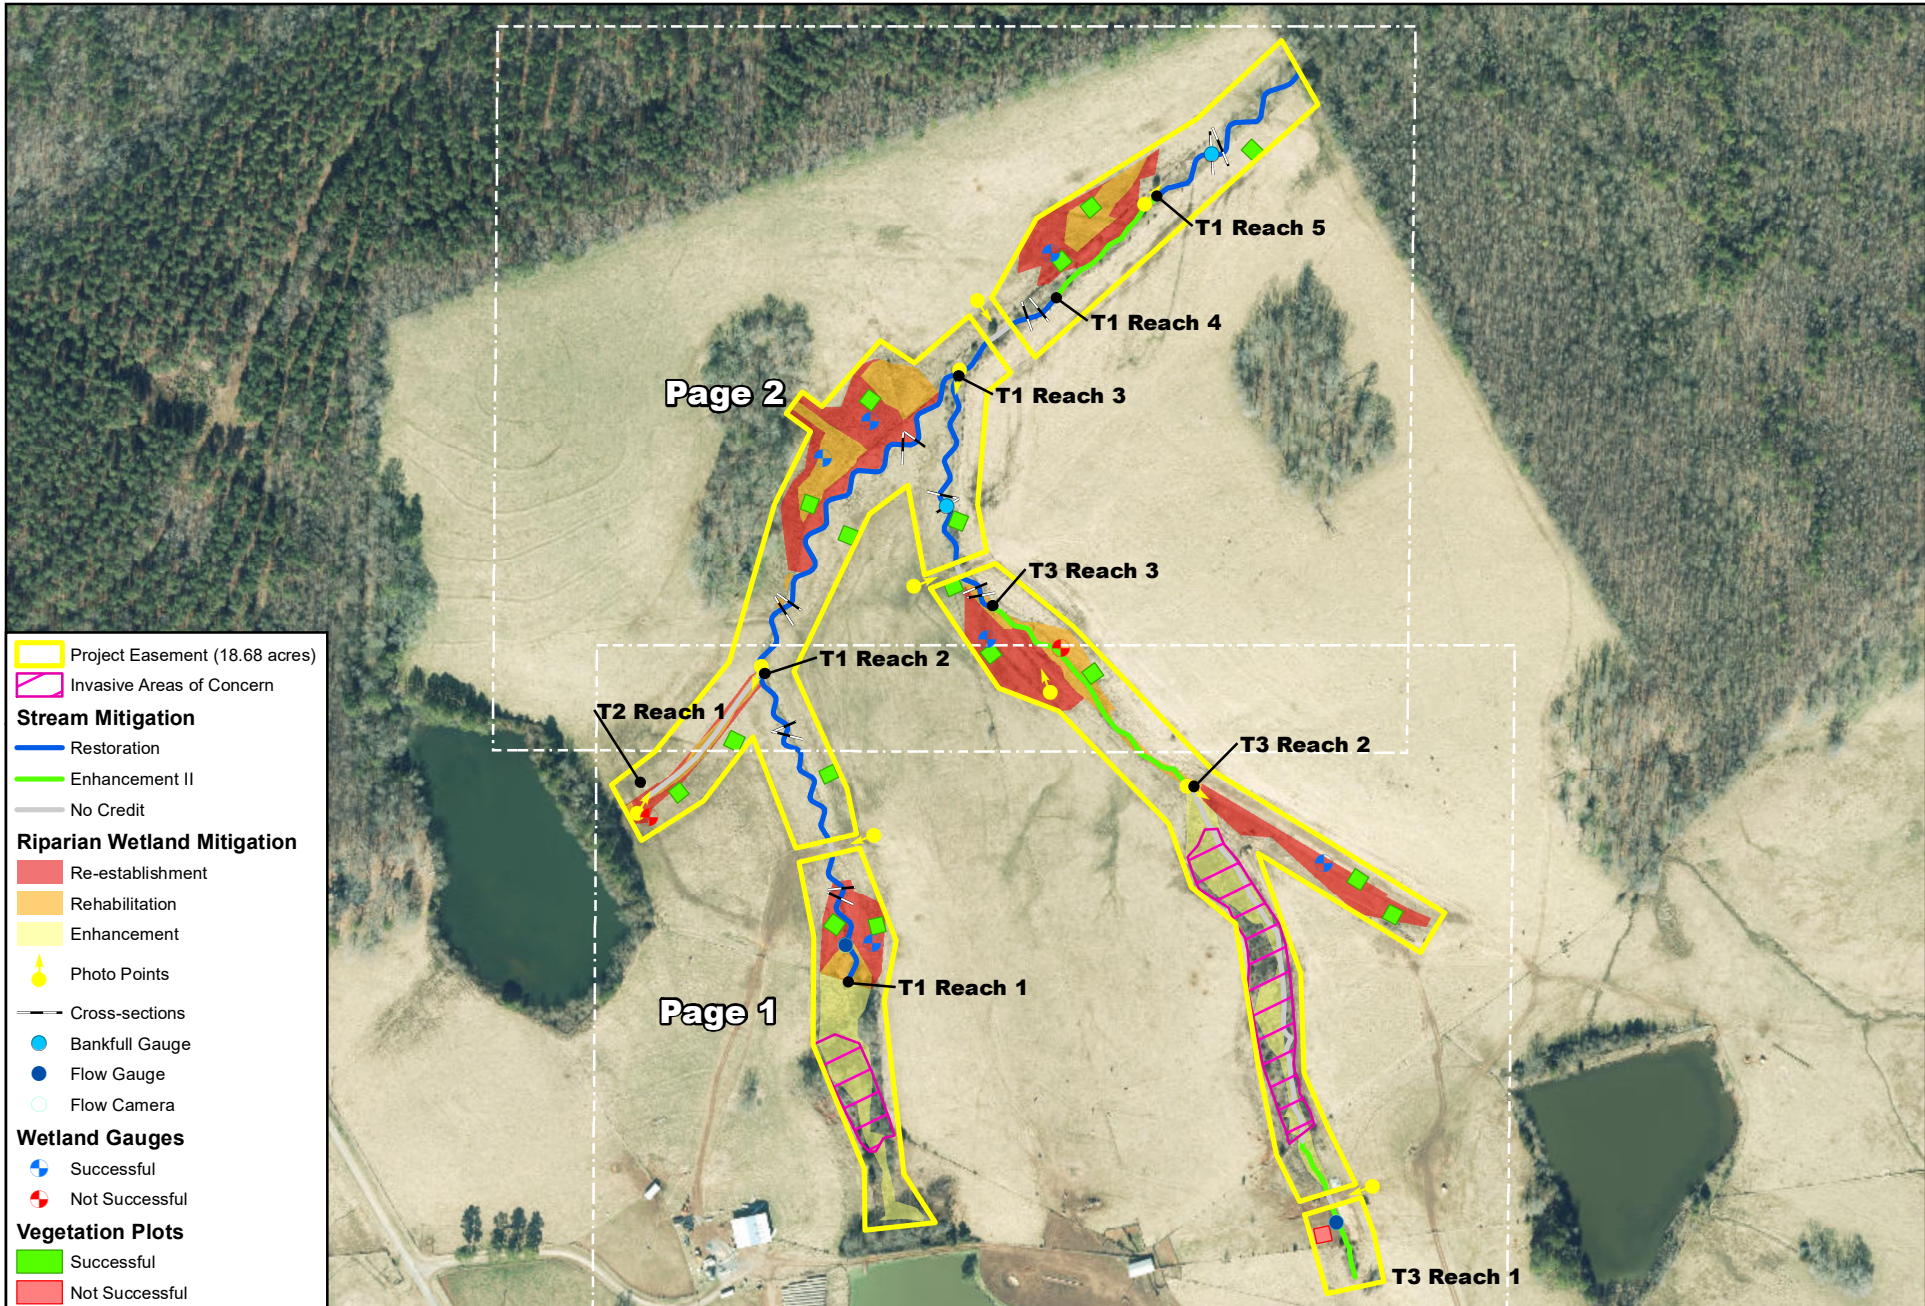
CURRENT CONDITIONS PLANVIEW PAGE
HIP BONE CREEK RESTORATION SITE
CHATHAM COUNTY, NC

1. Please update the wetland credits in the CCPV Legend to match the project credits in Table 1.
KCI Response: This error has been corrected.
2. VP 7 is colored red on the CCPV. Is this due to only having 3 species in the plot since it met the stem/acre interim success criteria? Please clarify.
KCI Response: That is correct, VP7 is colored red due to having only 3 different species.

3. The wetland gauges on the CCPV are not colored correctly according to successful/not successful. For example, WM4, WM5, and WM8 are incorrectly shown as not meeting success and WM 7 is shown as meeting when it did not.
KCI Response: This error has been corrected.
