# MY03 MONITORING REPORT

Hip Bone Creek Restoration Site  
Chatham County  
Cape Fear River Basin - 3030003

DMS Project #100059

Monitoring Data Collected: 2023

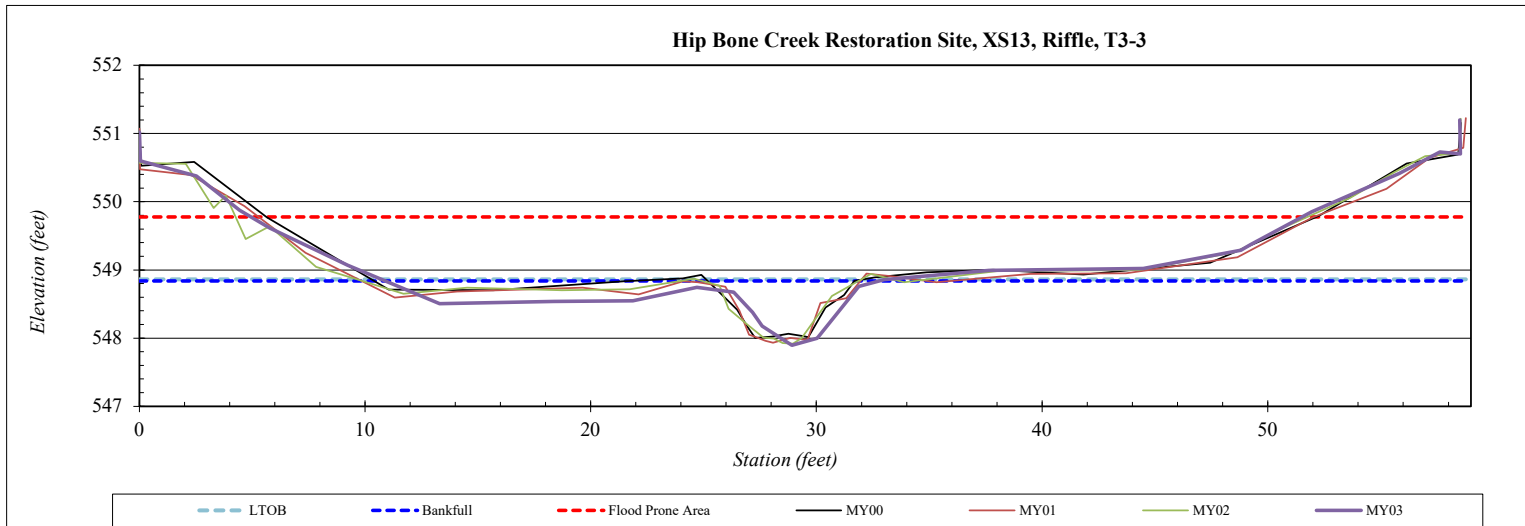
<b>River Basin:</b>	Cape Fear River
<b>Site:</b>	Hip Bone Creek Restoration Site
<b>XS ID</b>	XS13
<b>Drainage Area (sq mi):</b>	0.05
<b>Date:</b>	7/17/2023
<b>Field Crew:</b>	TS, CK, KB, ET

- c. Cross section 13 – please check the bankfull & LTOB lines on the graph. The location of the lines appears suspect and the reported change from a LTOB cross sectional area of 3 ft<sup>2</sup> to 1.1 ft<sup>2</sup> is questionable since the plot does not indicate aggradation to that degree.  
*KCI Response: The error with this cross section has been corrected and the morphology tables have been updated accordingly.*

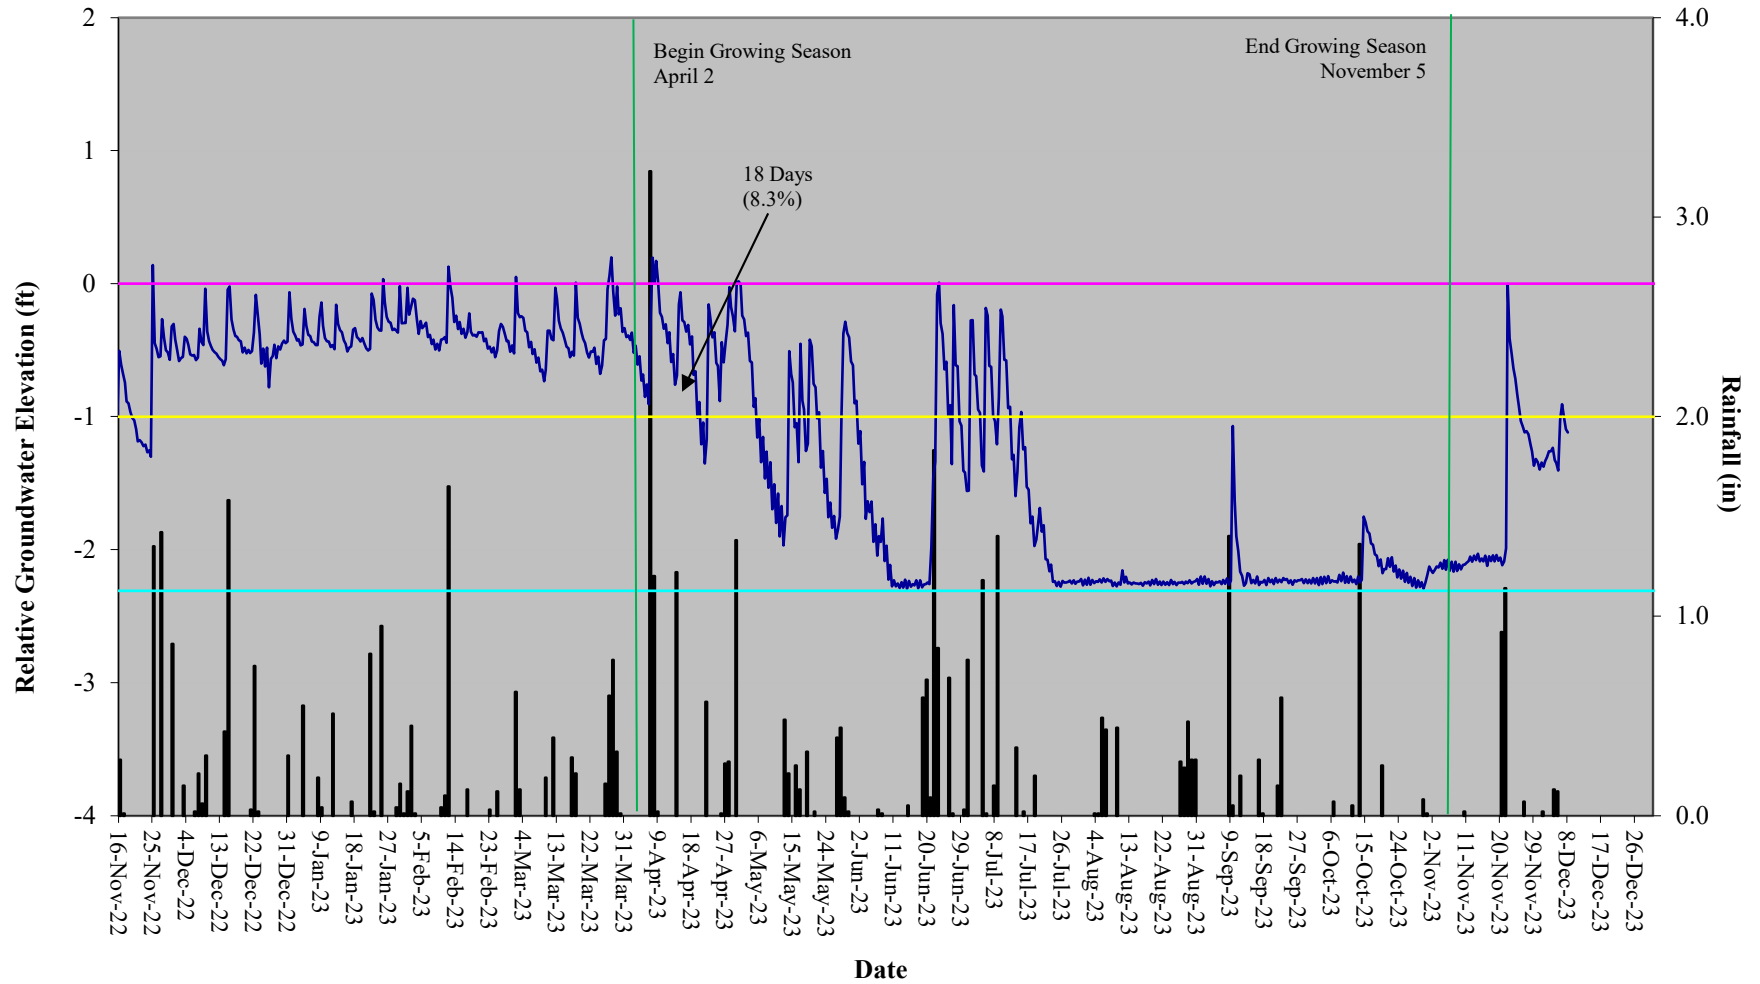
## Hip Bone Creek Restoration Site Hydrograph Wetland Gauge 2

During the site's third growing season, 7 of the 8 gauges achieved the success criteria of 12% continuous saturation (26 days). The gauge that did not achieve the success criteria (Gauge 2) has not achieved the success criteria in any of the monitoring years so far. This gauge is located near the fringe of the wetlands around T2 and although it has not achieved the success criteria, it has had greater than 5% continuous saturation in all three monitoring years. KCI does not believe that the failure of this gauge to achieve the success criteria is indicative of a larger issue with the site, but is rather the natural variability that exists in any natural system, especially around the fringes of that system. KCI is planning on installing a supplemental wetland gauge in the vicinity of Gauge 2 before the start of the 2024 growing season.
