**Annual Monitoring Report Final
Monitoring Year 1 of 5
Hogan Creek Stream Mitigation Project**

DEQ Contract Number: 6496
USACE Action ID: SAW-2011-02268
DWR Project Number: 20120182
SCO# 09-08566-01

Surry County, North Carolina
Data Collected: October 26-December 11, 2015
Data Submitted: January 2016

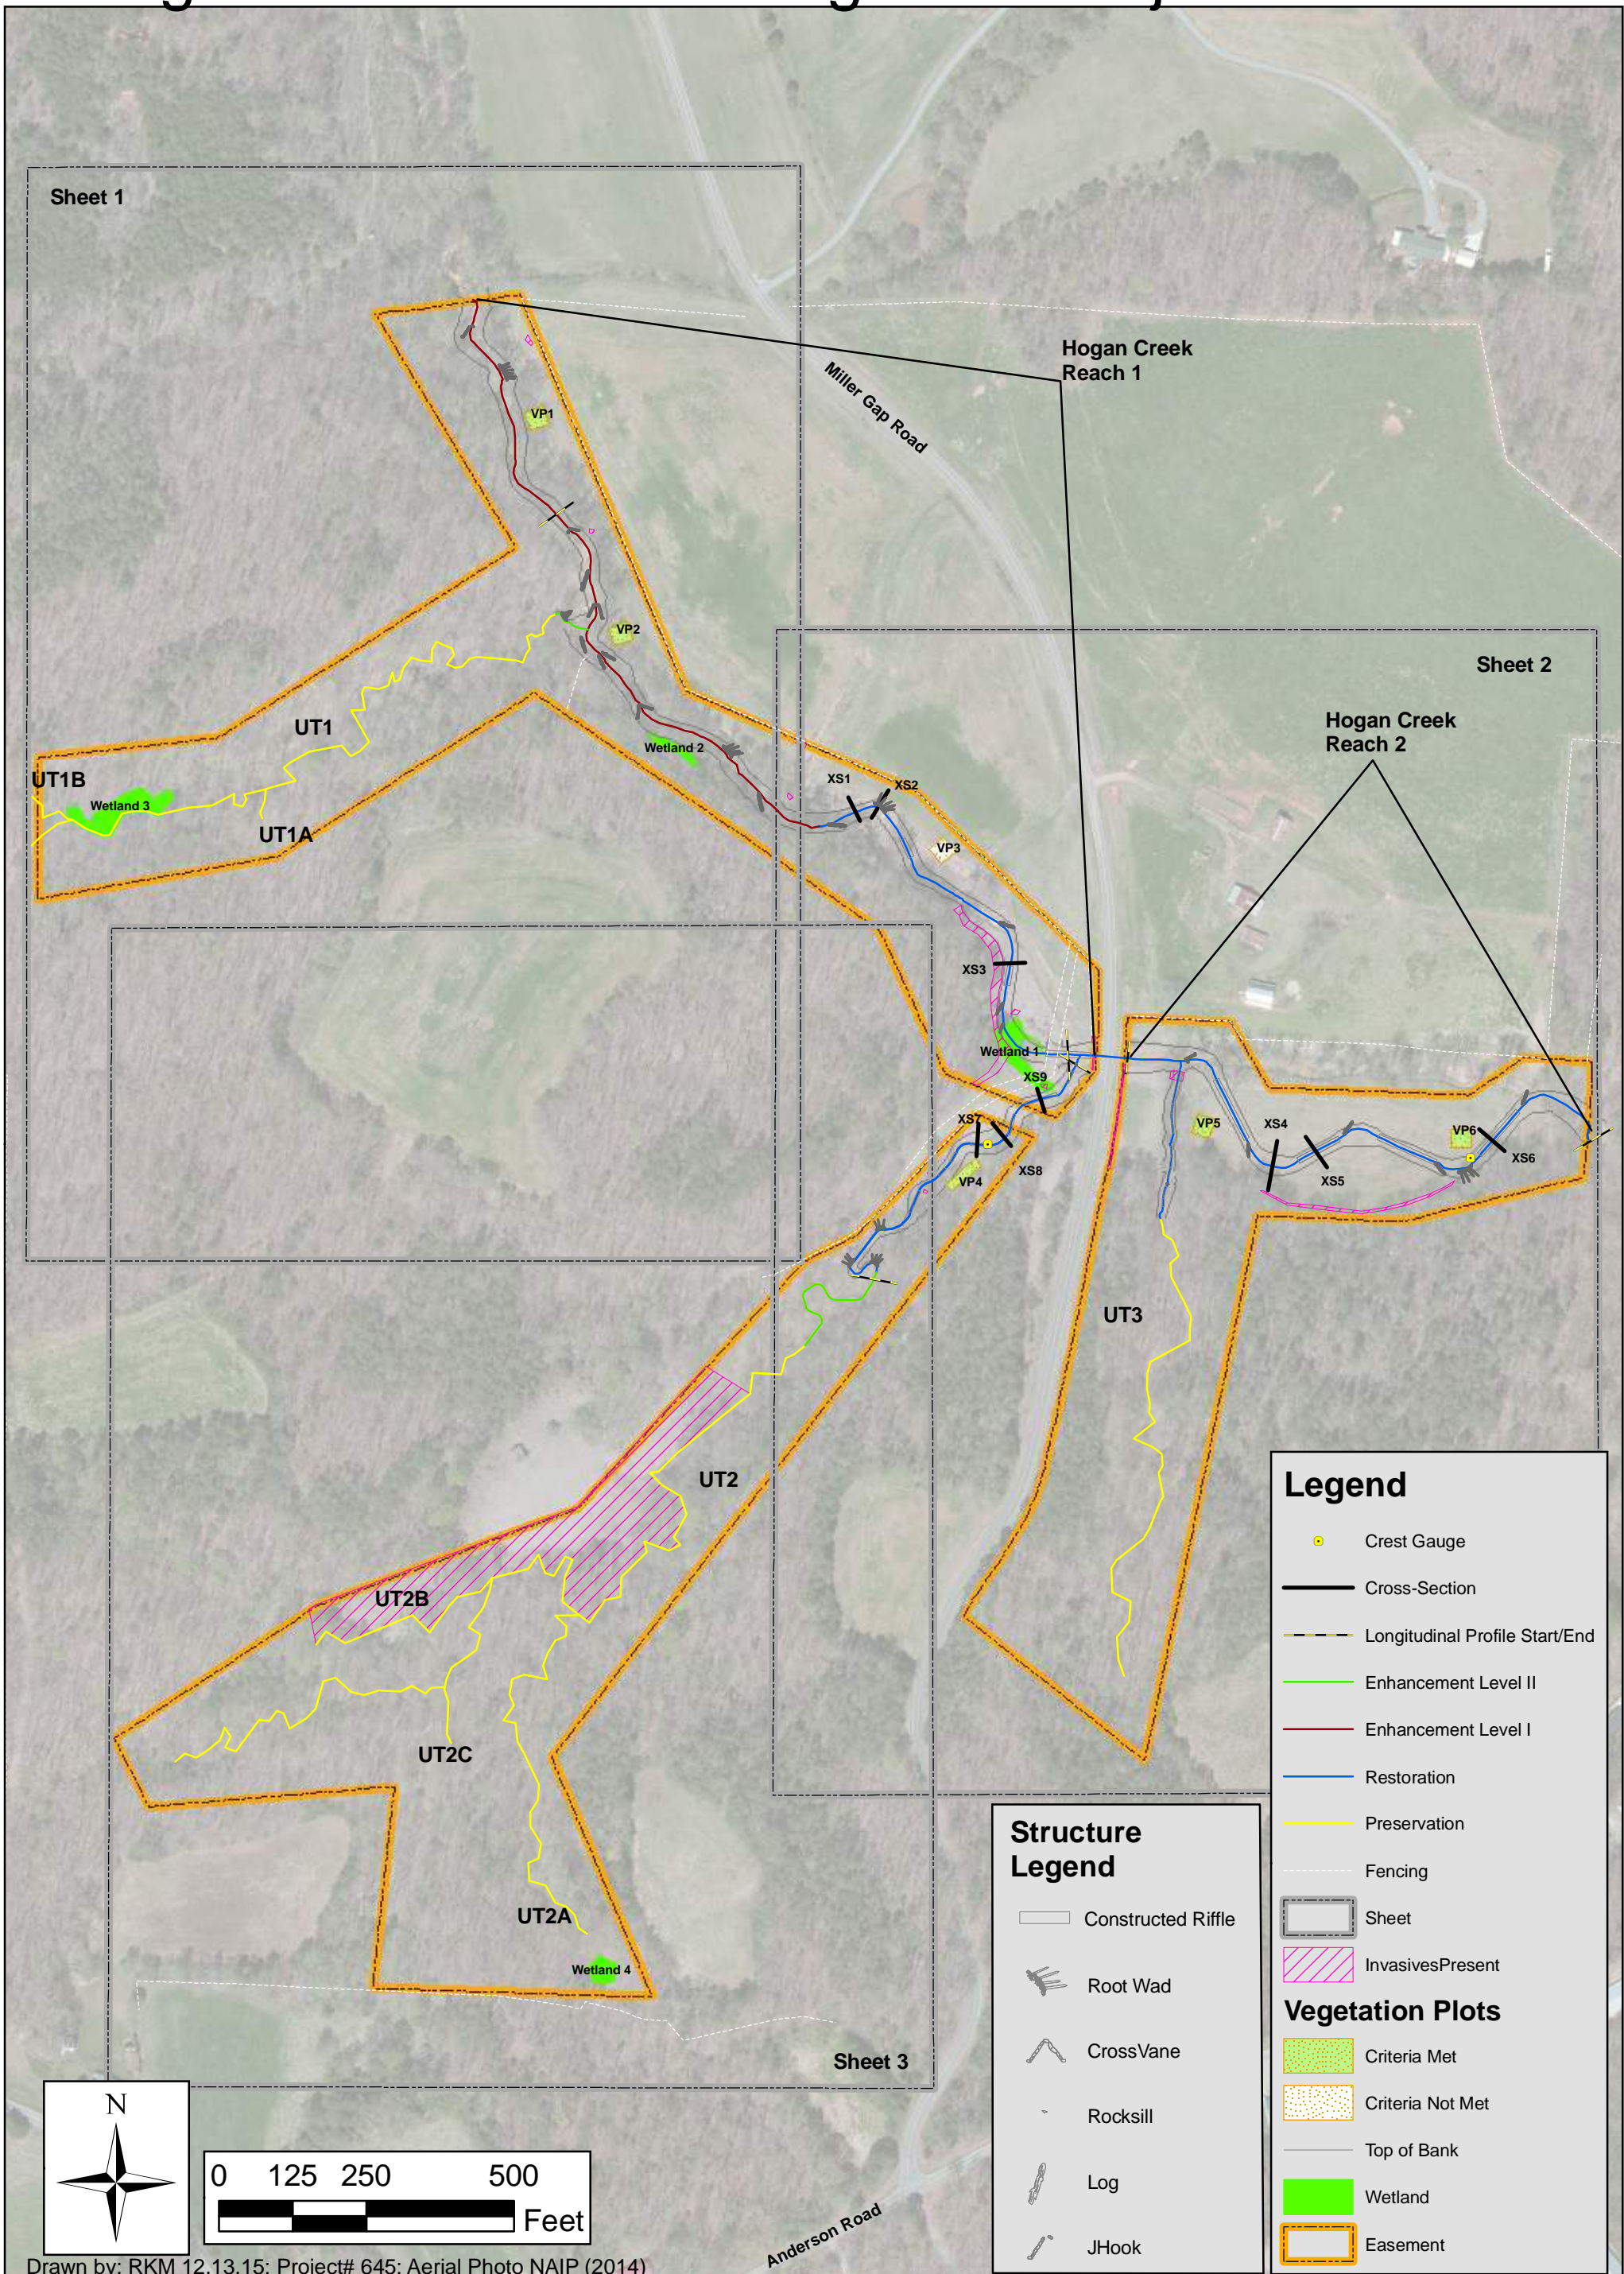
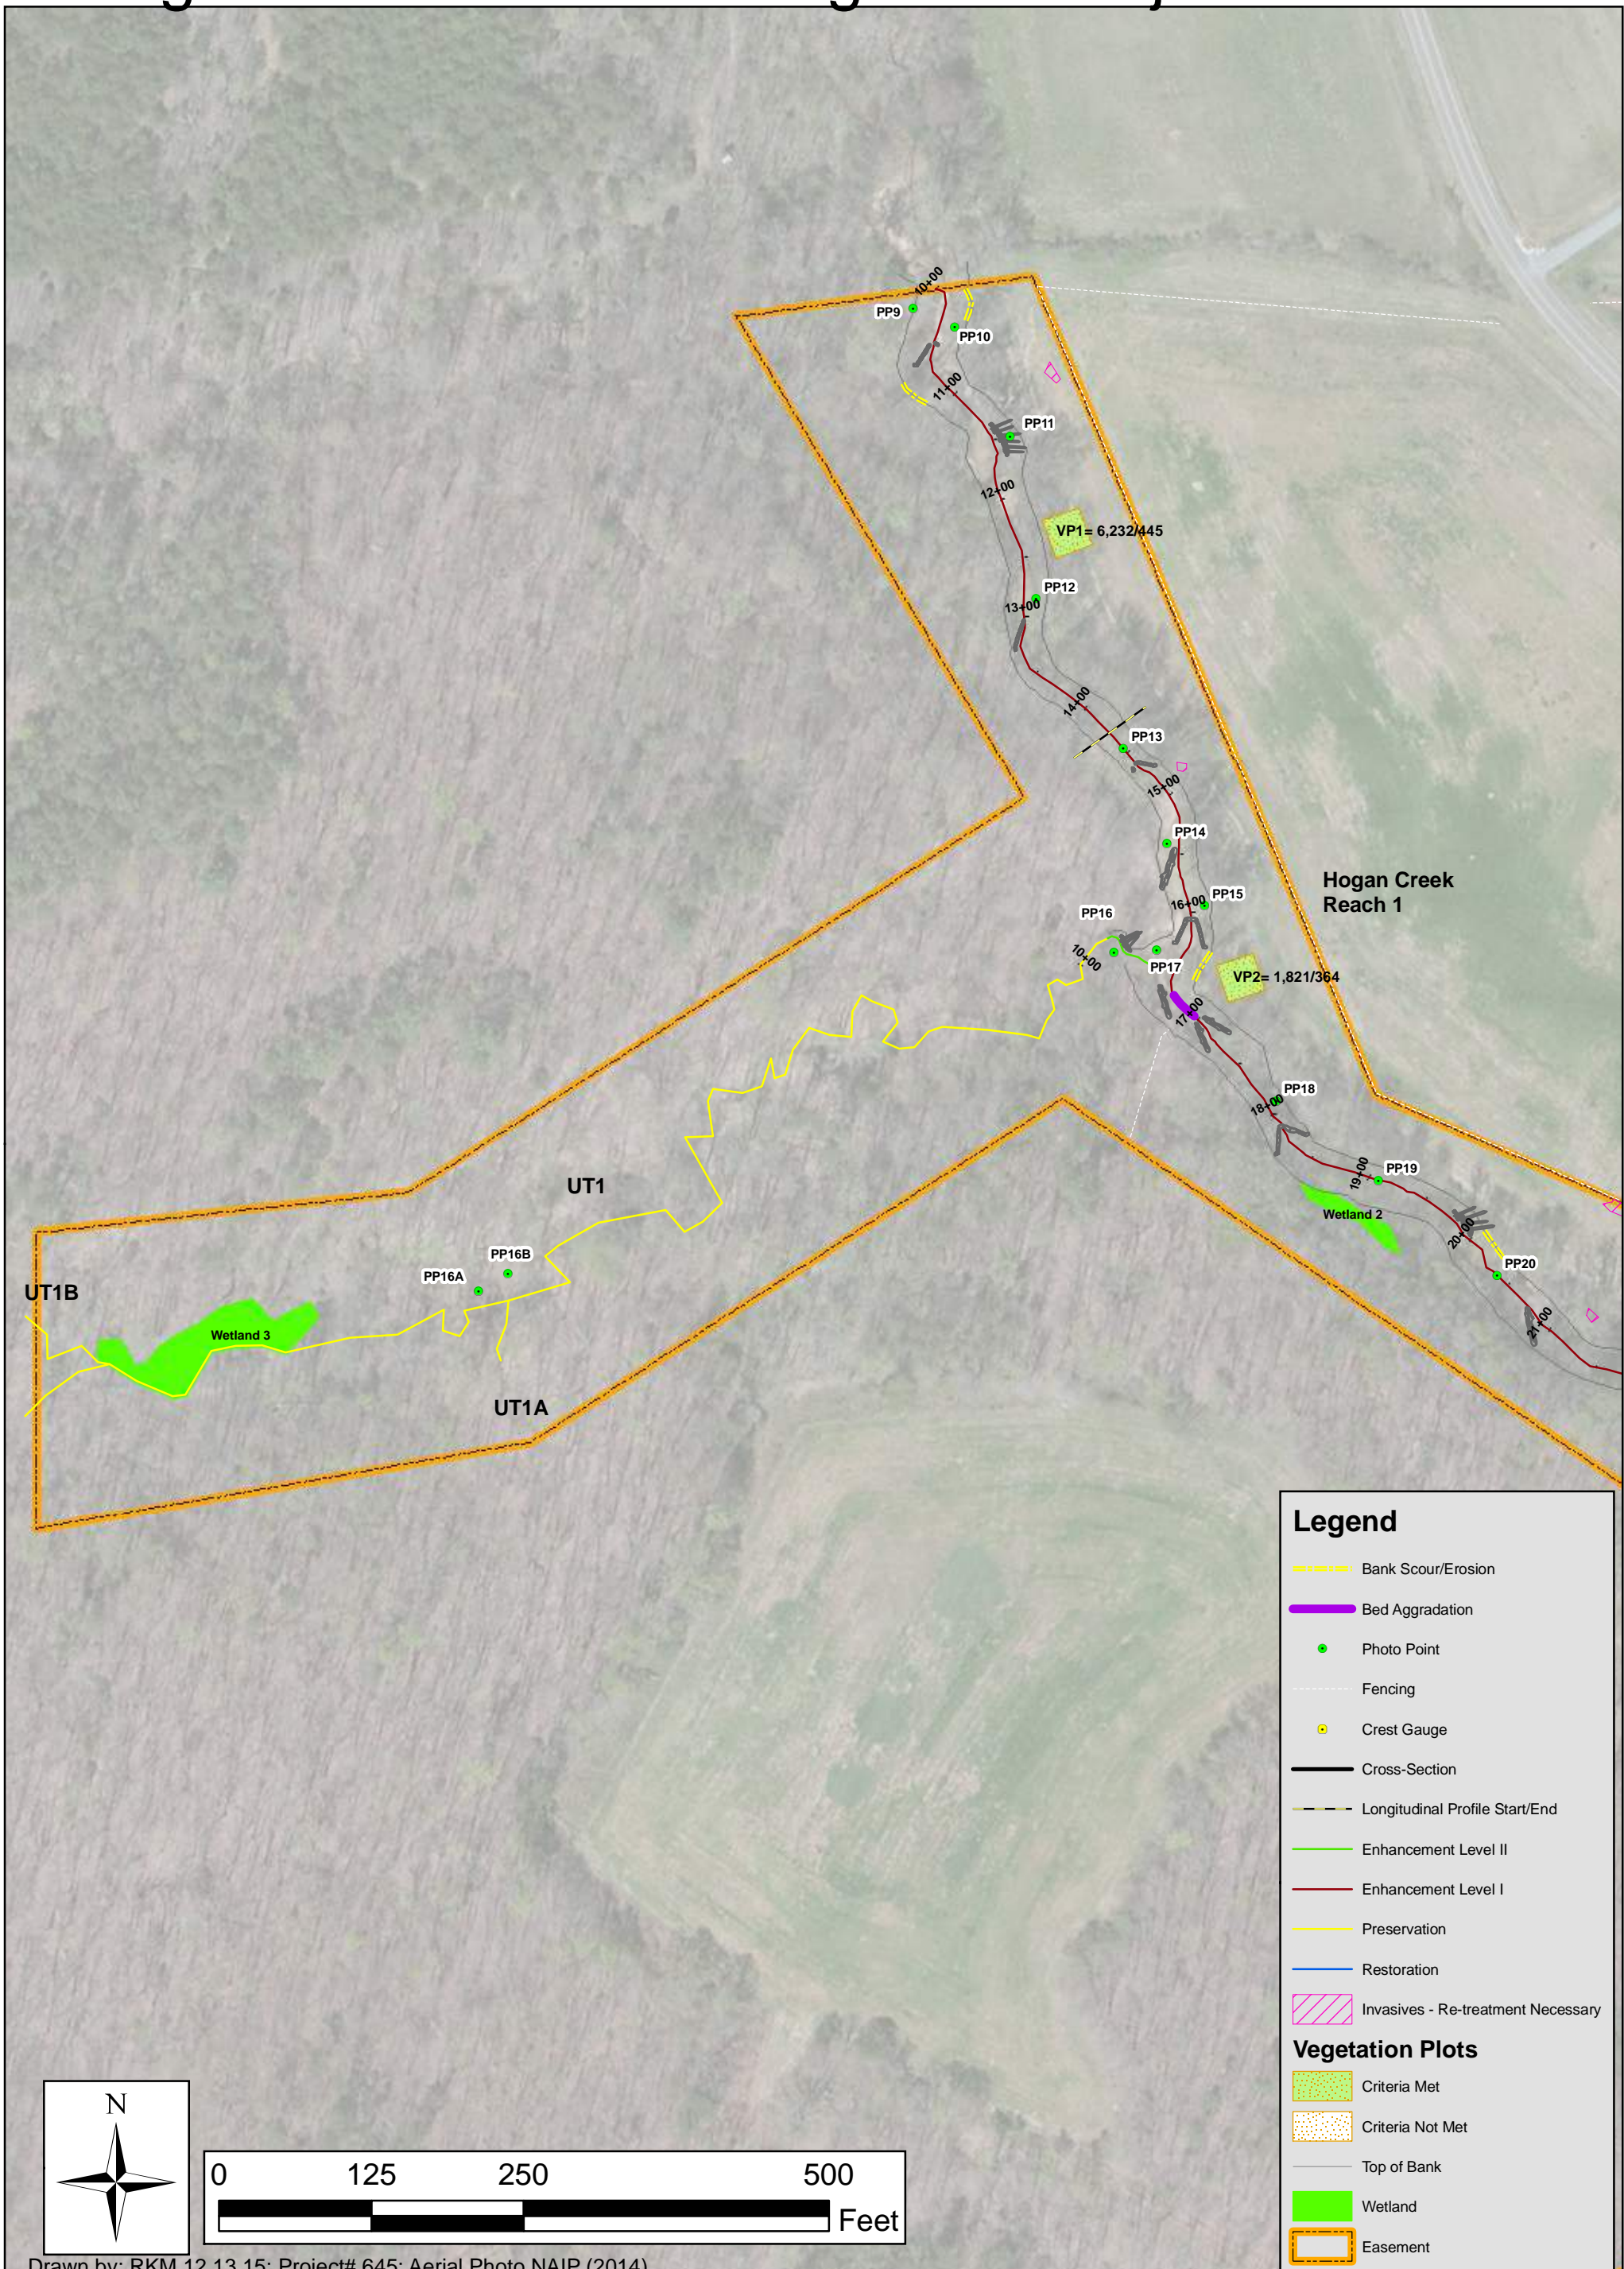
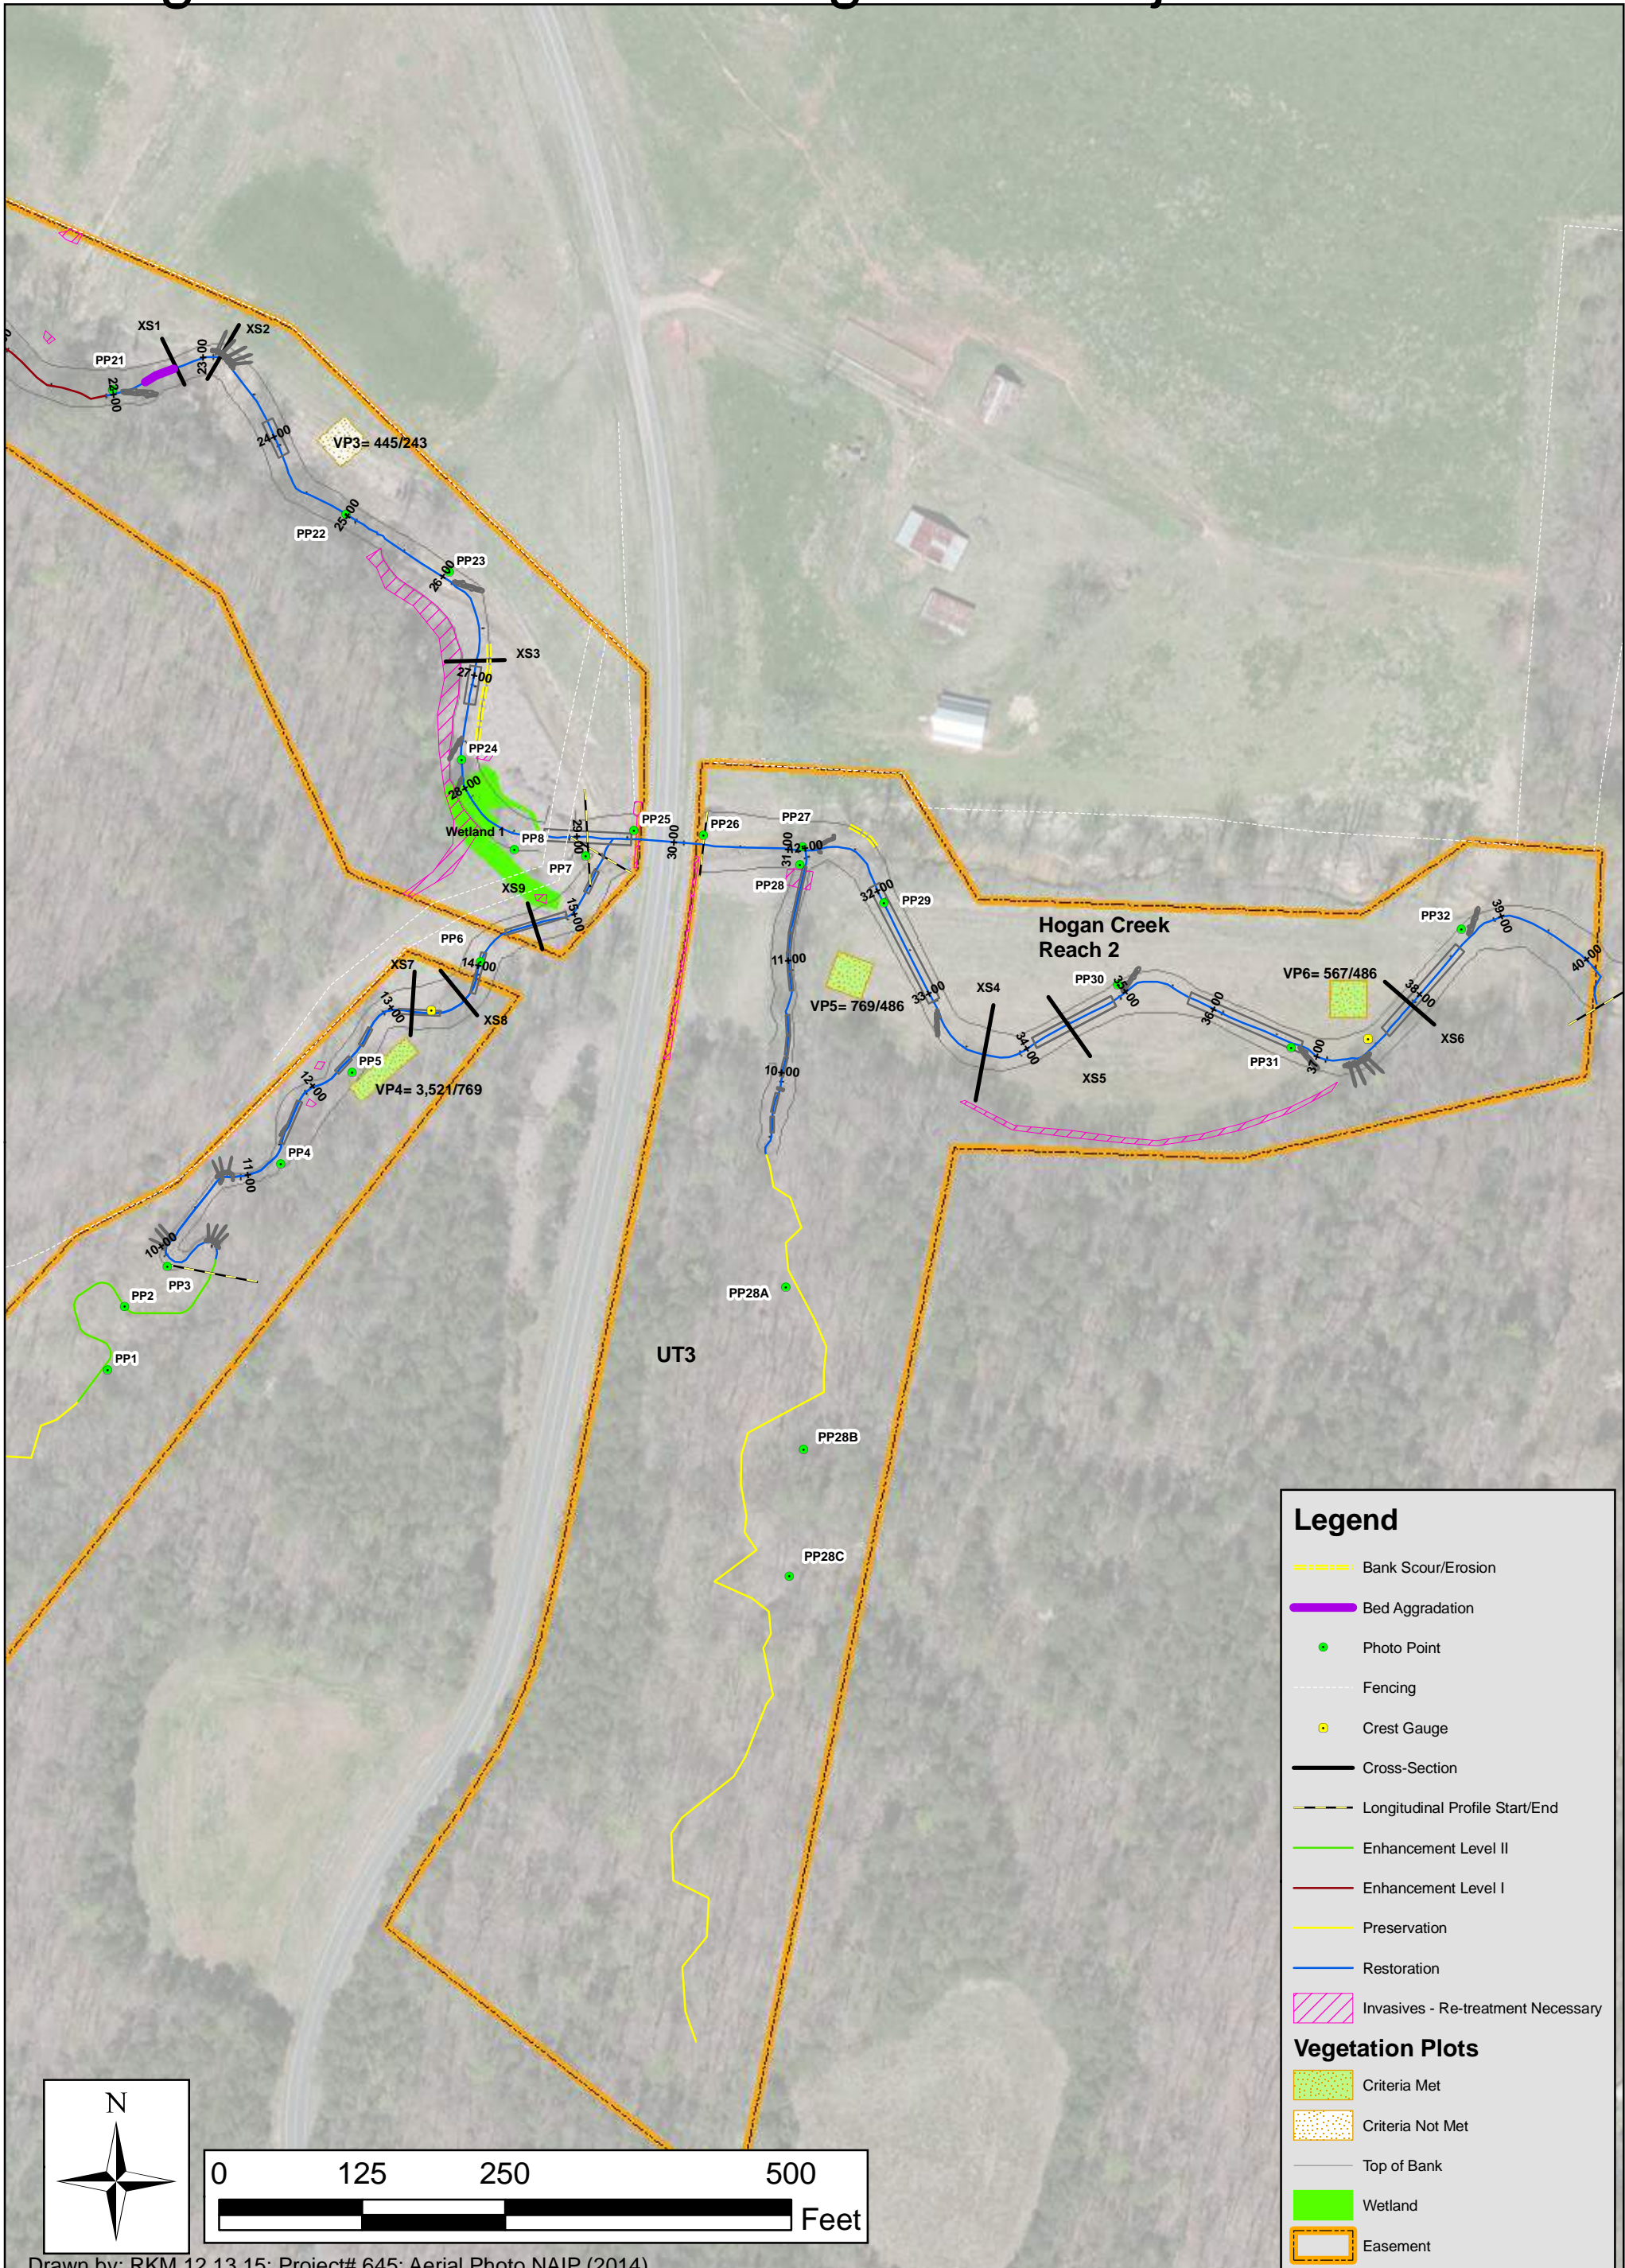
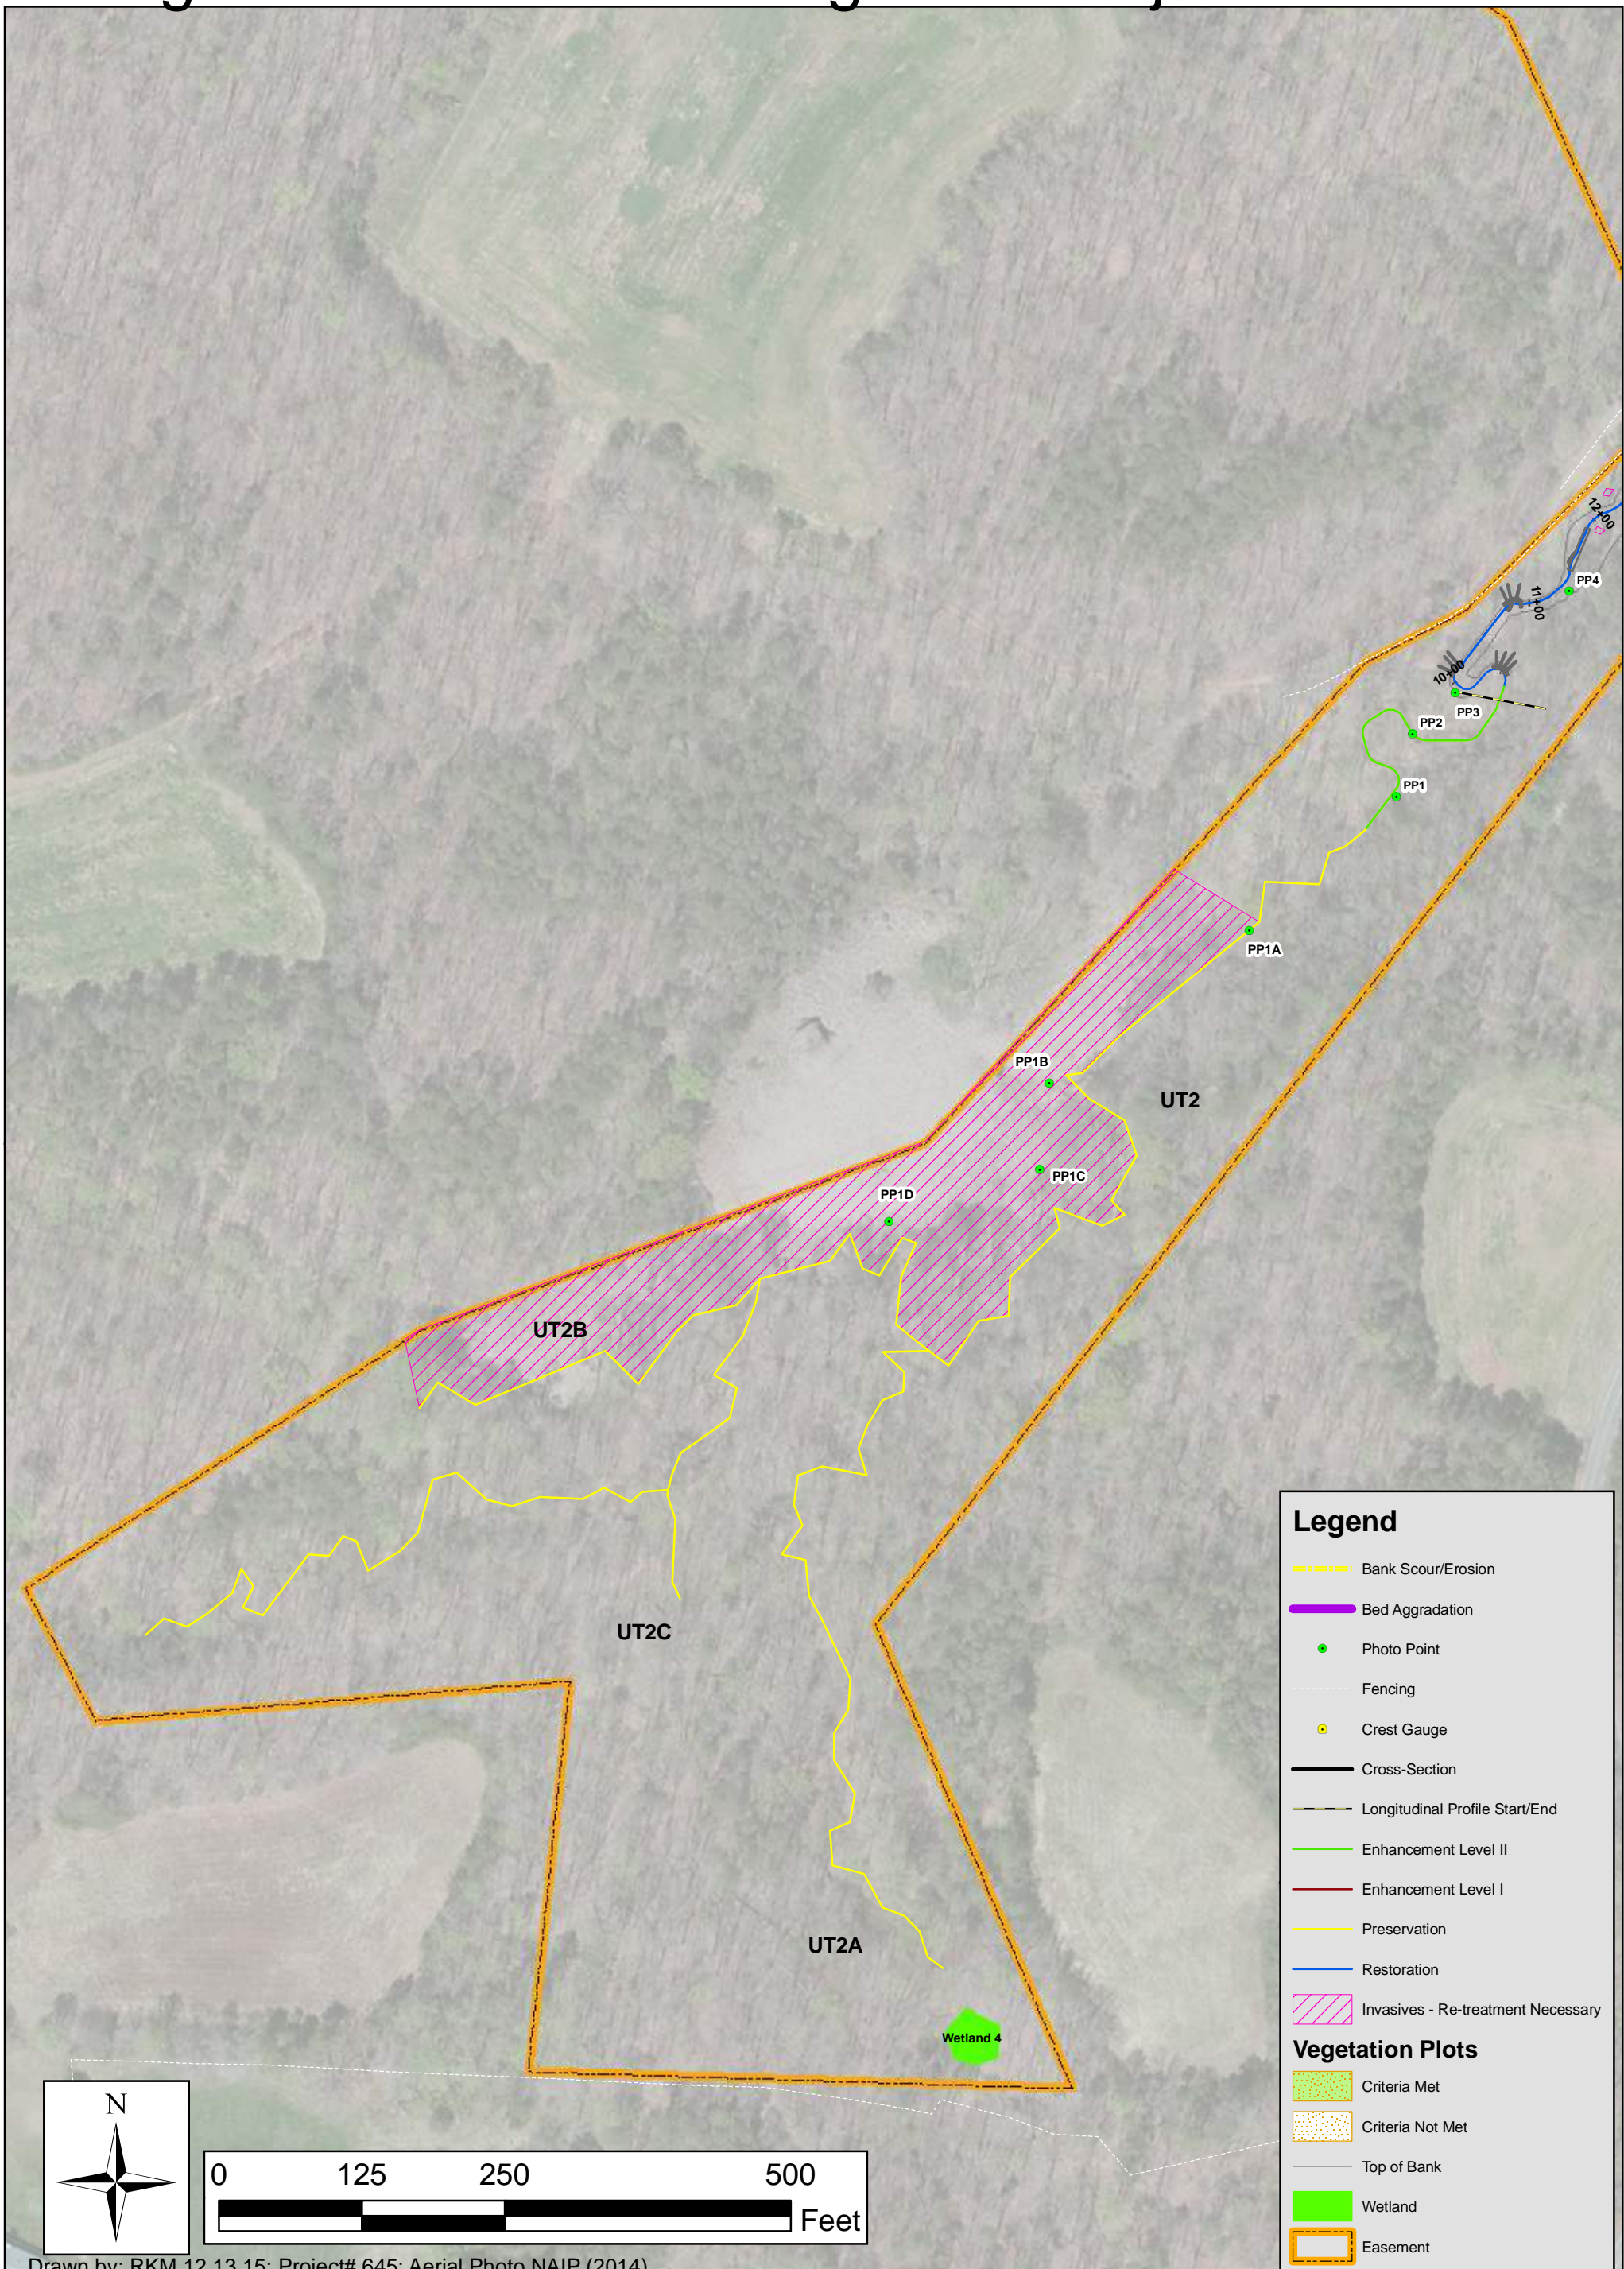
Figure 2

A visual inspection of the entire project was conducted after the repair work to ensure that the project is performing well. Visual assessment tables and photo points are included in Appendix B. With the exception of two areas of aggradation and six areas of toe or lower bank erosion in Reaches 1 and 2 of Hogan Creek, the project as a whole is performing as designed and stream issues were minimal. The six areas, labeled on the current condition plan view (Figure 2 Sheets 1-3) as bank scour/erosion, are scheduled to be live staked during the winter of 2016. Year 2 monitoring efforts will include an evaluation of the need for additional adaptive management.

- Hogan Reach 1 – Station 18+12. Cross vane was repaired to fix dislodged boulder.
- Hogan Reach 1 – Station 20+12. Left bank was repaired to alleviate scour behind root wad cluster.
- Hogan Reach 2 – Stations 34+00, 36+00, and 38+00. Substrate was added to three constructed riffles in order to address channel incision and repair damaged grade control structures.
- Hogan Reach 2 – Station 36+00. Bank work was required on the left bank to repair 50 linear feet of erosion.

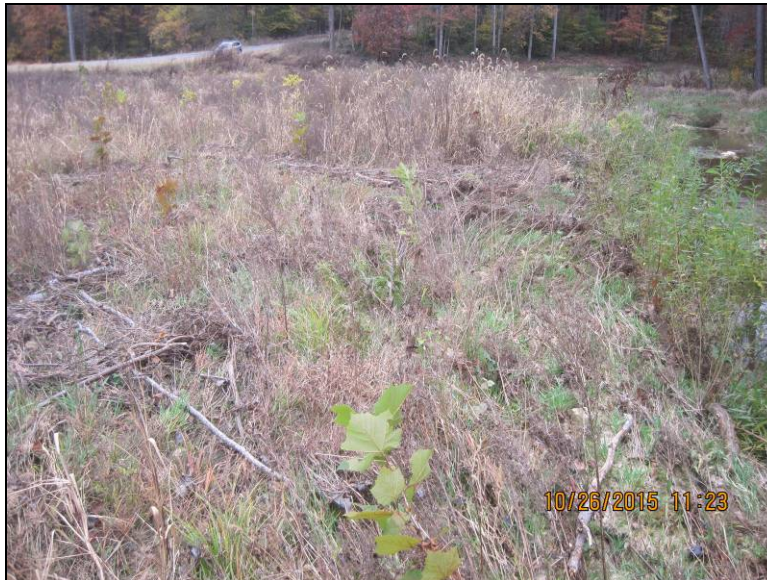
A bankfull event was documented in October 2015 based on visual observation of wrack lines and sediment deposition throughout the floodplain. Both crest gauges recorded readings indicating a bankfull flow had occurred. A nearby gauging station recorded over three inches of rain from October 2-4, 2015 (NCCRONOS, 2016).

Photograph of wrack lines on Hogan Creek Reach 1 Station 26+00
