**Annual Monitoring Report Final
Monitoring Year 2 of 5
Hogan Creek Stream Mitigation Project**

DEQ Contract Number: 6496
USACE Action ID: SAW-2011-02268
DWR Project Number: 20120182
SCO# 09-08566-01

Surry County, North Carolina
Data Collected: April 12-October 13, 2016
Data Submitted: November 29, 2016
Revised: December 15, 2016

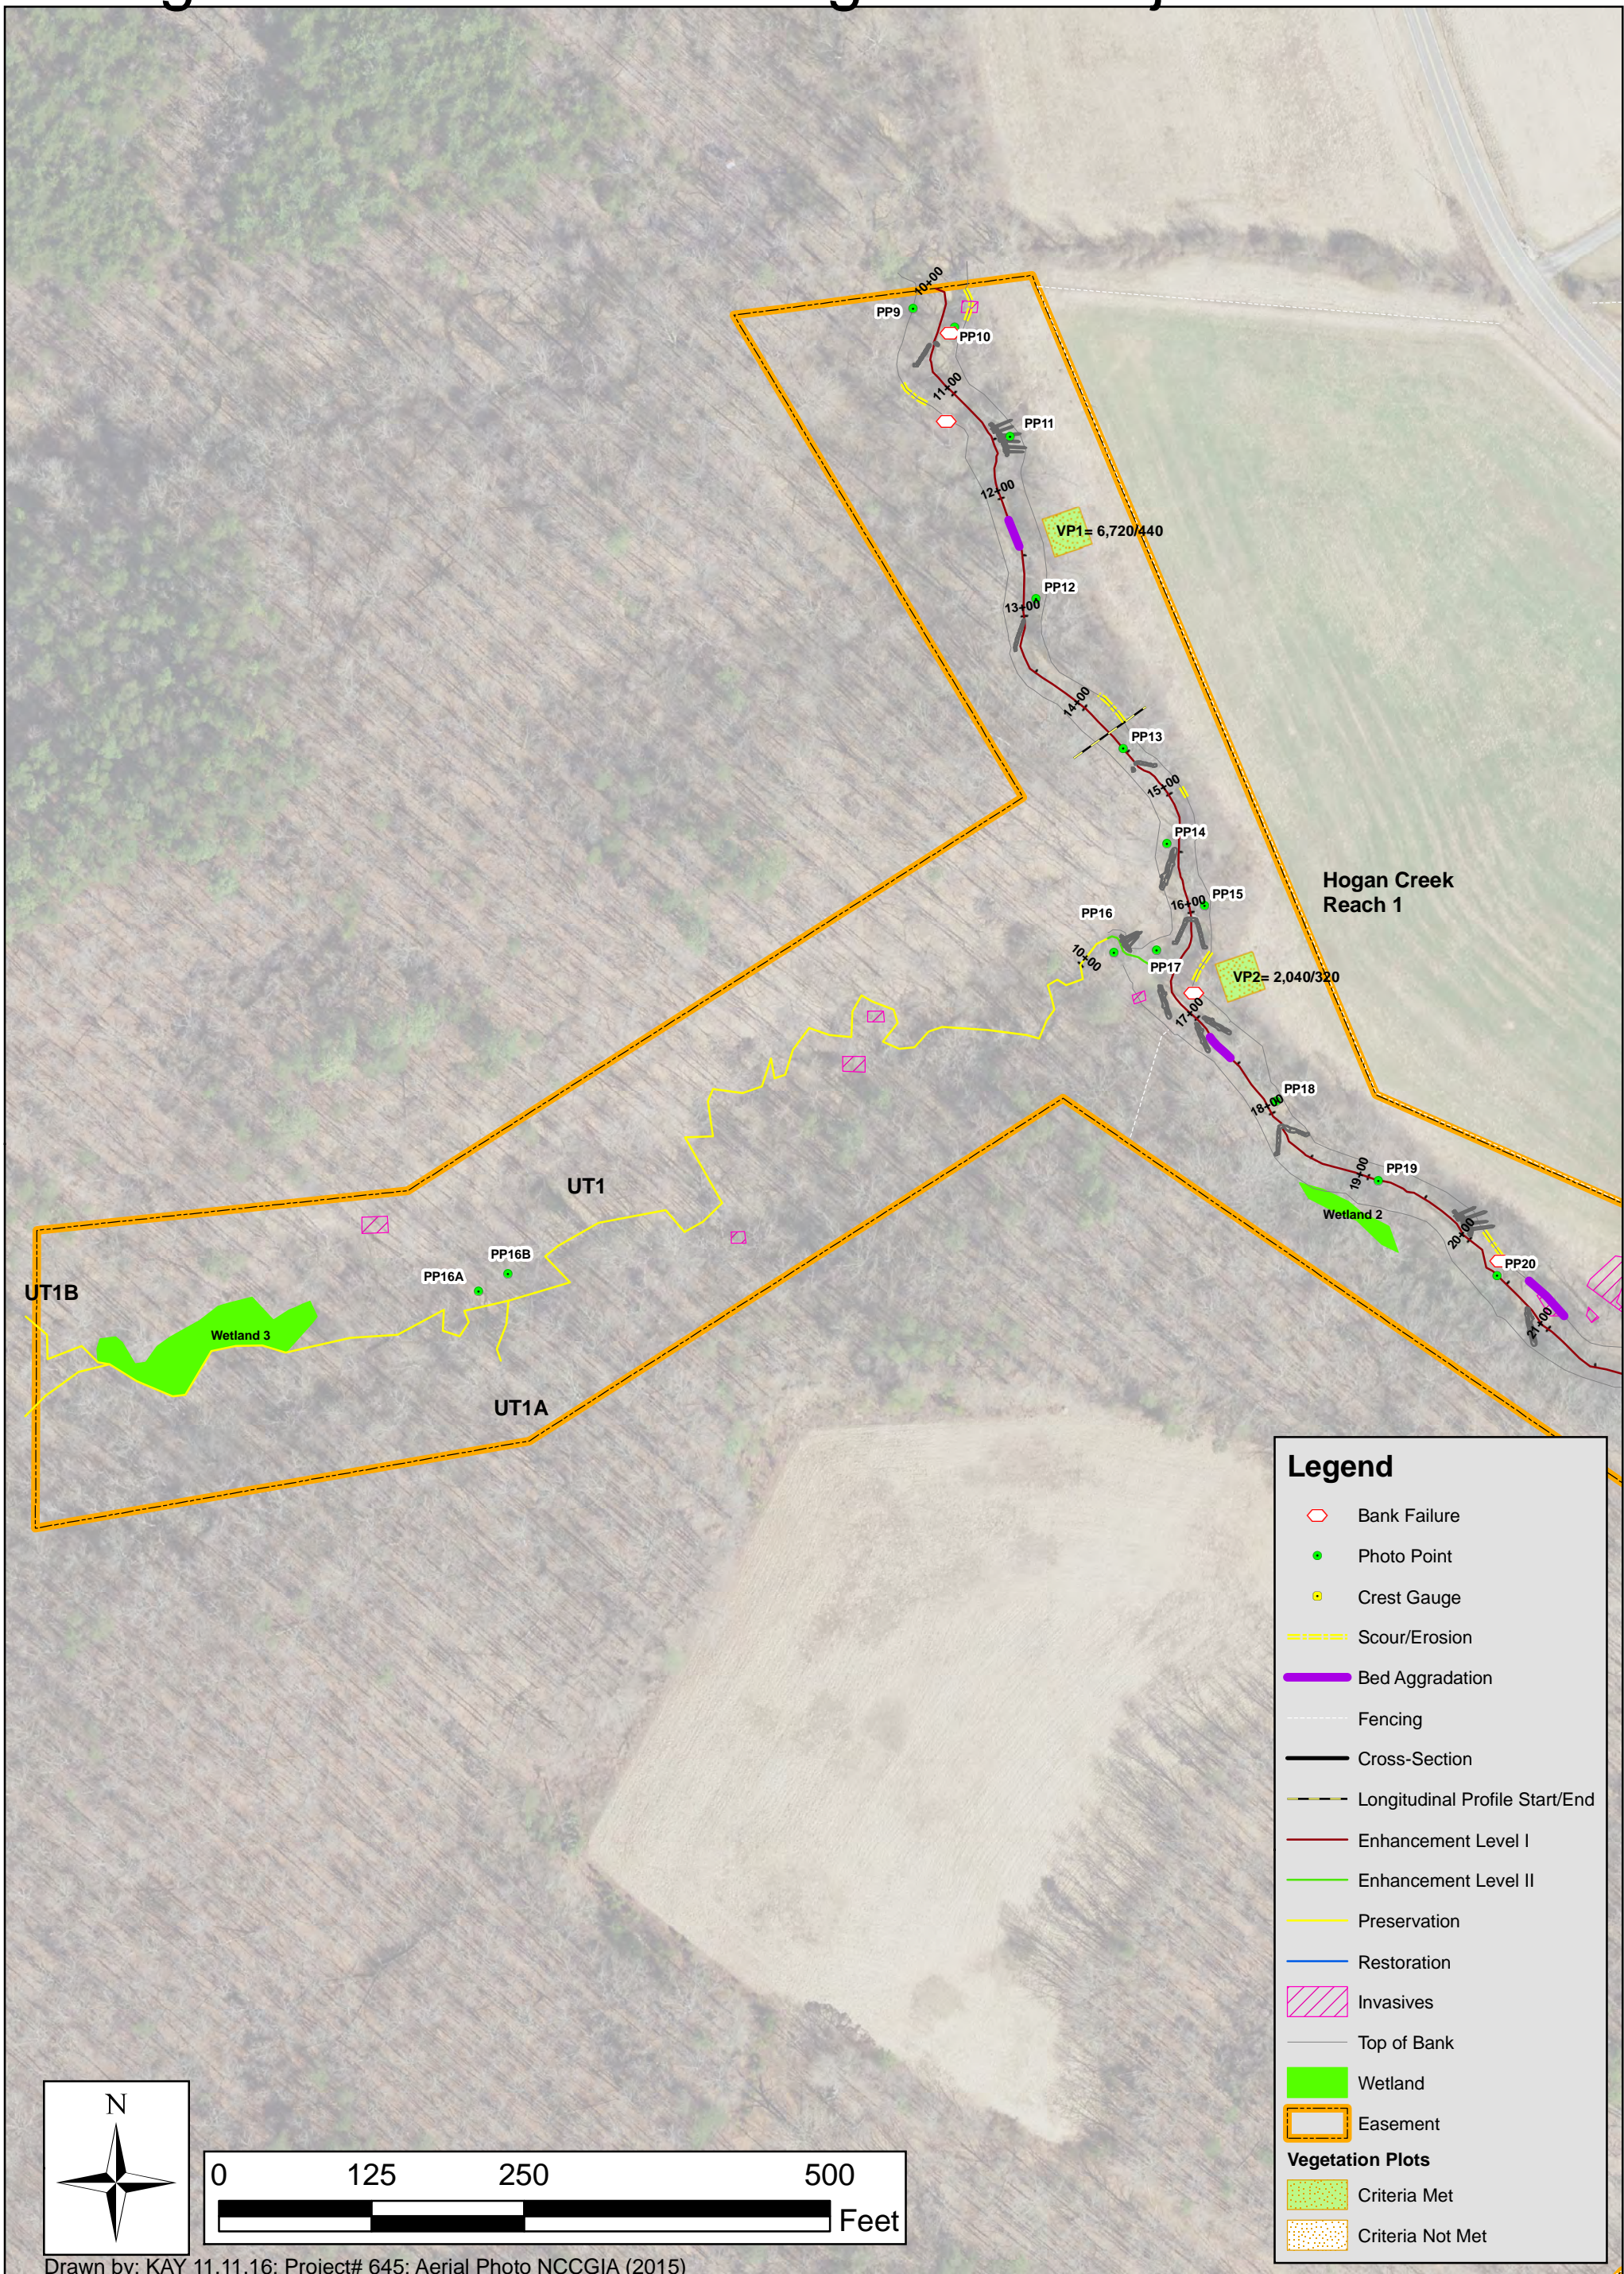
Figure 2 Sheet 1

MY2 data indicate that bank erosion and bed aggradation are issues on portions of Hogan Creek, while UT2 and UT3 are stable and performing well. Eight areas of bank erosion were observed in Hogan Creek Reach 1, and two were observed in Hogan Creek Reach 2. These areas, which are indicated on the CCPV, total about 13 percent of the total reach length. Six of these ten areas were noted and documented during MY1 monitoring efforts while the other four are new areas. The initial six areas appear to be related to sediment deposition and bank retreat following flooding that occurred at the site in October 2015. The four new areas are likely related to flood events documented in 2016. Five of the erosional areas have stabilizing woody vegetation nearby, while the other five do not. The latter five areas appear to be trending toward less stable conditions and likely warrant adaptive management in MY3.

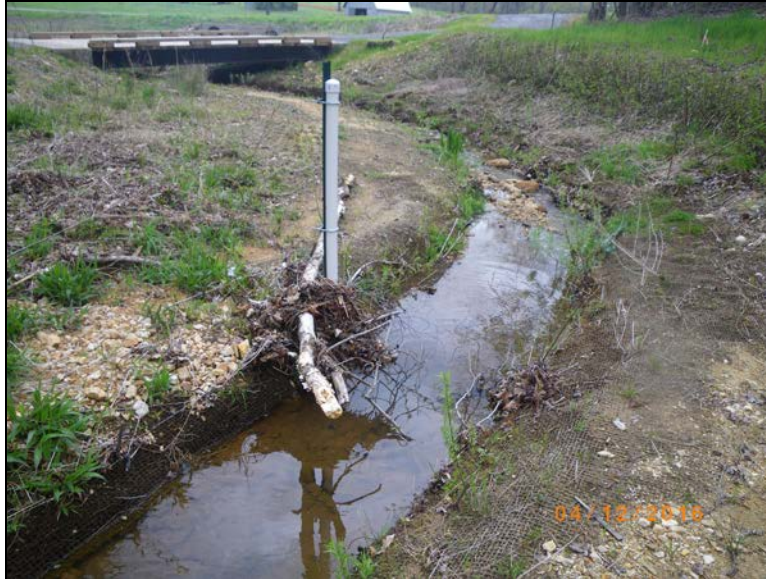
Photo 1. Wrack lines on UT2 Station 13+25, April 12, 2016

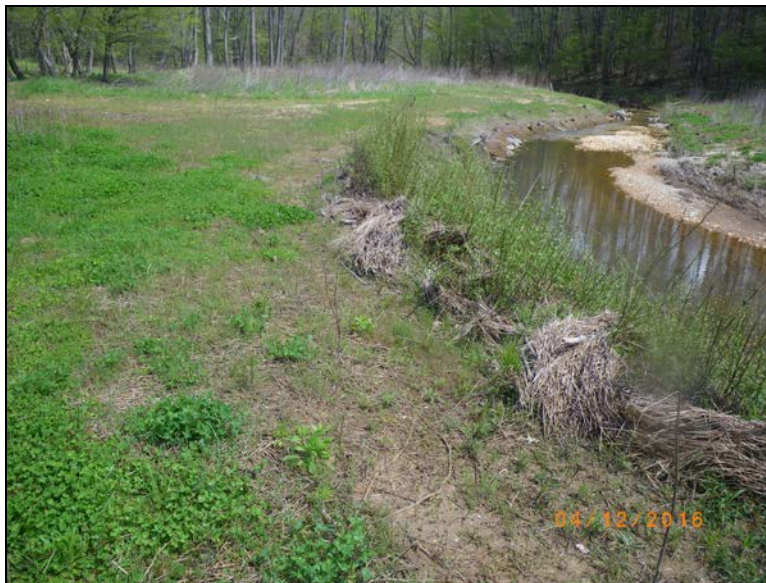
Photo 2. Wrack lines on Hogan Creek Reach 3 Station 36+00, April 12, 2016

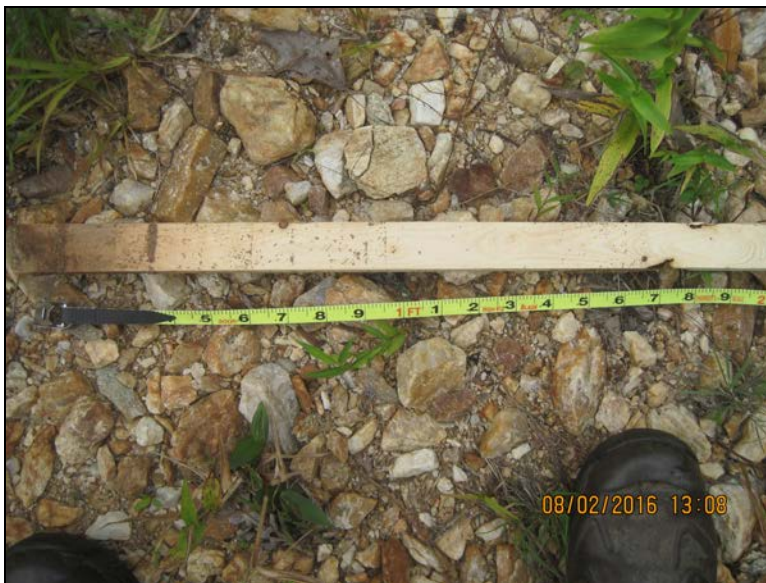
*Crest Gauge was damaged from bankfull event

Photo 4. UT2 Crest Guage, Station 13+25, 0.79 Ft., August 2, 2016
