MONITORING YEAR 3 ANNUAL REPORT

HOGAN CREEK STREAM MITIGATION PROJECT

Surry County, NC

NCDMS Project Number 94708

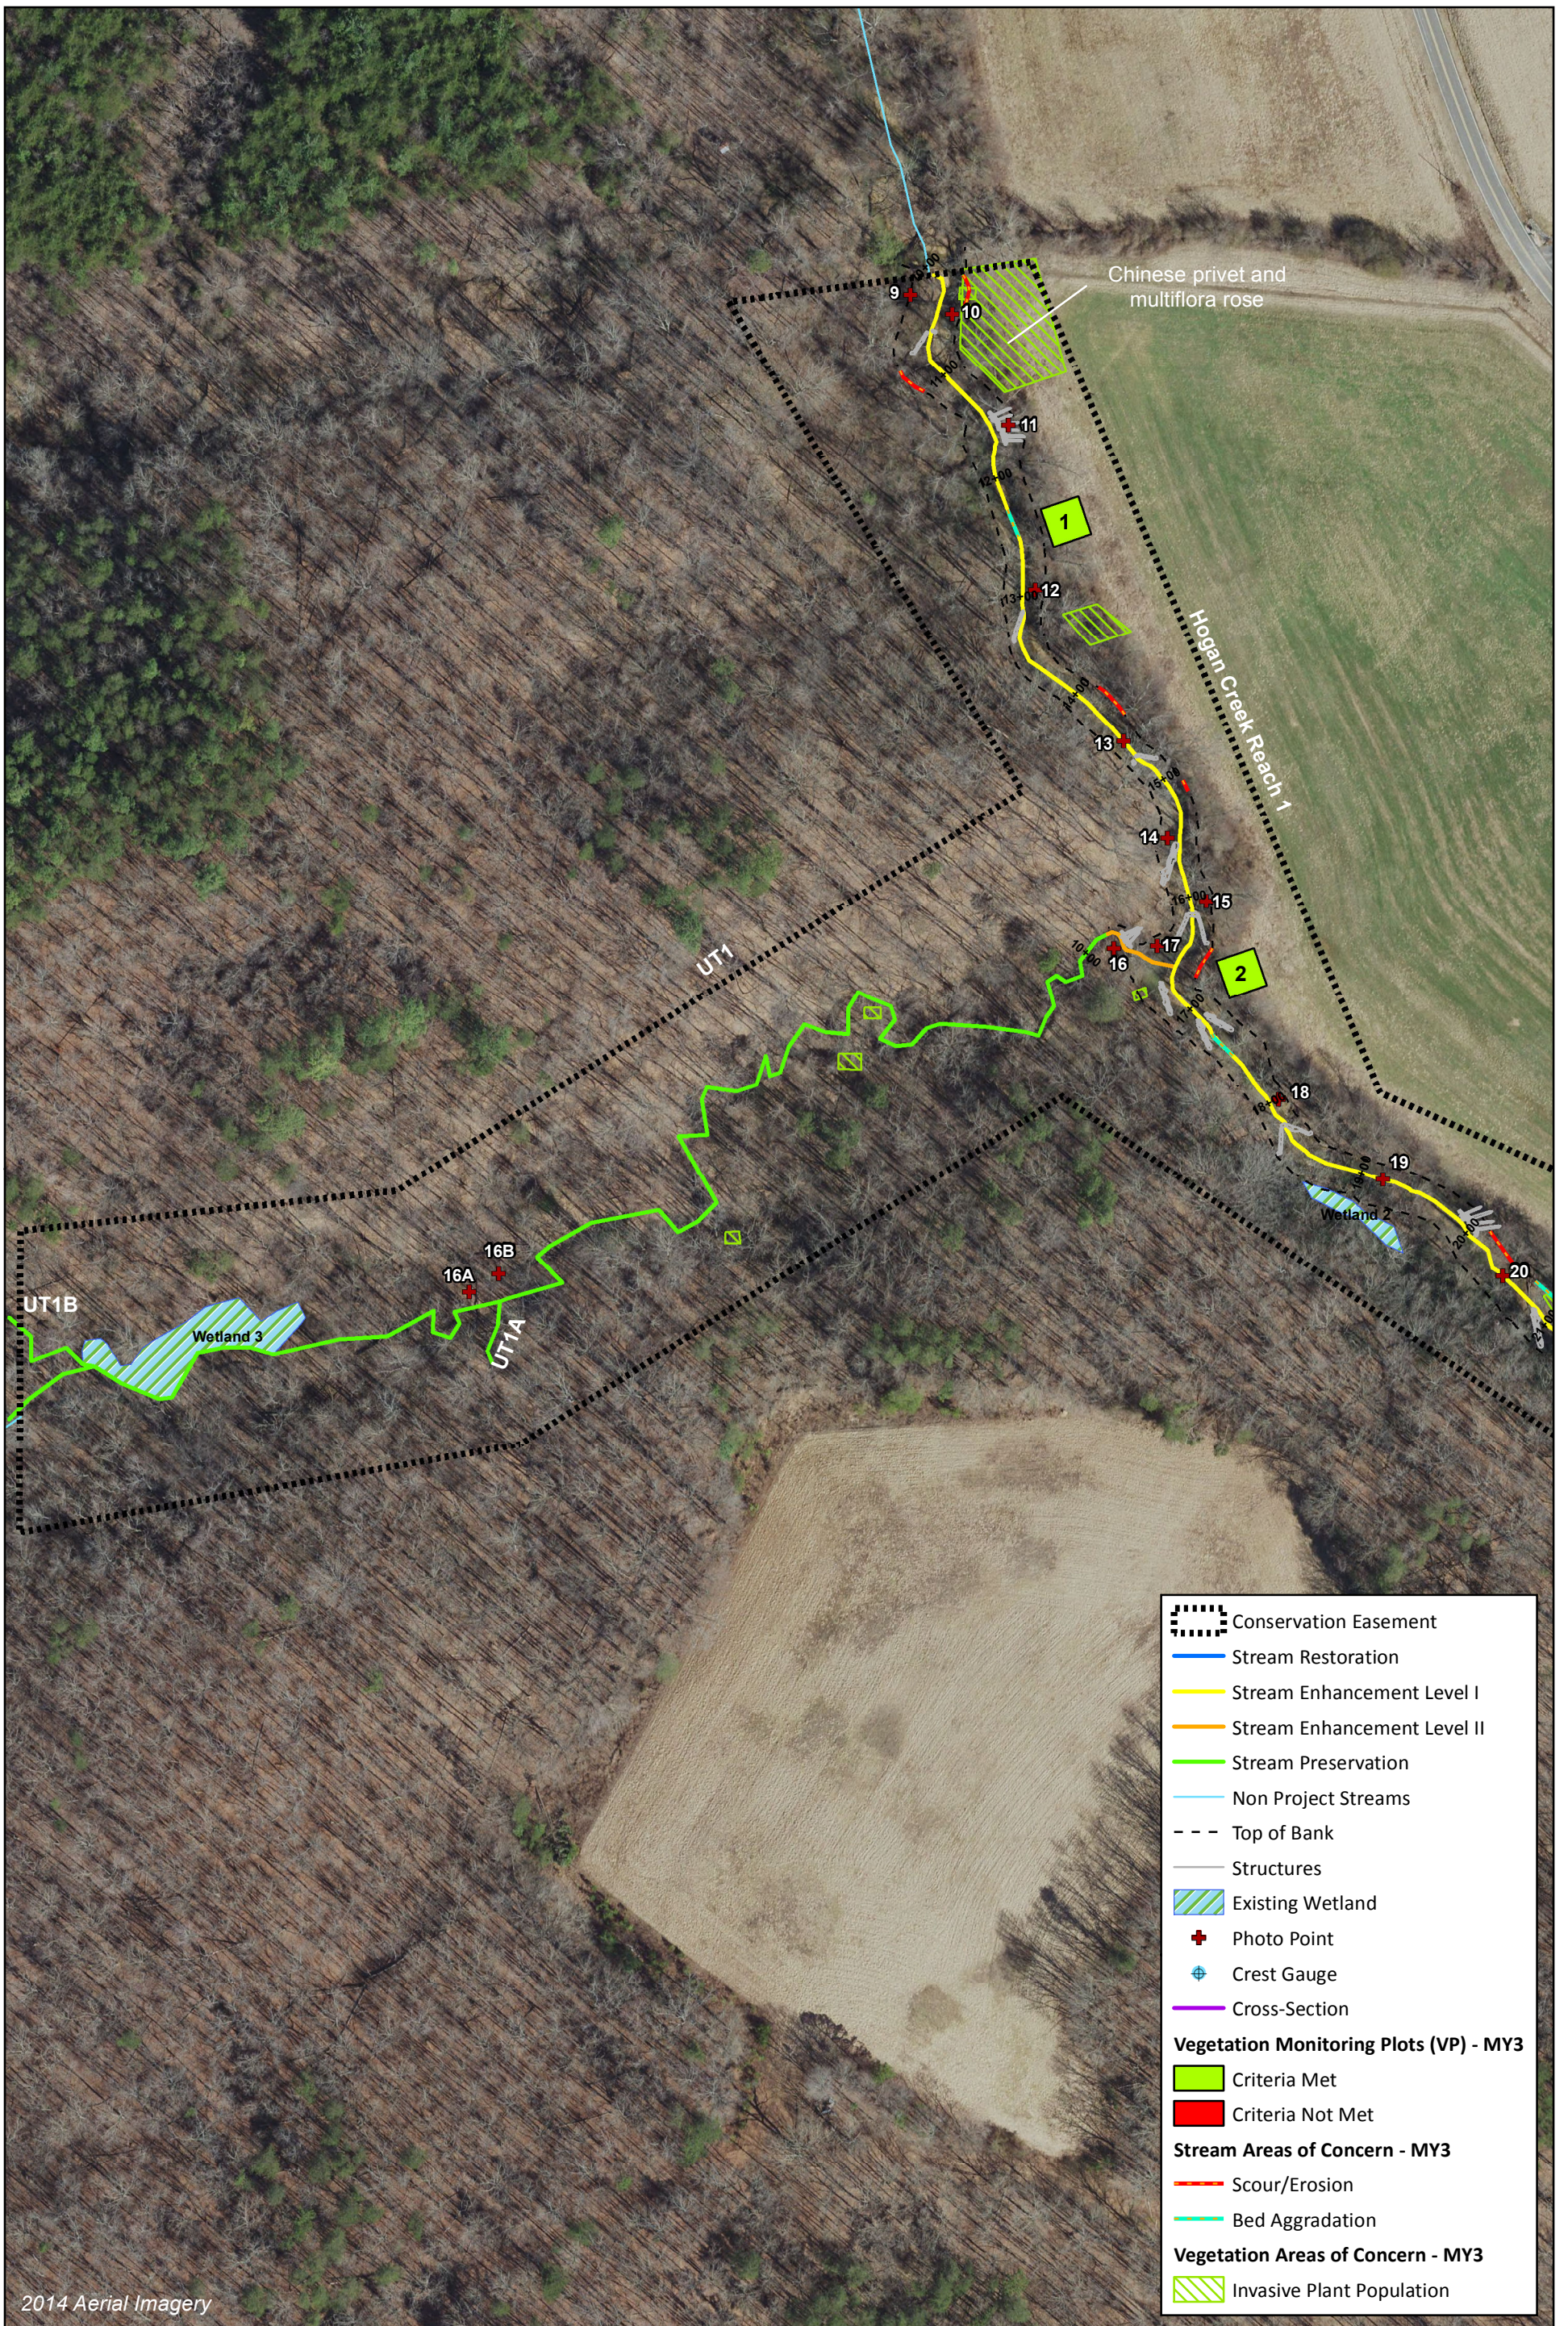
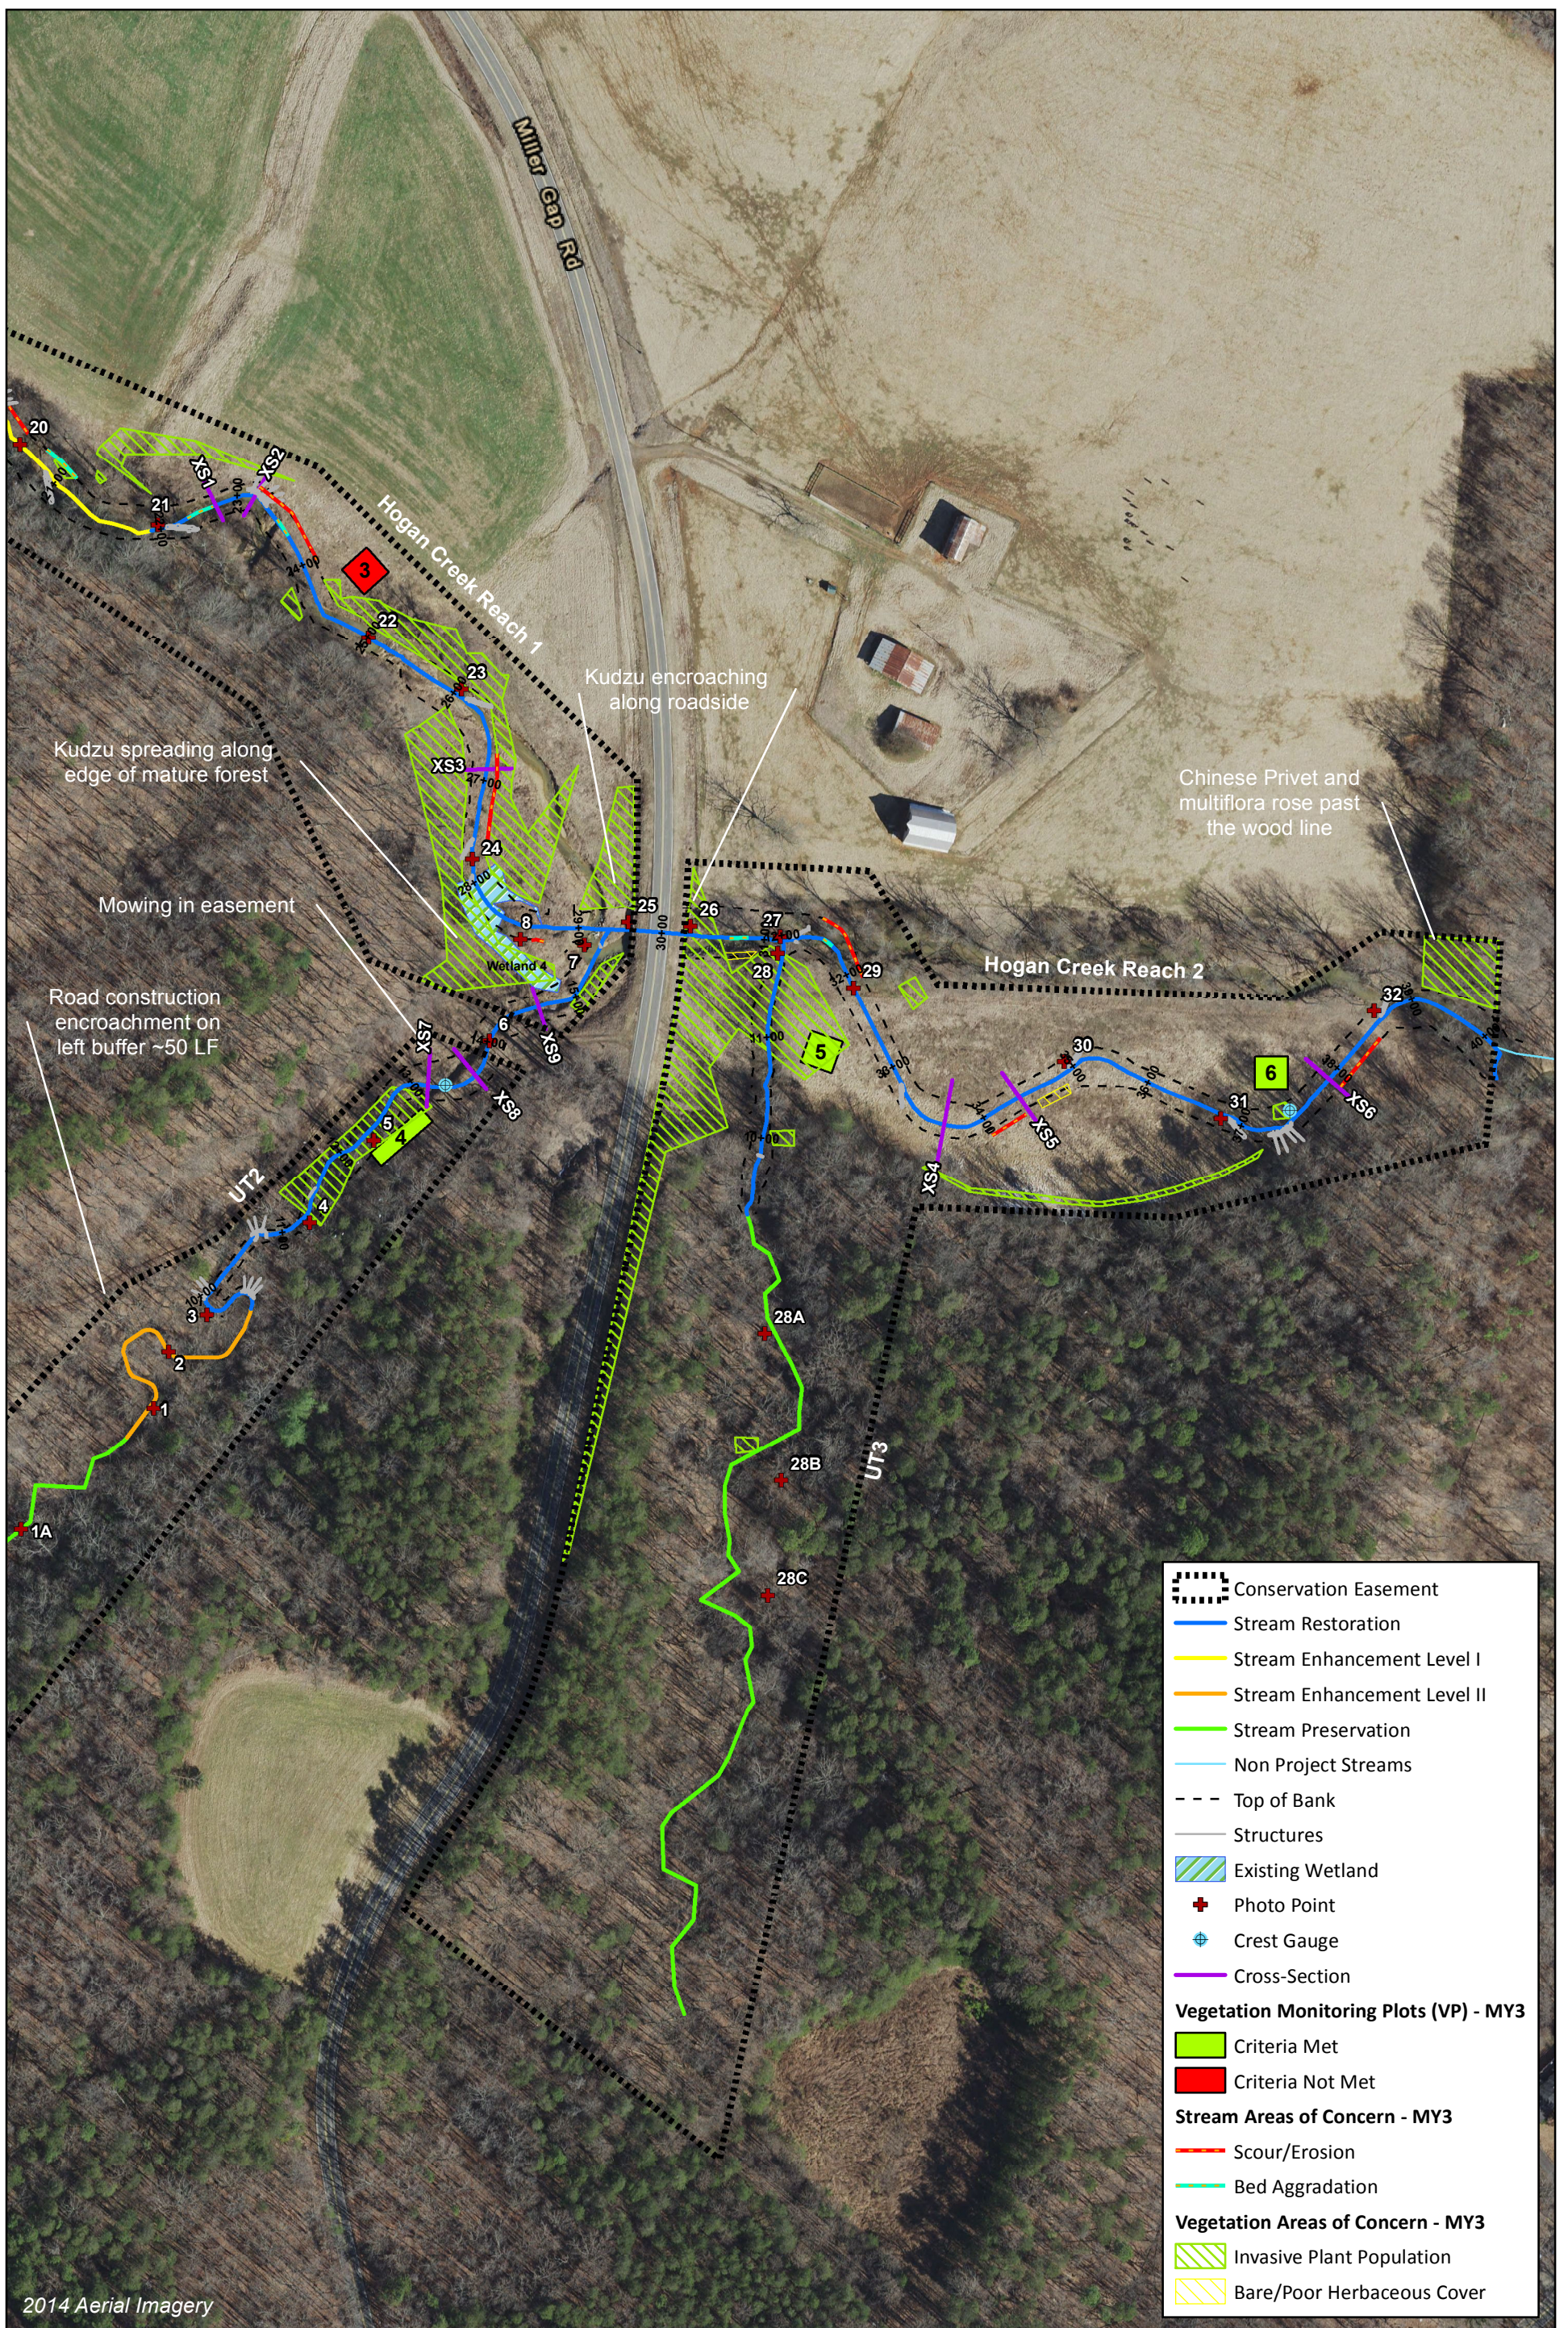
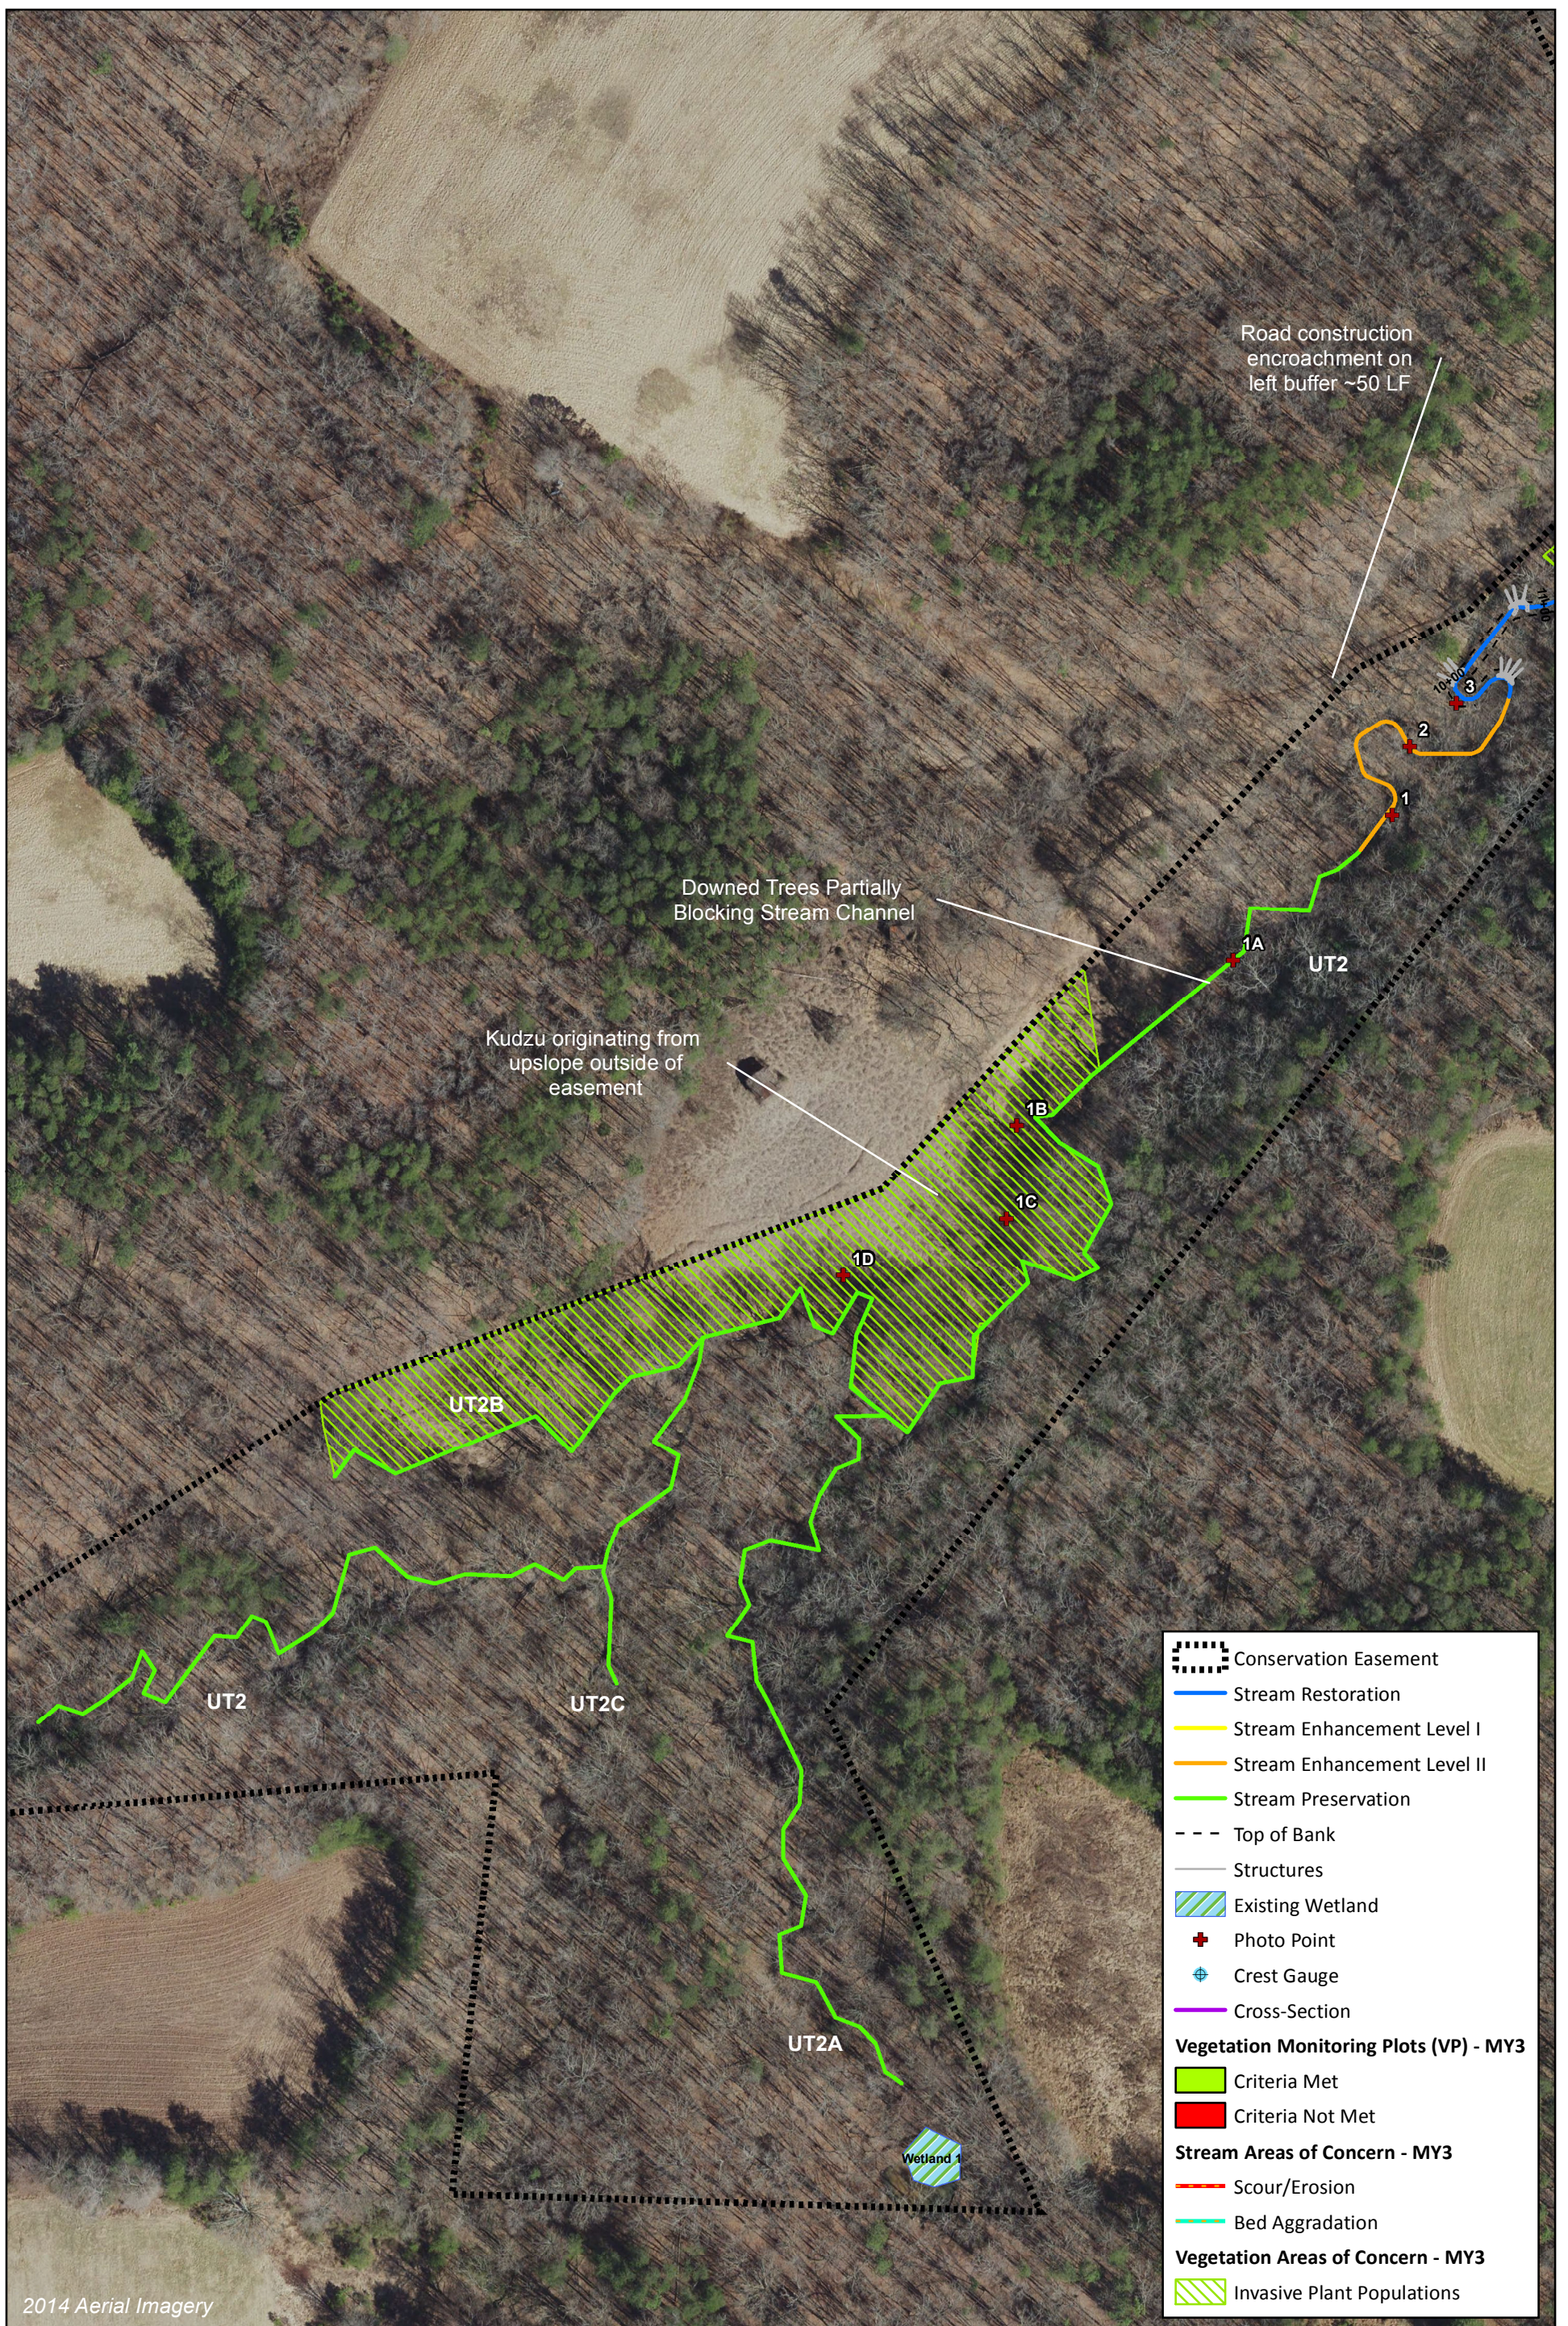
Stream areas of concern included instances of bank erosion and sediment deposition on portions of Hogan Creek. Nine areas of bank erosion were observed in Hogan Creek Reach 1 and three were observed in Hogan Creek Reach 2. Ten of these areas of bank erosion were noted in MY2 with two new areas noted in MY3. In Hogan Creek Reach 1, approximately 7% of both banks are unstable due to erosion with no stabilizing woody vegetation. Downstream, about 6% of both banks are unstable due to erosion on Hogan Creek Reach 2. Areas with no woody vegetation nearby appear to be trending toward less stable conditions. DMS has contracted with a provider to perform site evaluation, design and construction oversight for a repair on Hogan Creek. The repair is scheduled to be constructed in November 2018. These stream areas of concern are indicated on the current condition plan view Figure 3 and Table 6 in Appendix B.

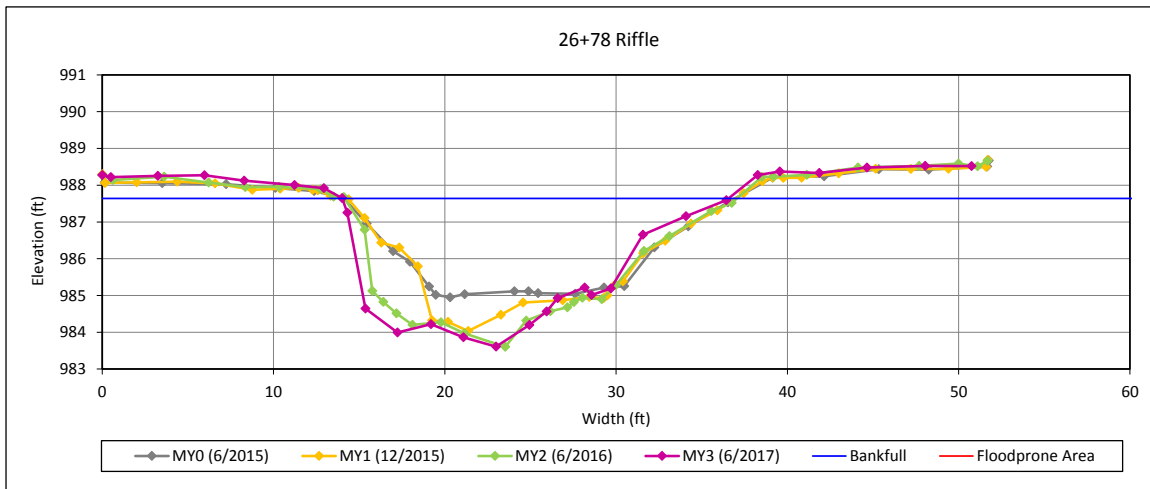
Cross-Section 3-Hogan Creek Reach 1

Cross-section data indicate modest changes between MY2 and MY3. Hogan Creek riffle cross-section 3 displayed a trend between MY0 and MY2 with a reduction in width-depth ratio and an increase in bankfull maximum depth. Between MY2 and MY3, cross-section 3 dimensions exhibited only modest changes indicating that the downcutting displayed in previous years has stabilized. Hogan Creek riffle cross-section 5 data shows a decrease in width-depth ratio and an increase in cross-sectional area. This is due to the right bank erosion that has migrated downstream. Hogan Creek pool cross-sections indicate maintenance of pool maximum depths and stable function. Hogan Creek pool cross-section 4 data displays a reduction in cross-sectional area between MY0 and MY3 due to the expansion of the point bar. Cross-section data from UT2 indicate some change in bankfull dimensions compared to the baseline. UT2 cross-section data indicate moderate change in width-depth ratio at the two riffles and a modest increase in maximum depth at the pool cross-section. Visual observations of UT2 indicate overall stability. Similarly, UT1 and UT3 appear stable and functioning as intended. Please refer to Appendix D for cross-section plots with annual overlays and Table 12 for morphology and hydraulic summary.

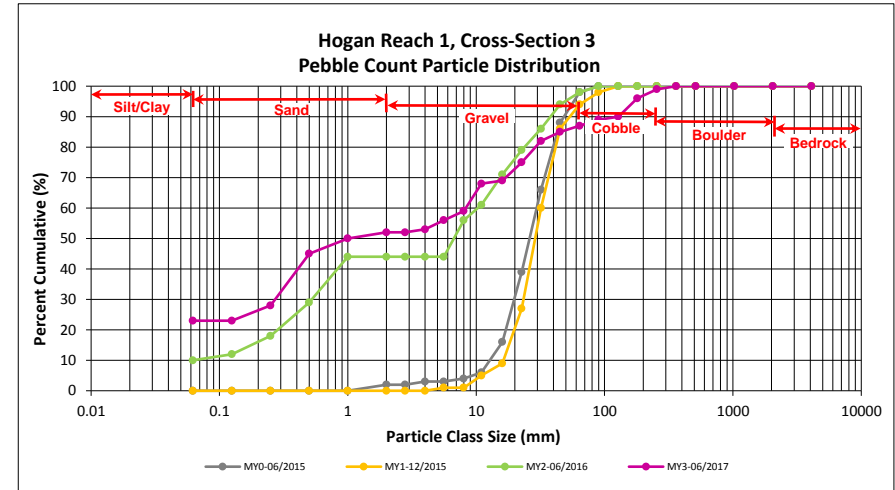
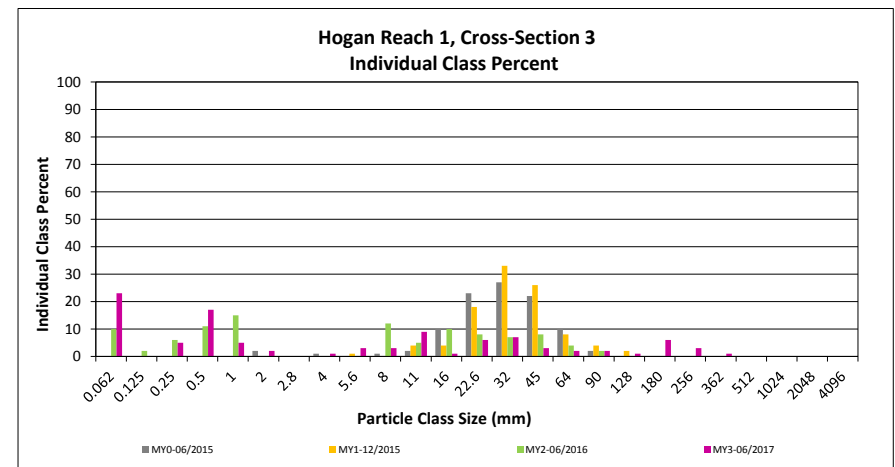
Cross Section 3	
Channel materials (mm)	
D ₁₆ =	Silt/Clay
D ₃₅ =	0.33
D ₅₀ =	1.0
D ₈₄ =	40.2
D ₉₅ =	170.1
D ₁₀₀ =	362.0

Morphological surveys for MY3 were conducted in June and July 2017. The MY3 riffle pebble counts in Hogan Creek for cross-sections 1, 5, and 6 indicate similar or coarser sediment size distribution as compared to MY0. The D_{50} values for these cross-sections have all increased as compared to MY2. For the riffle pebble count at cross-section 3, the sediment size distribution has remained consistent with MY2 which shows a fining of riffle bed materials. This increase in fine sediment size percentage may be indicative of excess fine sediment inputs from the watershed and movement of coarse sediment during large bankfull events. Refer to Appendix D for pebble count plots with annual overlays.
