# MONITORING YEAR 4 ANNUAL REPORT

## HOGAN CREEK STREAM MITIGATION PROJECT

Surry County, NC

DMS Project Number 94708

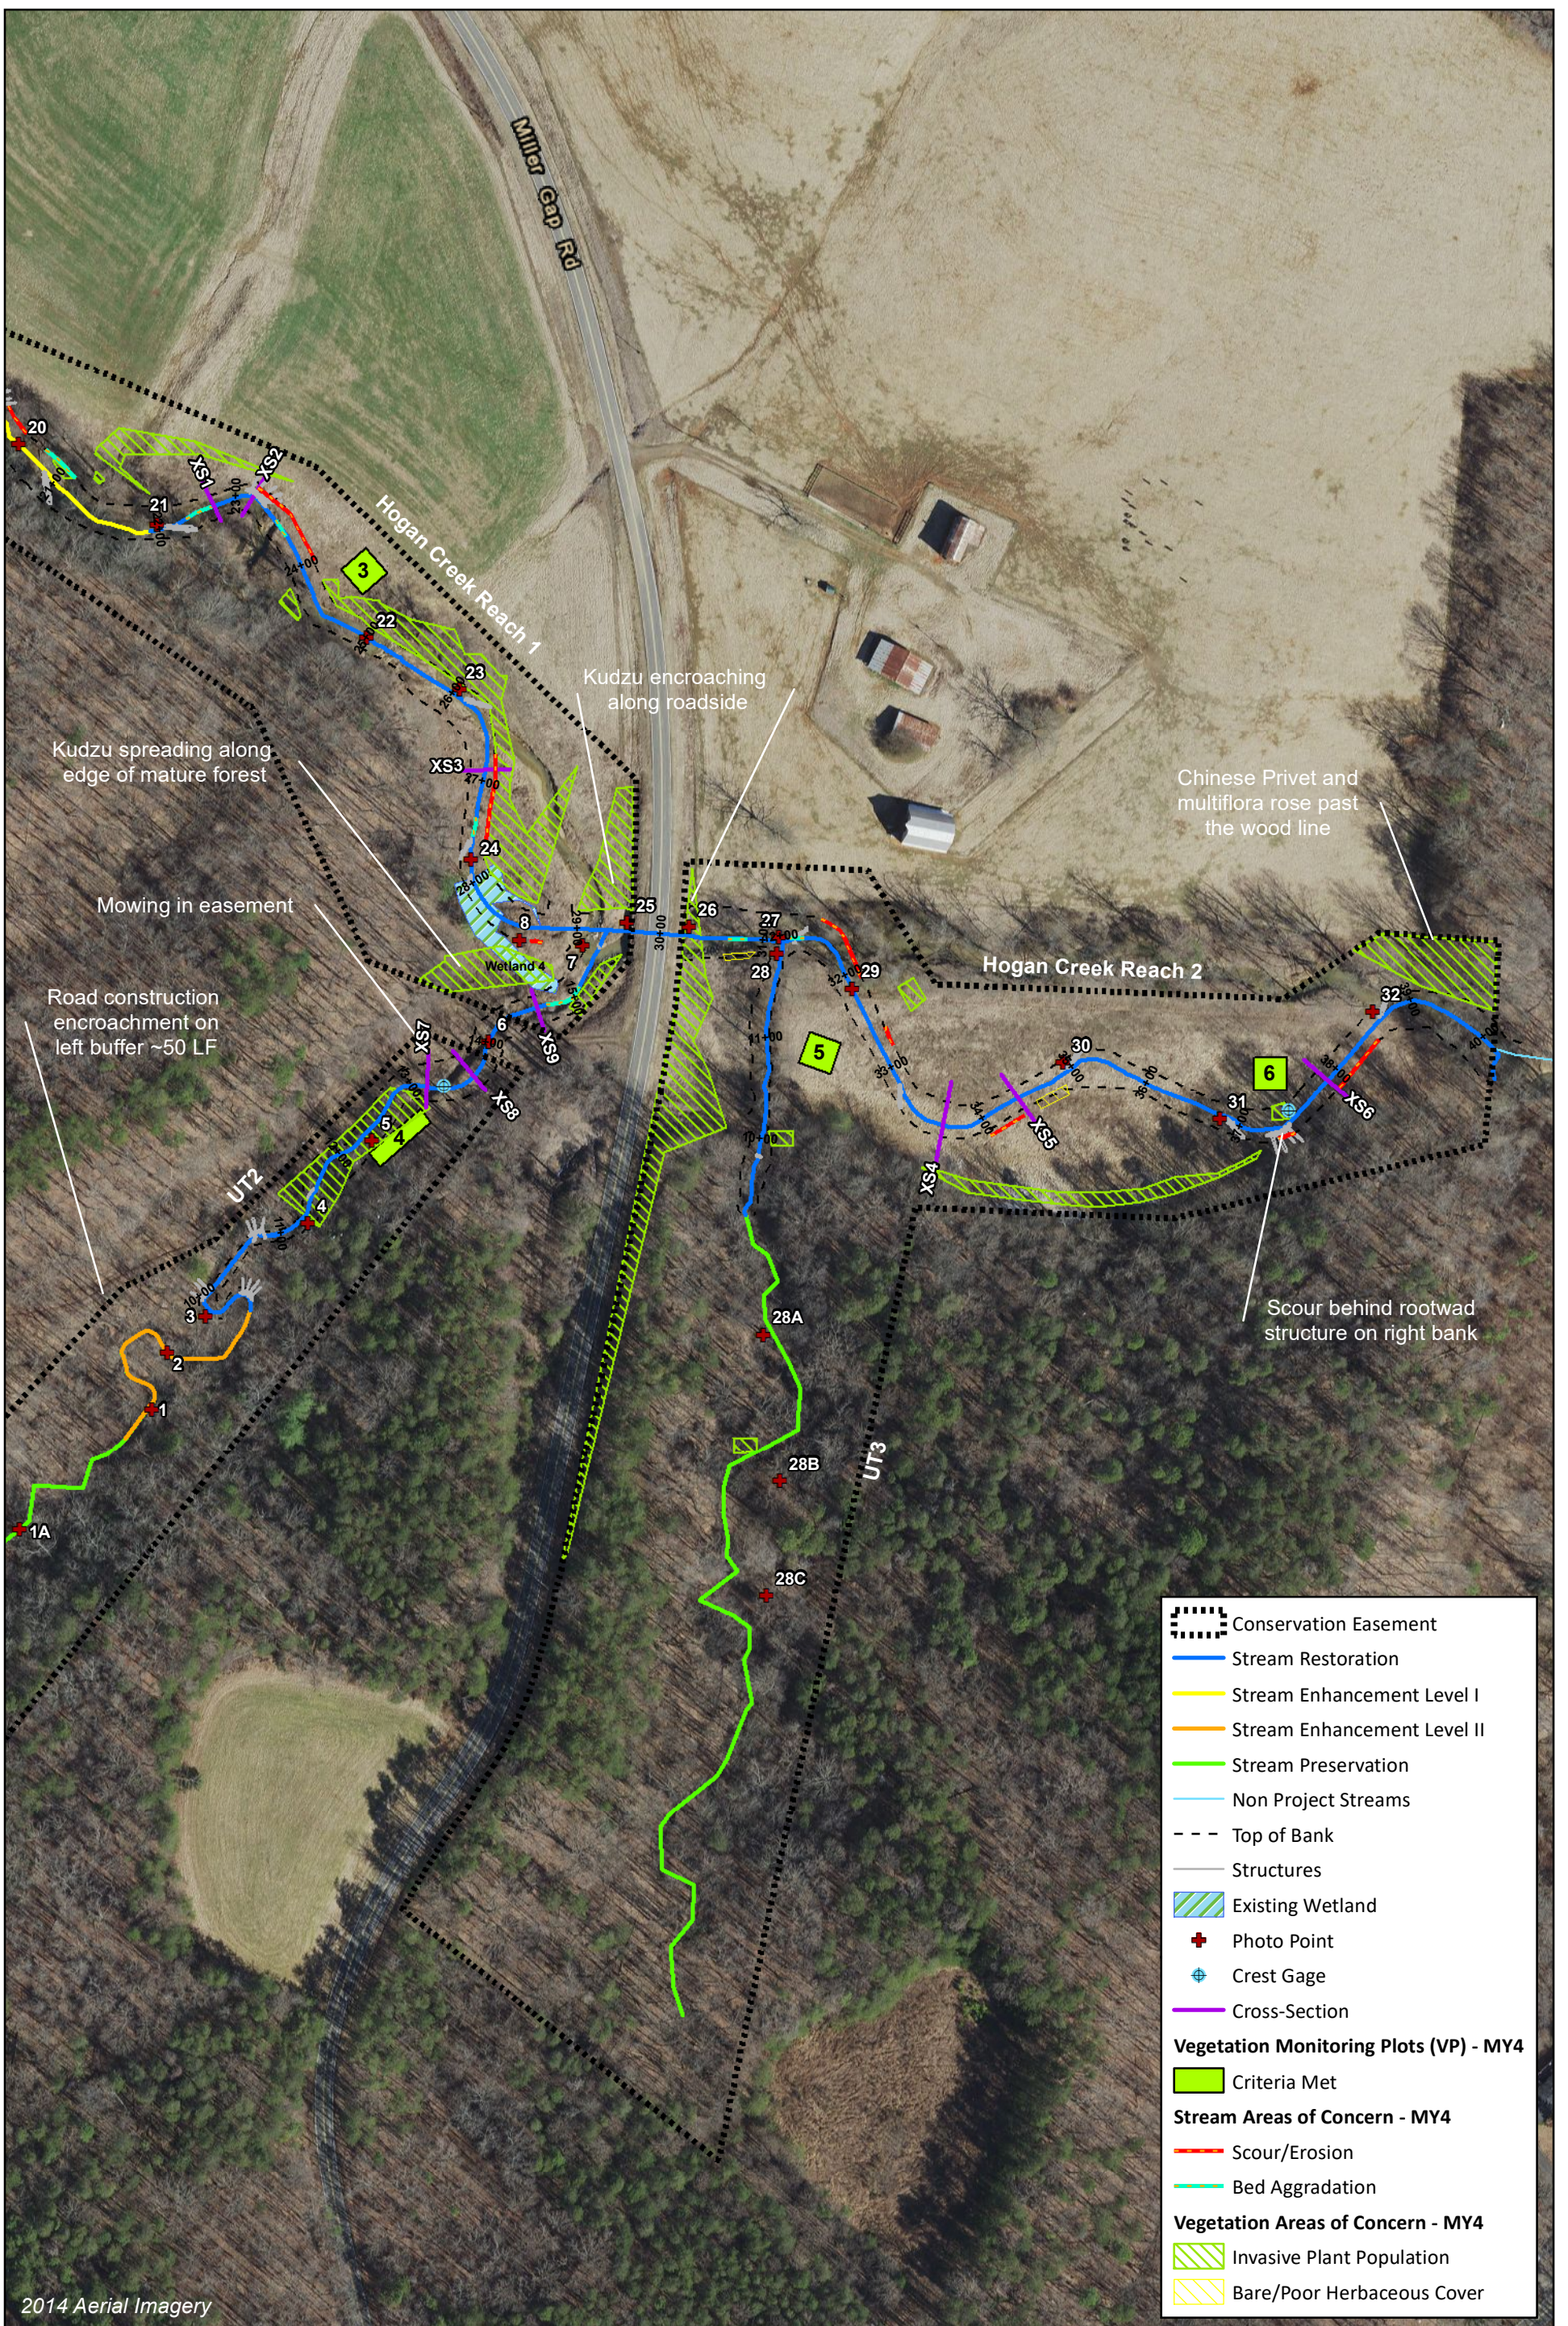
Figure 3.2 Integrated Current Condition Plan View Map (Sheet 2 of 3)  
 Hogan Creek Stream Mitigation Project  
 DMS Project No. 94708  
 Monitoring Year 4 - 2018  
 Surry County, NC

Stream areas of concern included instances of bank erosion and sediment deposition on portions of Hogan Creek and UT2. Nine areas of bank erosion were observed in Hogan Creek Reach 1 and five were observed in Hogan Creek Reach 2. Twelve of these areas of bank erosion were noted in MY3 with two new areas noted in MY4. In Hogan Creek Reach 1, approximately 7% of both banks are unstable due to

erosion with no stabilizing woody vegetation. Downstream, similarly about 10% of both banks are unstable due to erosion on Hogan Creek Reach 2. Areas with no woody vegetation nearby appear to be trending toward less stable conditions. DMS has contracted with a provider to perform site evaluation, design and construction oversight for a repair on Hogan Creek. The repair construction to Hogan Creek Reach 1 and Reach 2 will begin in January 2019. These stream areas of concern are indicated on the current condition plan view Figure 3 and Table 6 in Appendix B.
