MONITORING YEAR 5 ANNUAL REPORT

HOGAN CREEK STREAM MITIGATION PROJECT

Surry County, NC

DMS Project Number 94708

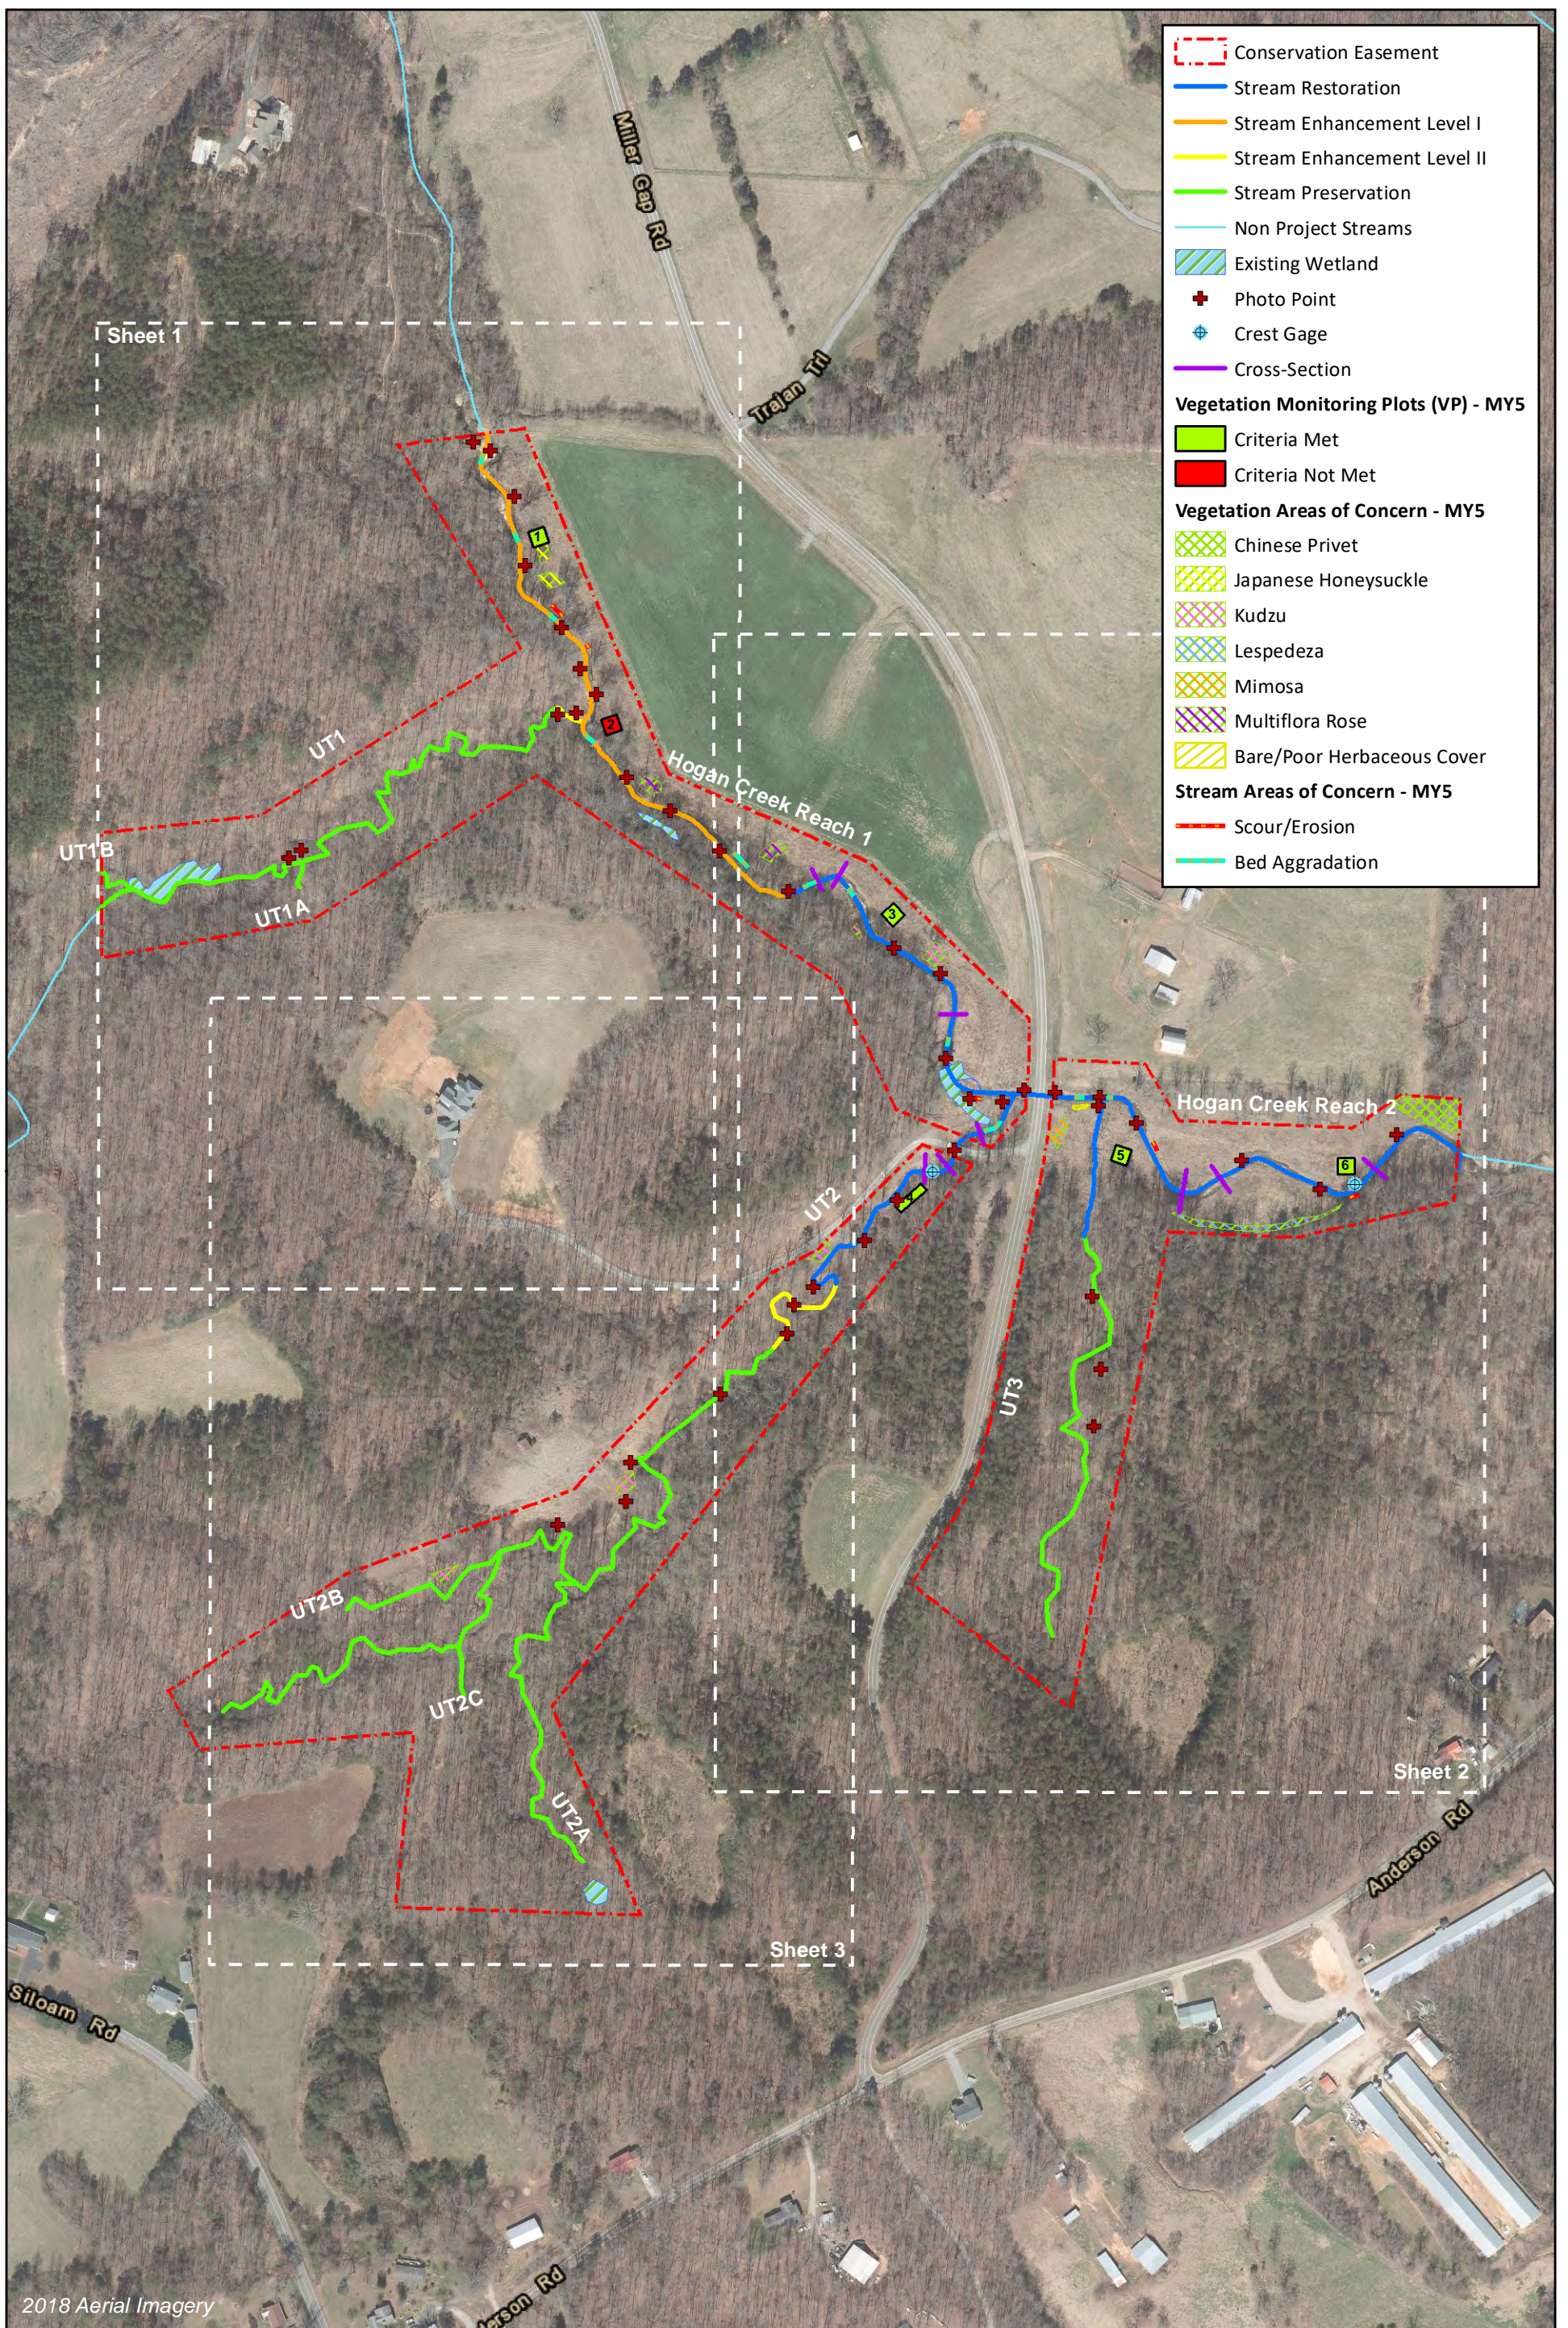
Figure 3.0 Integrated Current Condition Plan View Map (Key)
 Hogan Creek Stream Mitigation Project
 DMS Project No. 94708
 Monitoring Year 5 - 2019

In previous monitoring years, several significant stream areas of concern were noted on Hogan Creek Reach 1 and Reach 2 near stations 10+20, 10+80, 16+50, 20+10, 23+20, 26+70, 31+30, 34+00, and 37+70. To address previously noted areas of bank erosion, construction repairs on Hogan Creek began in January 2019 and concluded in March 2019. The repairs appear to be performing well and livestock vegetation already becoming well established on the banks. These repairs have decreased bank erosion along Reach 1 of Hogan Creek from 9% in MY4 to 1% in MY5 and along Hogan Creek Reach 2, from 10% in MY4 to 2% in MY5. Please refer to a photolog of the repair work in Appendix B. Additional areas of concern are depicted on the current condition plan view Figures 3.0-3.3 and Table 6 in Appendix B.

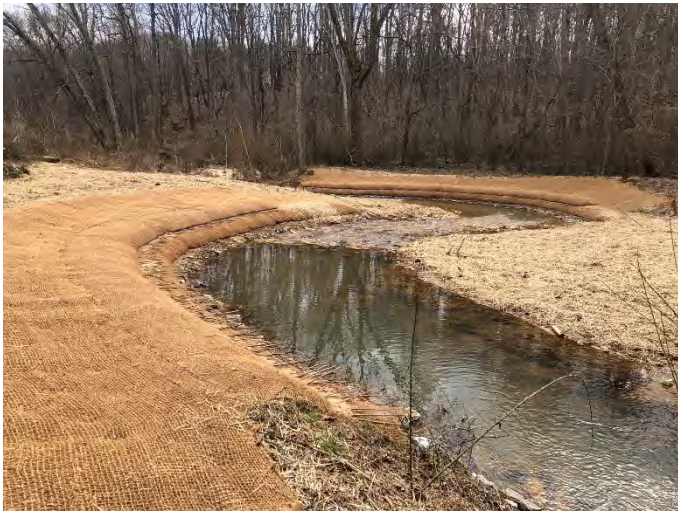
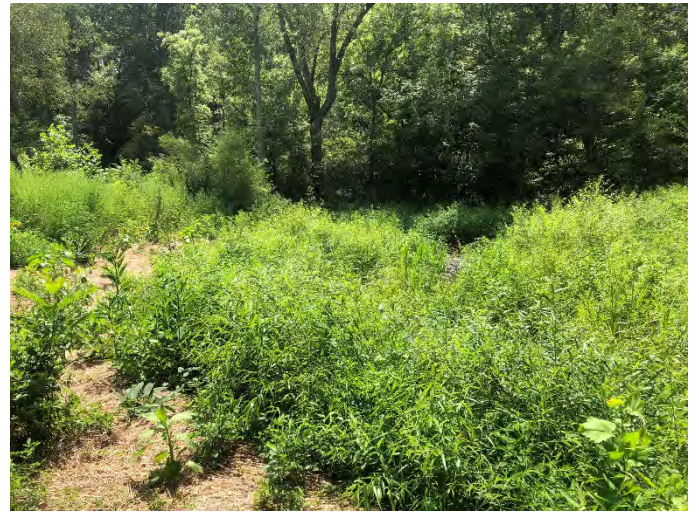
Hogan Creek Reach 1 STA 10+20 left bank and 10+80 right bank repairs – (3/13/2019)

Hogan Creek Reach 1 STA 10+20 left bank and 10+80 right bank repairs – (8/19/2019)

To address previously noted areas of bank erosion, a repair along Hogan Creek was completed in March 2019. Approximately 980' of live lifts were installed and a constructed riffle was repaired on Hogan Reach 2. Transplants were used where possible, and disturbed areas were replanted with bare roots, live stakes and permanent/temporary seeding. Construction began in February 2019 and finished up March 2019. Following the MY4 Interagency Review Team (IRT) credit release site walk, an additional year of monitoring was requested to further assess the repairs.

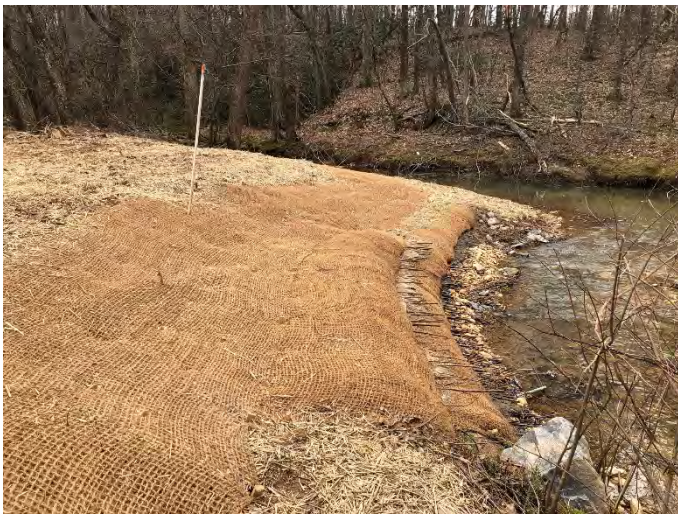
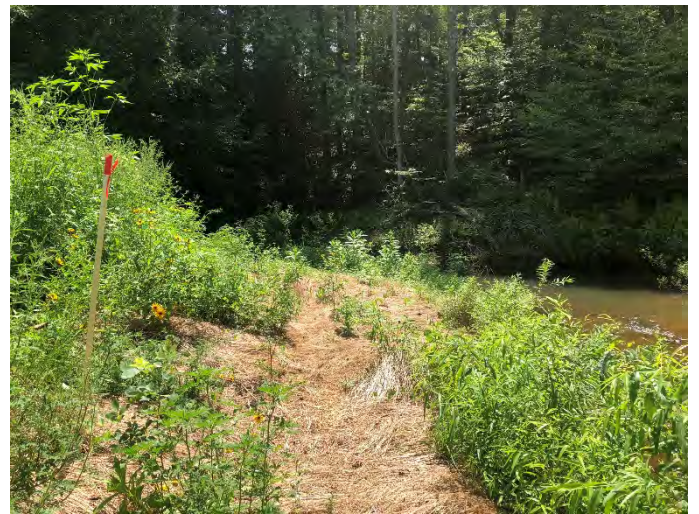
Hogan Creek Reach 1 STA 16+50 left bank repair – (3/13/2019)

Hogan Creek Reach 1 STA 16+50 left bank repair – (8/19/2019)

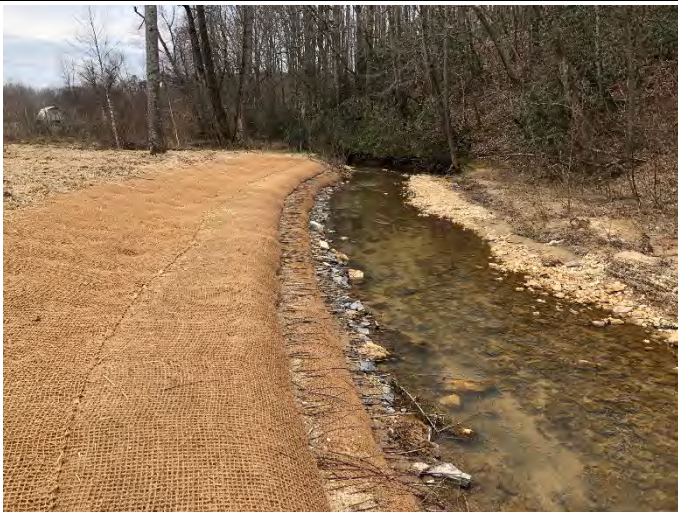
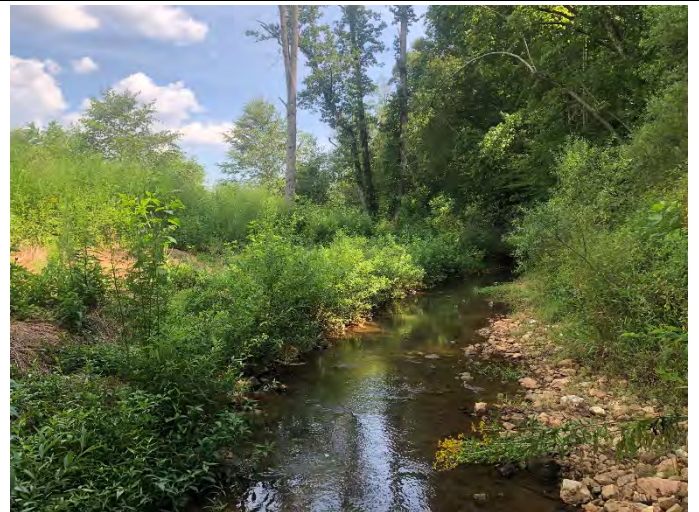
Hogan Creek Reach 1 STA 20+10 left bank repair – (3/13/2019)

Hogan Creek Reach 1 STA 20+10 left bank repair – (8/19/2019)

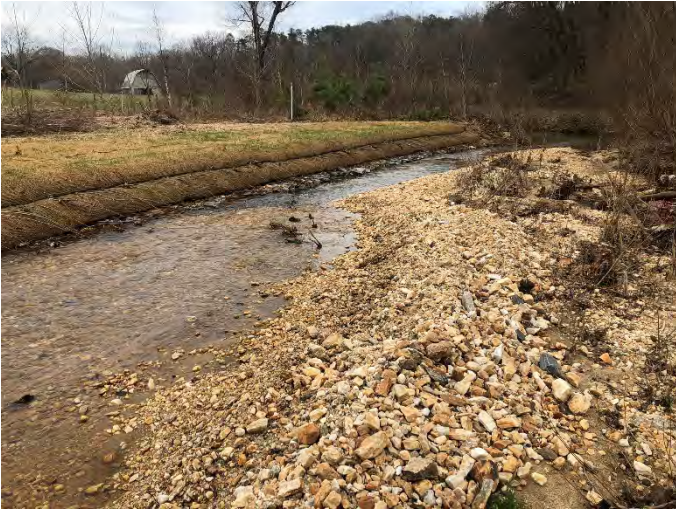
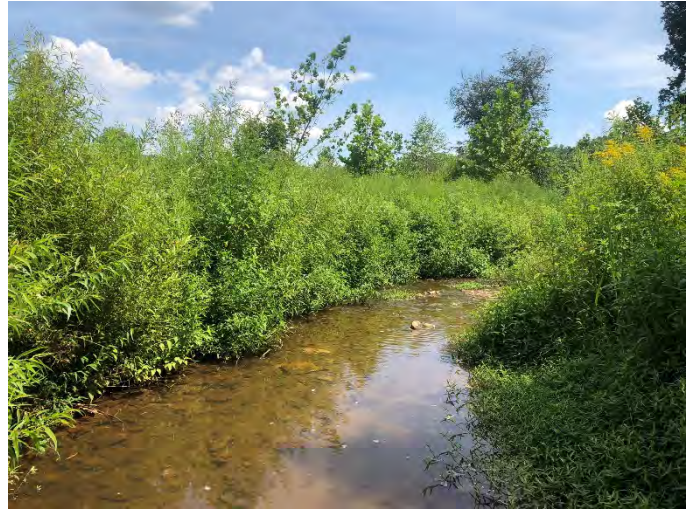
Hogan Creek Reach 1 STA 23+20 left bank repair – (3/13/2019)

Hogan Creek Reach 1 STA 23+20 left bank repair – (8/19/2019)

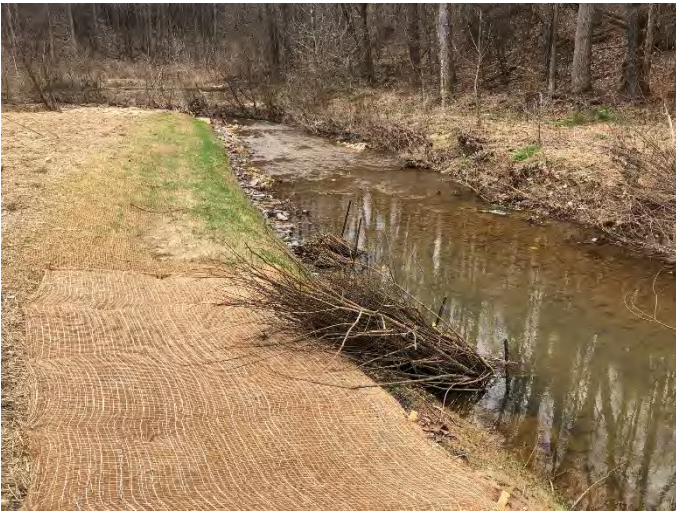
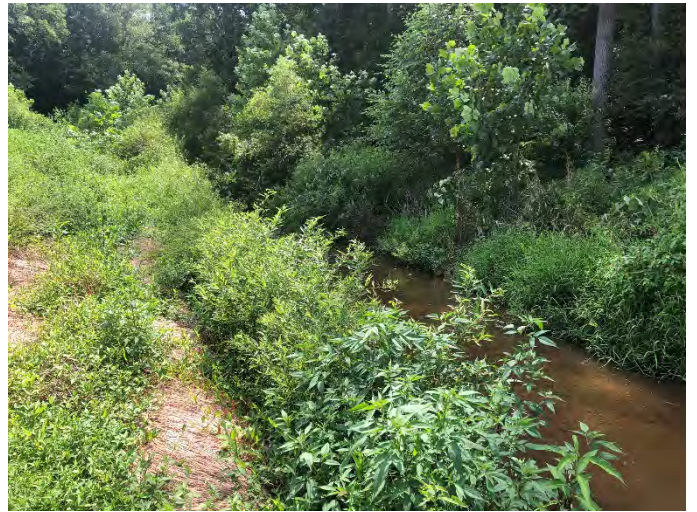
Hogan Creek Reach 1 STA 26+70 left bank repair – (3/13/2019)

Hogan Creek Reach 1 STA 26+70 left bank repair – (8/19/2019)

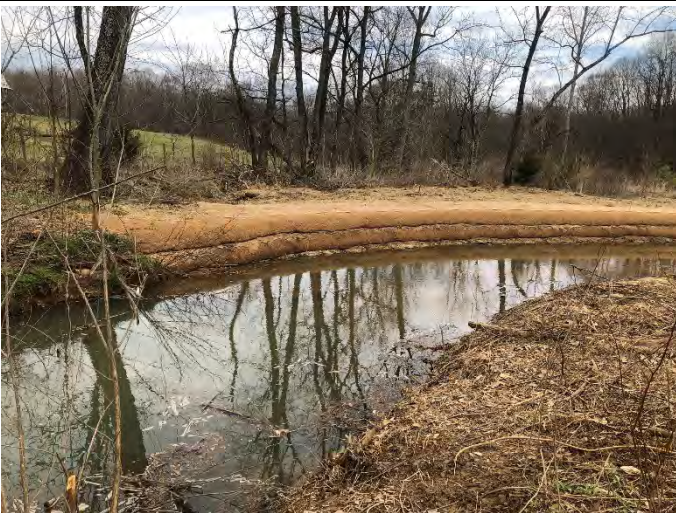
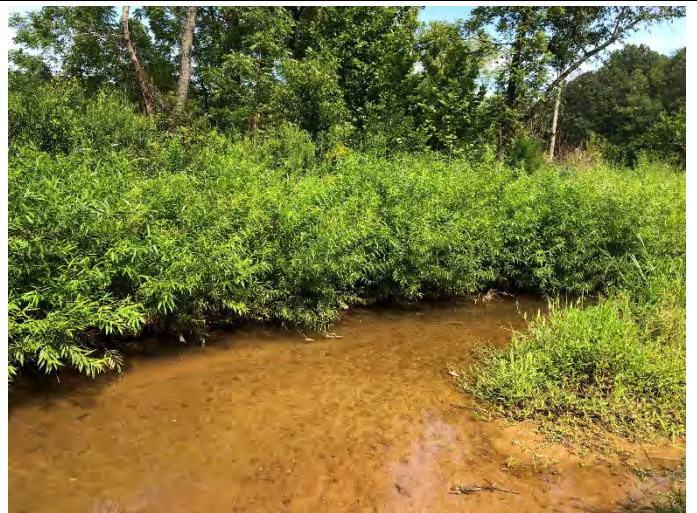
Hogan Creek Reach 2 STA 31+30 left bank repair – (3/13/2019)

Hogan Creek Reach 2 STA 31+30 left bank repair – (8/19/2019)

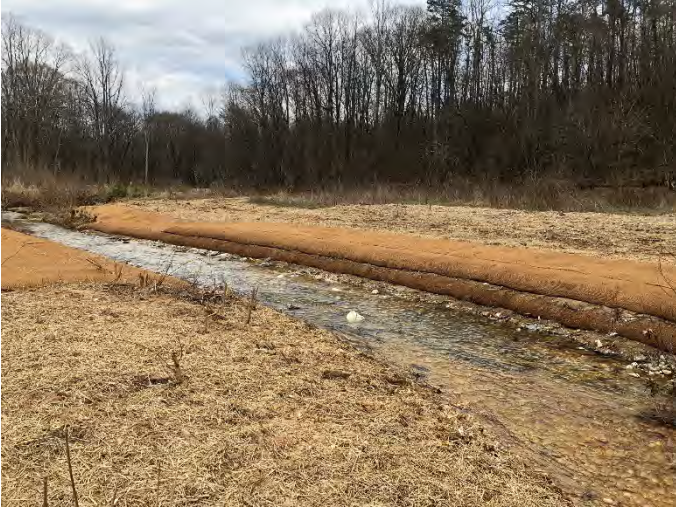
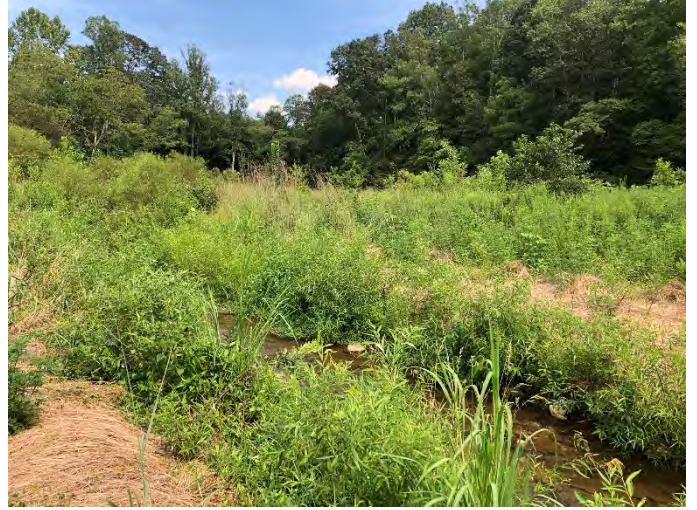
Hogan Creek Reach 2 STA 34+00 repair on both banks view downstream – (3/13/2019)

Hogan Creek Reach 2 STA 34+00 repair on both banks view downstream – (8/19/2019)

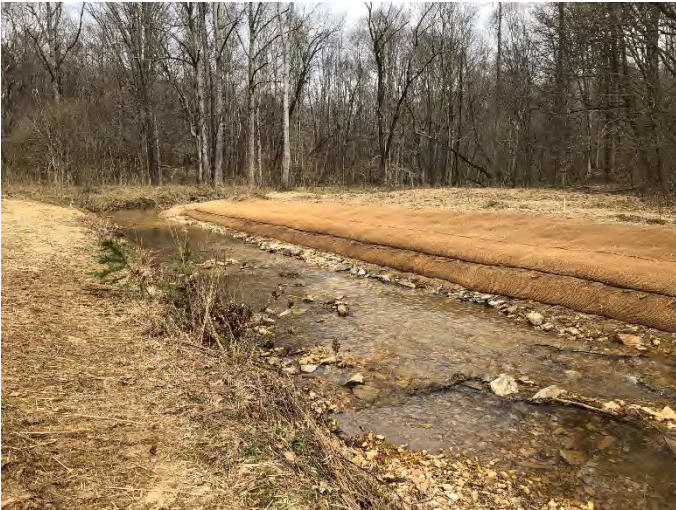
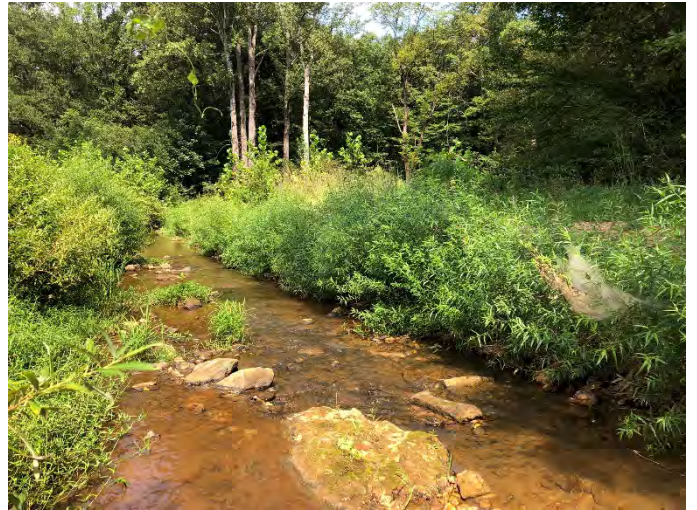
Hogan Creek Reach 2 STA 37+70 right bank repair – (3/13/2019)

Hogan Creek Reach 2 STA 37+70 right bank repair – (8/19/2019)
