MONITORING YEAR 6 ANNUAL REPORT

HOGAN CREEK STREAM MITIGATION PROJECT

Surry County, NC

DMS Project Number 94708

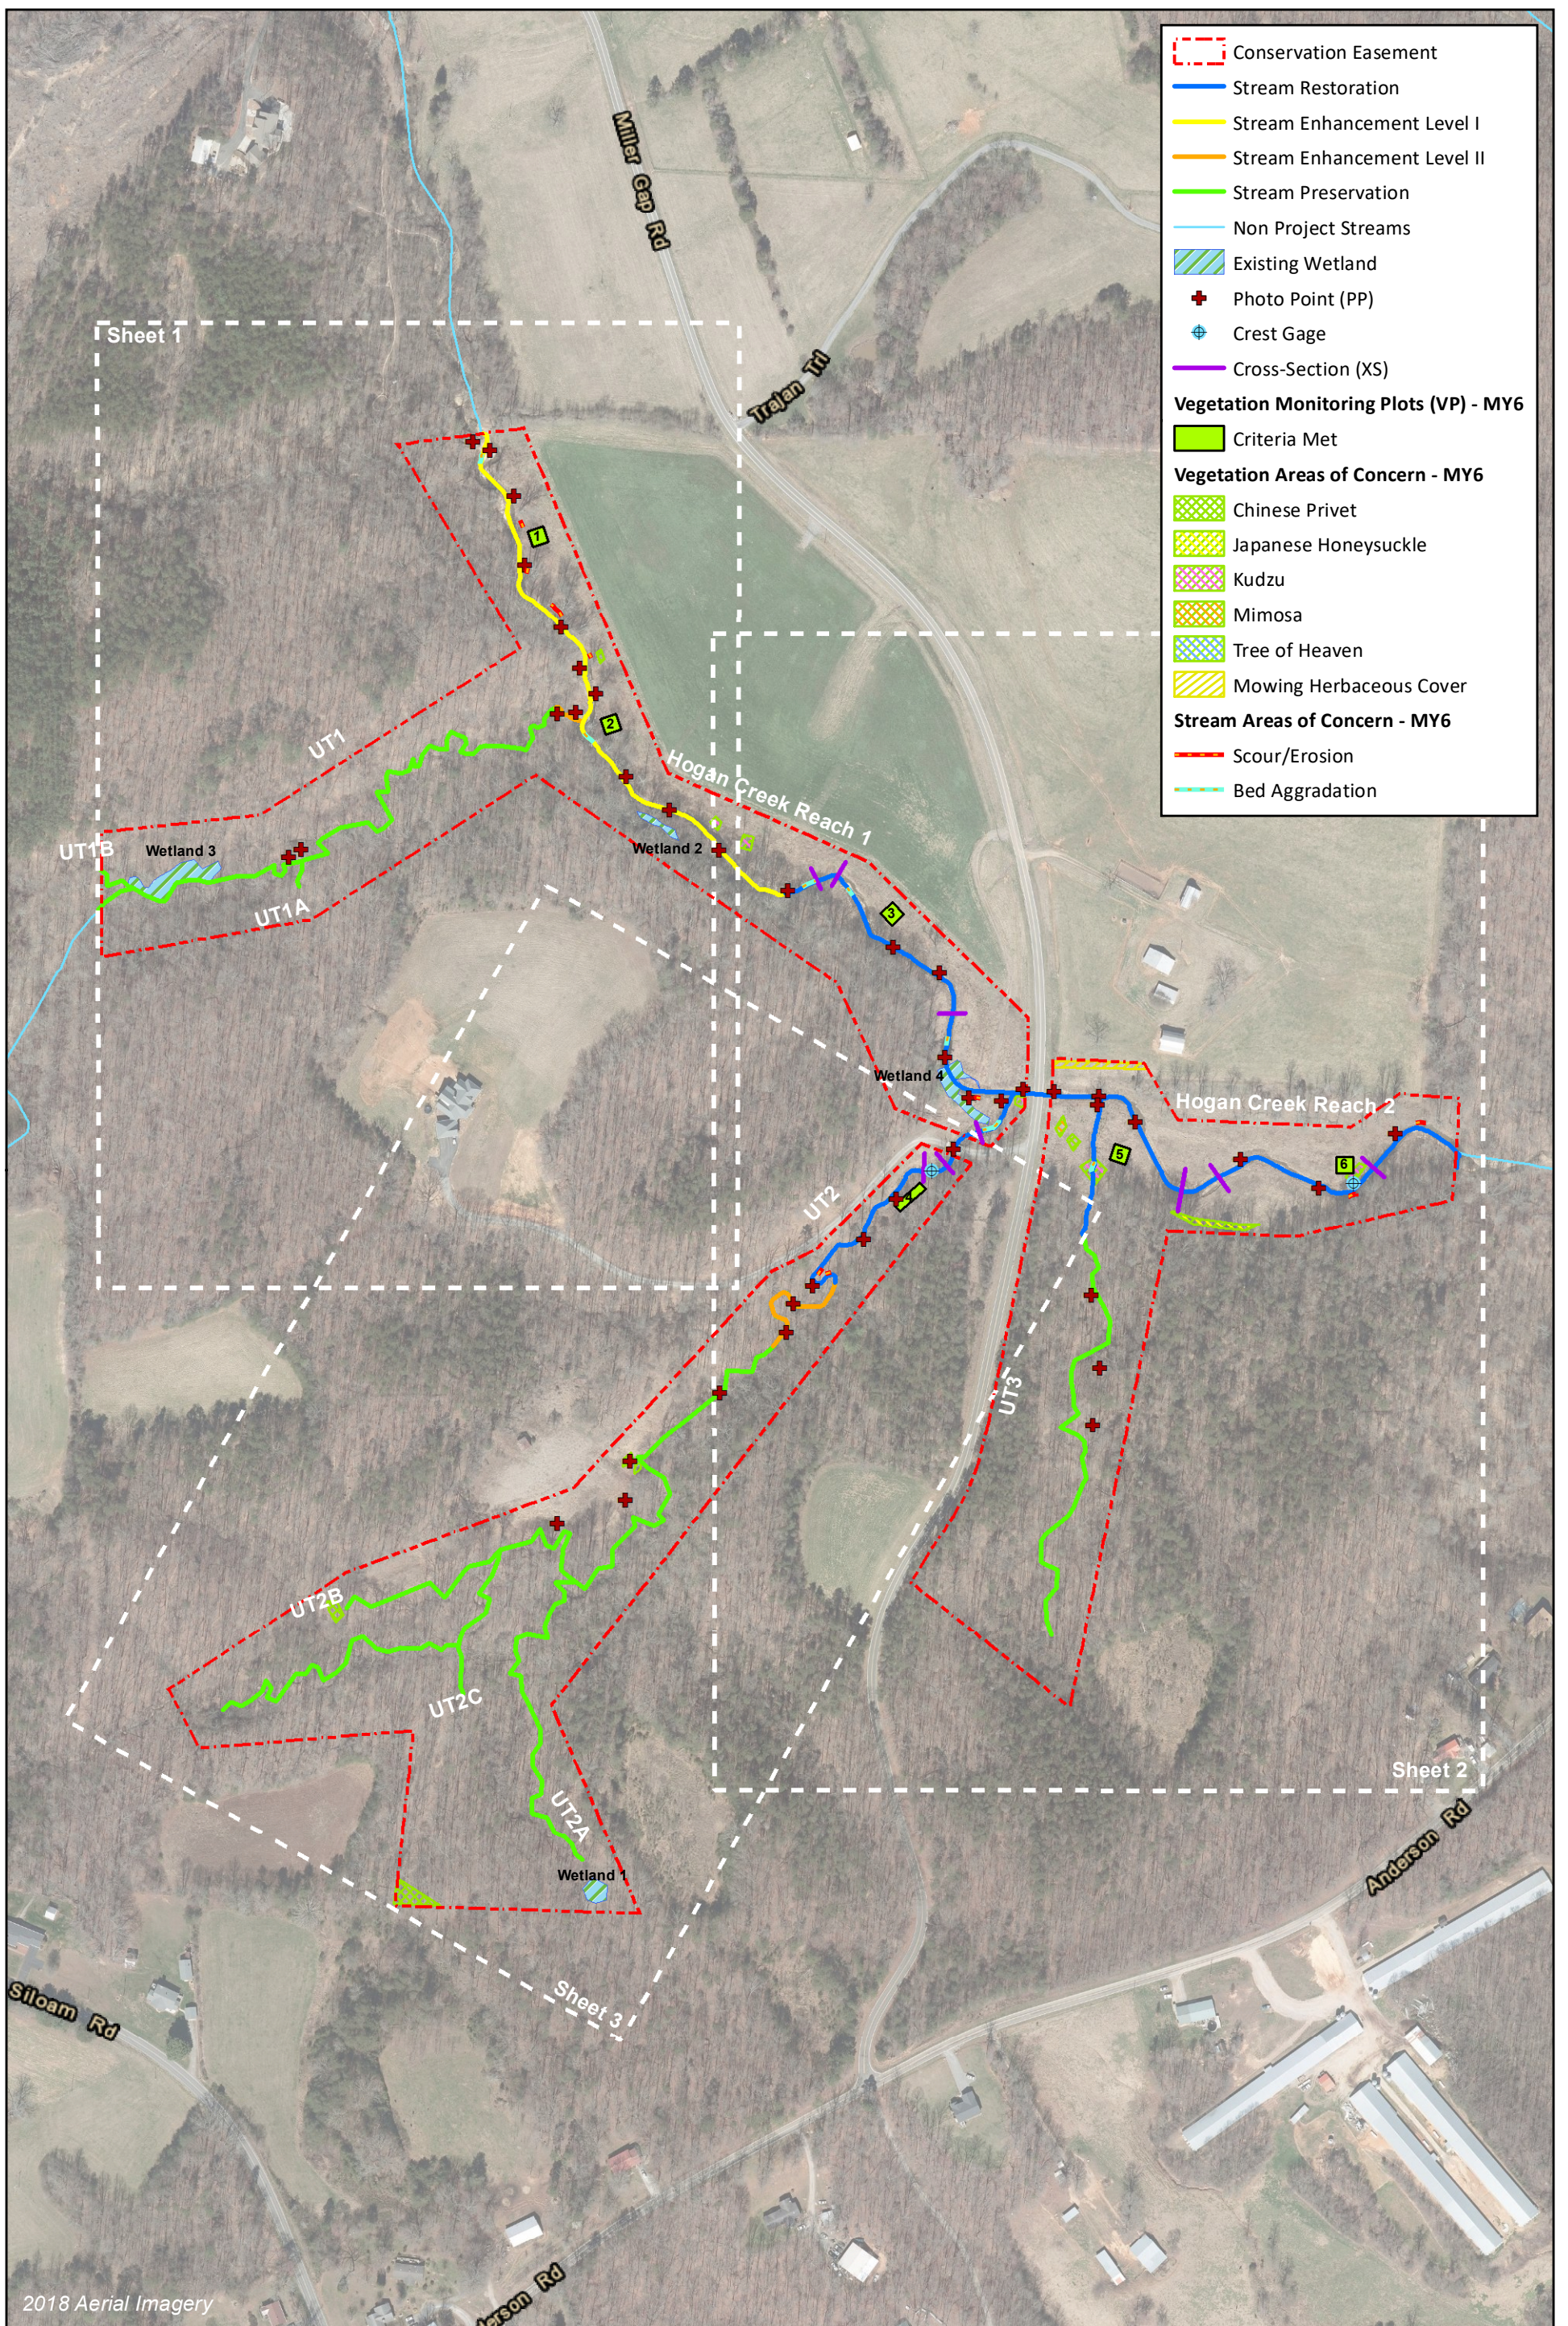
Figure 3.0 Current Condition Plan View Map (Key)
 Hogan Creek Stream Mitigation Project
 DMS Project No. 94708
 Monitoring Year 6 - 2020

honeysuckle (*Lonicera japonica*), multiflora rose (*Rosa multiflora*), mimosa tree (*Albizia julibrissin*), and tree of heaven (*Ailanthus altissima*). DMS contracted with a provider for ongoing invasive species treatments which will continue through December 2021. In 2020, additional invasive treatment occurred in May, August, and September. There was about a 50% reduction in invasive areas of concern compared to last year with less than 1% of the easement acreage currently affected by invasive species. Current vegetation areas of concern are shown in Figure 3.0-3.3 of Appendix B.

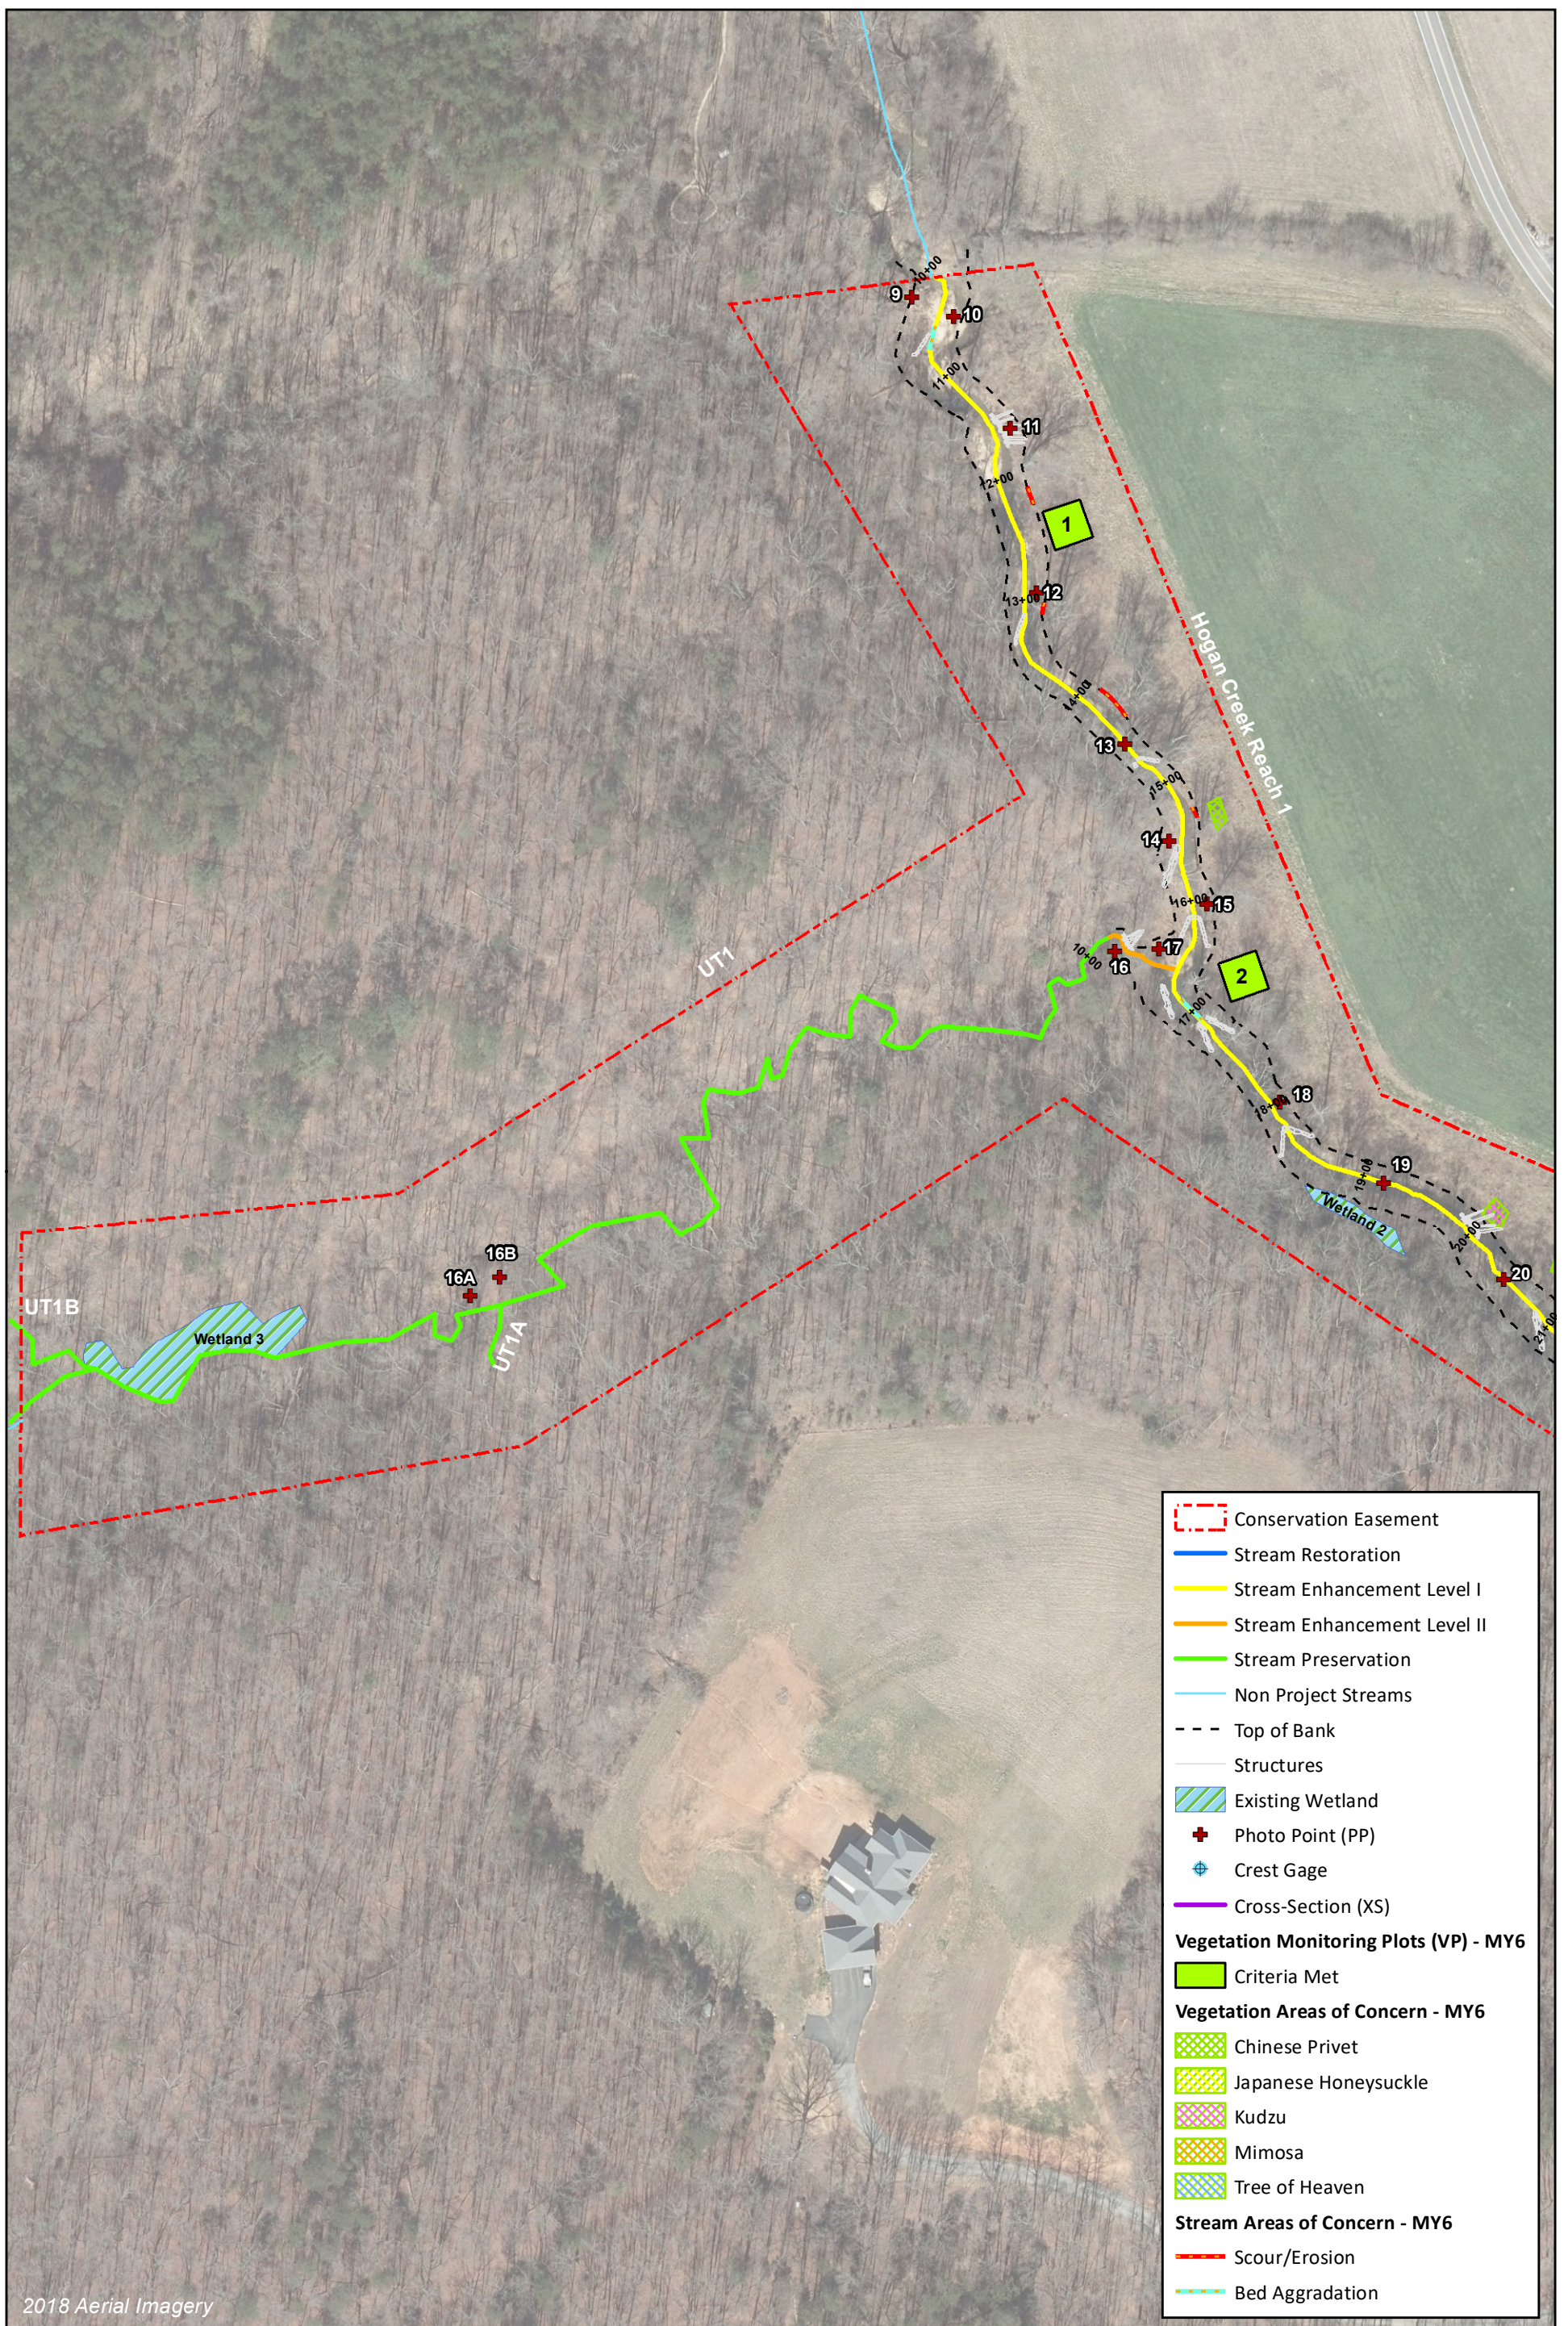
Figure 3.1 Current Condition Plan View Map (Sheet 1 of 3)
 Hogan Creek Stream Mitigation Project
 DMS Project No. 94708
 Monitoring Year 6 - 2020

Wildlands response; Two rootwad structures, one along Hogan Creek Reach 2 near station 37+30 and the other along UT2 near station 9+50, were noted to have some bank scour at these locations which is shown on the CCPV. However, upon additional consideration, the overall integrity of these structures has not been compromised since the bank scour is minor with woody vegetation still established along the bank. Tables 6b and 6c have been updated to account for this just in the Bank Protection channel sub-category.

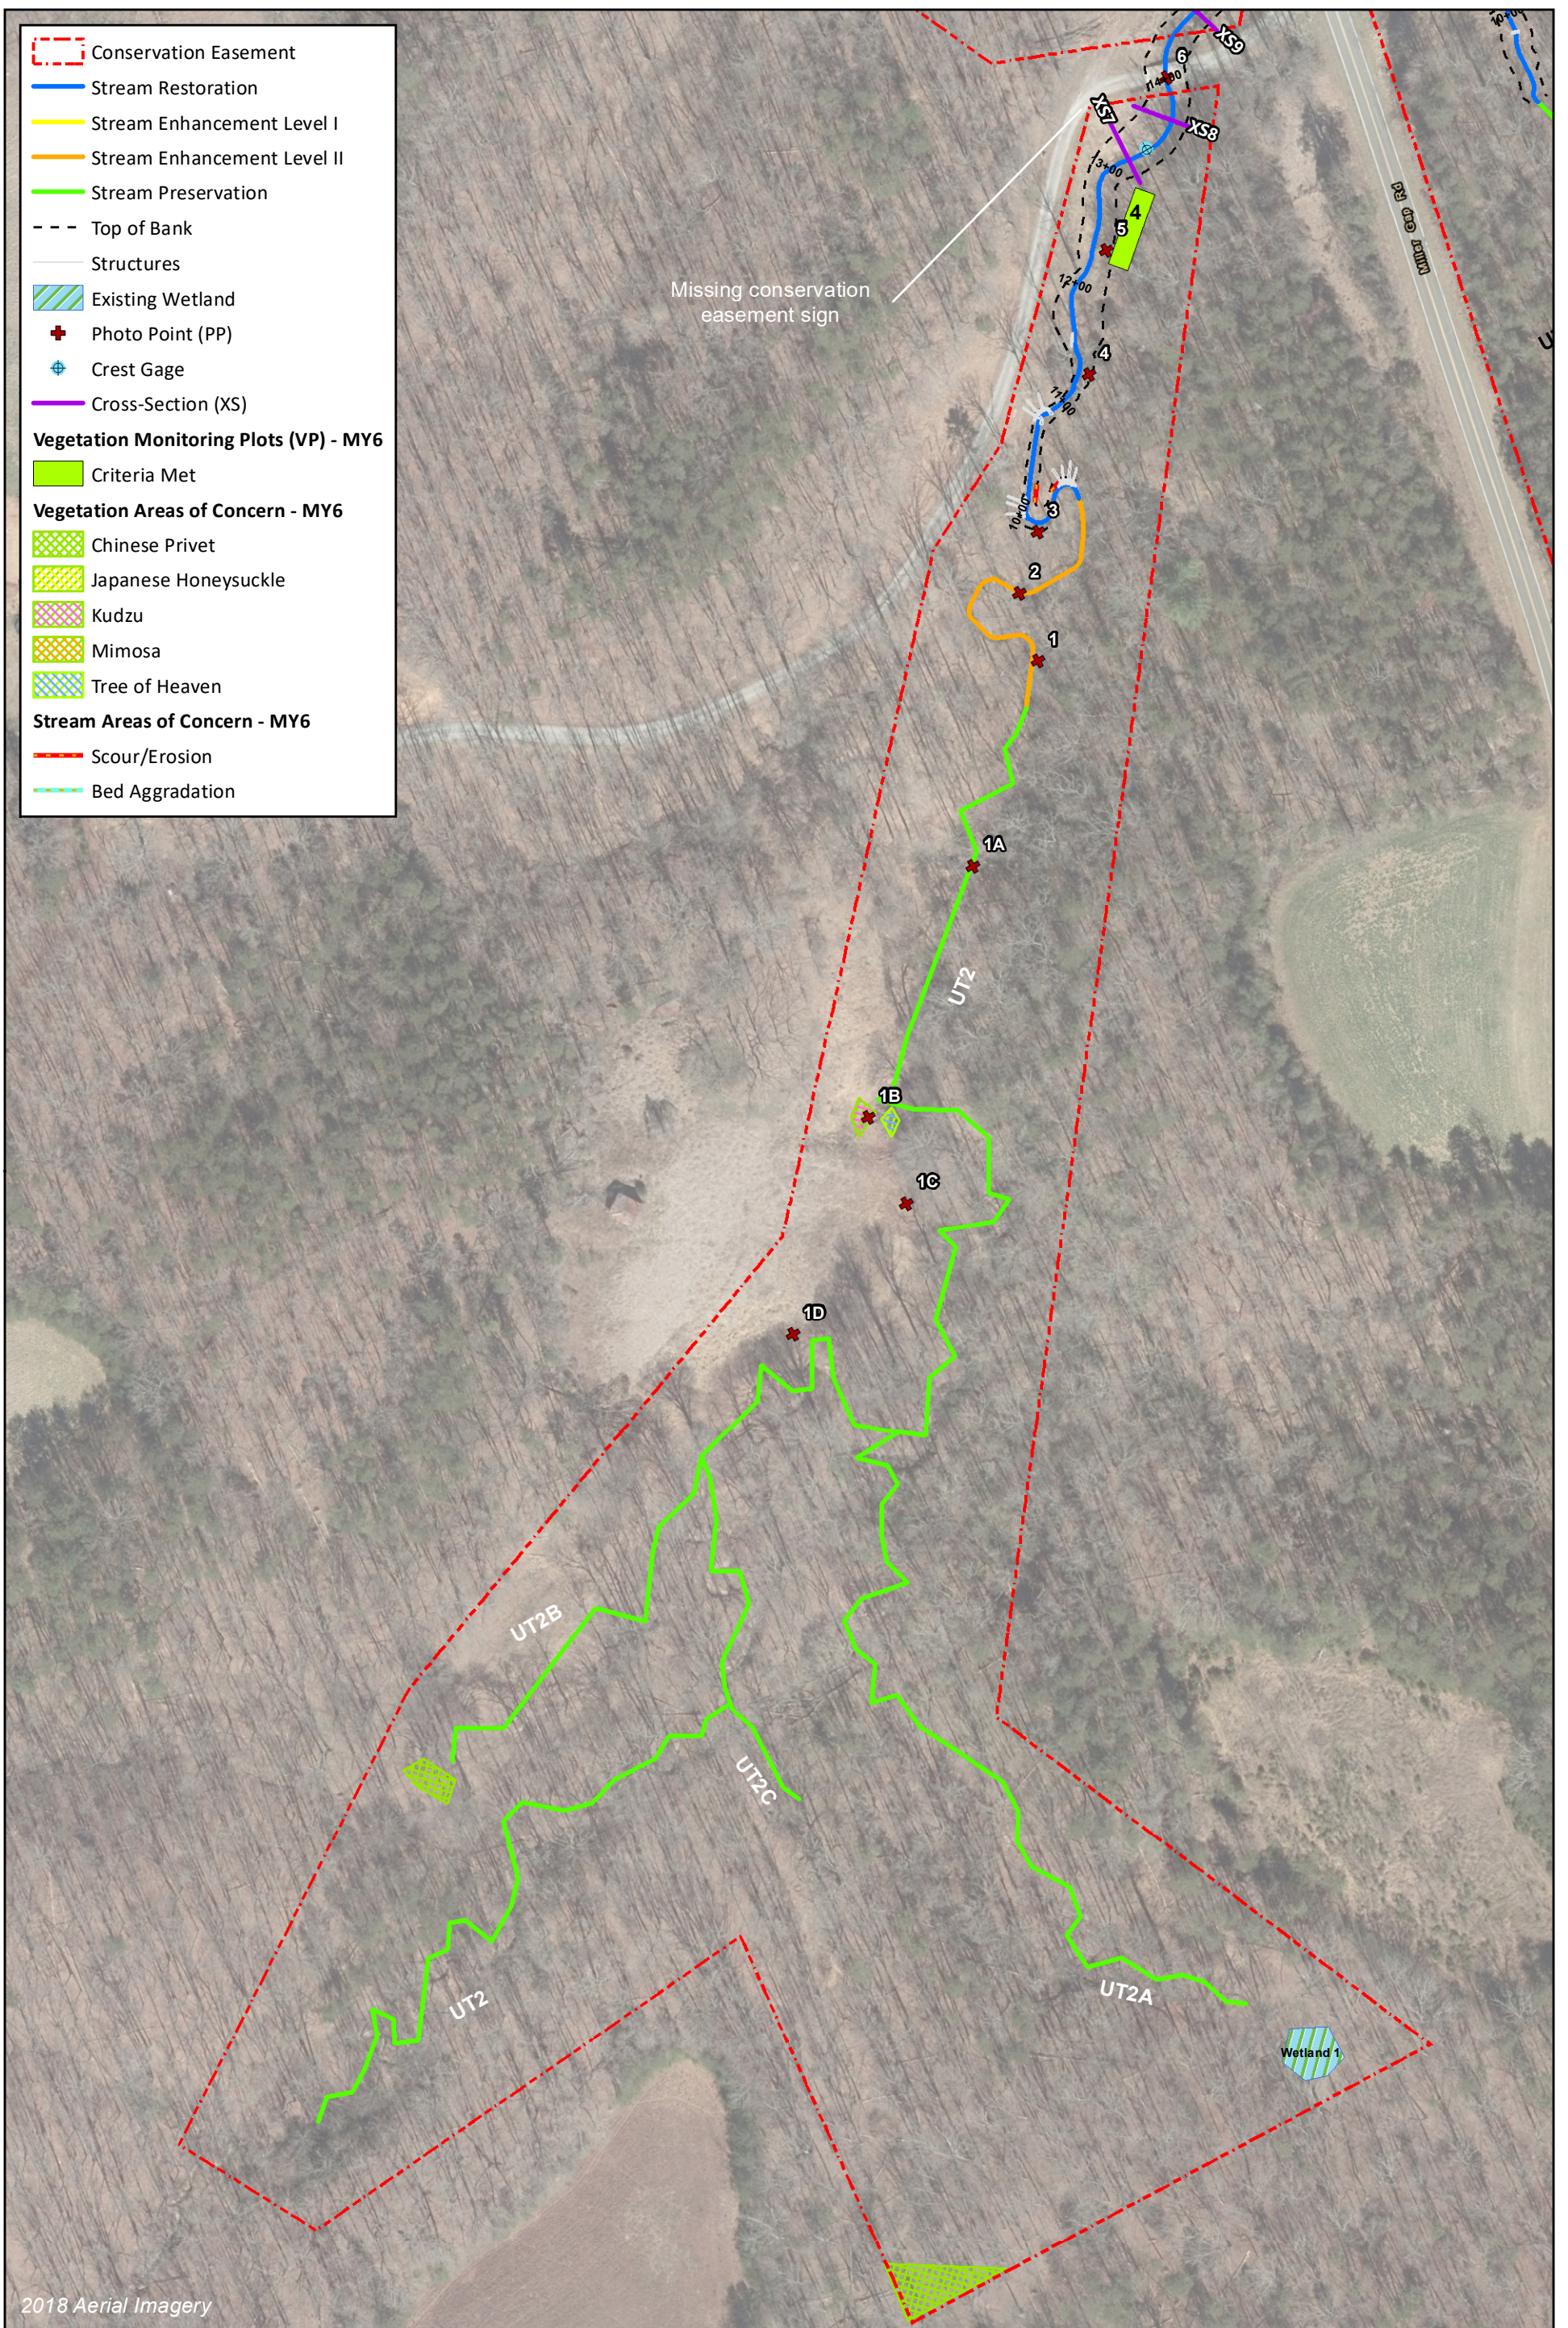
Figure 3.3 Current Condition Plan View Map (Sheet 3 of 3)
 Hogan Creek Stream Mitigation Project
 DMS Project No. 94708
 Monitoring Year 6 - 2020

The stream repairs that were completed in March 2019 along Hogan Creek are continuing to maintain stability. Live stake woody stems have become well established and banks have remained stable, even after several large storm events in 2020. A few segments of scoured banks are present along Hogan Creek and UT2. However, most of these segments have stabilizing woody vegetation along the top of banks, thus minimizing the percentage of unstable banks. The downstream portions of UT2 and UT3 have some aggradation present, but willows and other woody stems along the banks have maintained these channels' bankfull form and function. Stream areas of concern are depicted on the current condition plan view Figures 3.0-3.3 and Table 6 in Appendix B.
