Holly Grove Stream Restoration Site

Guilford County, North Carolina

MONITORING REPORT 2009 (YEAR 1)

Wolf Creek Engineering, pllc
51 North Knob Lane
Weaverville, NC 28787

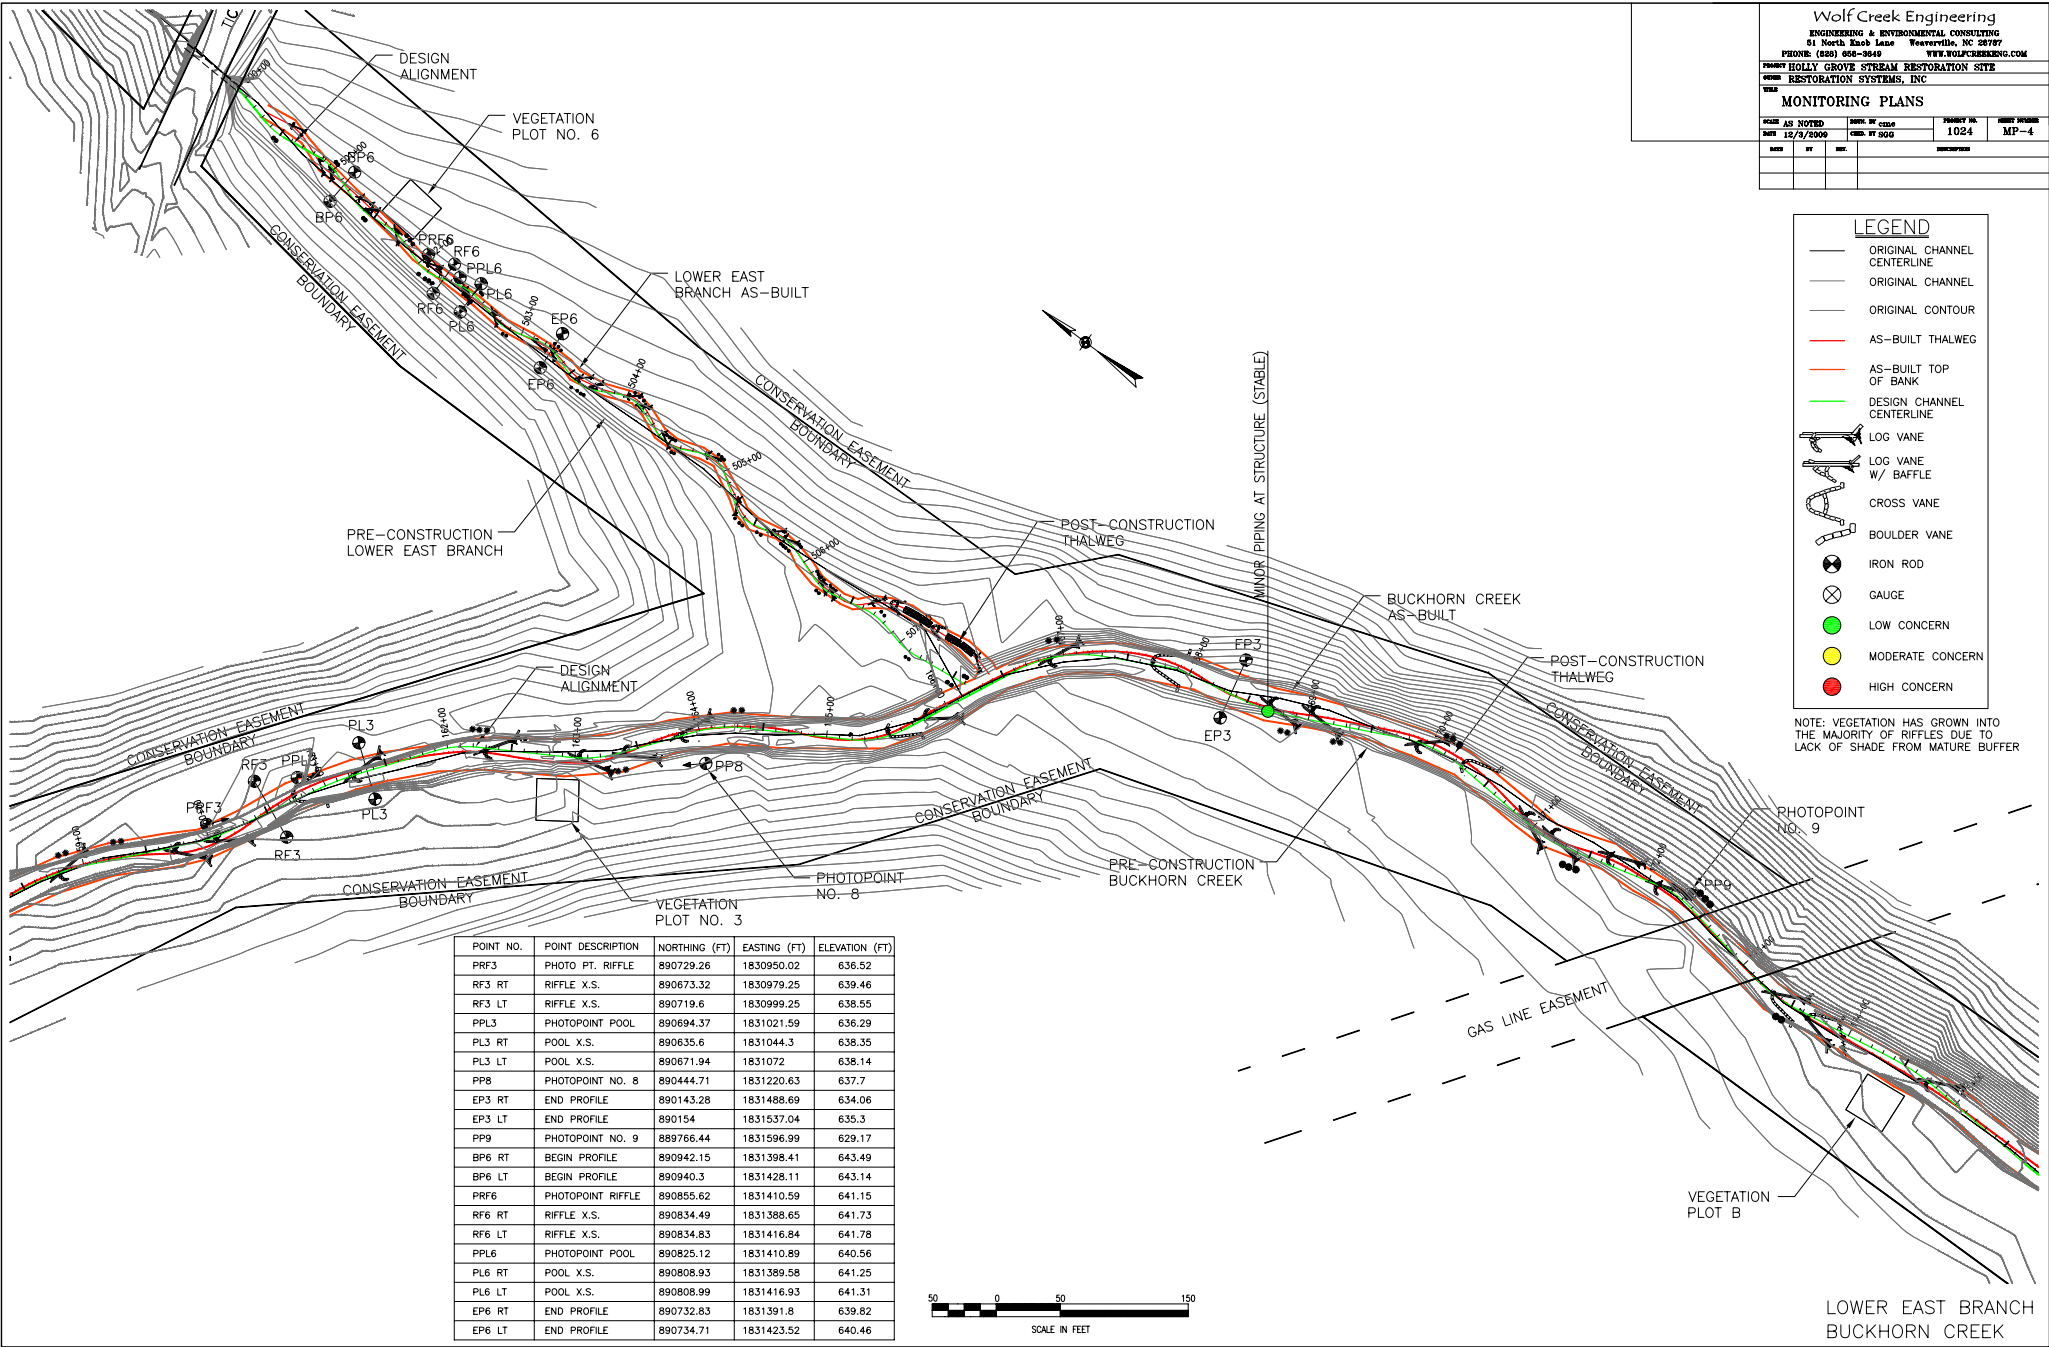
DATE AS NOTED	DATE W/ CHG	PROJECT NO.	ASSET NUMBER
DATE 12/9/2000	DATE W/ CHG	1024	MP-5
NO.	BY	CHK.	DESCRIPTION

NOTE: VEGETATION HAS GROWN INTO THE MAJORITY OF RIFFLES DUE TO LACK OF SHADE FROM MATURE BUFFER

Inadequate shade due to lack of mature riparian buffer has allowed vegetation to take root in the bed matrix. It is anticipated that this vegetation will die back during the winter but

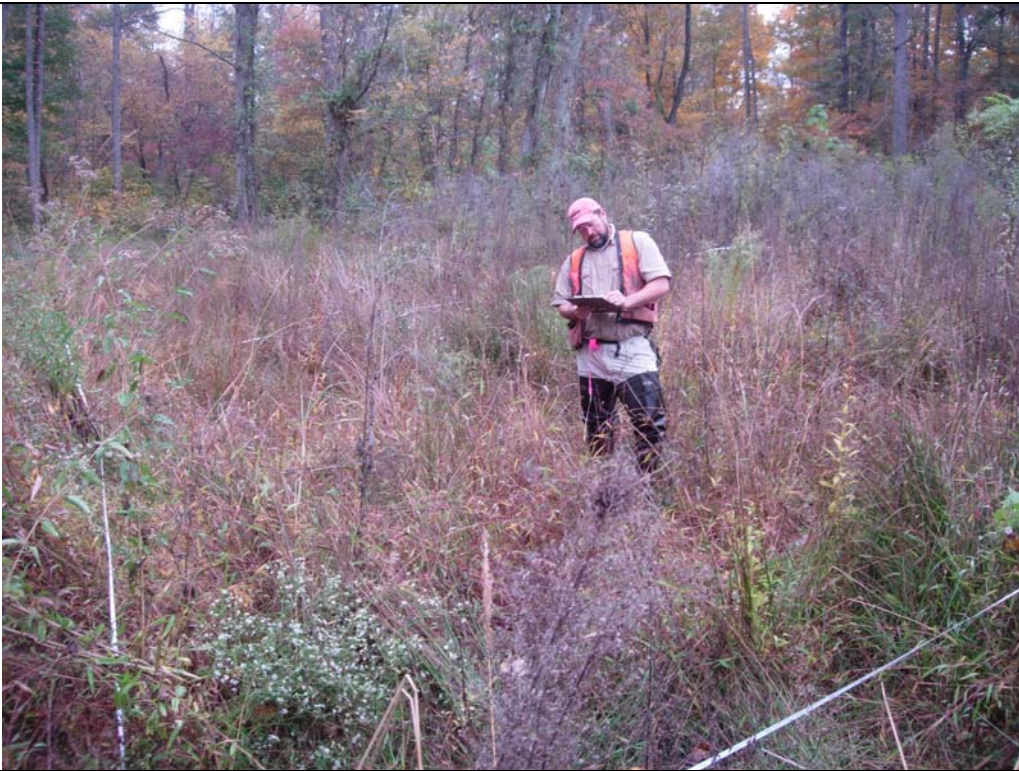
Vegetation Monitoring Plot 1 – 10/28/09

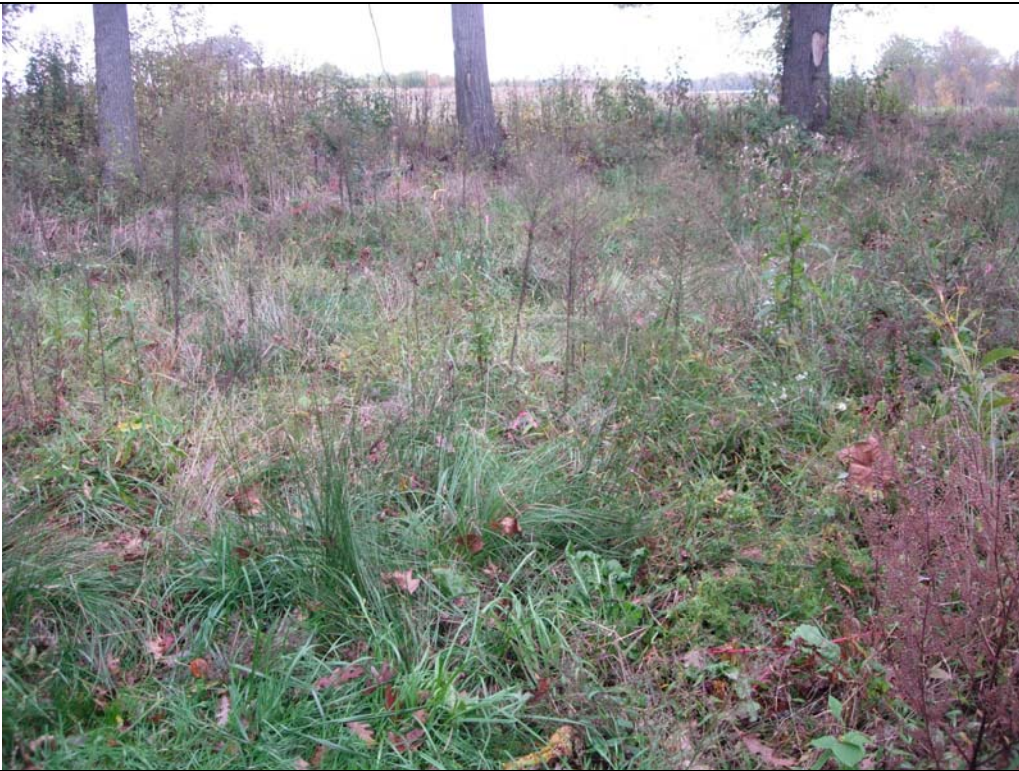
Vegetation Monitoring Plot 2 – 10/28/09

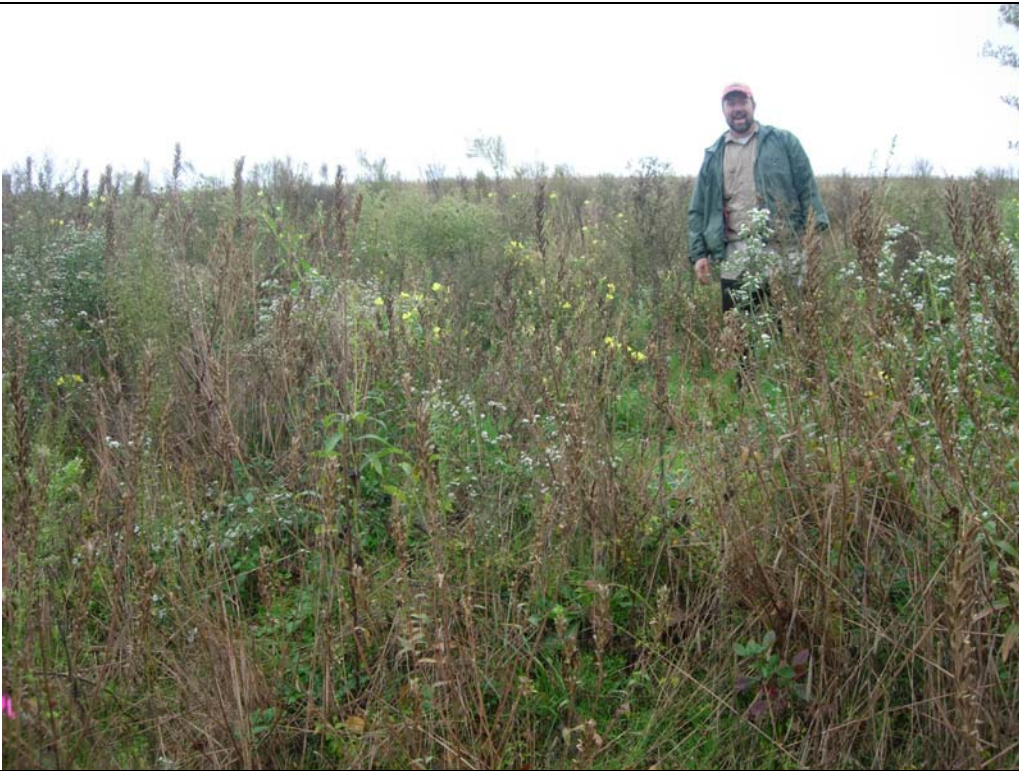
Vegetation Monitoring Plot 3 – 10/28/09

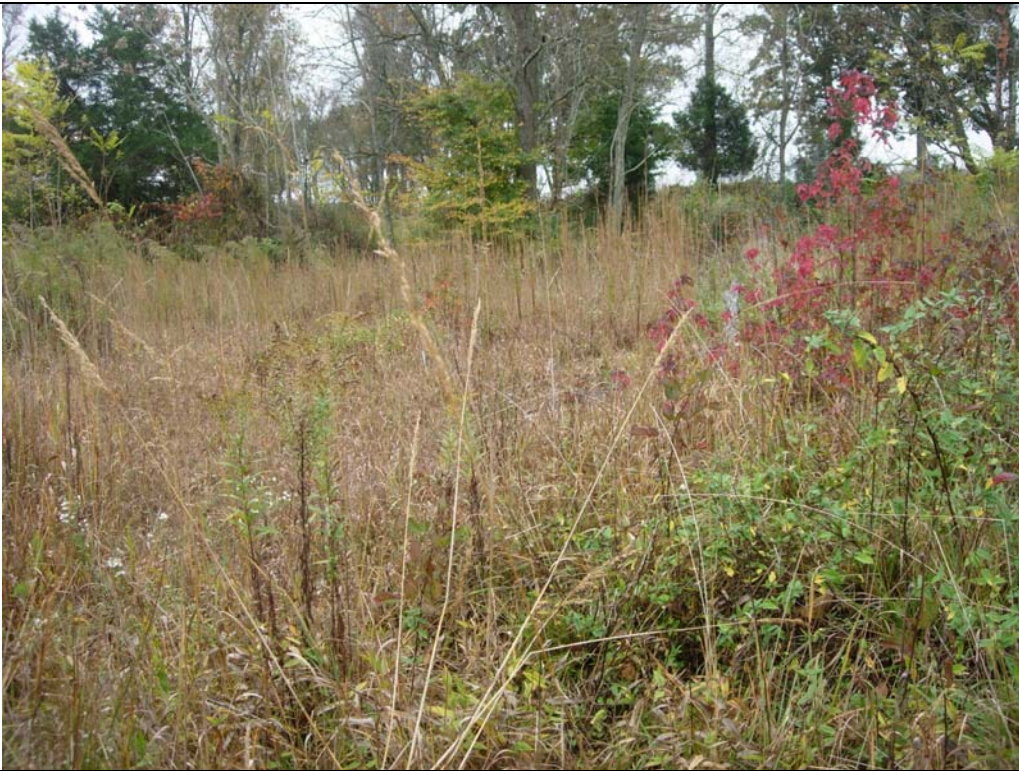
Vegetation Monitoring Plot 4 – 10/28/09

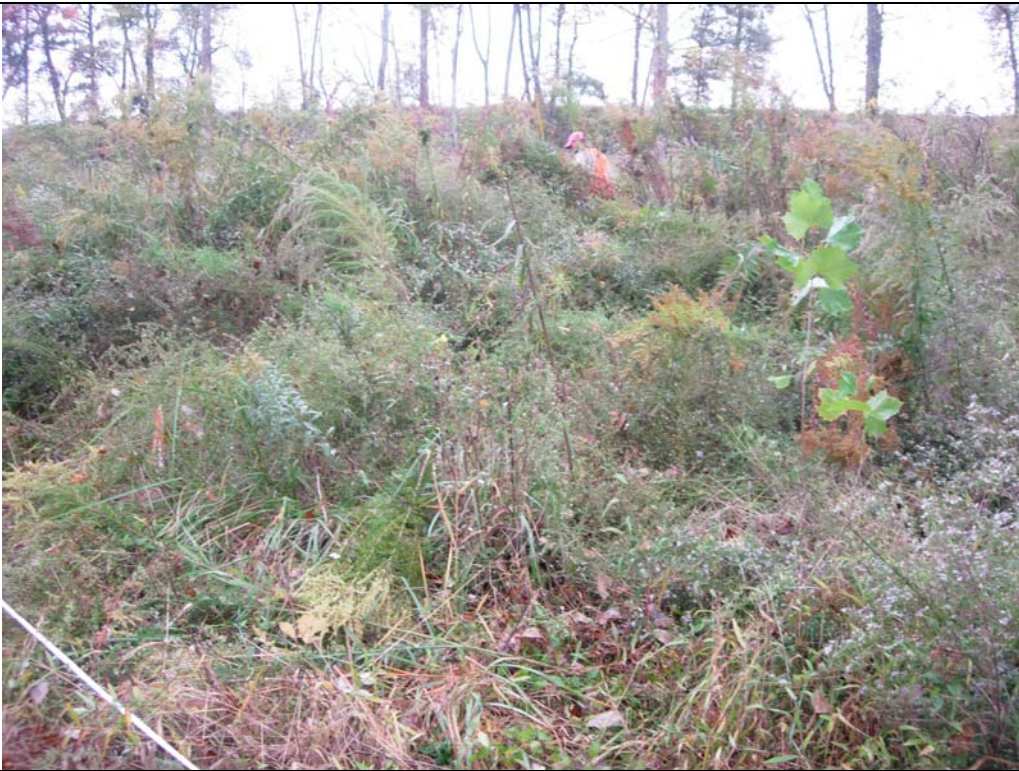
Vegetation Monitoring Plot 5 – 10/28/09

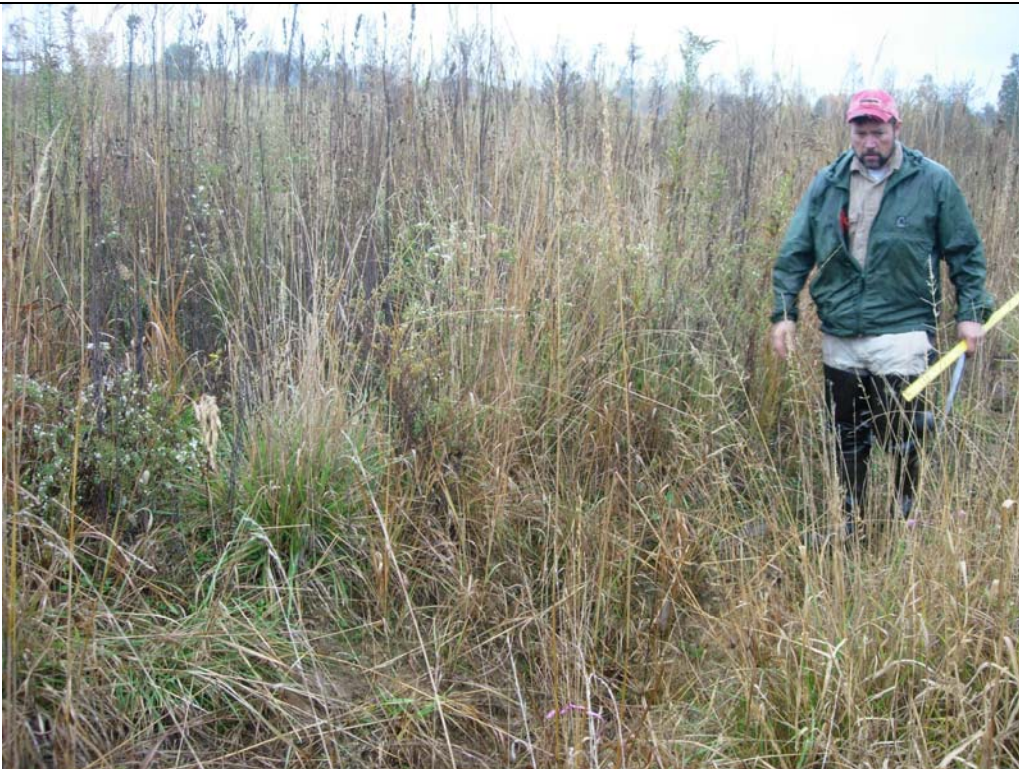
Vegetation Monitoring Plot 6 – 10/28/09

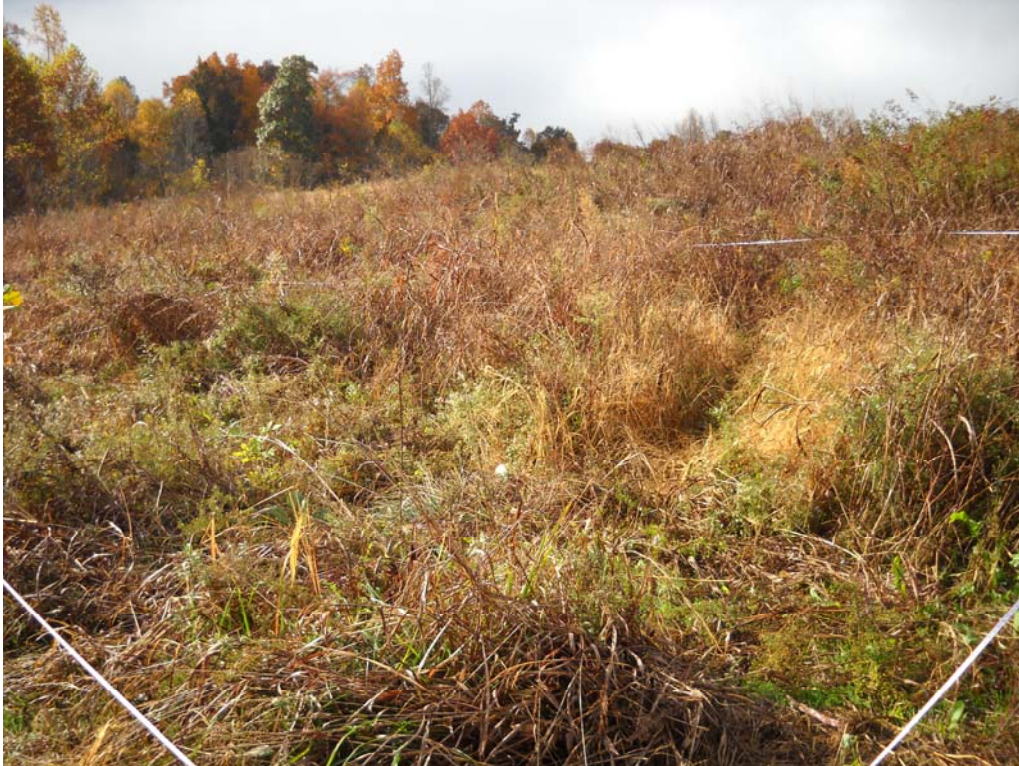
exotic plant populations should be monitored both within the vegetation plots in which they occur and within the larger restoration area. It should be noted that after the vegetation survey was conducted VP7 was partially mowed along with the gas easement that crosses Southeast Creek.

Vegetation Monitoring Plot 7 – 10/28/09

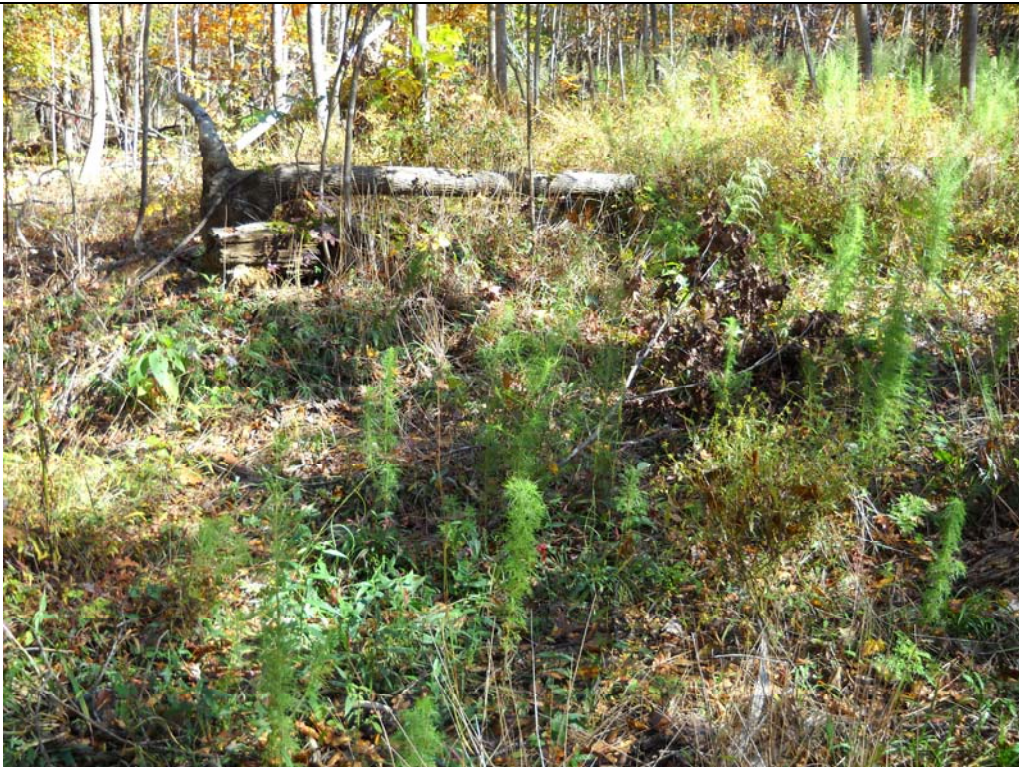
Vegetation Monitoring Plot 8 – 10/28/09

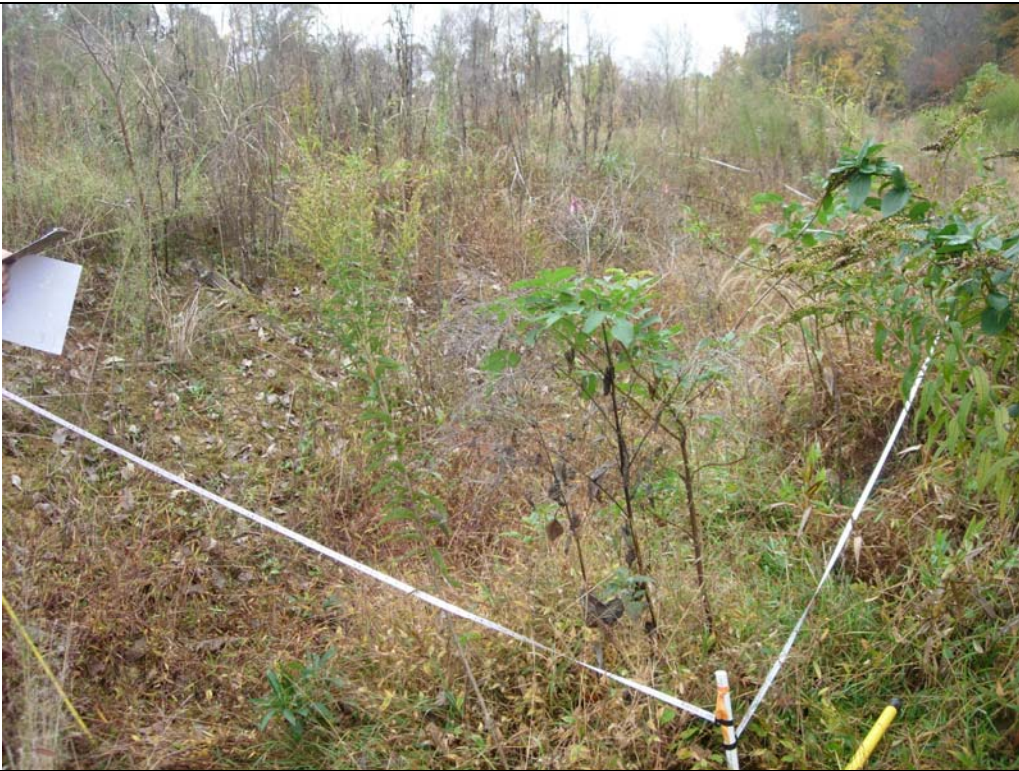
Vegetation Monitoring Plot A – 10/28/09

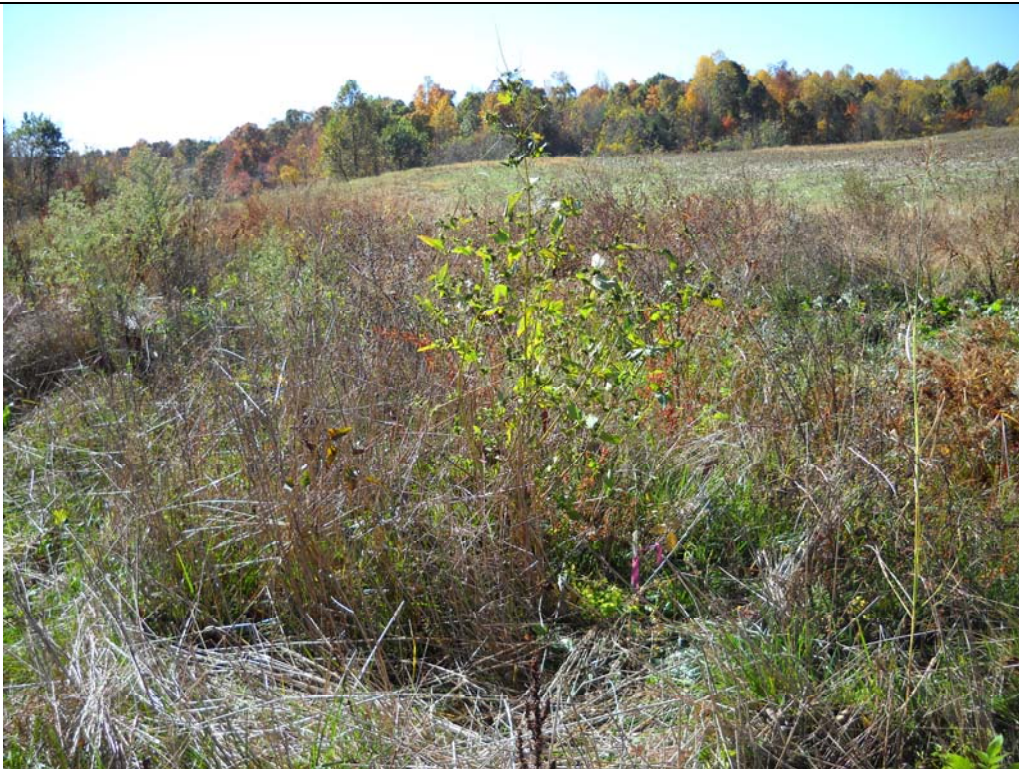
Vegetation Monitoring Plot B – 10/28/09

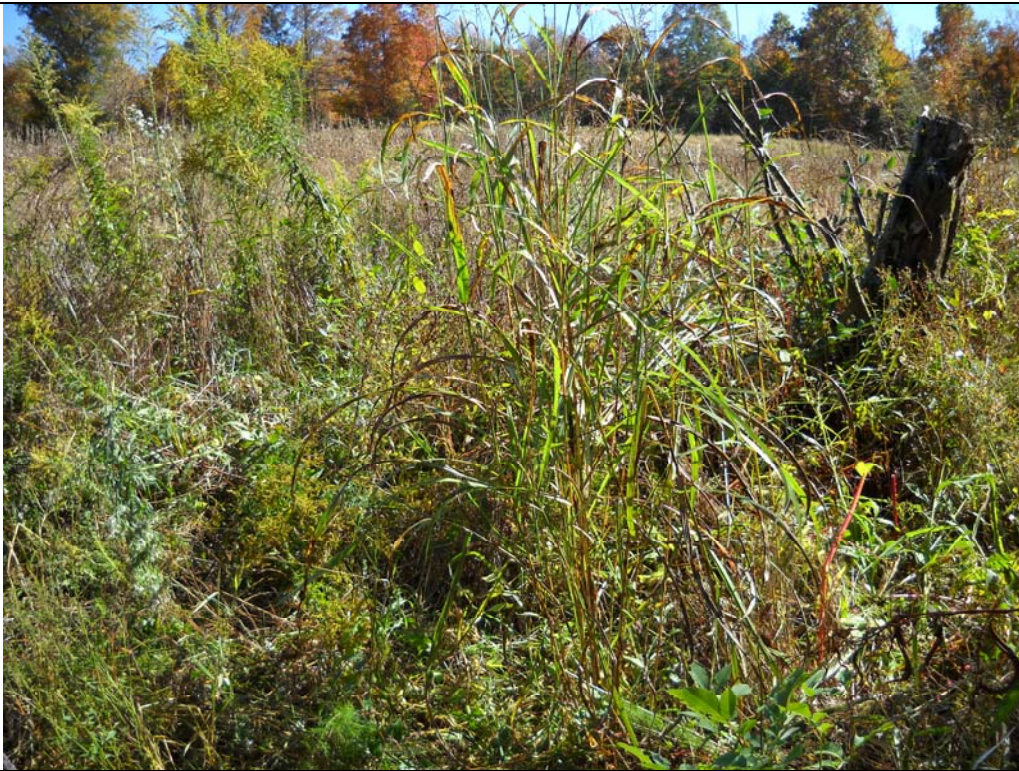
Vegetation Monitoring Plot C – 10/28/09
