Holly Grove Stream Restoration Site

Guilford County, North Carolina

MONITORING REPORT 2011 (YEAR 3)

Restoration Systems, LLC

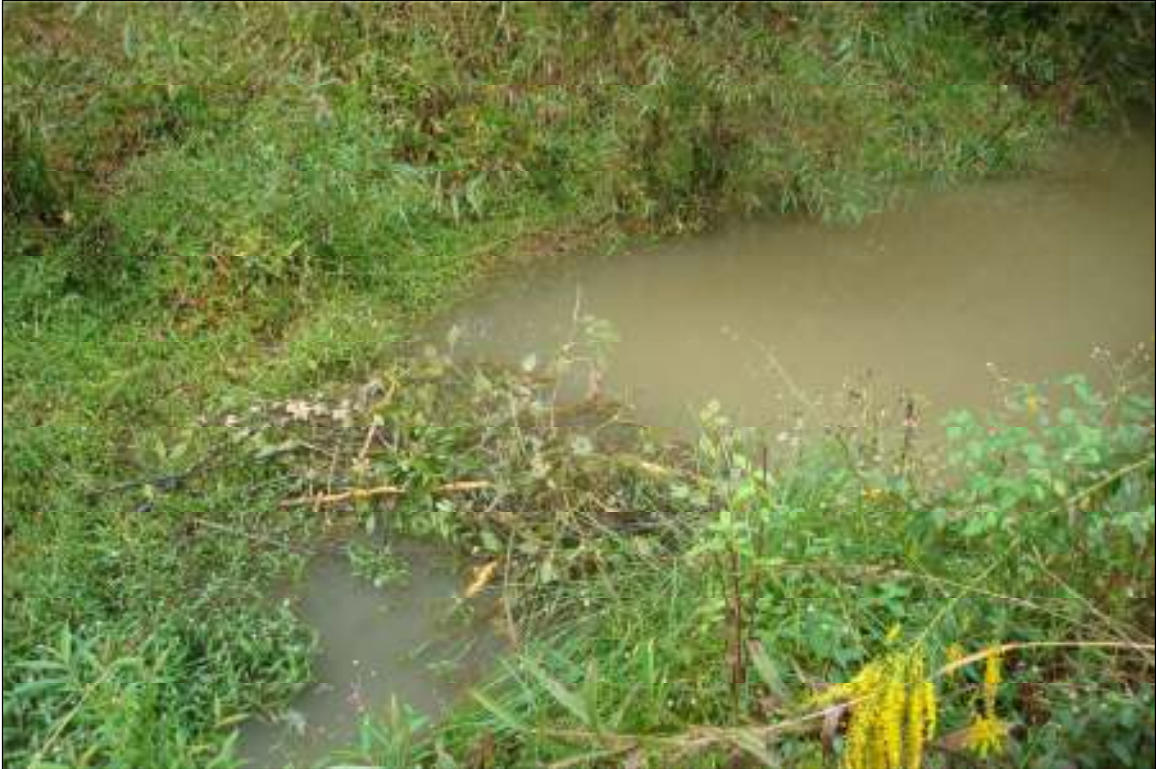
Beaver Dam , Sta 118+50 9/26/11 Photo No. 47

Additionally, three beaver dams were identified on upper Buckhorn Creek that are impounding water up to the top of bank elevation. These dams will be manually removed in order to restore base flow conditions.

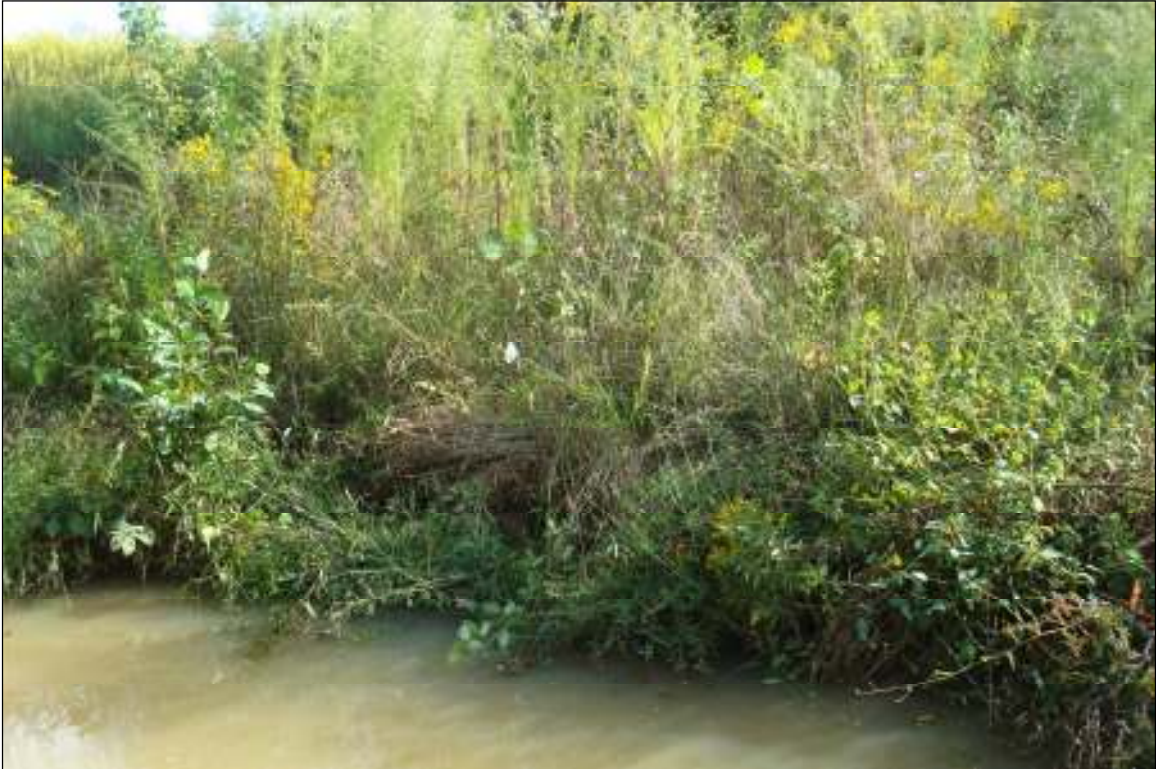
Buckhorn Creek, minor bank scour , Sta 152+90 9/26/11 Photo No. 48

Continued visual monitoring is planned for the stream areas that have been identified as “Areas of Concern”. Repair work is not warranted at this time on any of the areas. This is based on the judgment that these issues have not risen to the level of posing a threat to channel or structure stability and are not resulting in excessive erosion. It is recommended that natural stream processes and natural re-vegetation be allowed the opportunity to mend these areas and then reassess their condition in the next monitoring cycle.

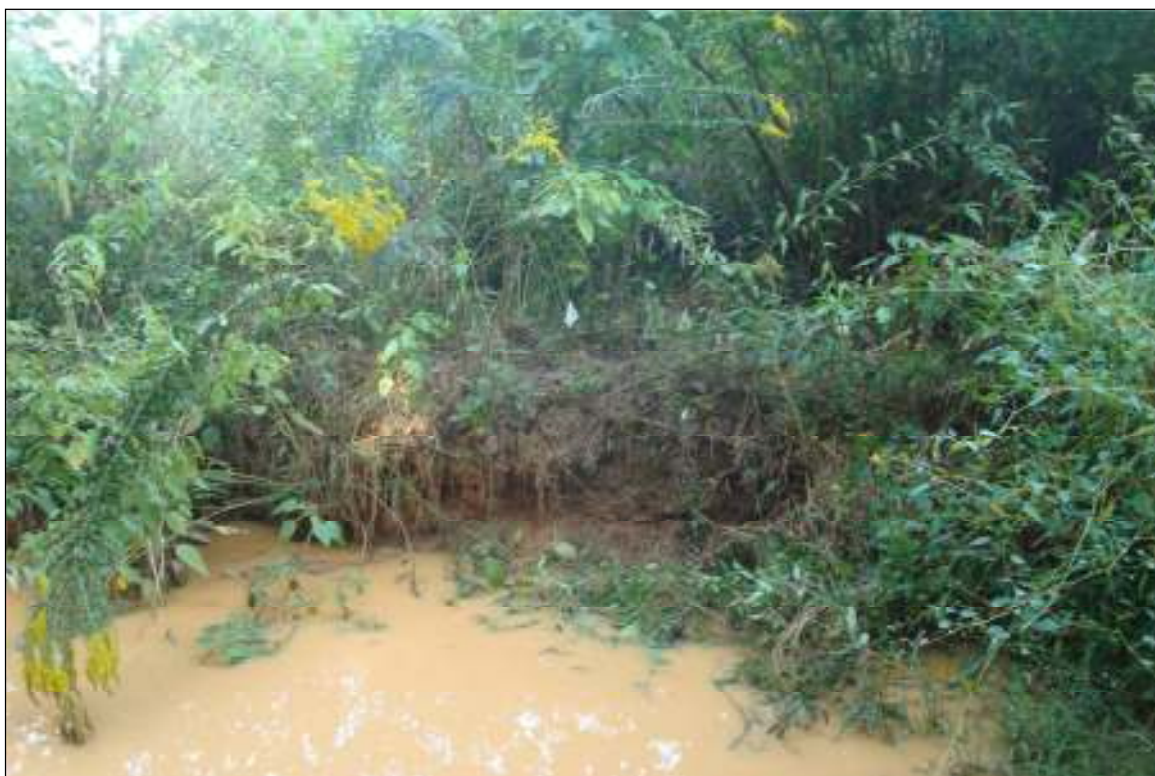
Buckhorn Creek, minor bank scour, Sta 183+40 9/26/11 Photo No. 49

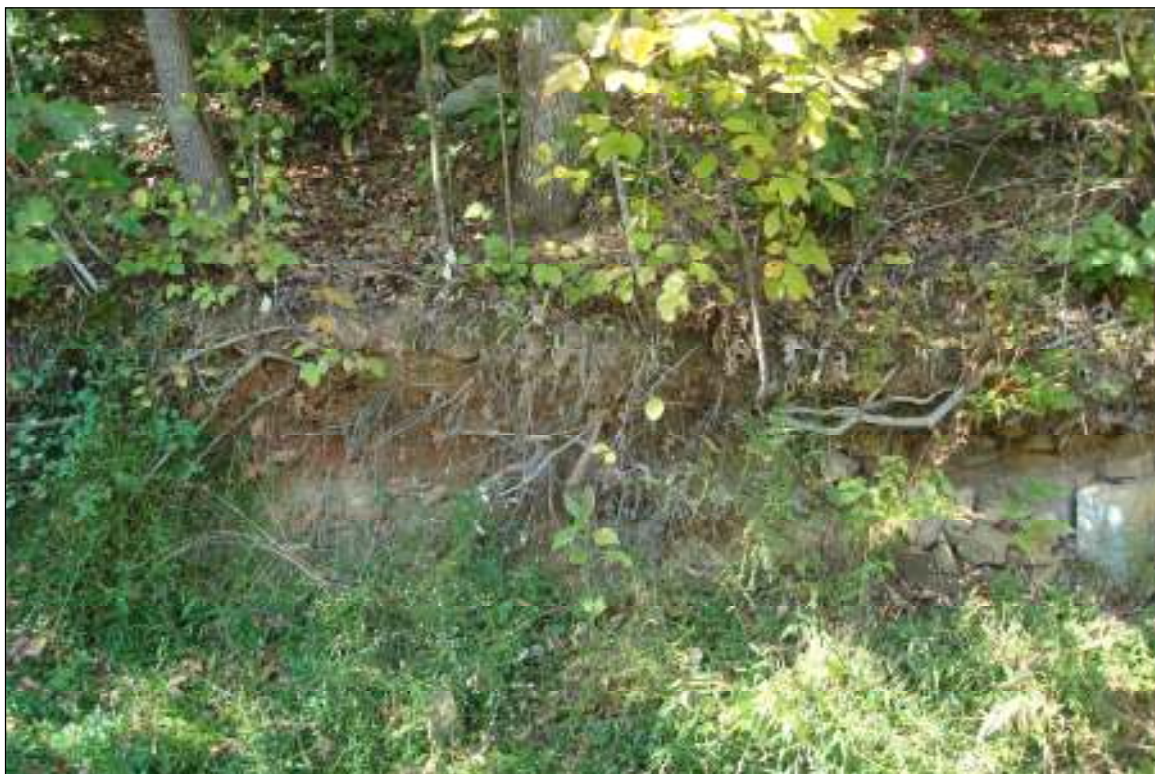
Buckhorn Creek, minor scour , Sta 187+70 9/26/11 Photo No. 50
