Holly Grove Stream Restoration Site

Guilford County, North Carolina

MONITORING REPORT 2012 (YEAR 4)

Wolf Creek Engineering, pllc
7 Florida Avenue
Weaverville, NC 28787

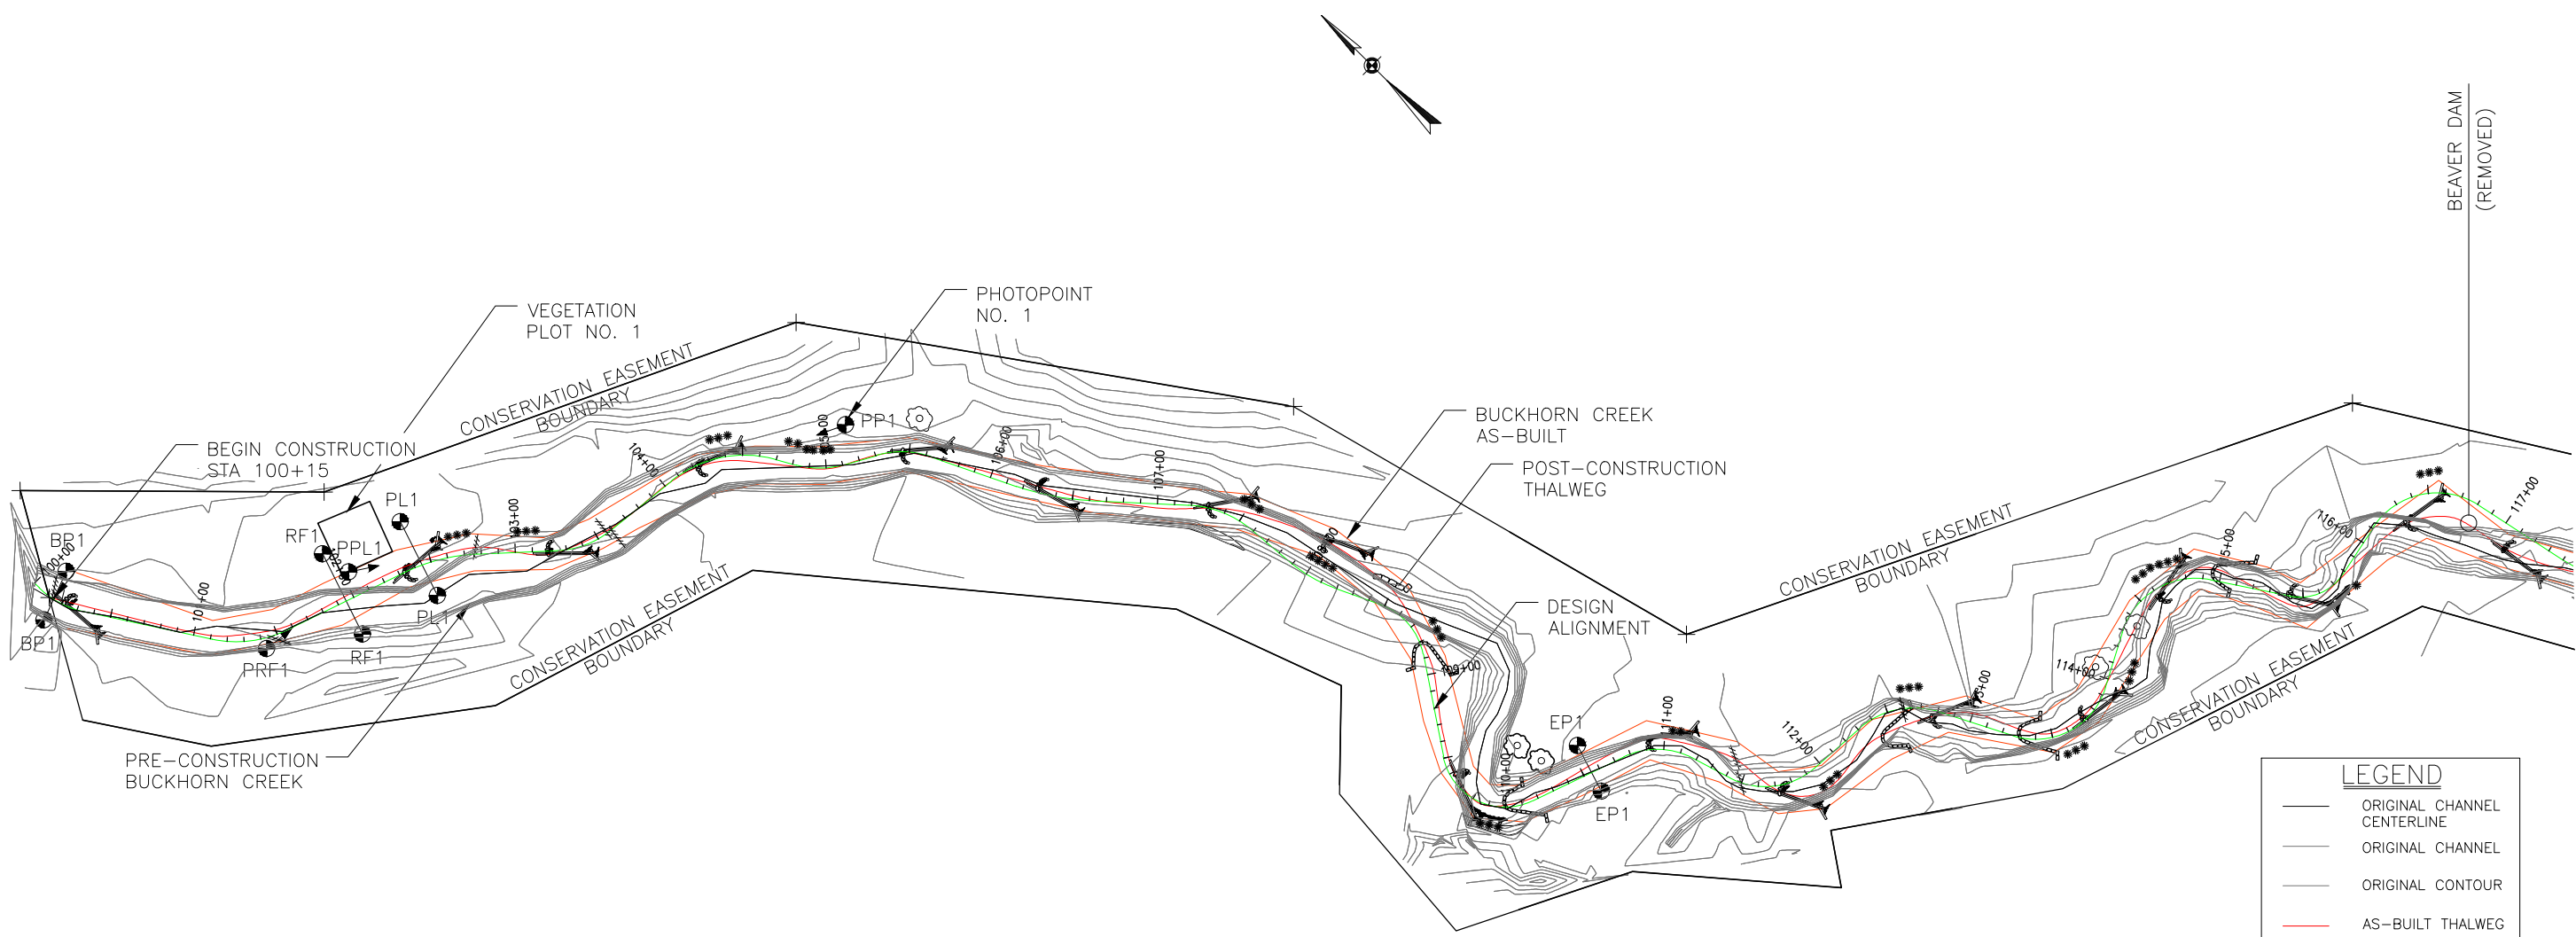
NOTE: VEGETATION HAS GROWN INTO THE MAJORITY OF RIFFLES DUE TO LACK OF SHADE FROM MATURE BUFFER

Inadequate shade due to lack of mature riparian buffer has allowed vegetation to take root in the bed matrix. It is anticipated that this vegetation will die back during the winter but will reestablish during each growing season until sufficient shading is provided by the canopy of the

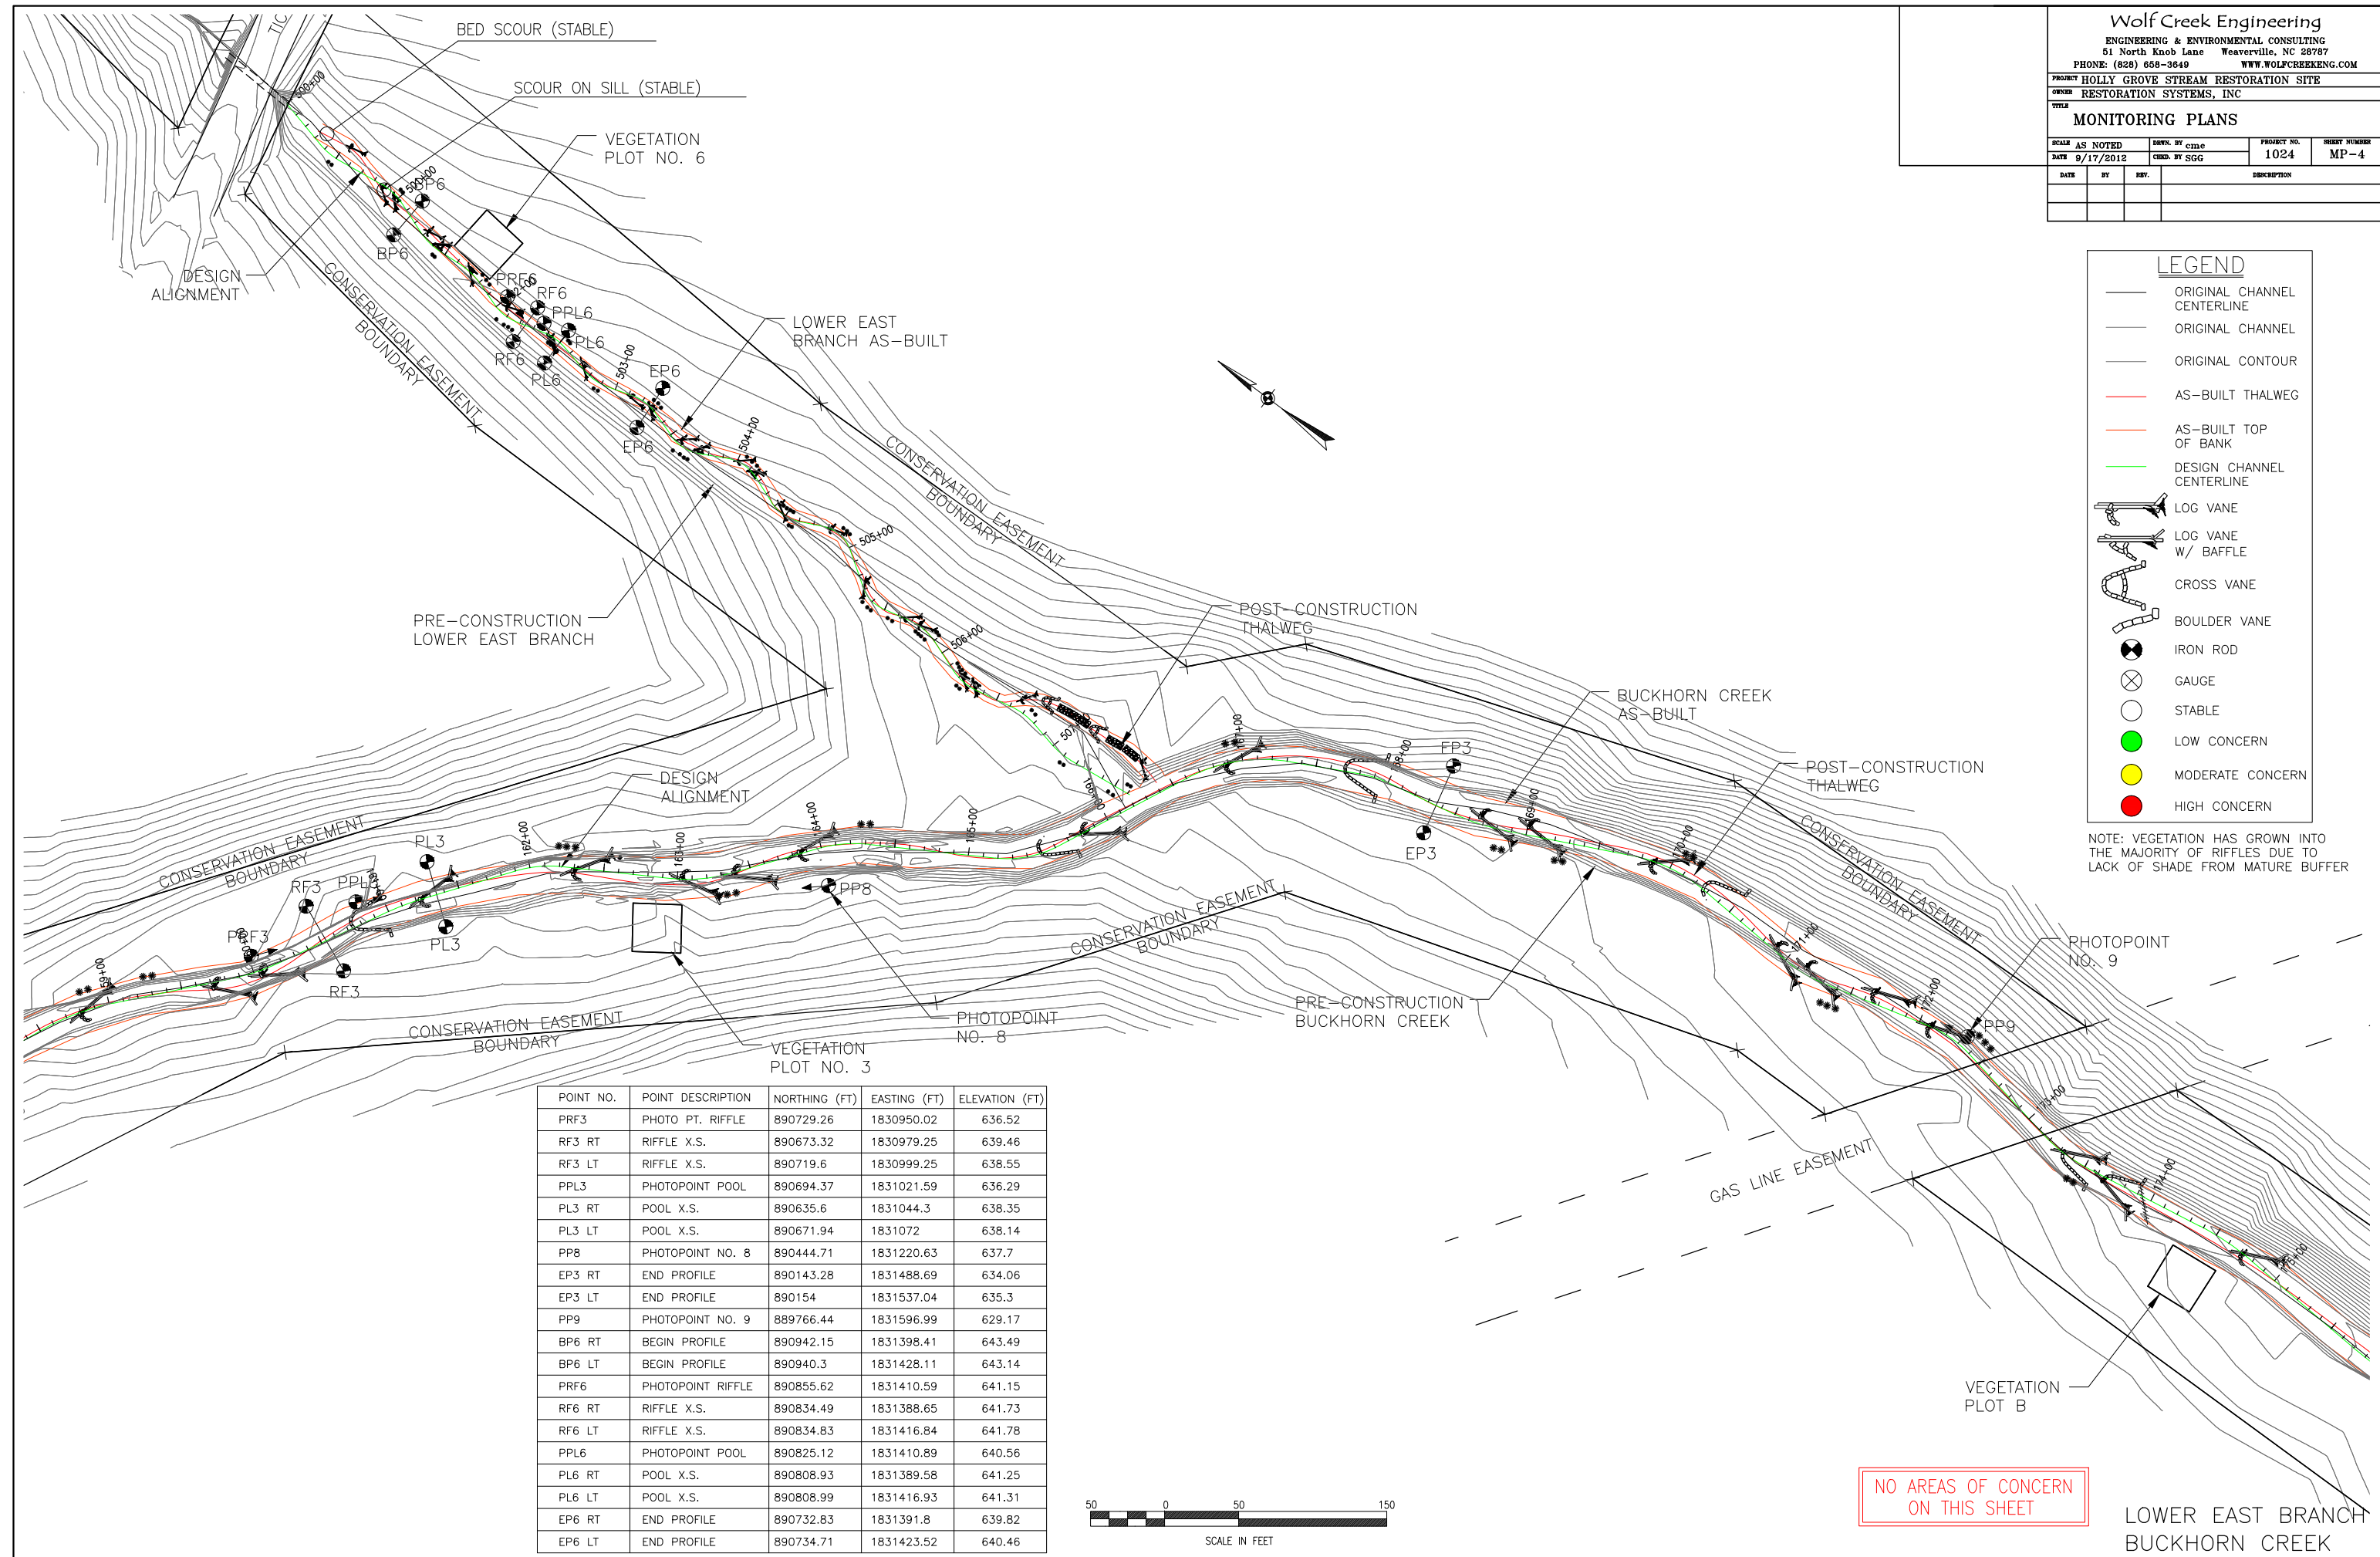
NOTE: VEGETATION HAS GROWN INTO THE MAJORITY OF RIFFLES DUE TO LACK OF SHADE FROM MATURE BUFFER

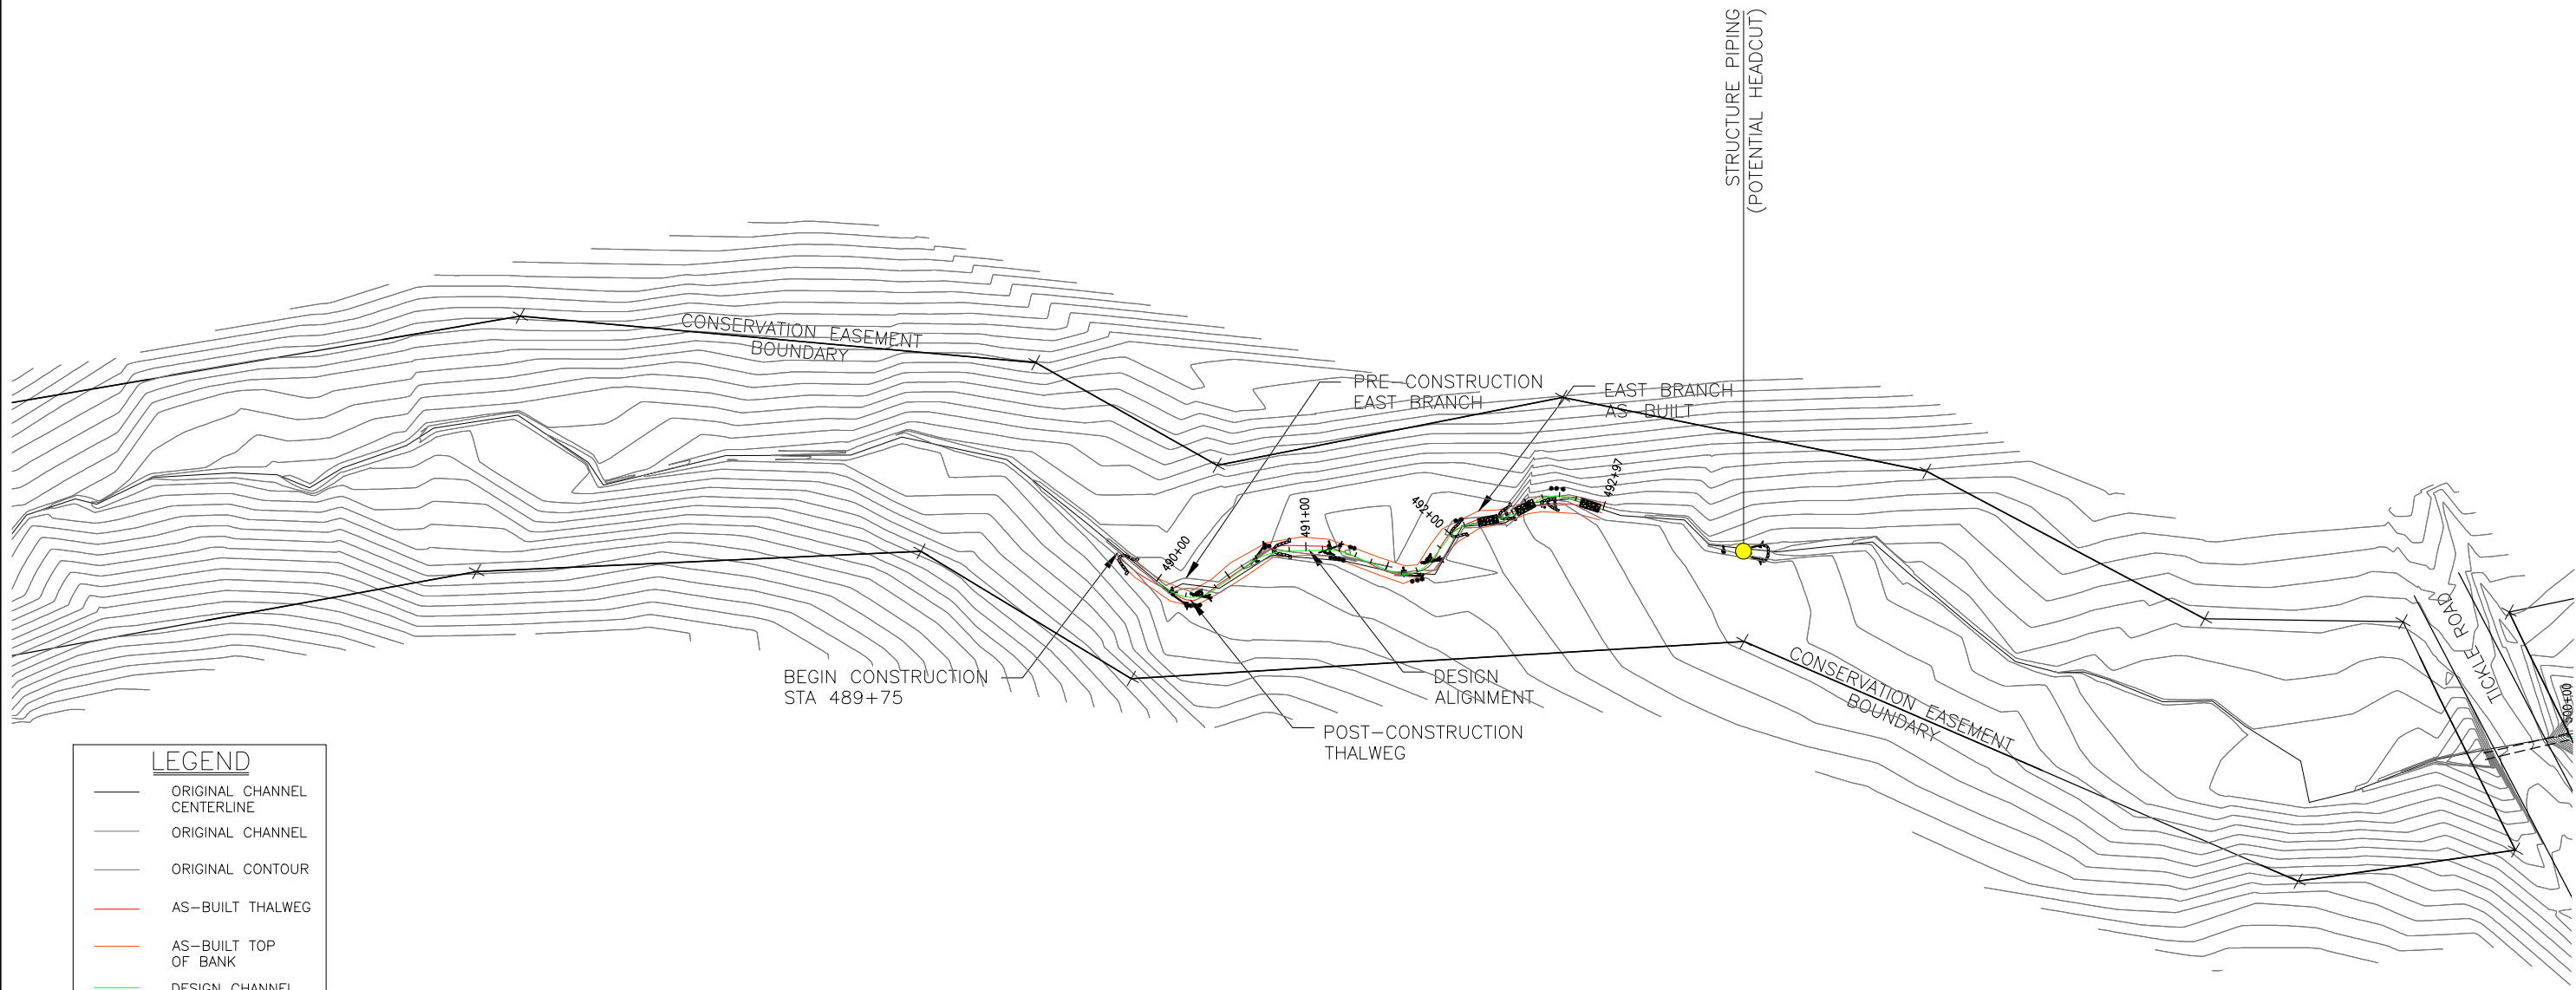
NOTE: VEGETATION HAS GROWN INTO THE MAJORITY OF RIFFLES DUE TO LACK OF SHADE FROM MATURE BUFFER

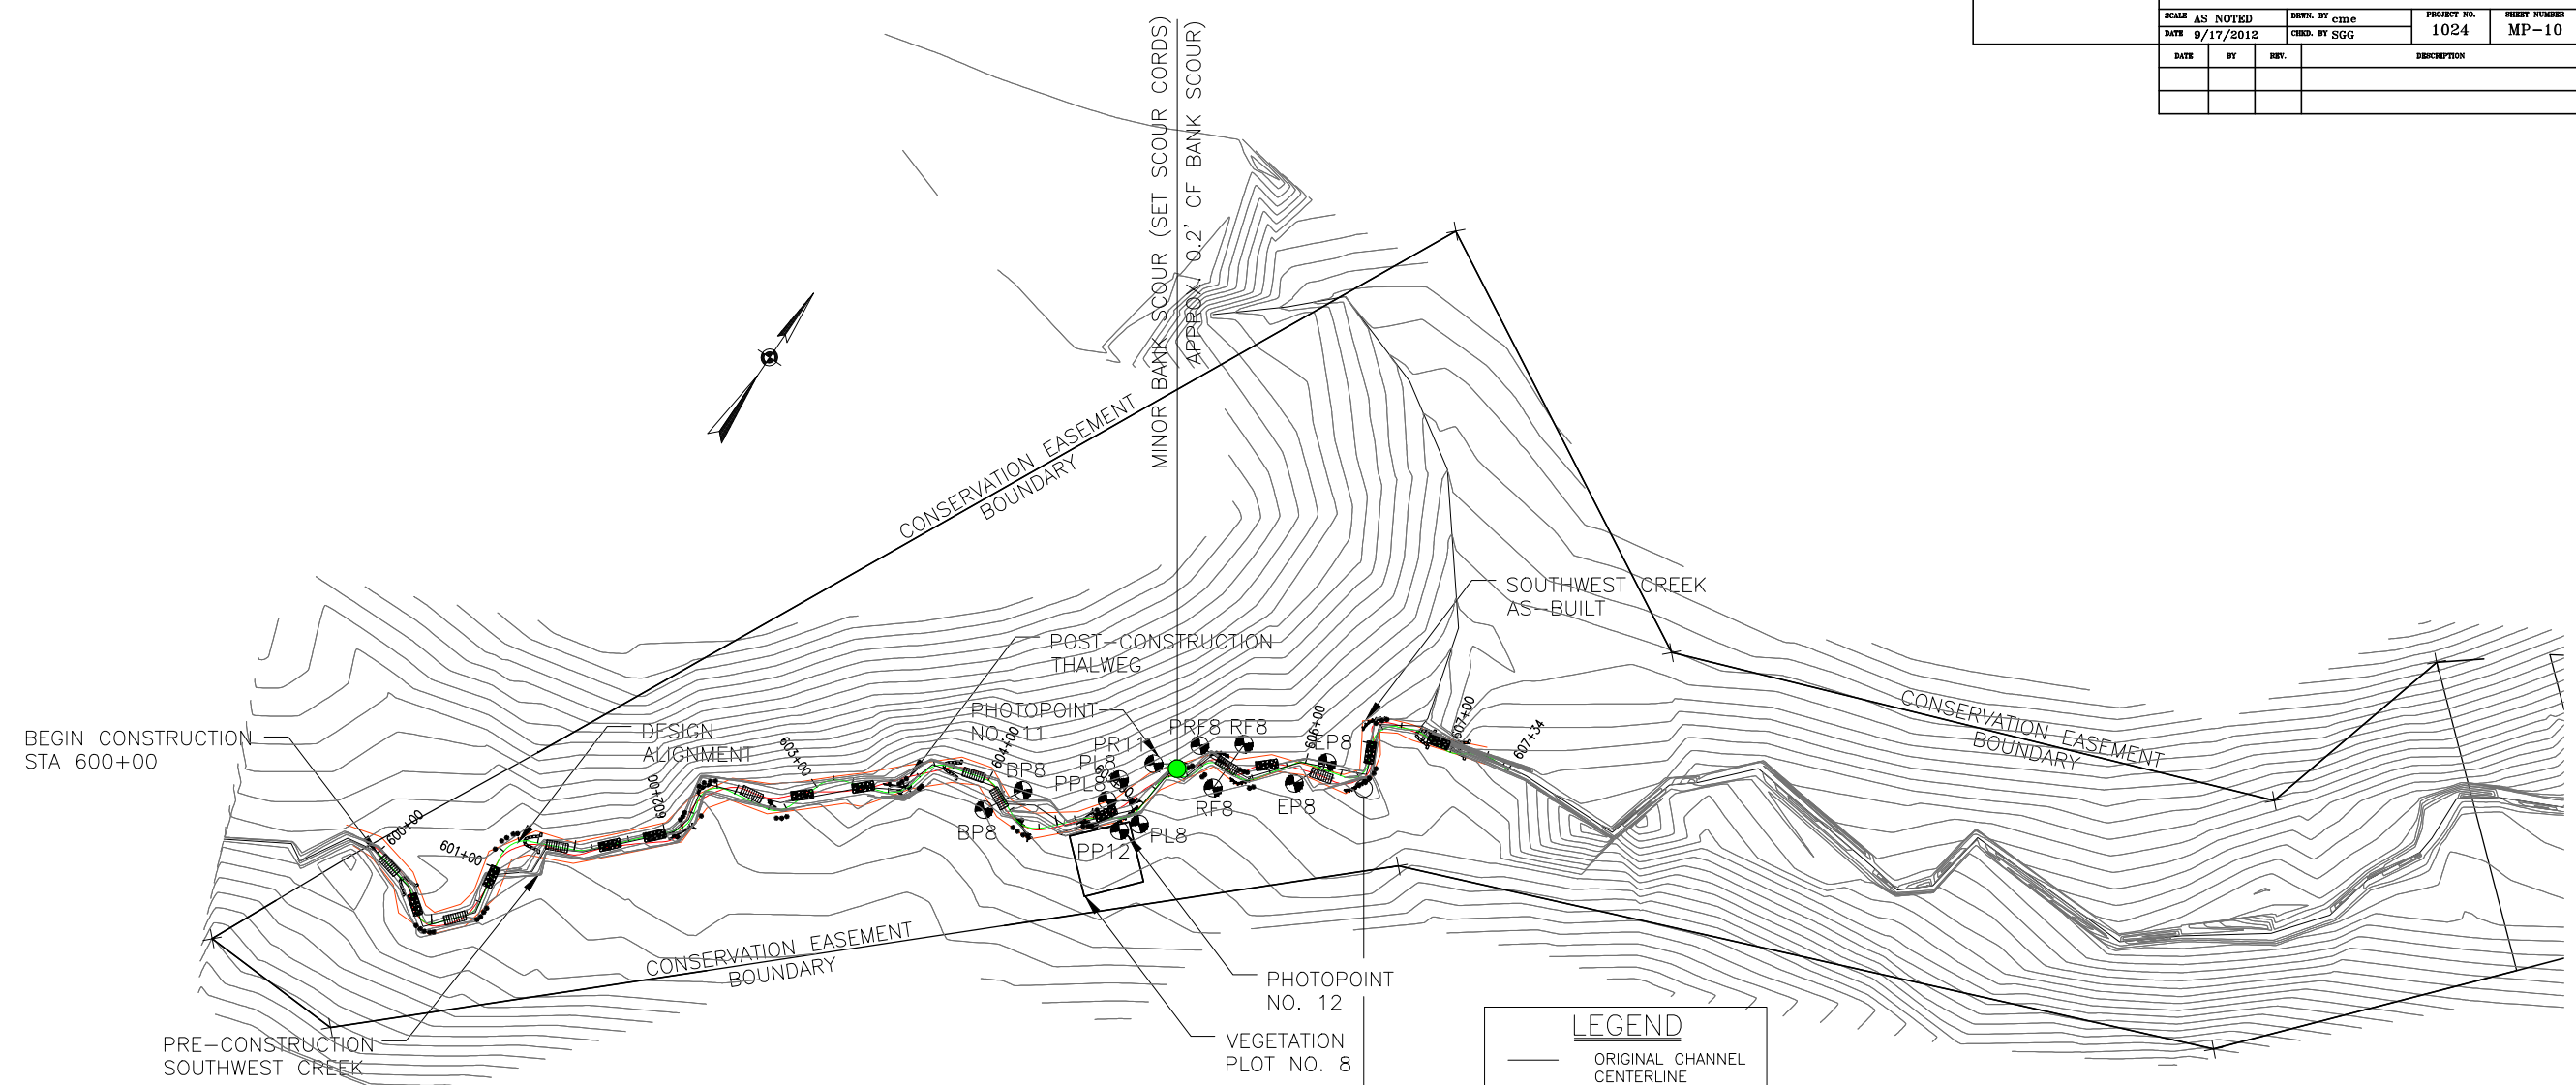
NOTE: VEGETATION HAS GROWN INTO THE MAJORITY OF RIFFLES DUE TO LACK OF SHADE FROM MATURE BUFFER

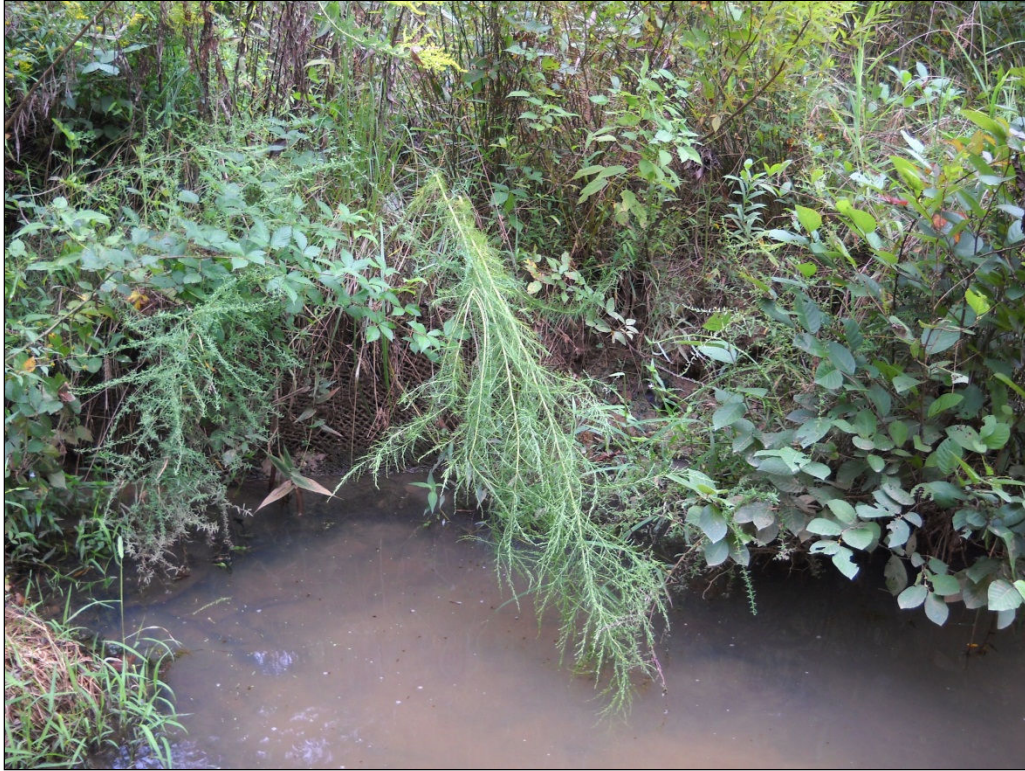
Buckhorn Creek, minor bank scour, Sta 152+90
