Holly Grove Stream Restoration Site

October 28, 2013

MONITORING REPORT 2013 (YEAR 5)

Restoration Systems, LLC

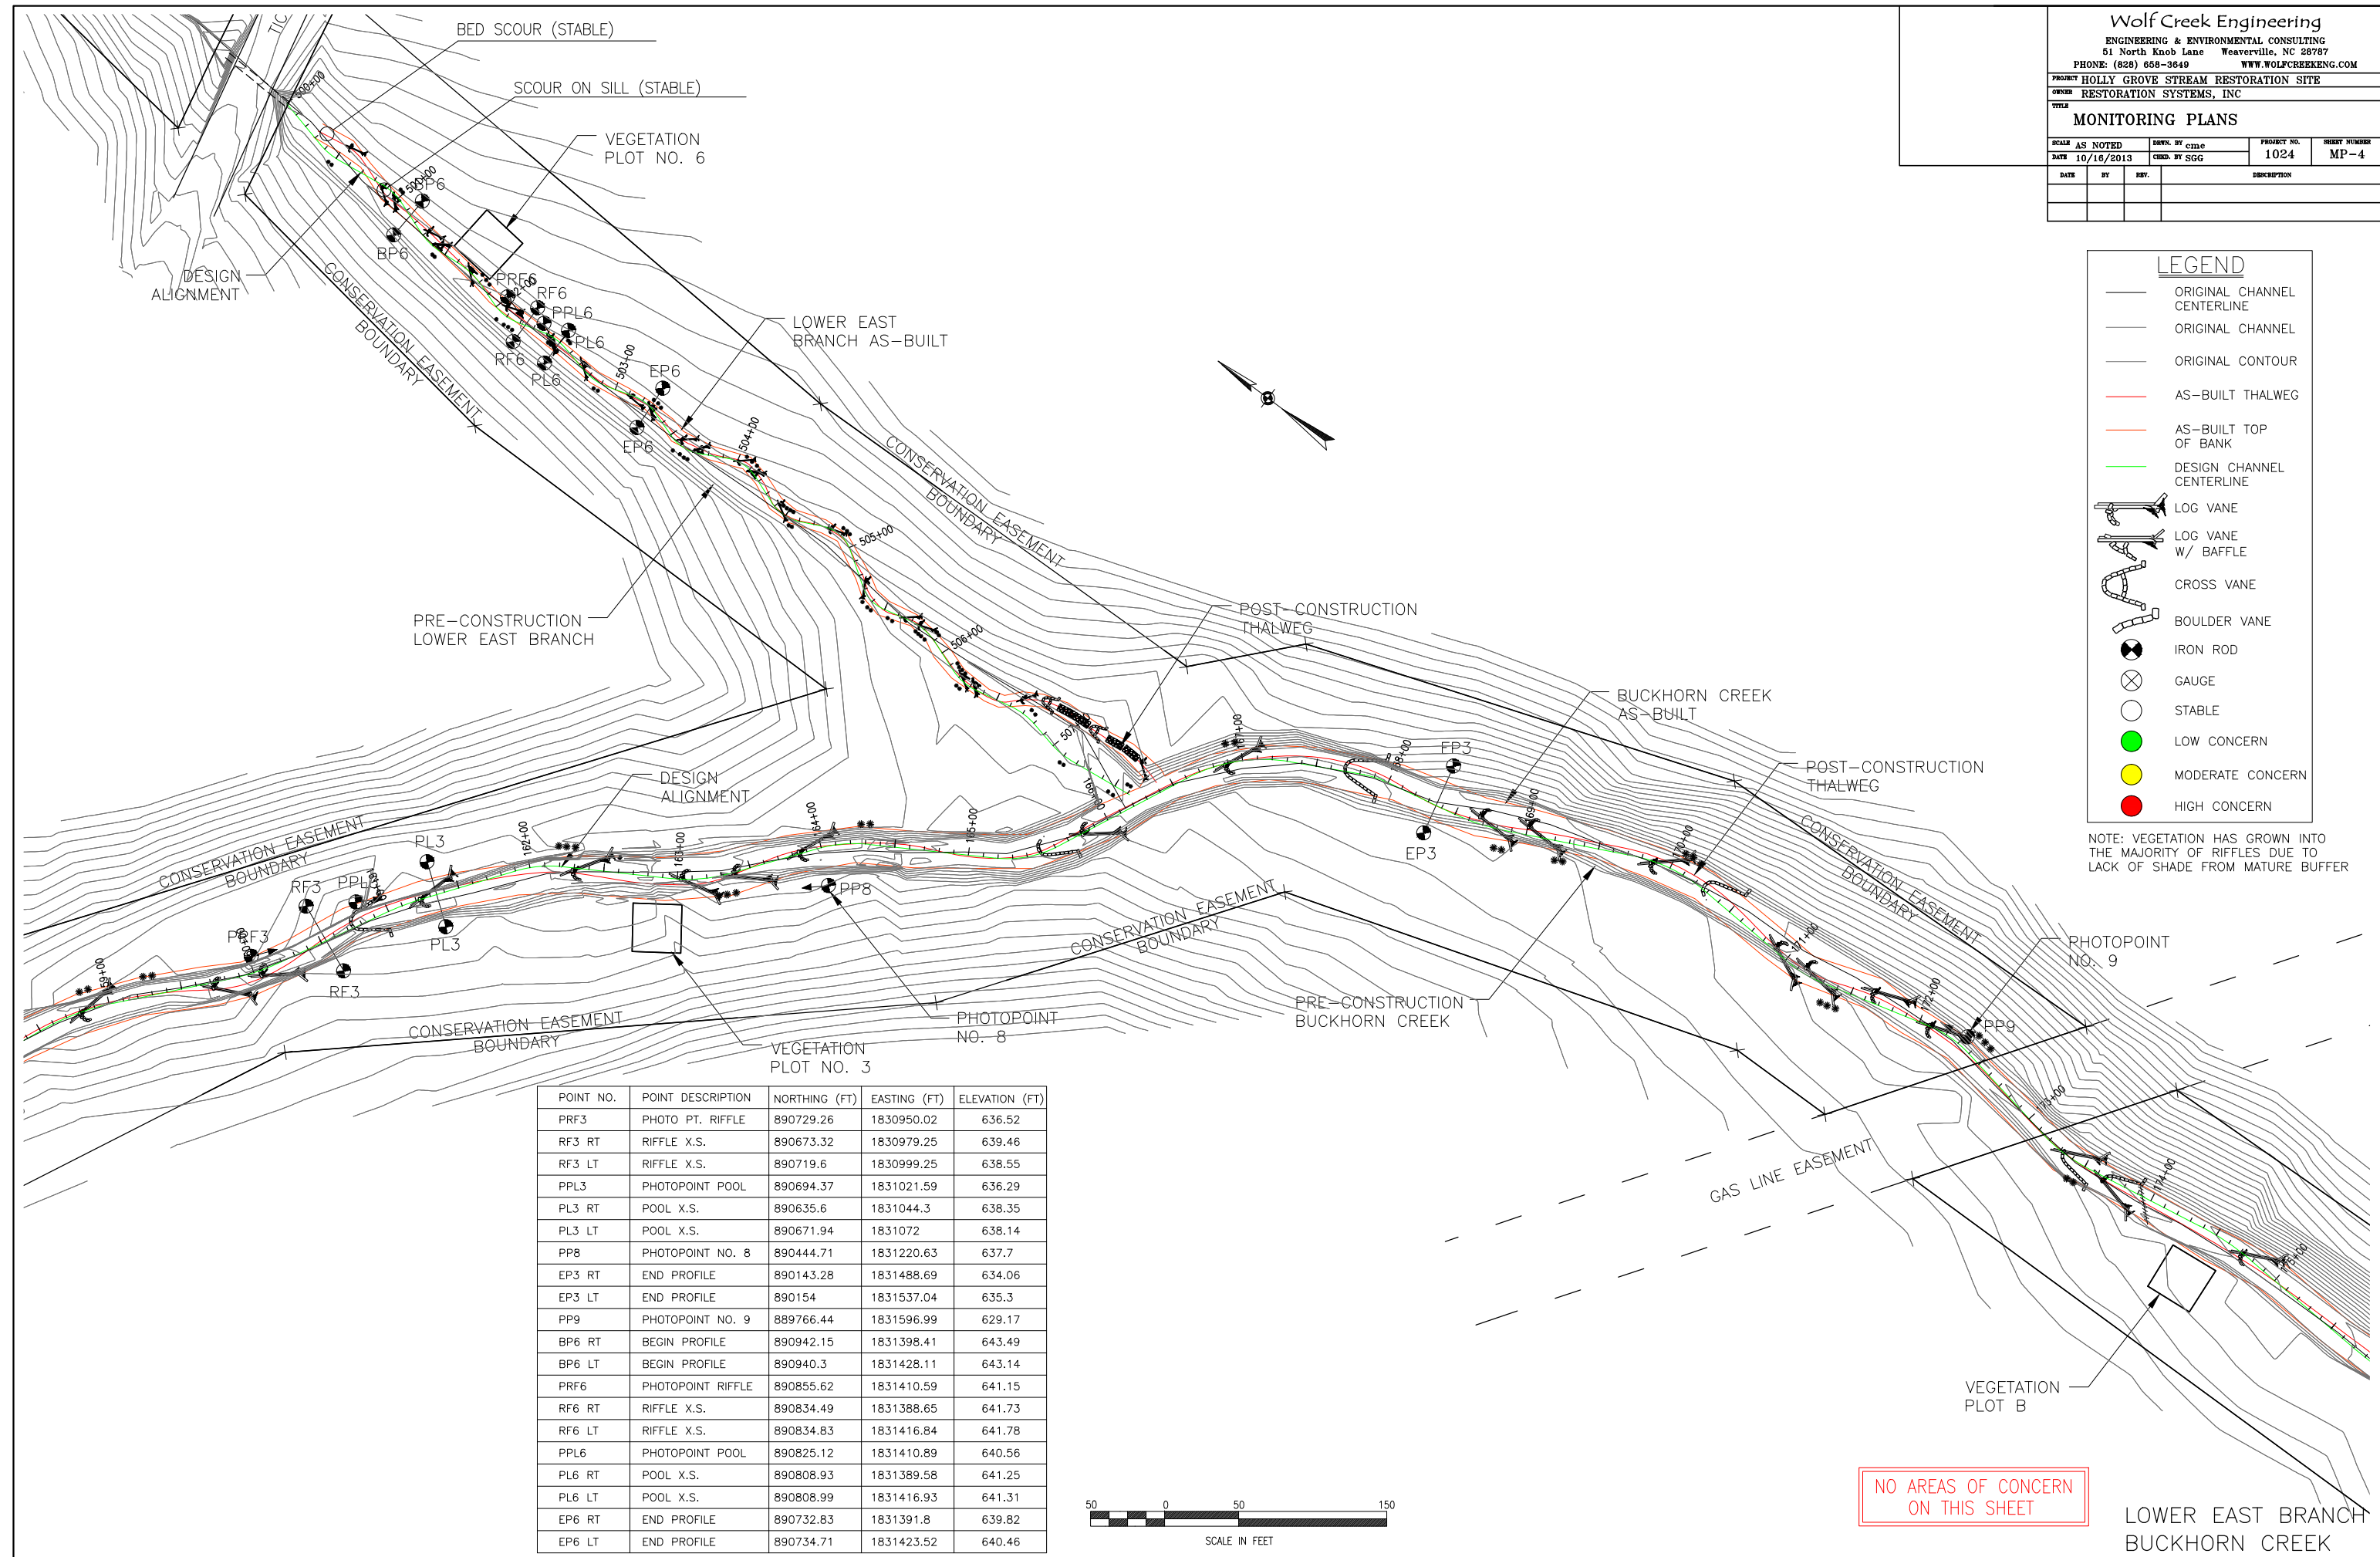
NOTE: VEGETATION HAS GROWN INTO THE MAJORITY OF RIFFLES DUE TO LACK OF SHADE FROM MATURE BUFFER

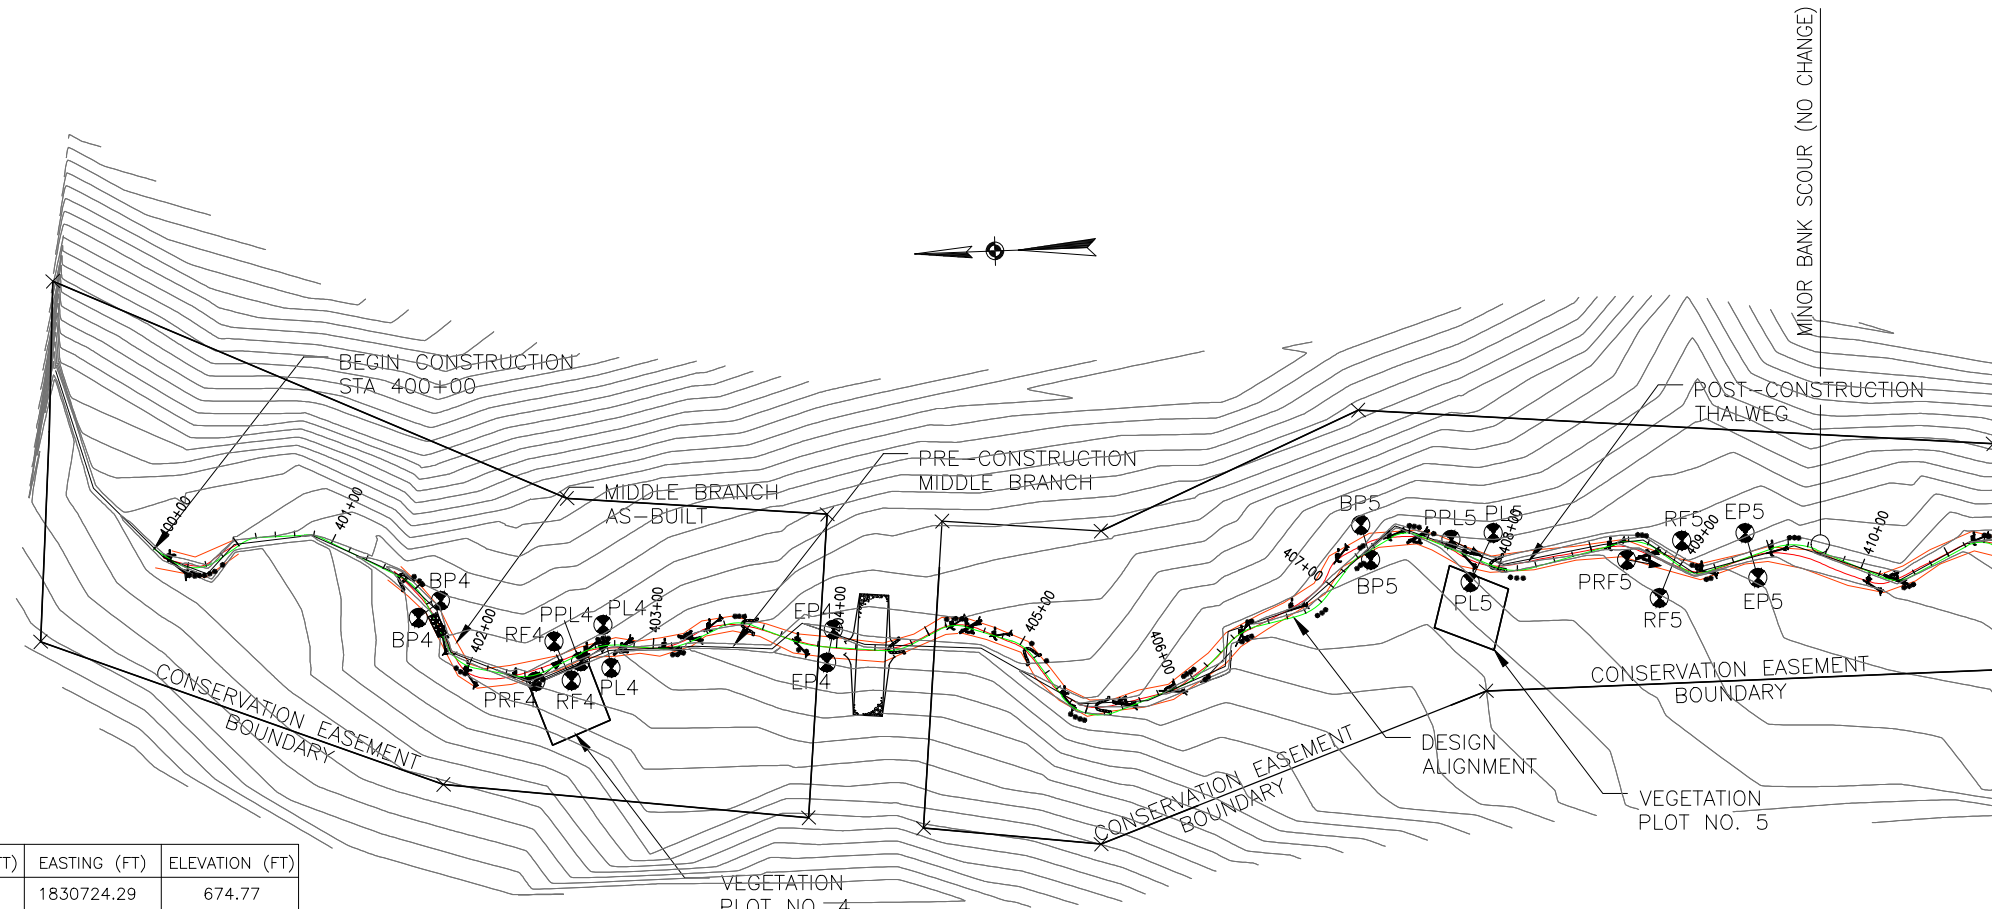
NOTE: VEGETATION HAS GROWN INTO THE MAJORITY OF RIFFLES DUE TO LACK OF SHADE FROM MATURE BUFFER

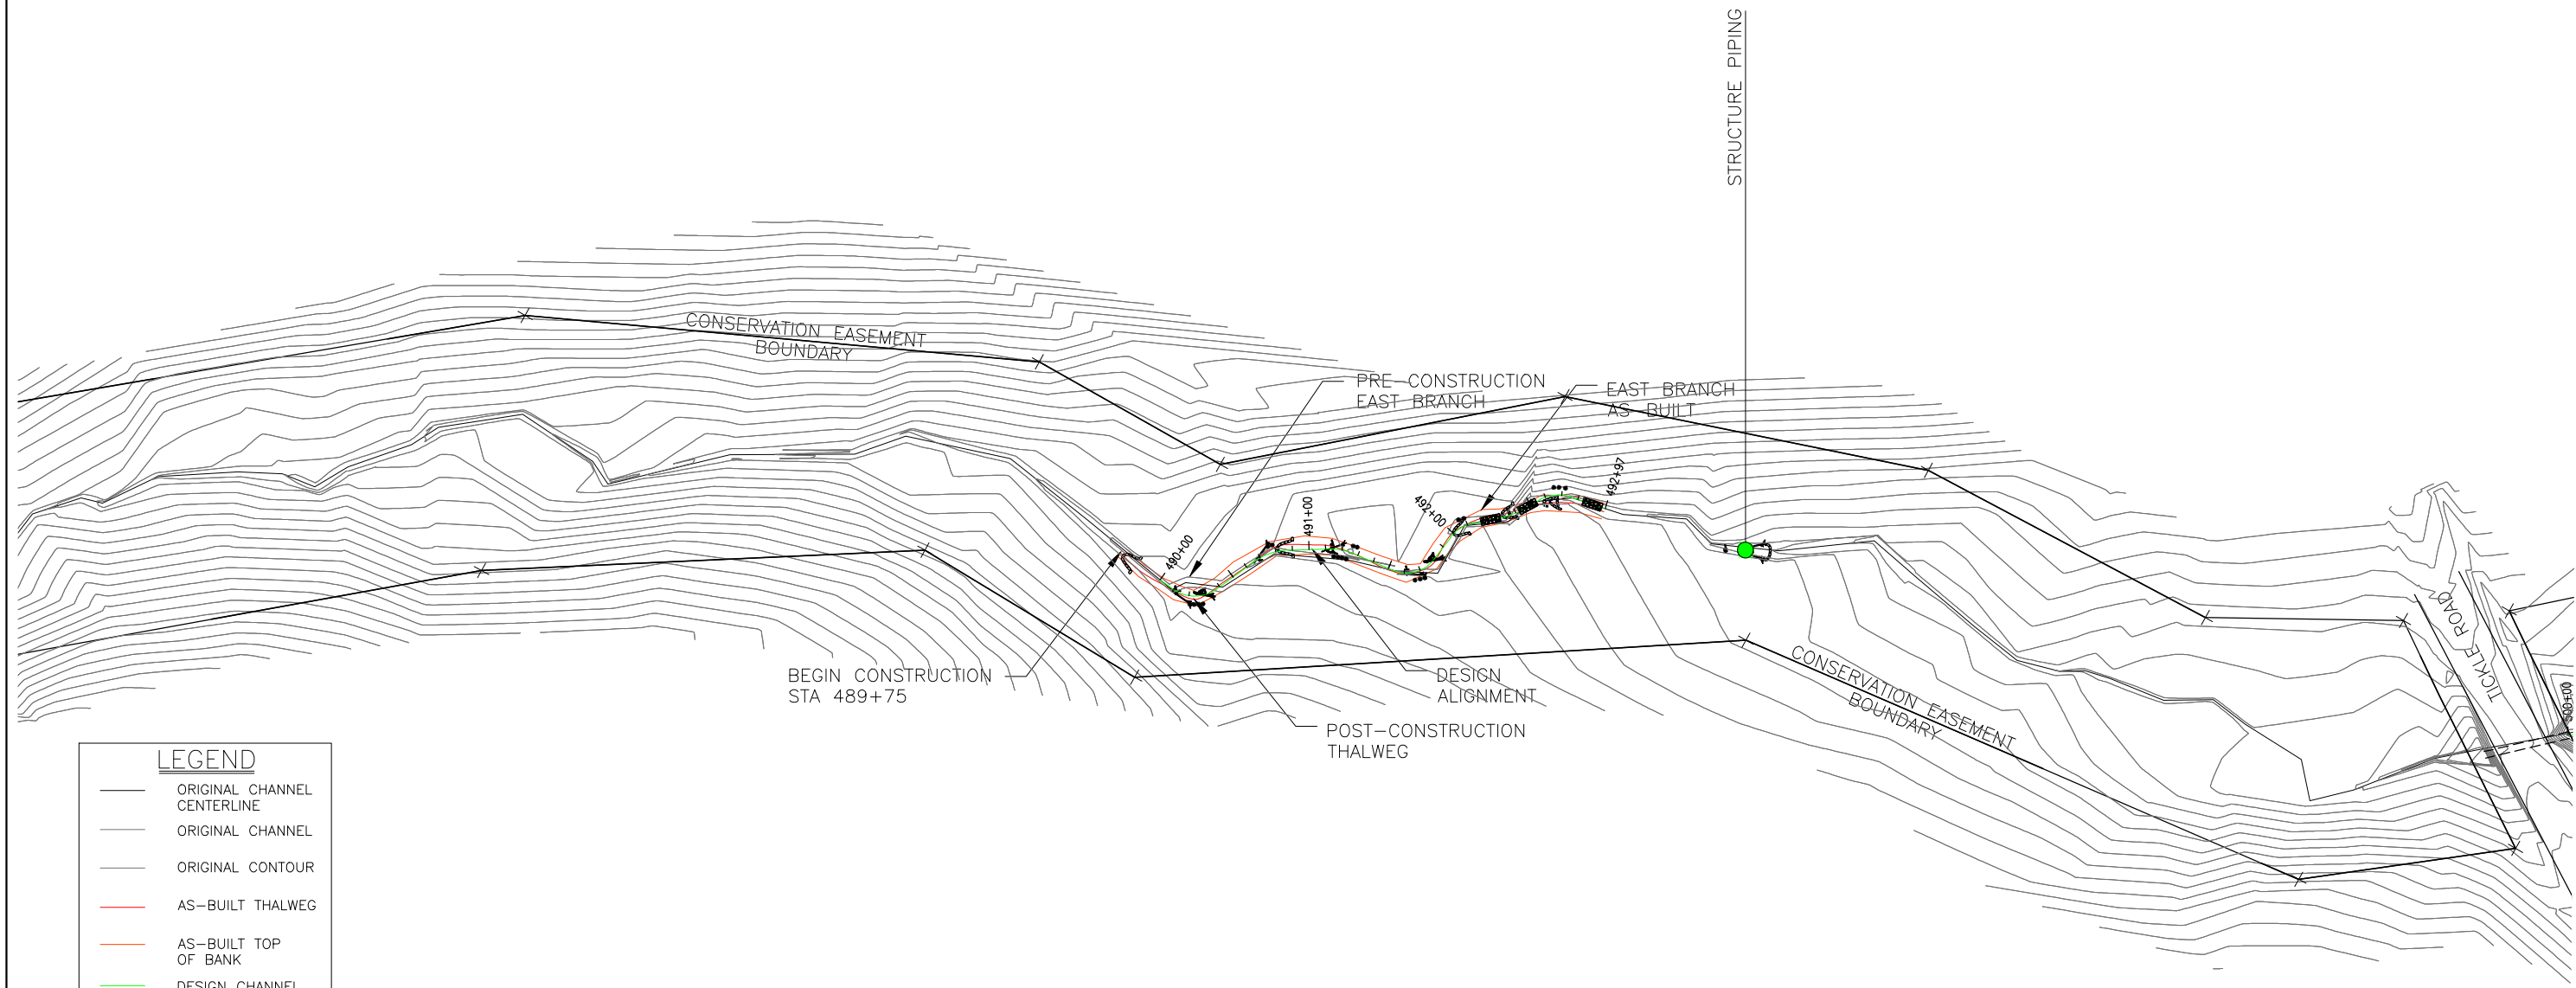
NOTE: VEGETATION HAS GROWN INTO THE MAJORITY OF RIFFLES DUE TO LACK OF SHADE FROM MATURE BUFFER

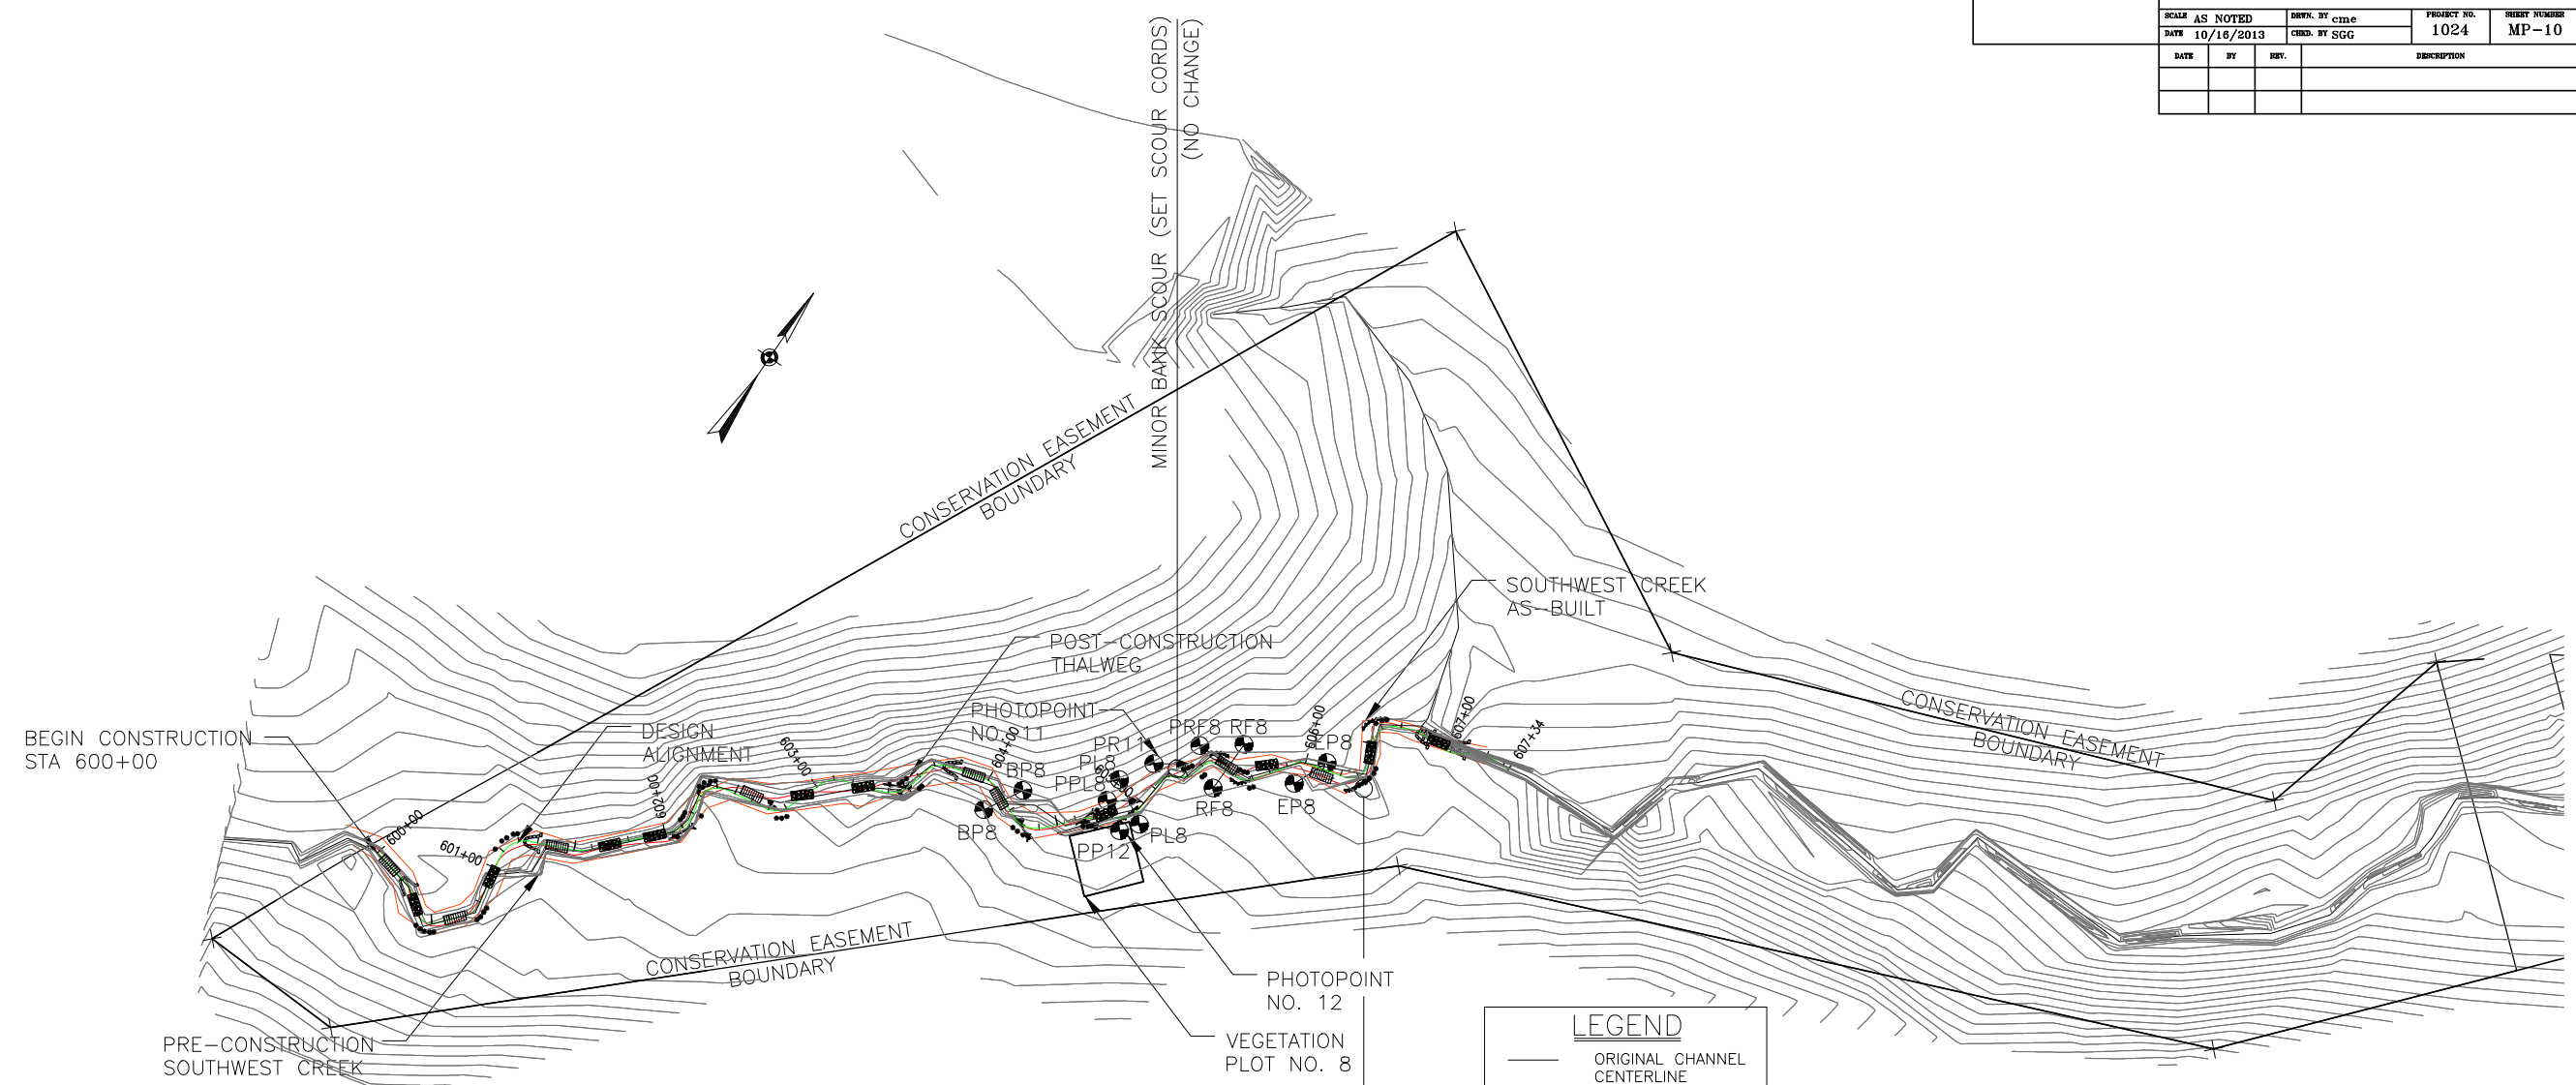
NOTE: VEGETATION HAS GROWN INTO THE MAJORITY OF RIFFLES DUE TO LACK OF SHADE FROM MATURE BUFFER
