BASELINE MONITORING DOCUMENT AND AS-BUILT BASELINE REPORT

HOLMAN MILL MITIGATION SITE

Alamance County, NC
DEQ Contract 005795
DMS Project Number 96316

Data Collection Period: January 2016 – April 2016
Draft Submission Date: May 20, 2016
Final Submission Date: November 2, 2016

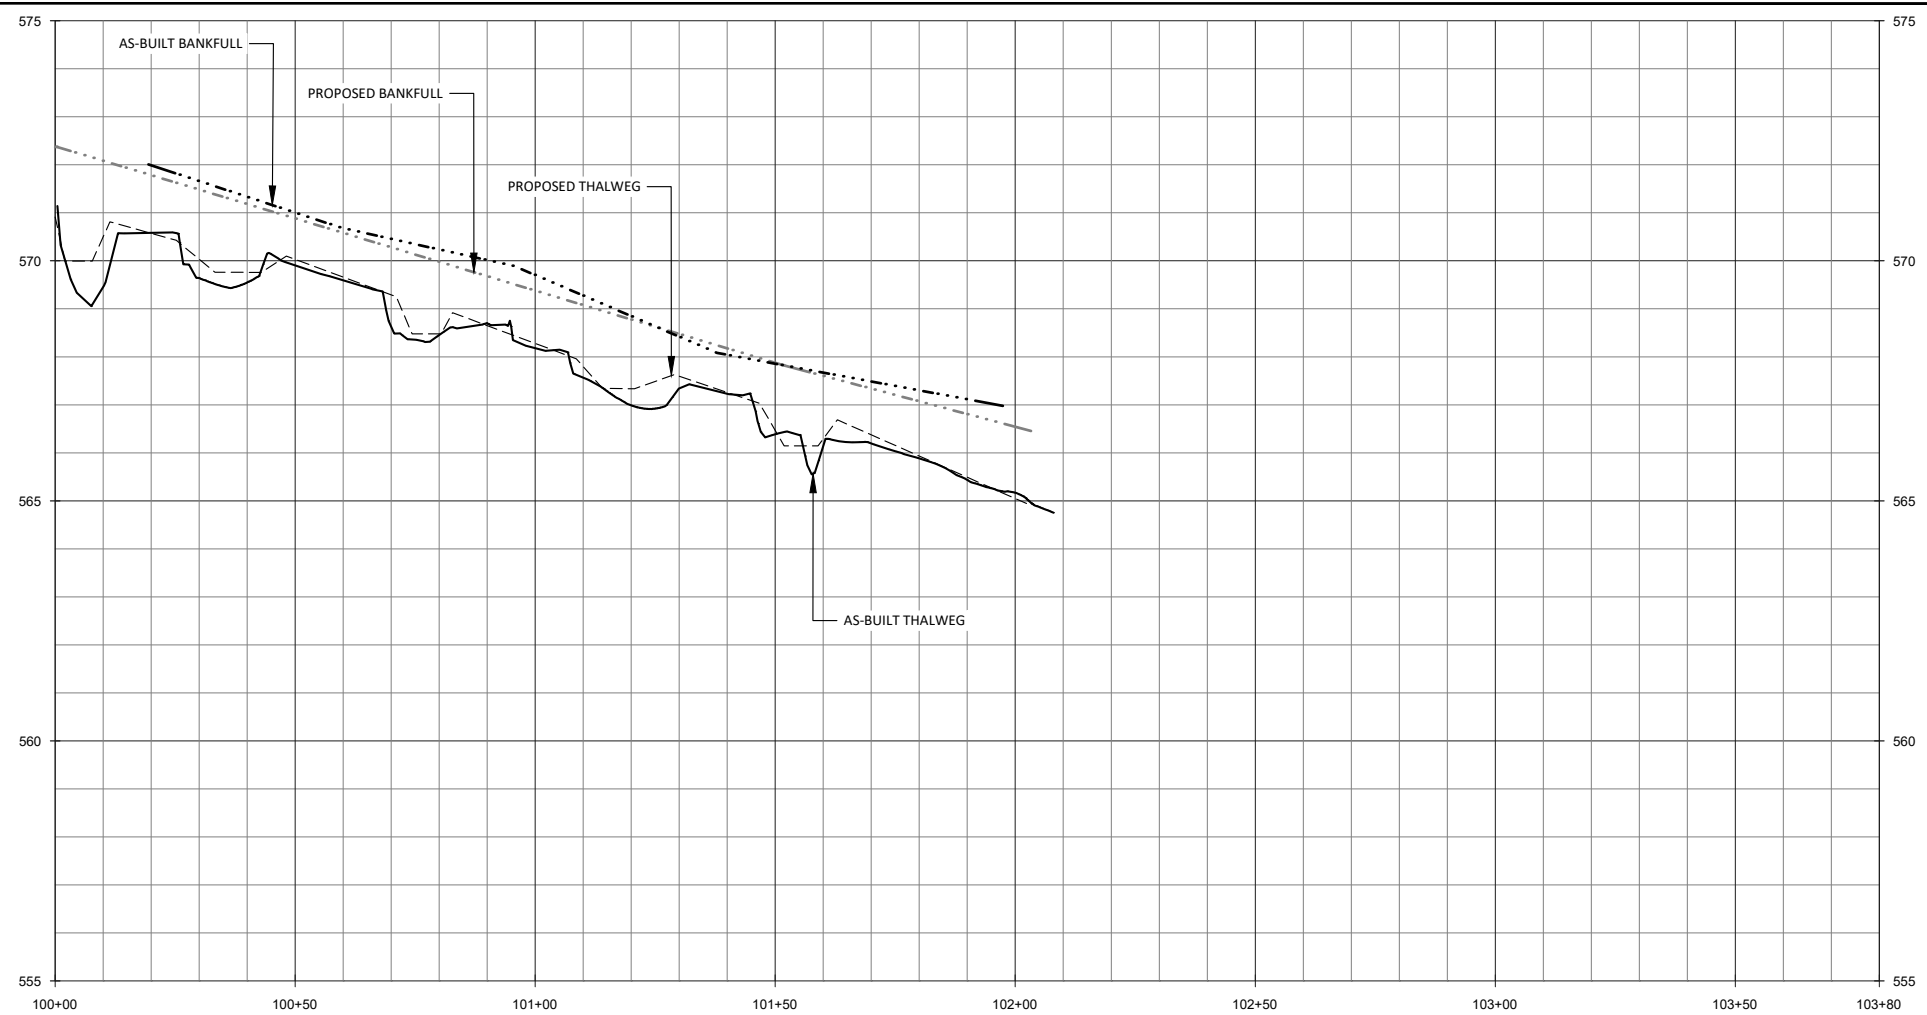
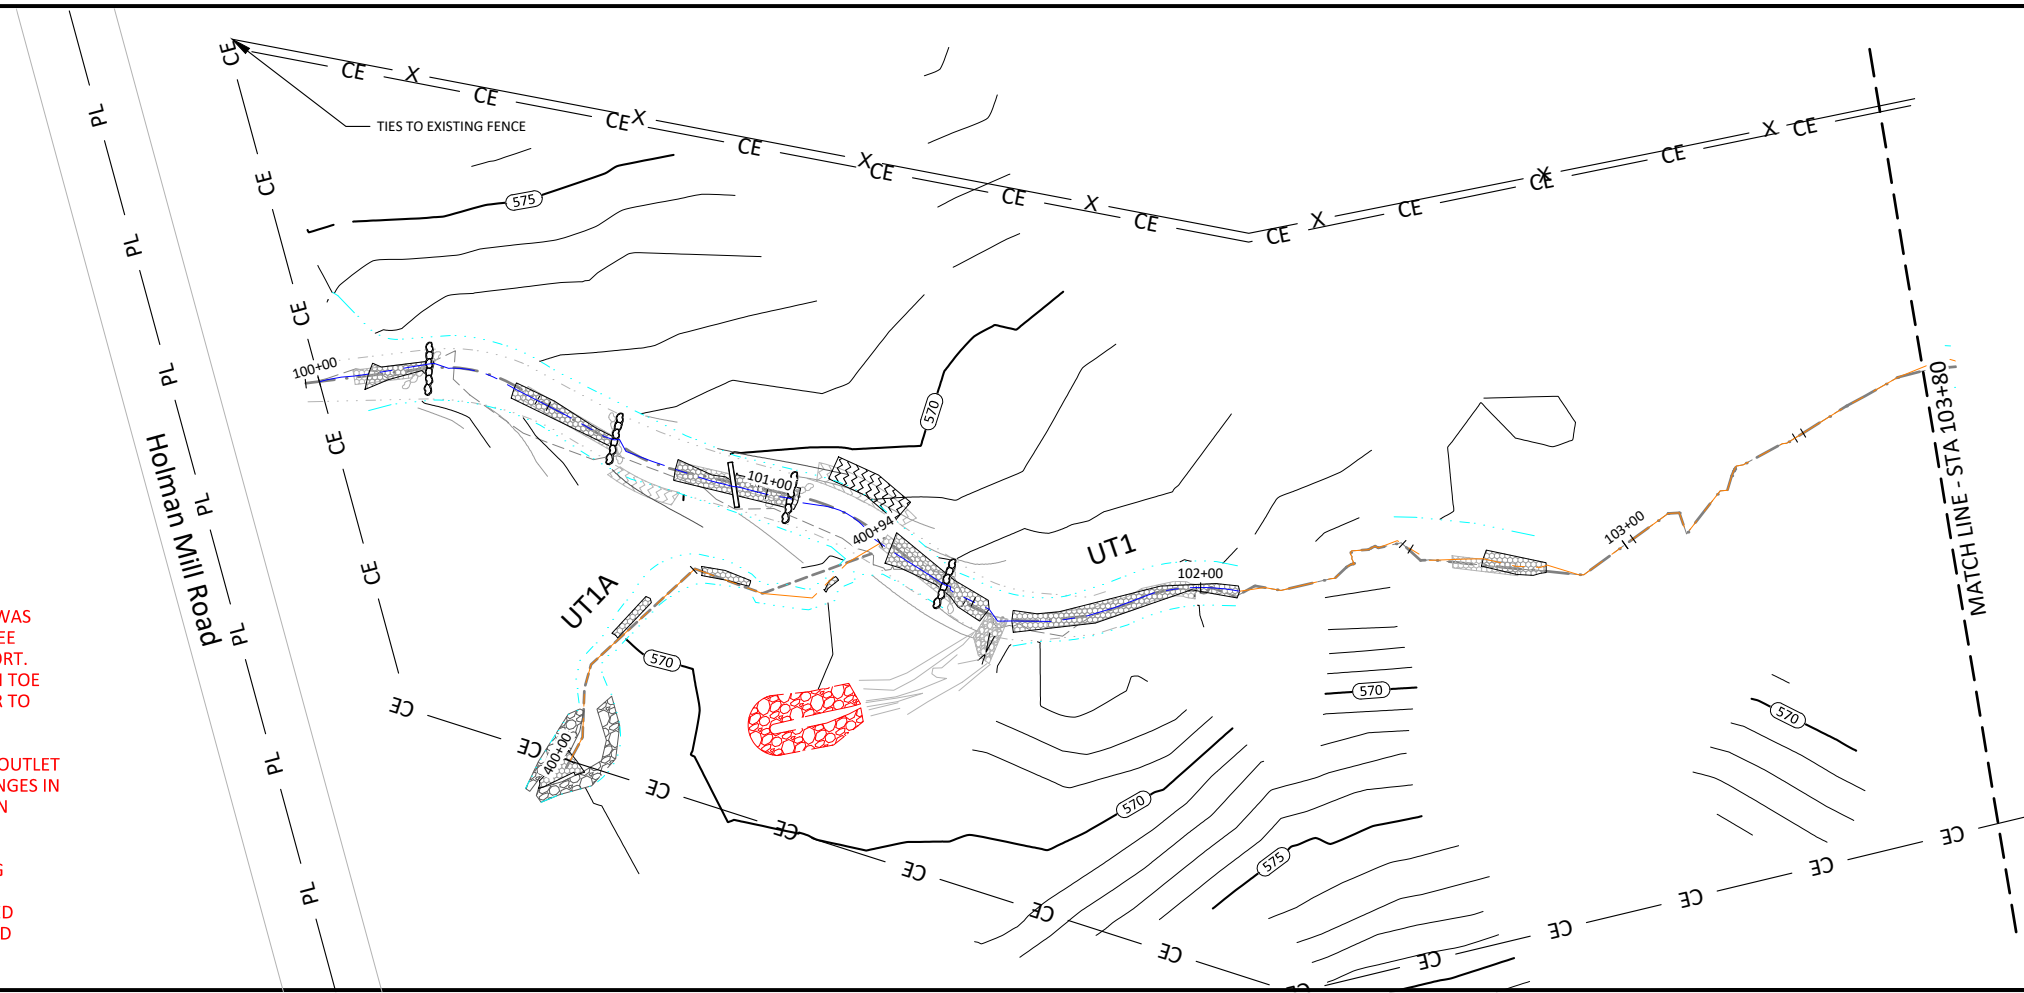
- NOTE:
1. AT STATION 100+00 LT, ROCK WAS ADDED TO ROADSIDE DITCH. SEE SECTION 5.1 OF AS-BUILT REPORT.
 2. AT STATION 100+75 RT, BRUSH TOE WAS NOT INSTALLED IN ORDER TO AVOID IMPACTS TO EXISTING, MATURE TREES.
 3. AT STATION 101+35 RT, ROCK OUTLET WAS RELOCATED DUE TO CHANGES IN DRAINAGE PATTERNS BETWEEN PROJECT DESIGN AND CONSTRUCTION.
 4. UT1A WAS STABILIZED DURING CONSTRUCTION DUE TO DEGRADATION THAT OCCURRED BETWEEN PROJECT DESIGN AND CONSTRUCTION.

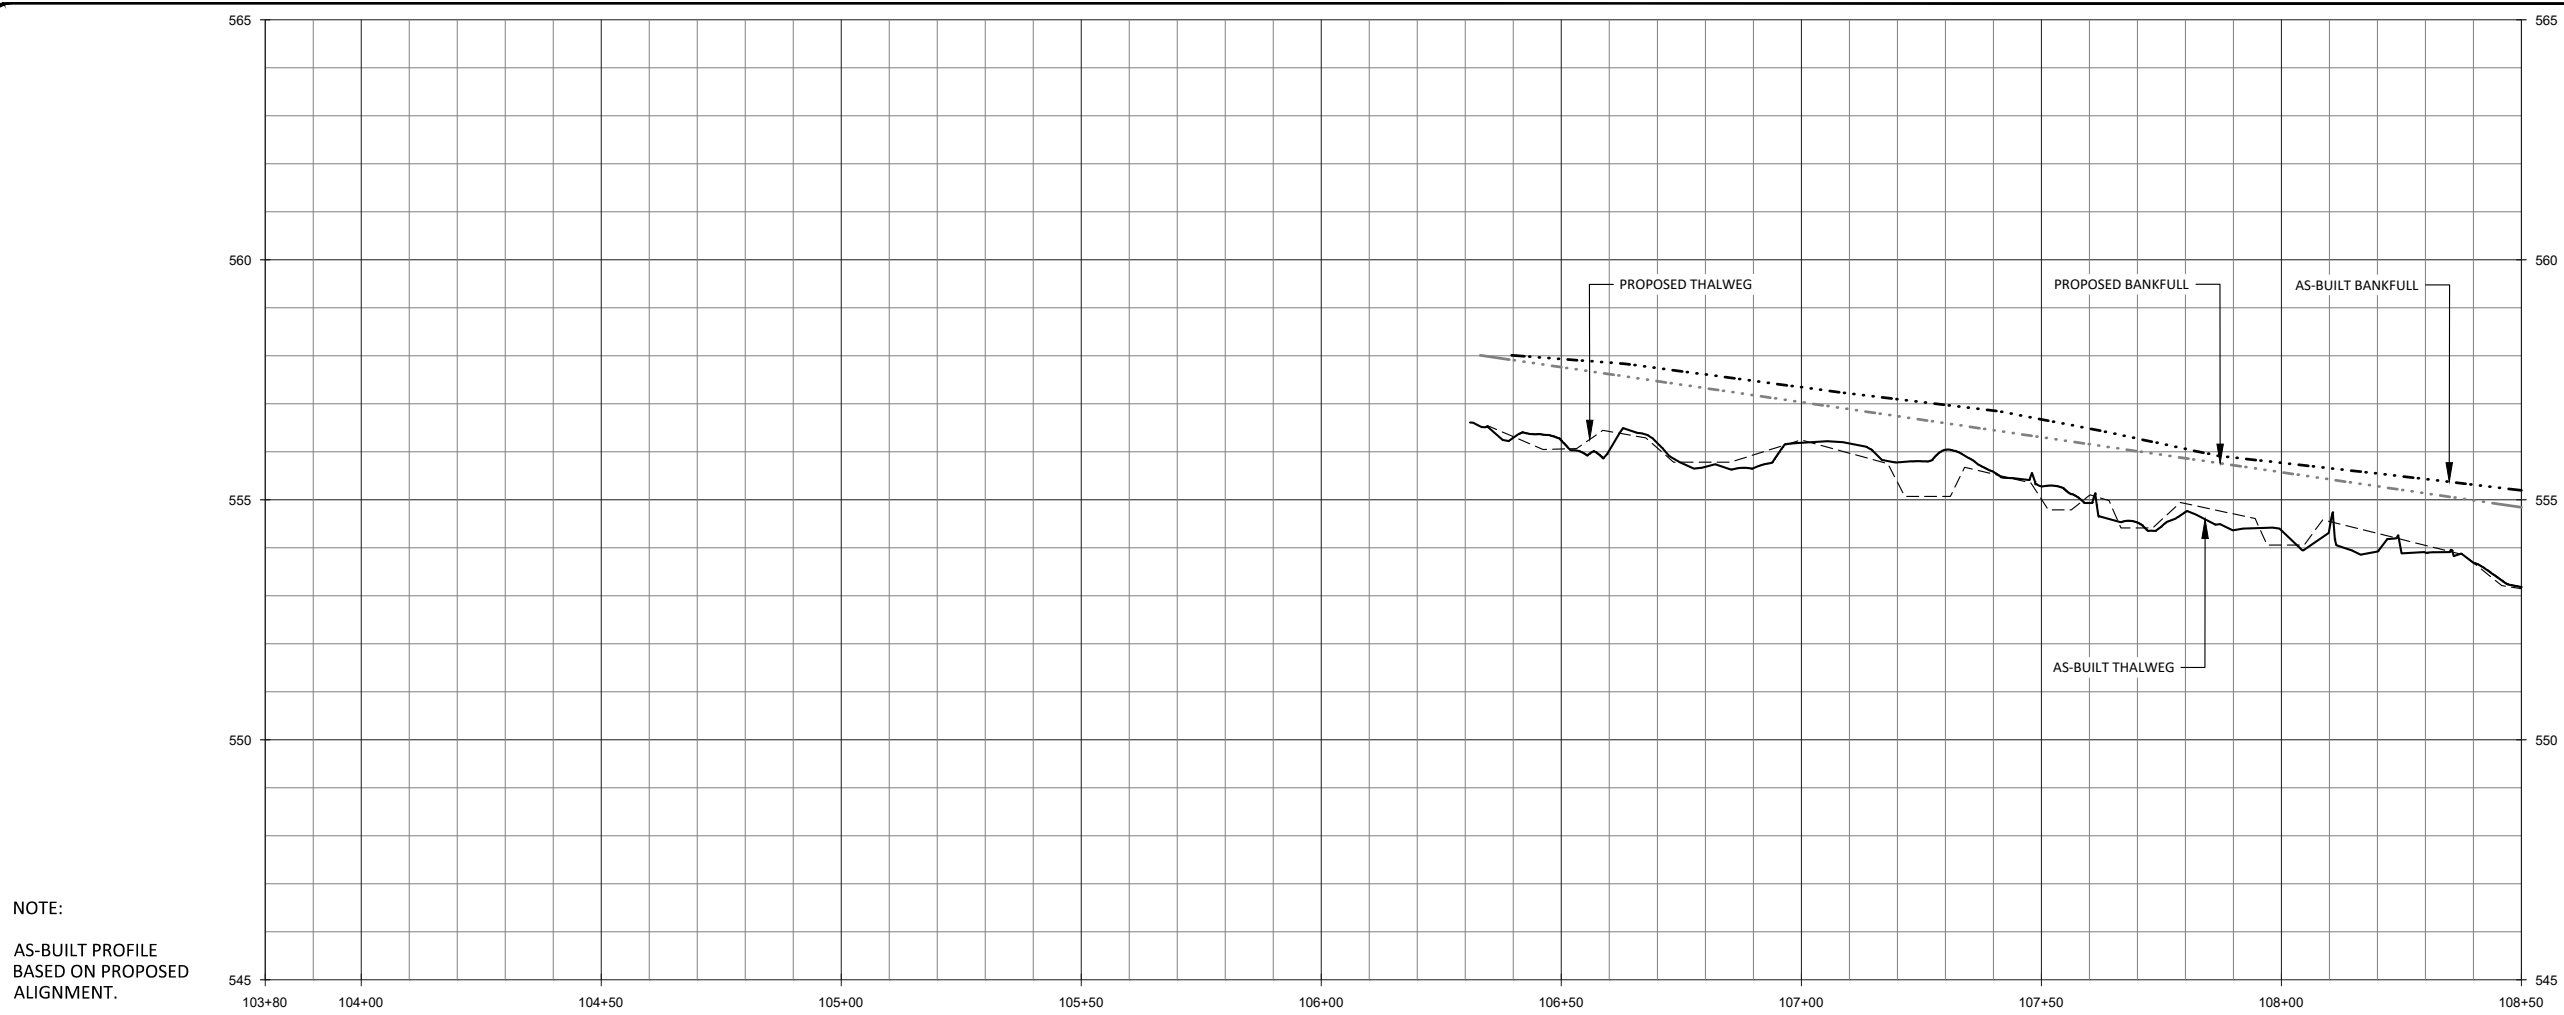
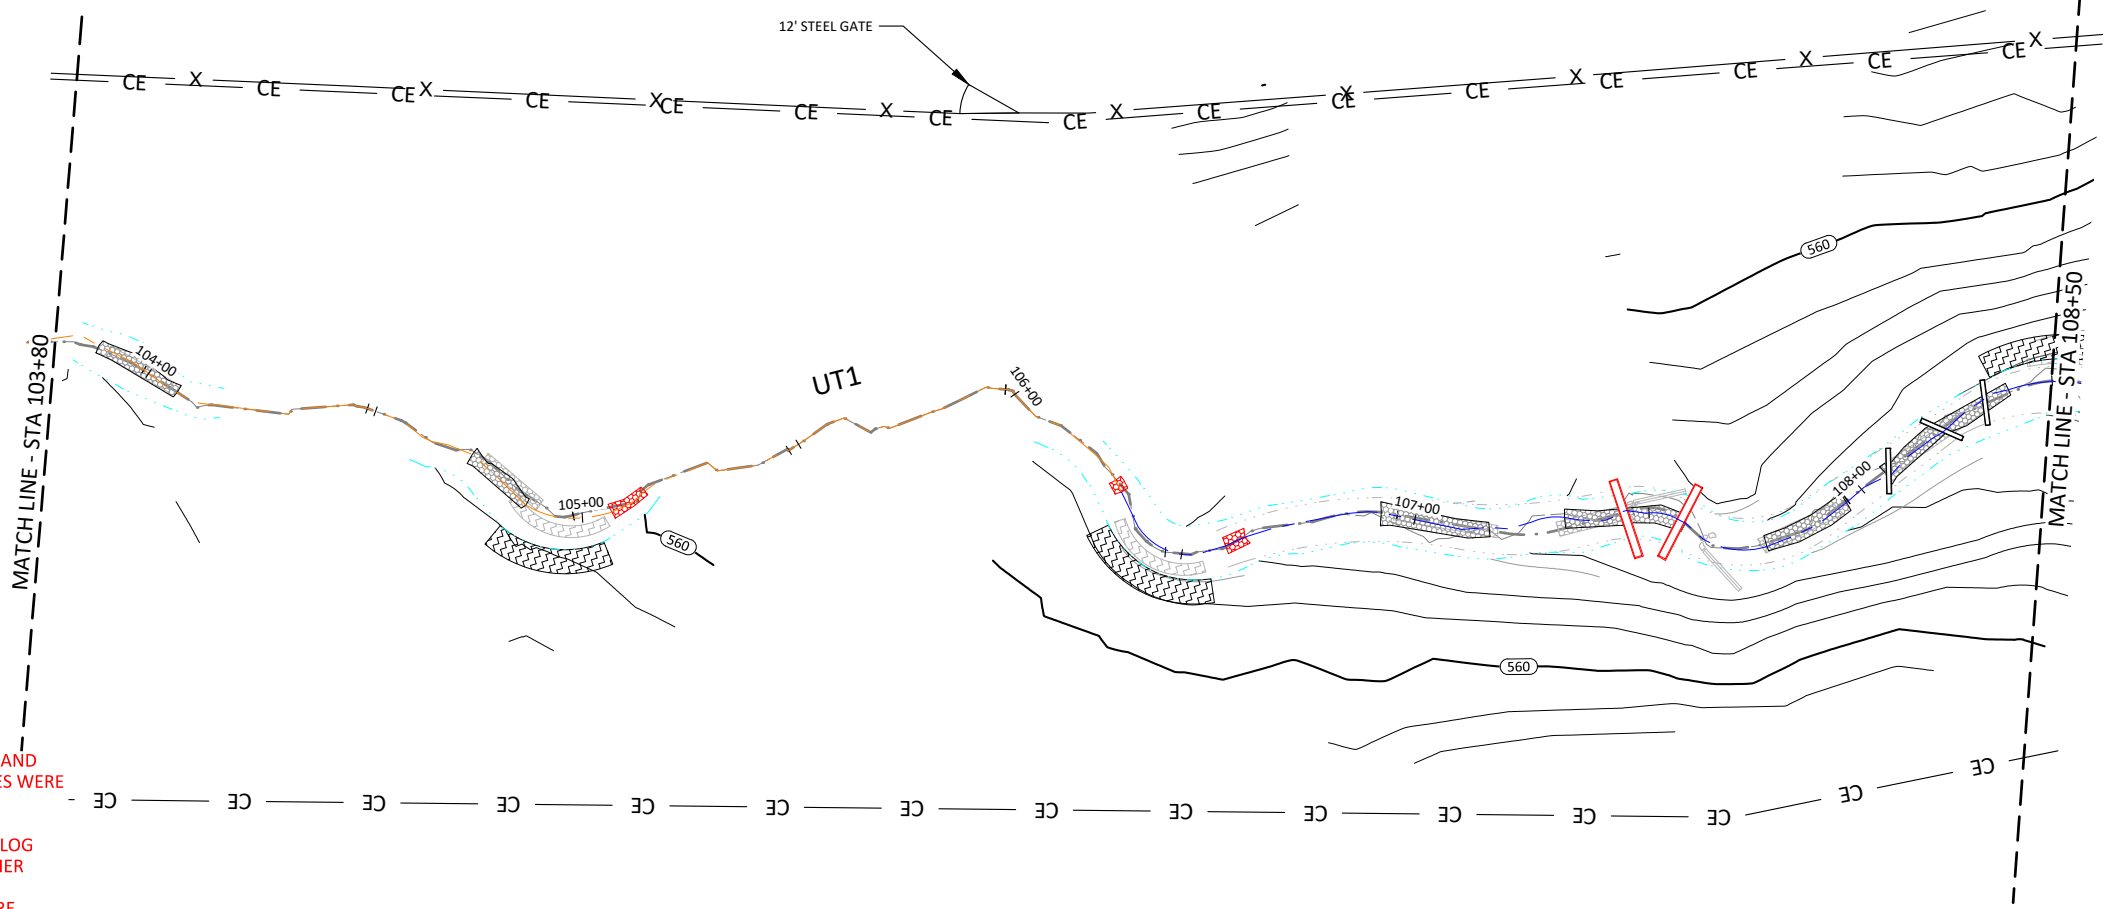
NOTE: 1. AT STATIONS 105+10, 106+30 AND 106+60, CONSTRUCTED RIFFLES WERE INSTALLED WHERE CHANNEL STABILIZATION WAS NEEDED.
2. AT STATION 107+50, ANGLED LOG DROPS WERE INSTALLED RATHER THAN LOG J-HOOKS TO AVOID IMPACTS TO EXISTING, MATURE TREES ON LEFT BANK.

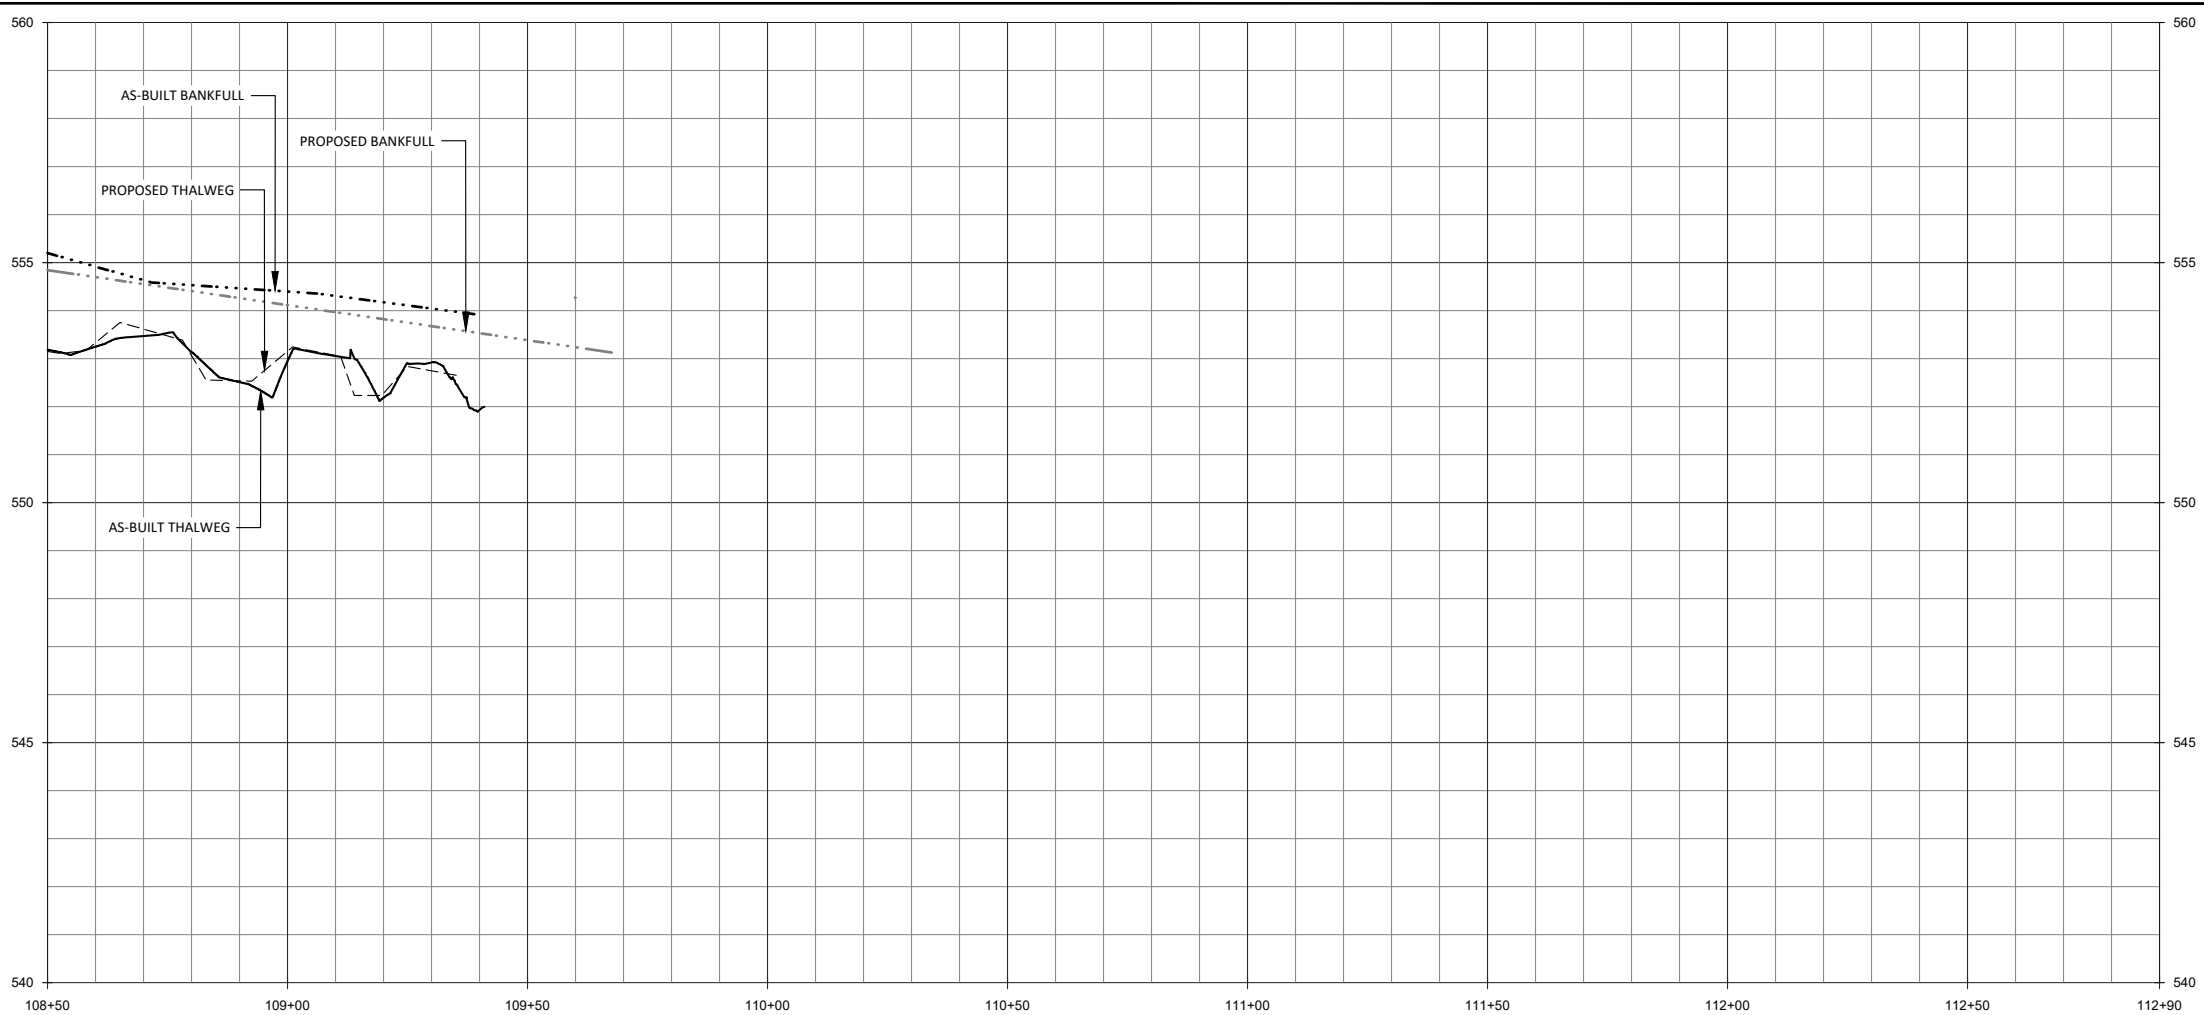
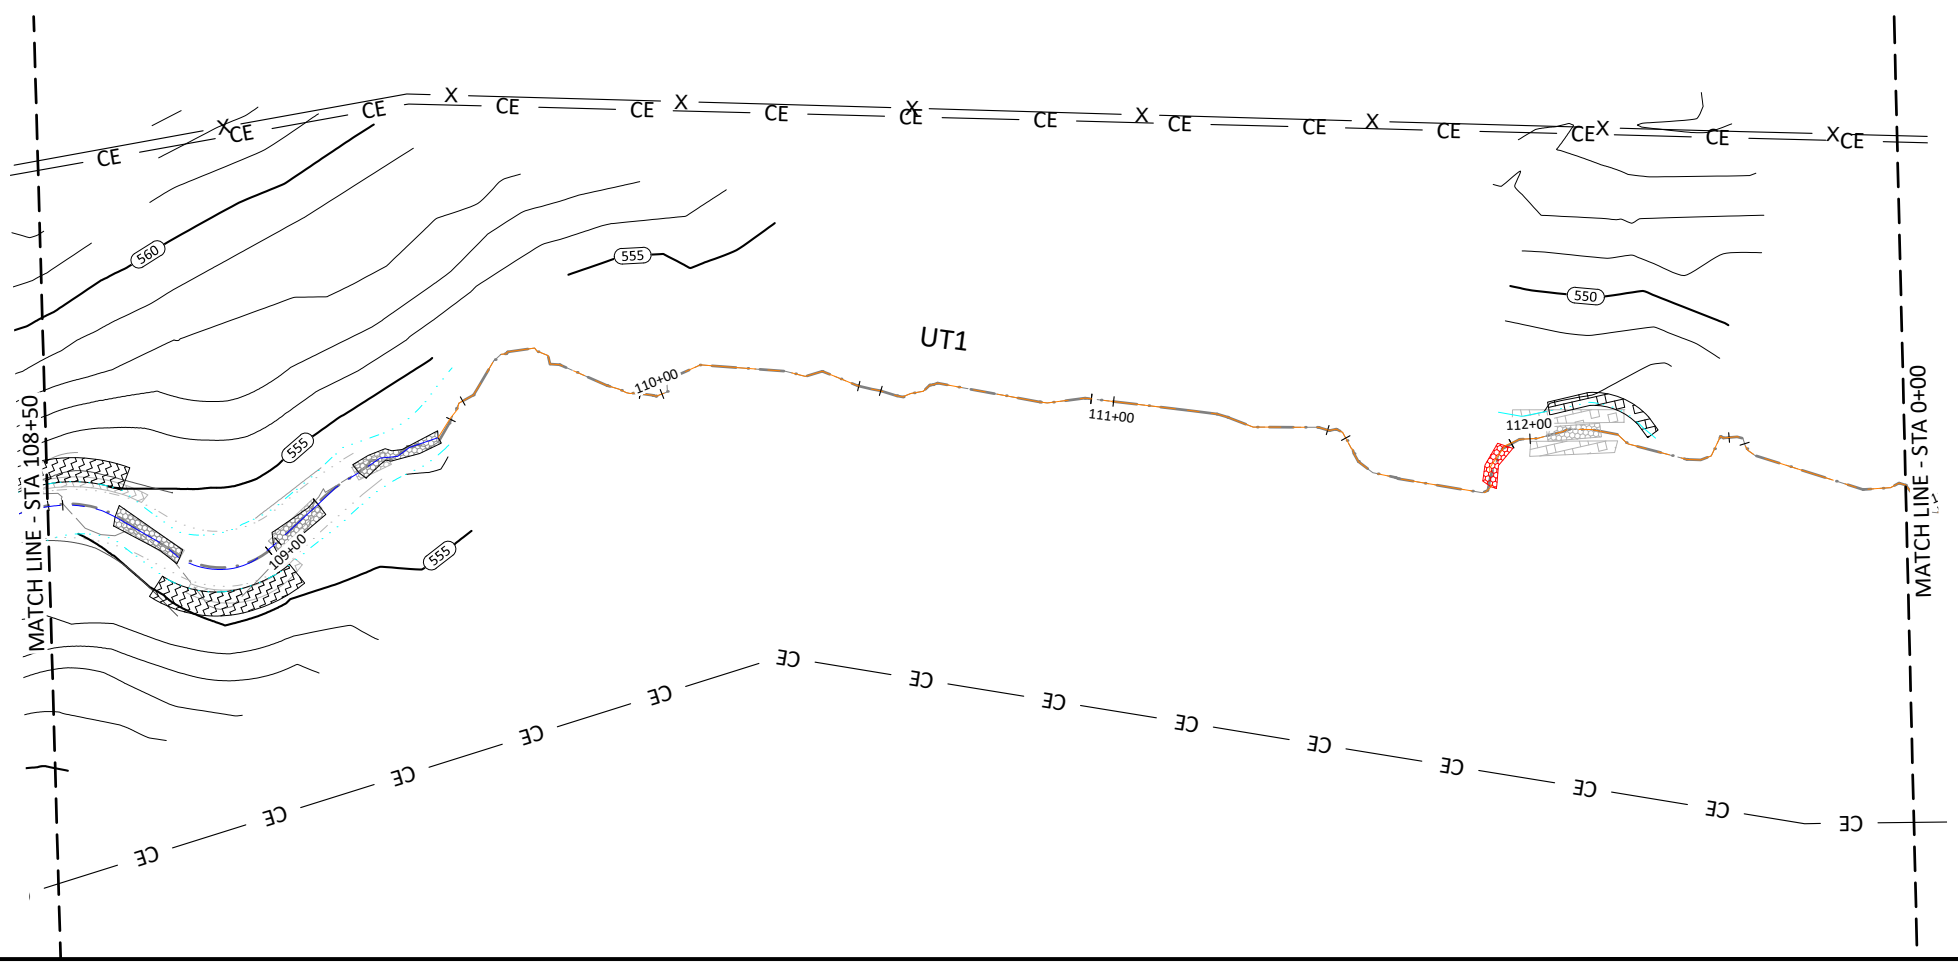
NOTE: 1. AT STATION 111+90, CONSTRUCTED
RIFFLER WAS SHIFTED UPSTREAM
WHERE CHANNEL STABILIZATION WAS
NEEDED.

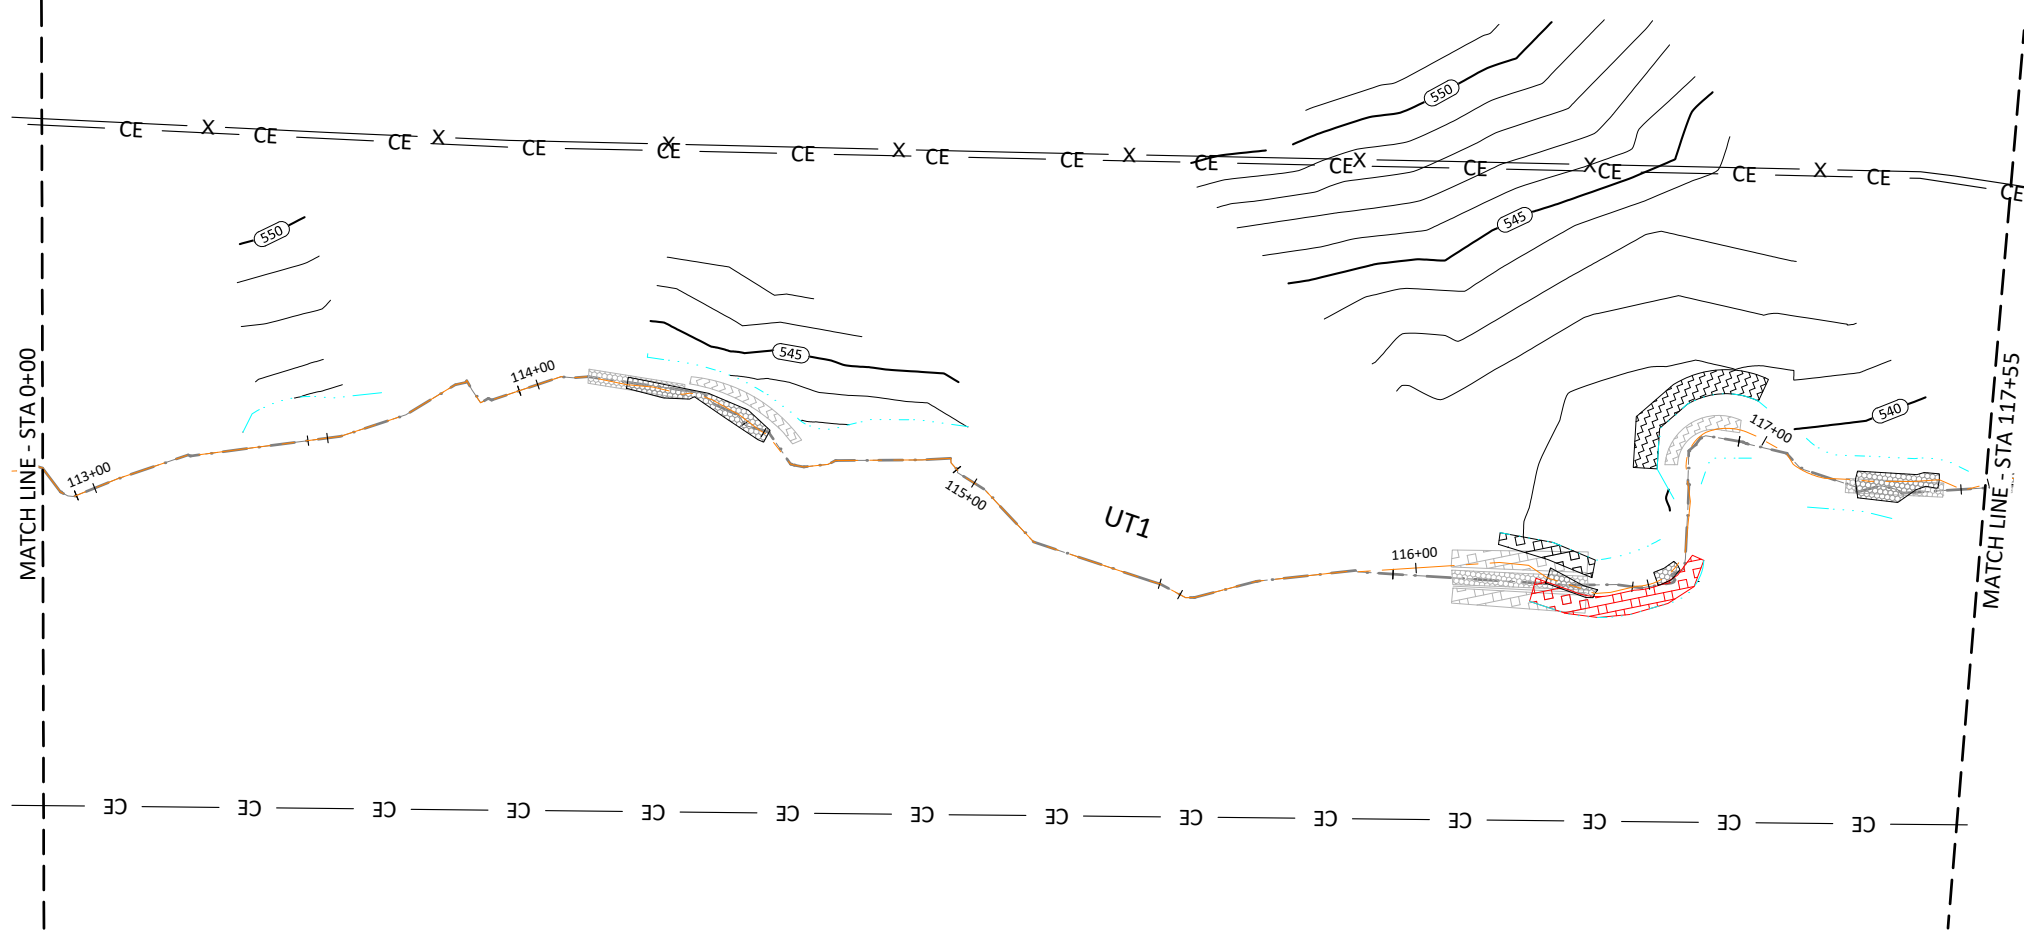
NOTE: 1. AT STATION 114+45 LT, BRUSH TOE WAS NOT INSTALLED IN ORDER TO MINIMIZE DISTURBANCE TO HILLSLOPE.
2. AT STATION 116+45 RT, SOD MATS WERE EXTENDED FURTHER DOWNSTREAM TO STABILIZE BANK.

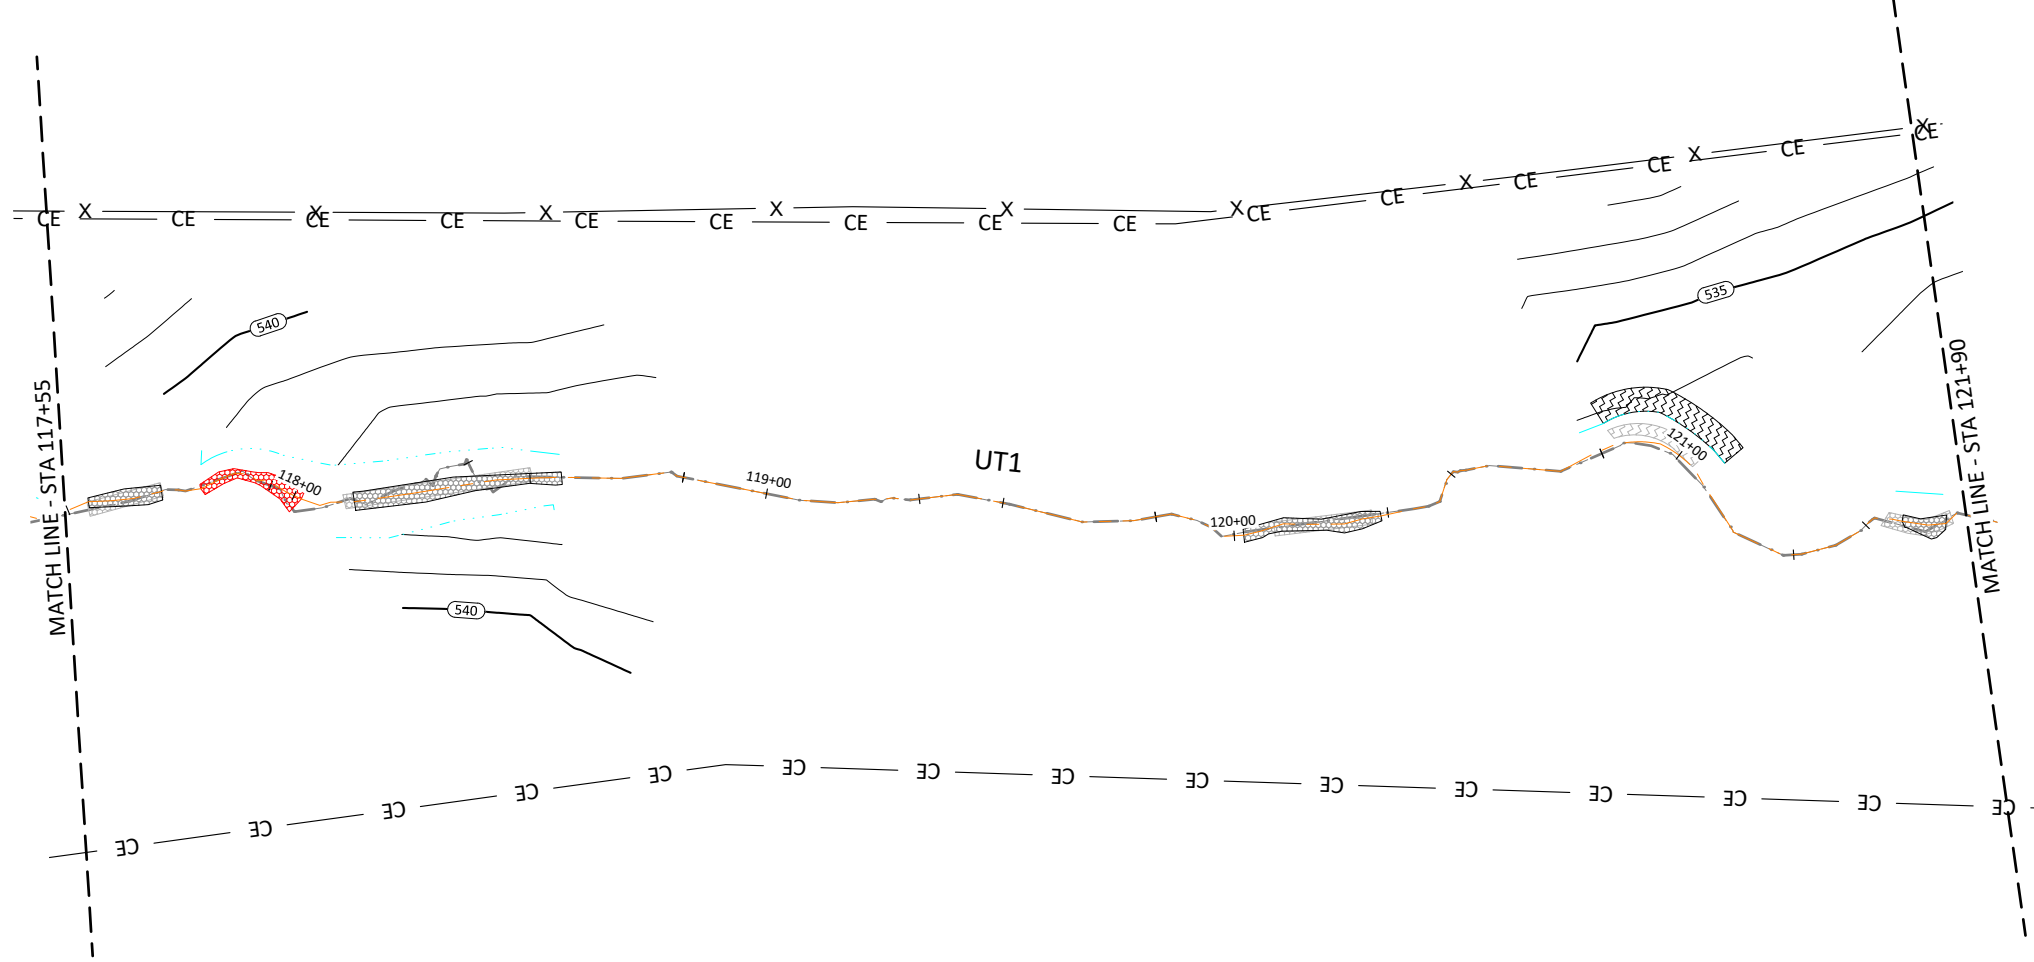
NOTE: 1. AT STATION 117+90, CONSTRUCTED RIFFLE WAS INSTALLED FOR GRADE STABILIZATION.

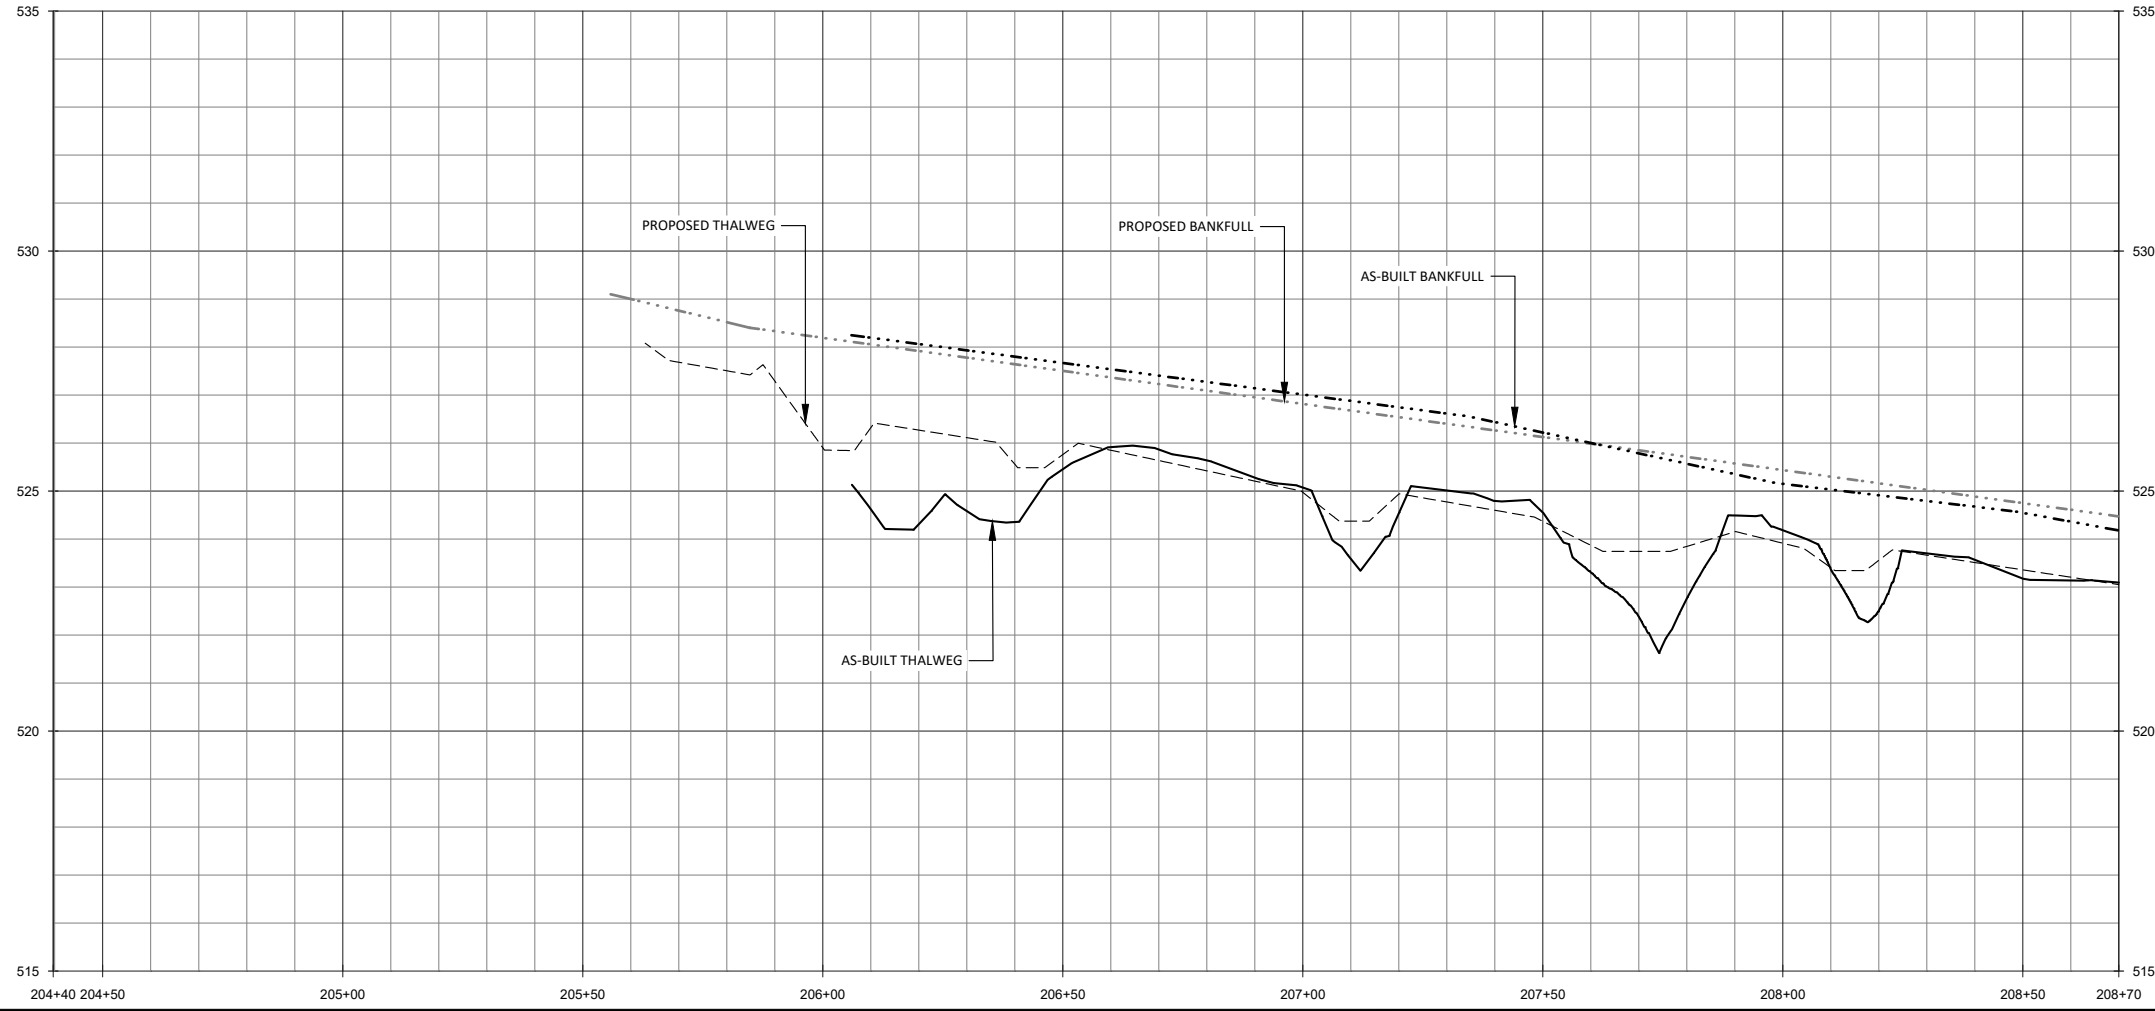
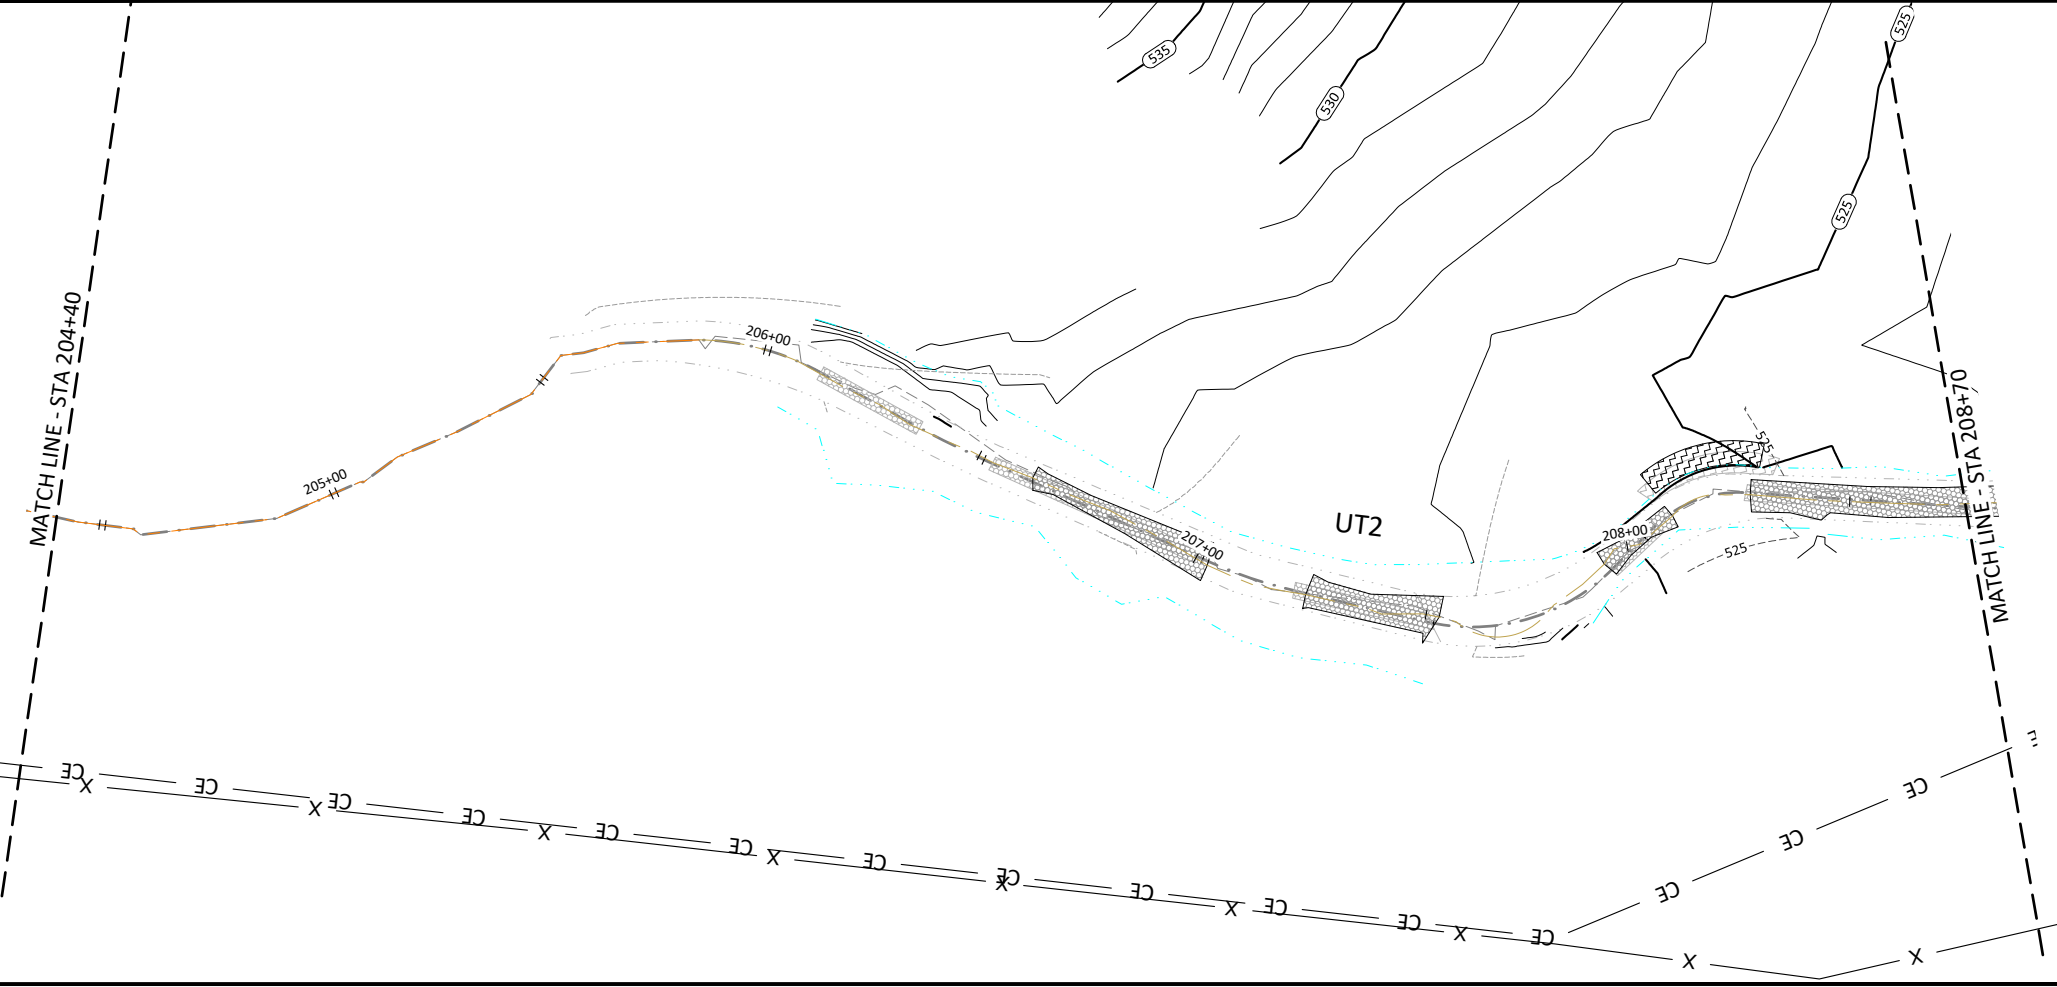
NOTE: 1. AT STATION 206+25, CONSTRUCTED RIFFLE WAS NOT INSTALLED IN ORDER TO ALLOW PLUNGE POOL DOWNSTREAM OF KNICK POINT TO REMAIN.

2. AT STATION 207+50, ANGLED LOG DROP WAS NOT INSTALLED TO AVOID IMPACTS TO EXISTING, MATURE TREES.
