BASELINE MONITORING DOCUMENT AND AS-BUILT BASELINE REPORT

HOLMAN MILL MITIGATION SITE

Alamance County, NC
DEQ Contract 005795
DMS Project Number 96316

Data Collection Period: January 2016 – April 2016
Draft Submission Date: May 20, 2016
Final Submission Date: November 2, 2016

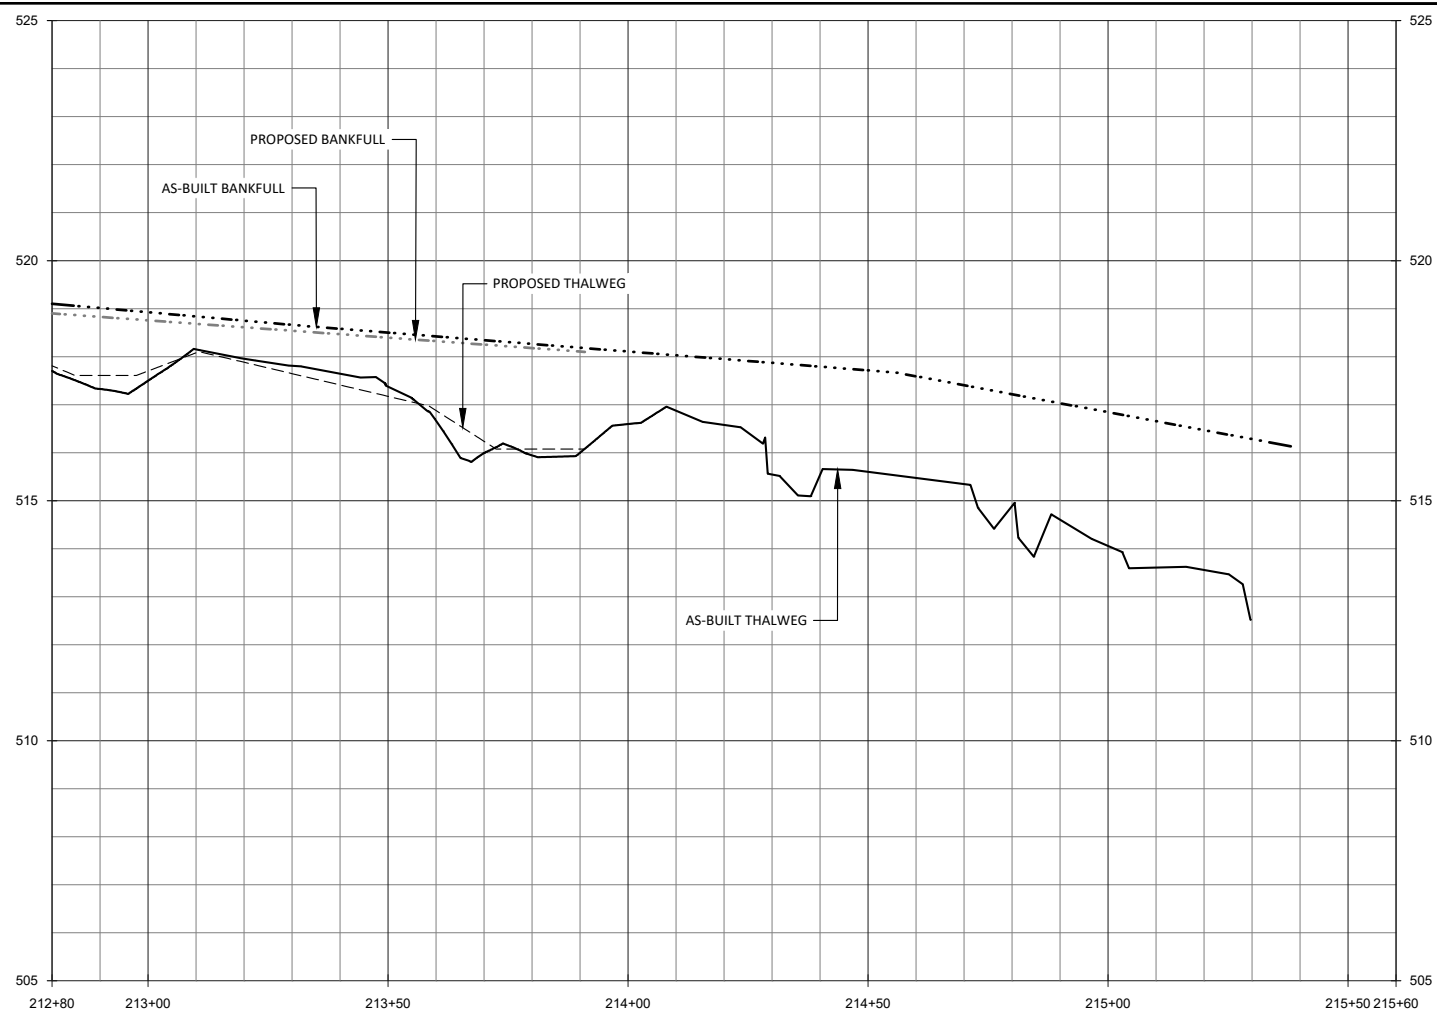
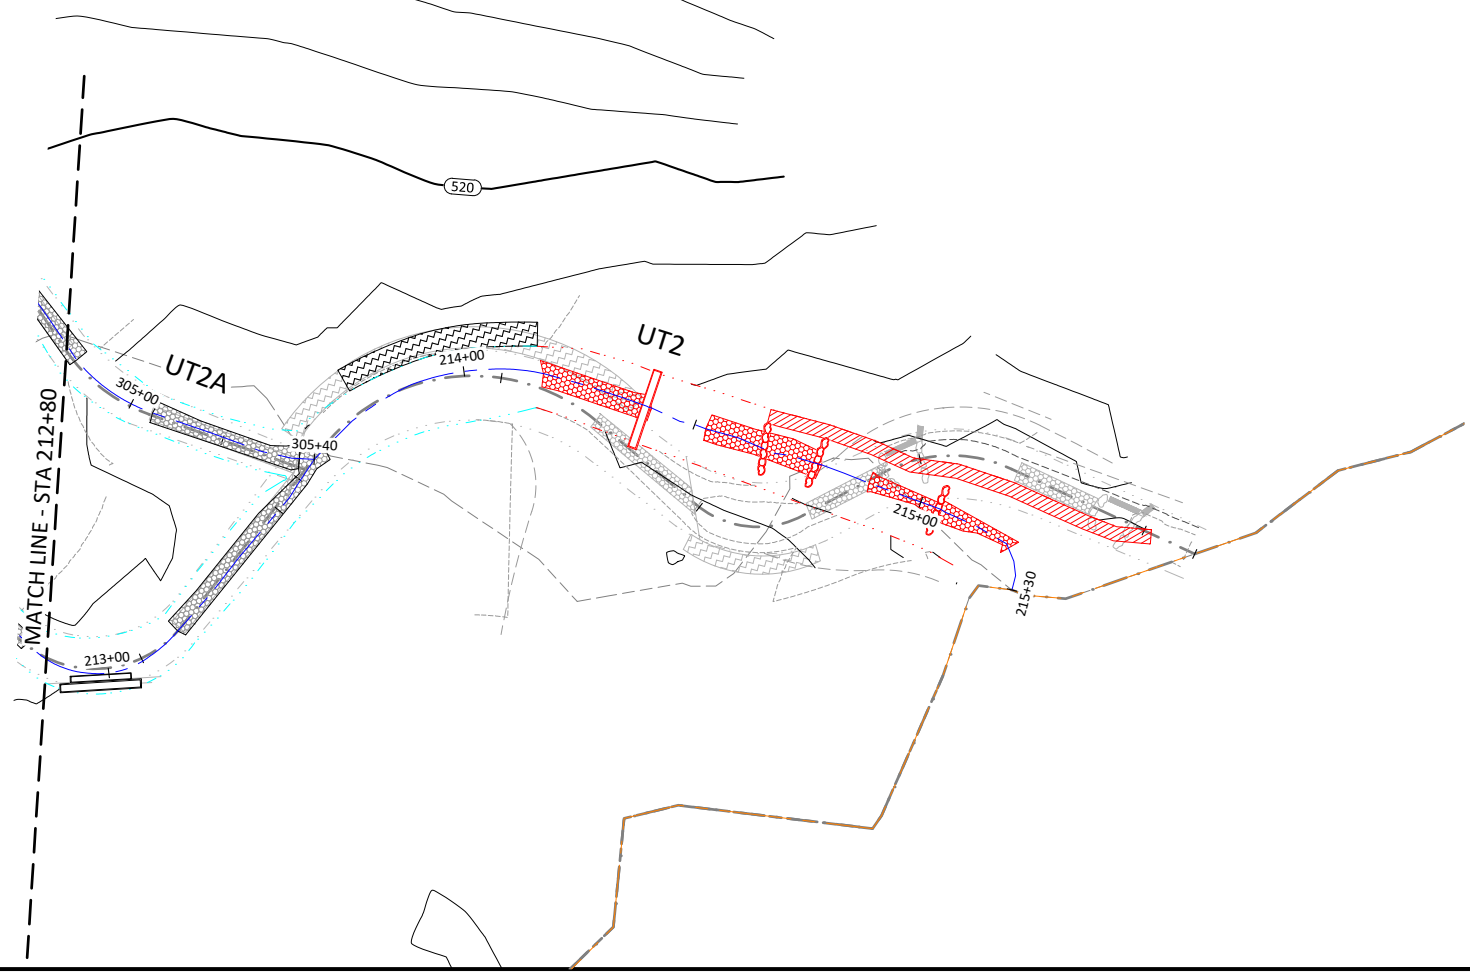
NOTE: 1. AT STATION 213+90, ALIGNMENT CHANGED TO AVOID IMPACTS TO EXISTING, MATURE TREES AND TO AVOID IMPACTING ERODED BANKS THAT HAD FORMED ON RIGHT BANK OF UT TO PINE HILL BRANCH.

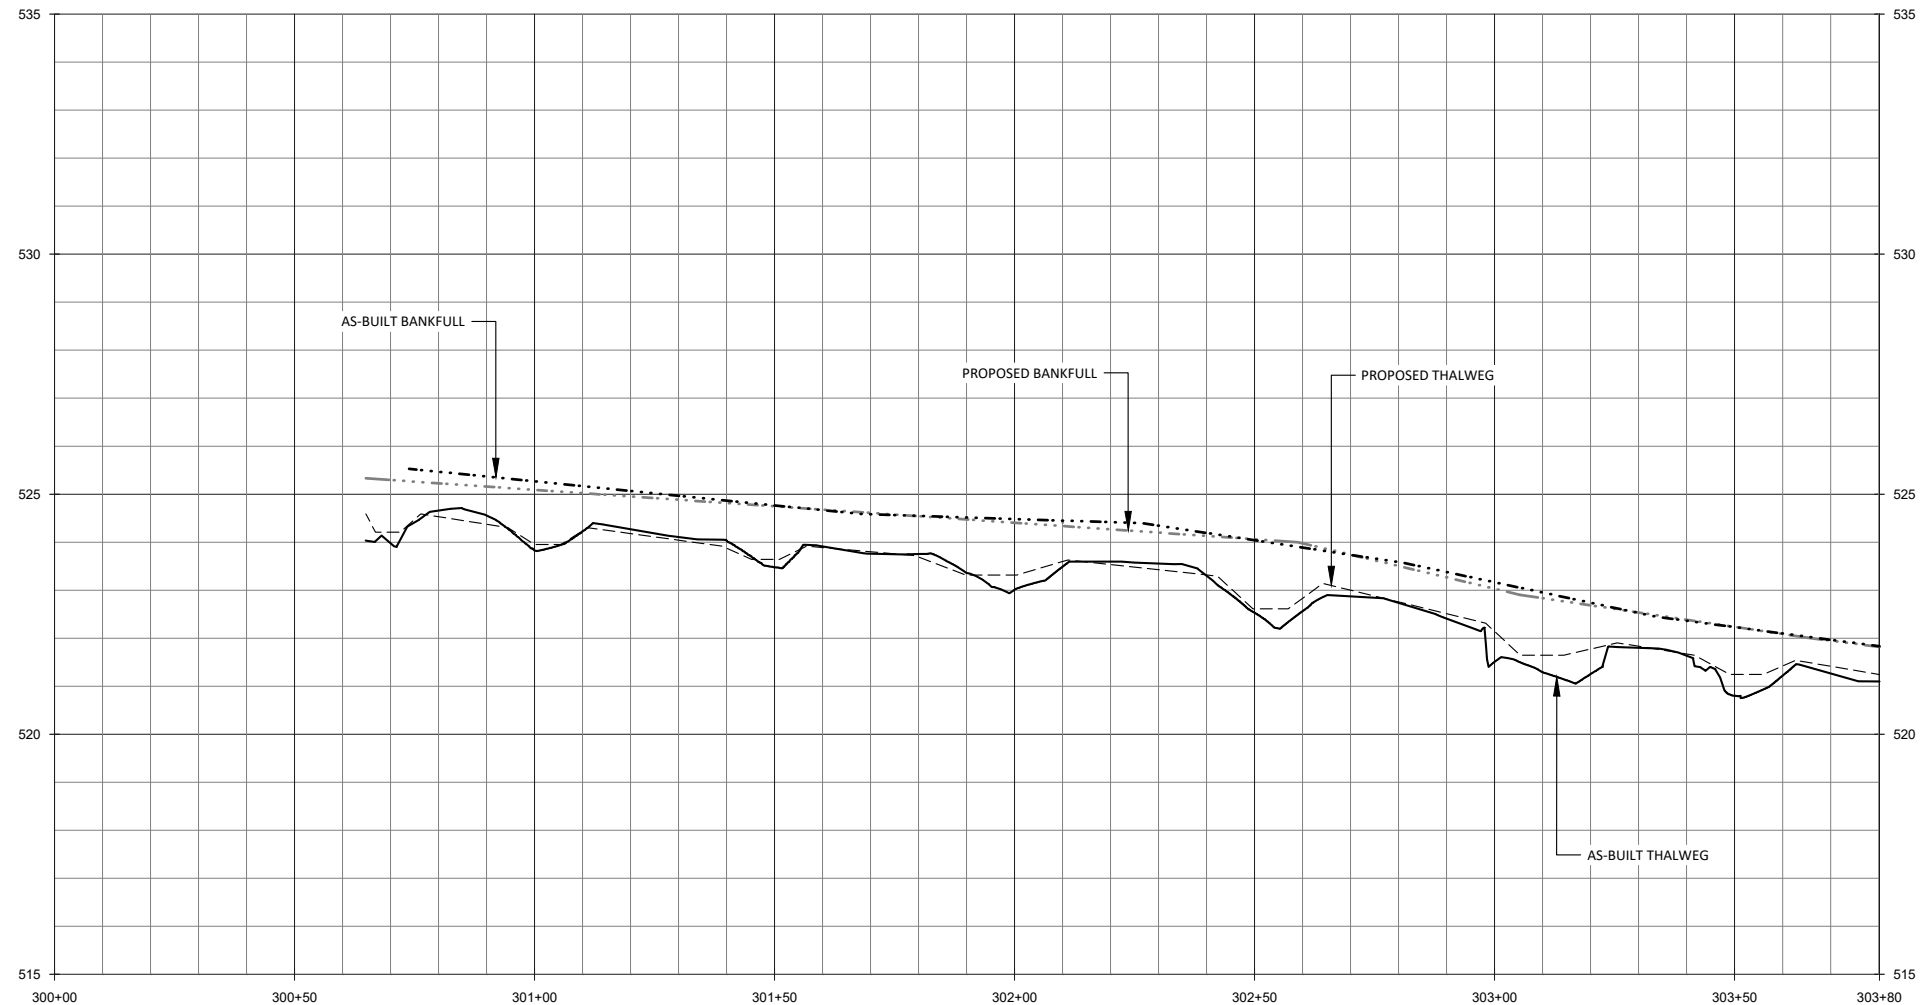
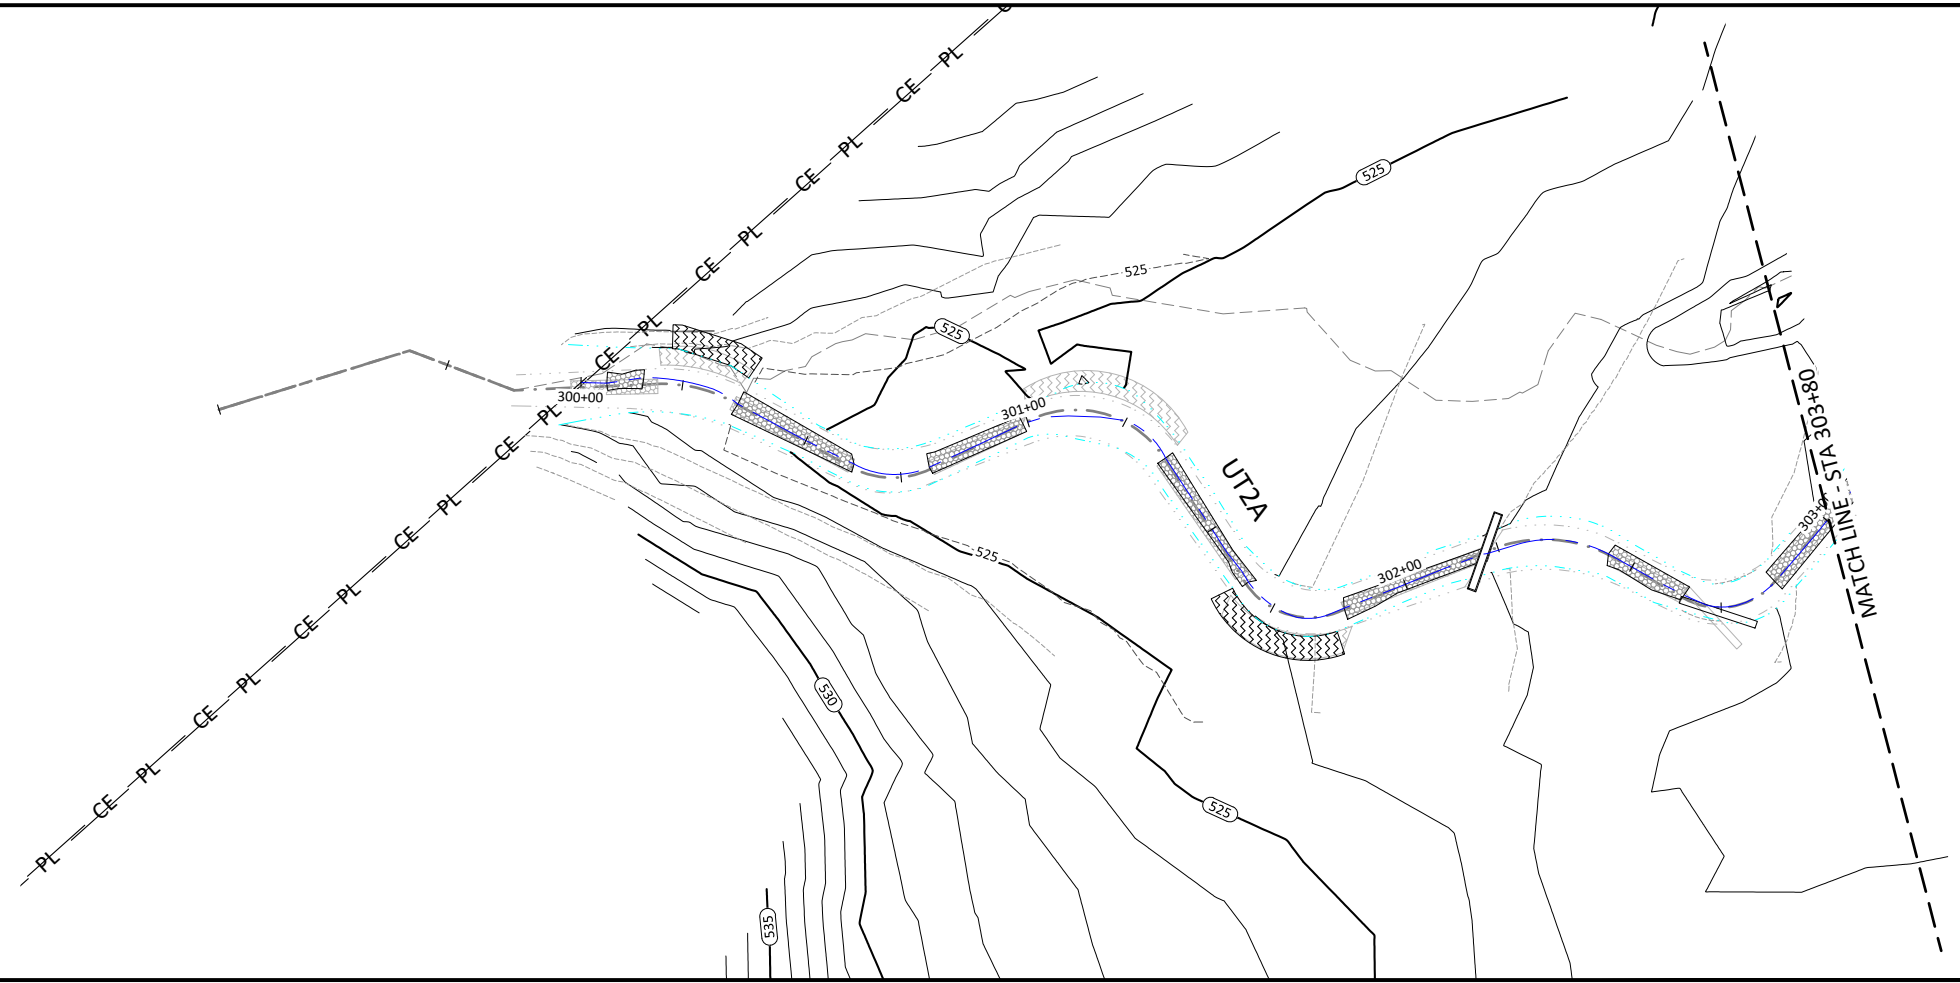
NOTE: 1. AT STATION 301+15, BRUSH TOE
WAS NOT INSTALLED IN ORDER TO
AVOID IMPACTS TO EXISTING,
MATURE TREES.
