MONITORING YEAR 2 ANNUAL REPORT

HOLMAN MILL MITIGATION SITE

Alamance County, NC
NCDEQ Contract 005795
DMS ID No. 96316

Data Collection Period: January - October 2017
Draft Submission Date: November 14, 2017
Final Submission Date:

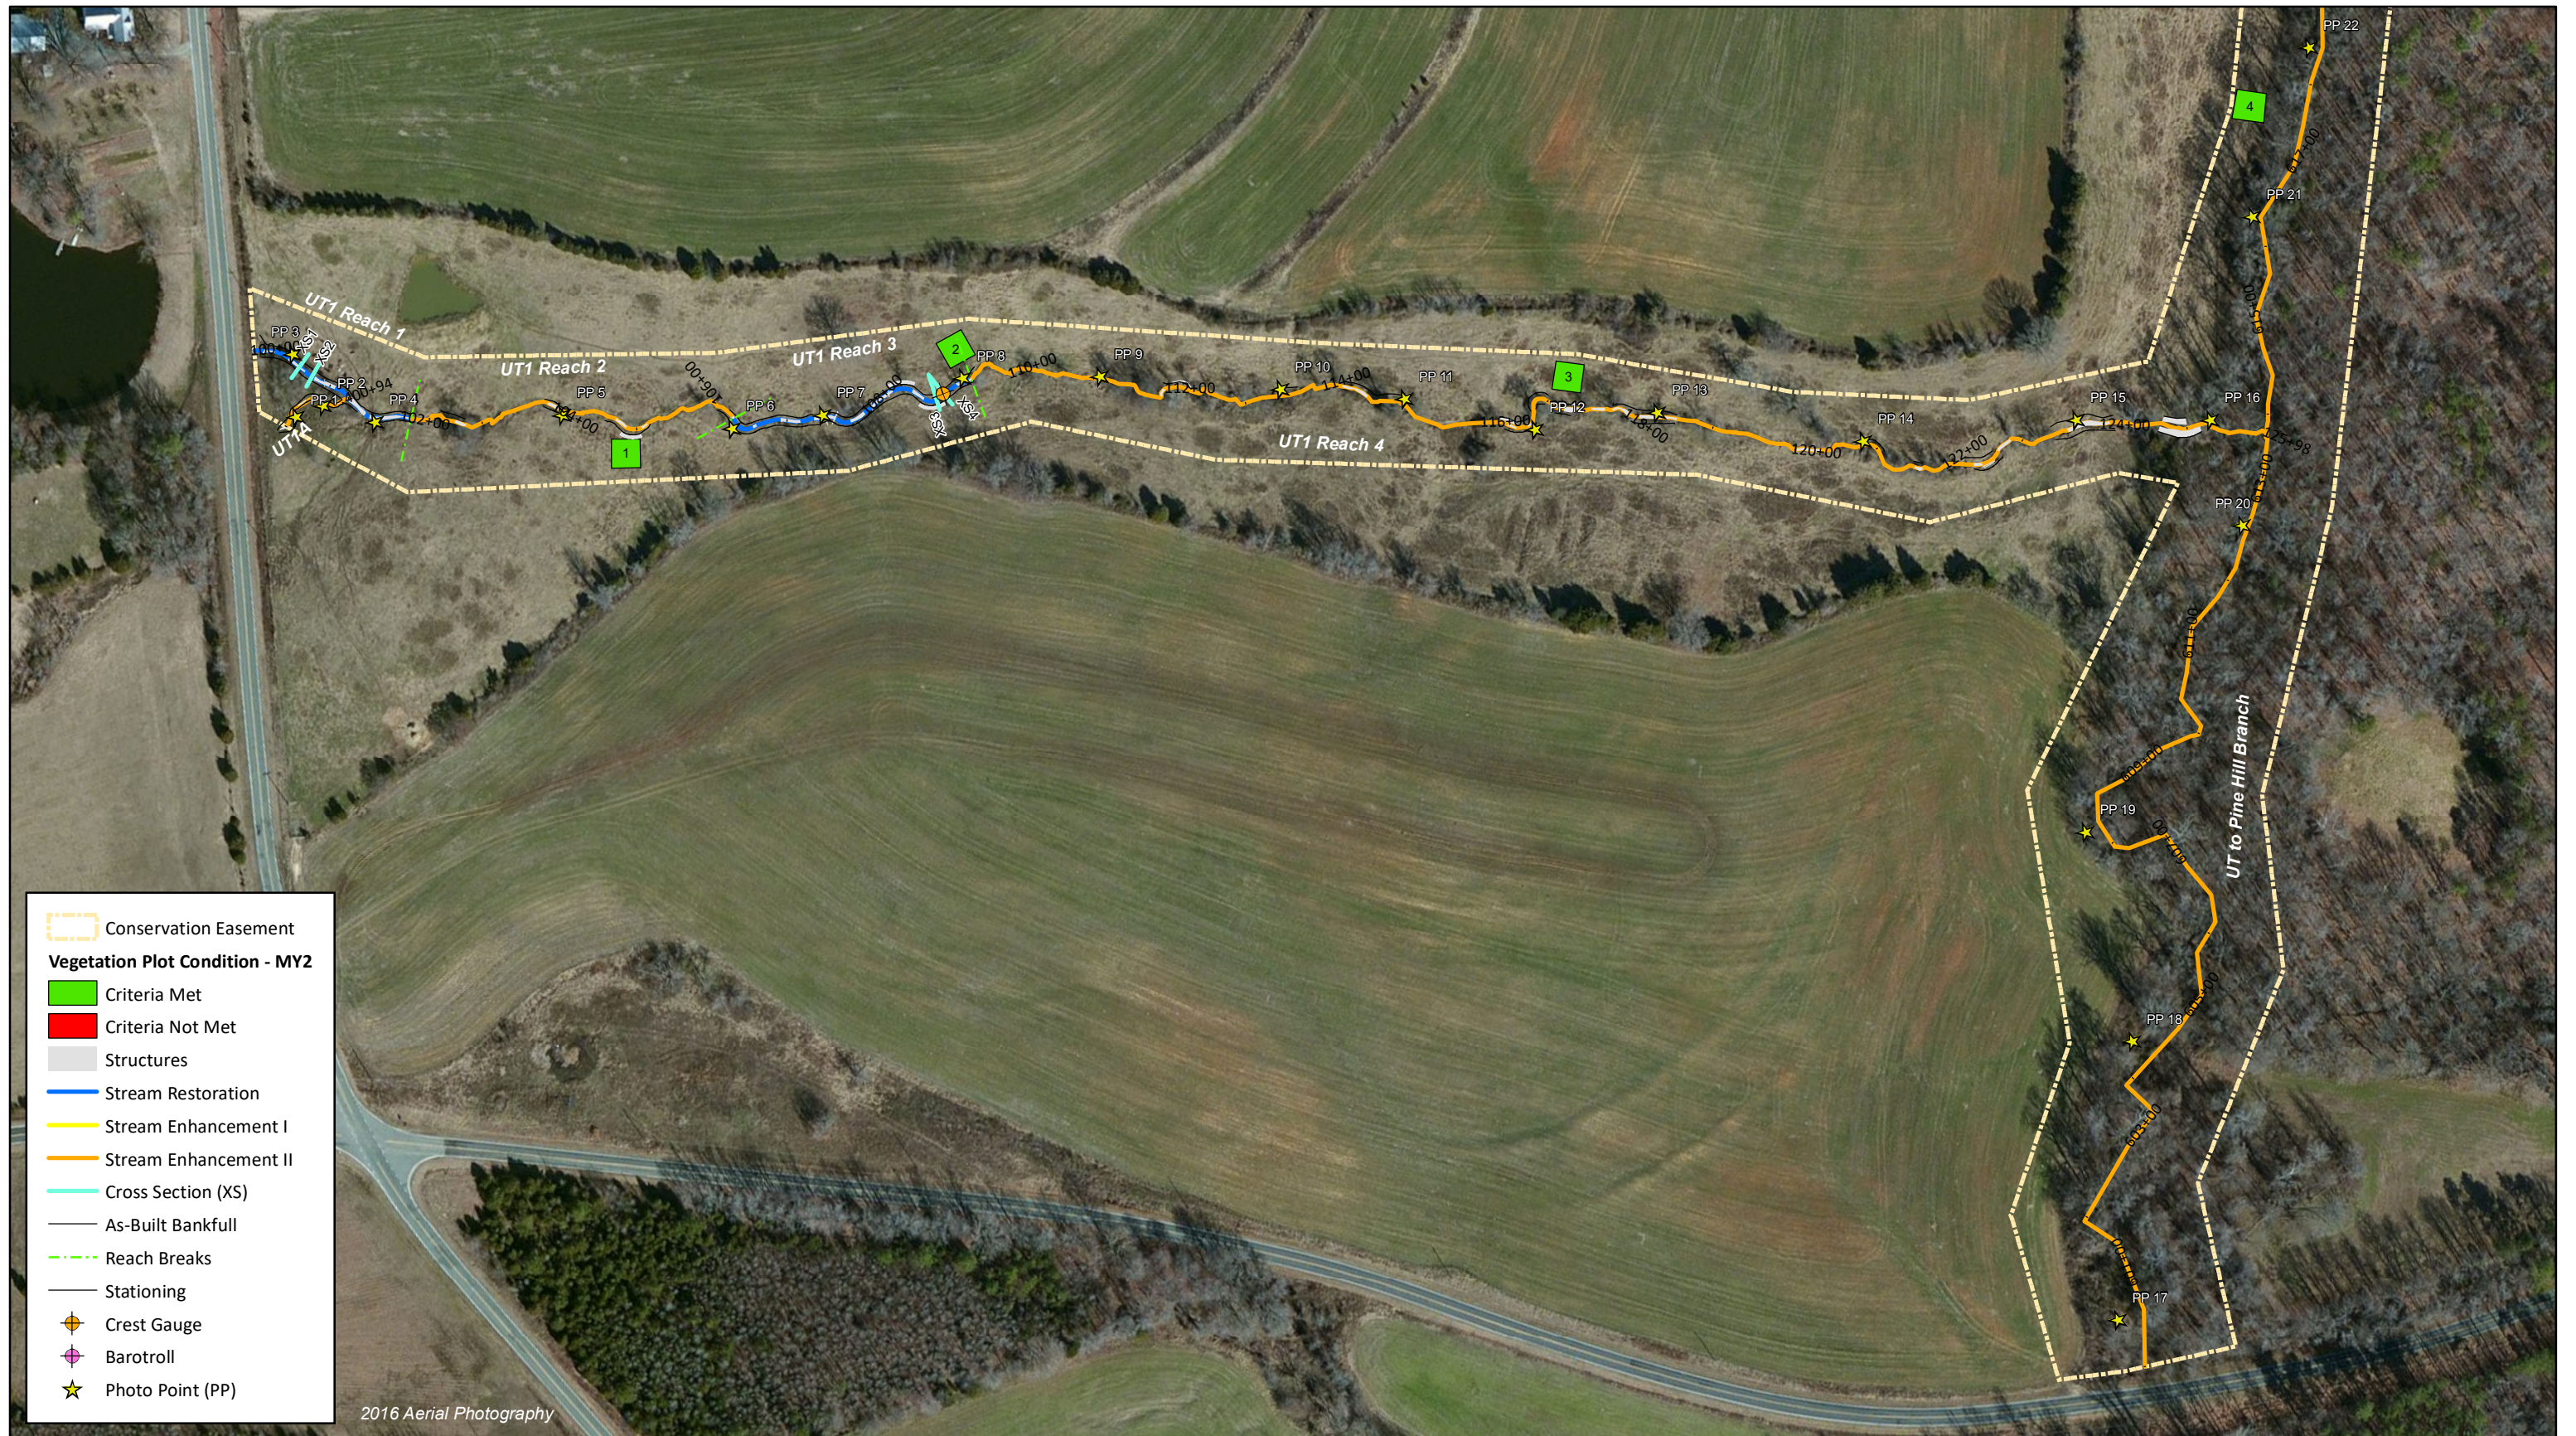
Figure 3.1 Integrated Current Condition Plan View
 Holman Mill Mitigation Site
 DMS Project No. 96316
 Monitoring Year 2 - 2017

Vegetation plot 12 will not meet the MY3 interim success criteria of 320 planted stems per acre. The primary reason for this plot not meeting is due to the poor survival rates of tulip poplar (*Liriodendron tulipifera*) of which comprised five of the fifteen trees planted in this plot. All five tulip poplars were either dead or missing during MY2. Additionally, there was significant competition from herbaceous
