MONITORING YEAR 4 ANNUAL REPORT

HOLMAN MILL MITIGATION SITE

Alamance County, NC

DMS Project Number 96316

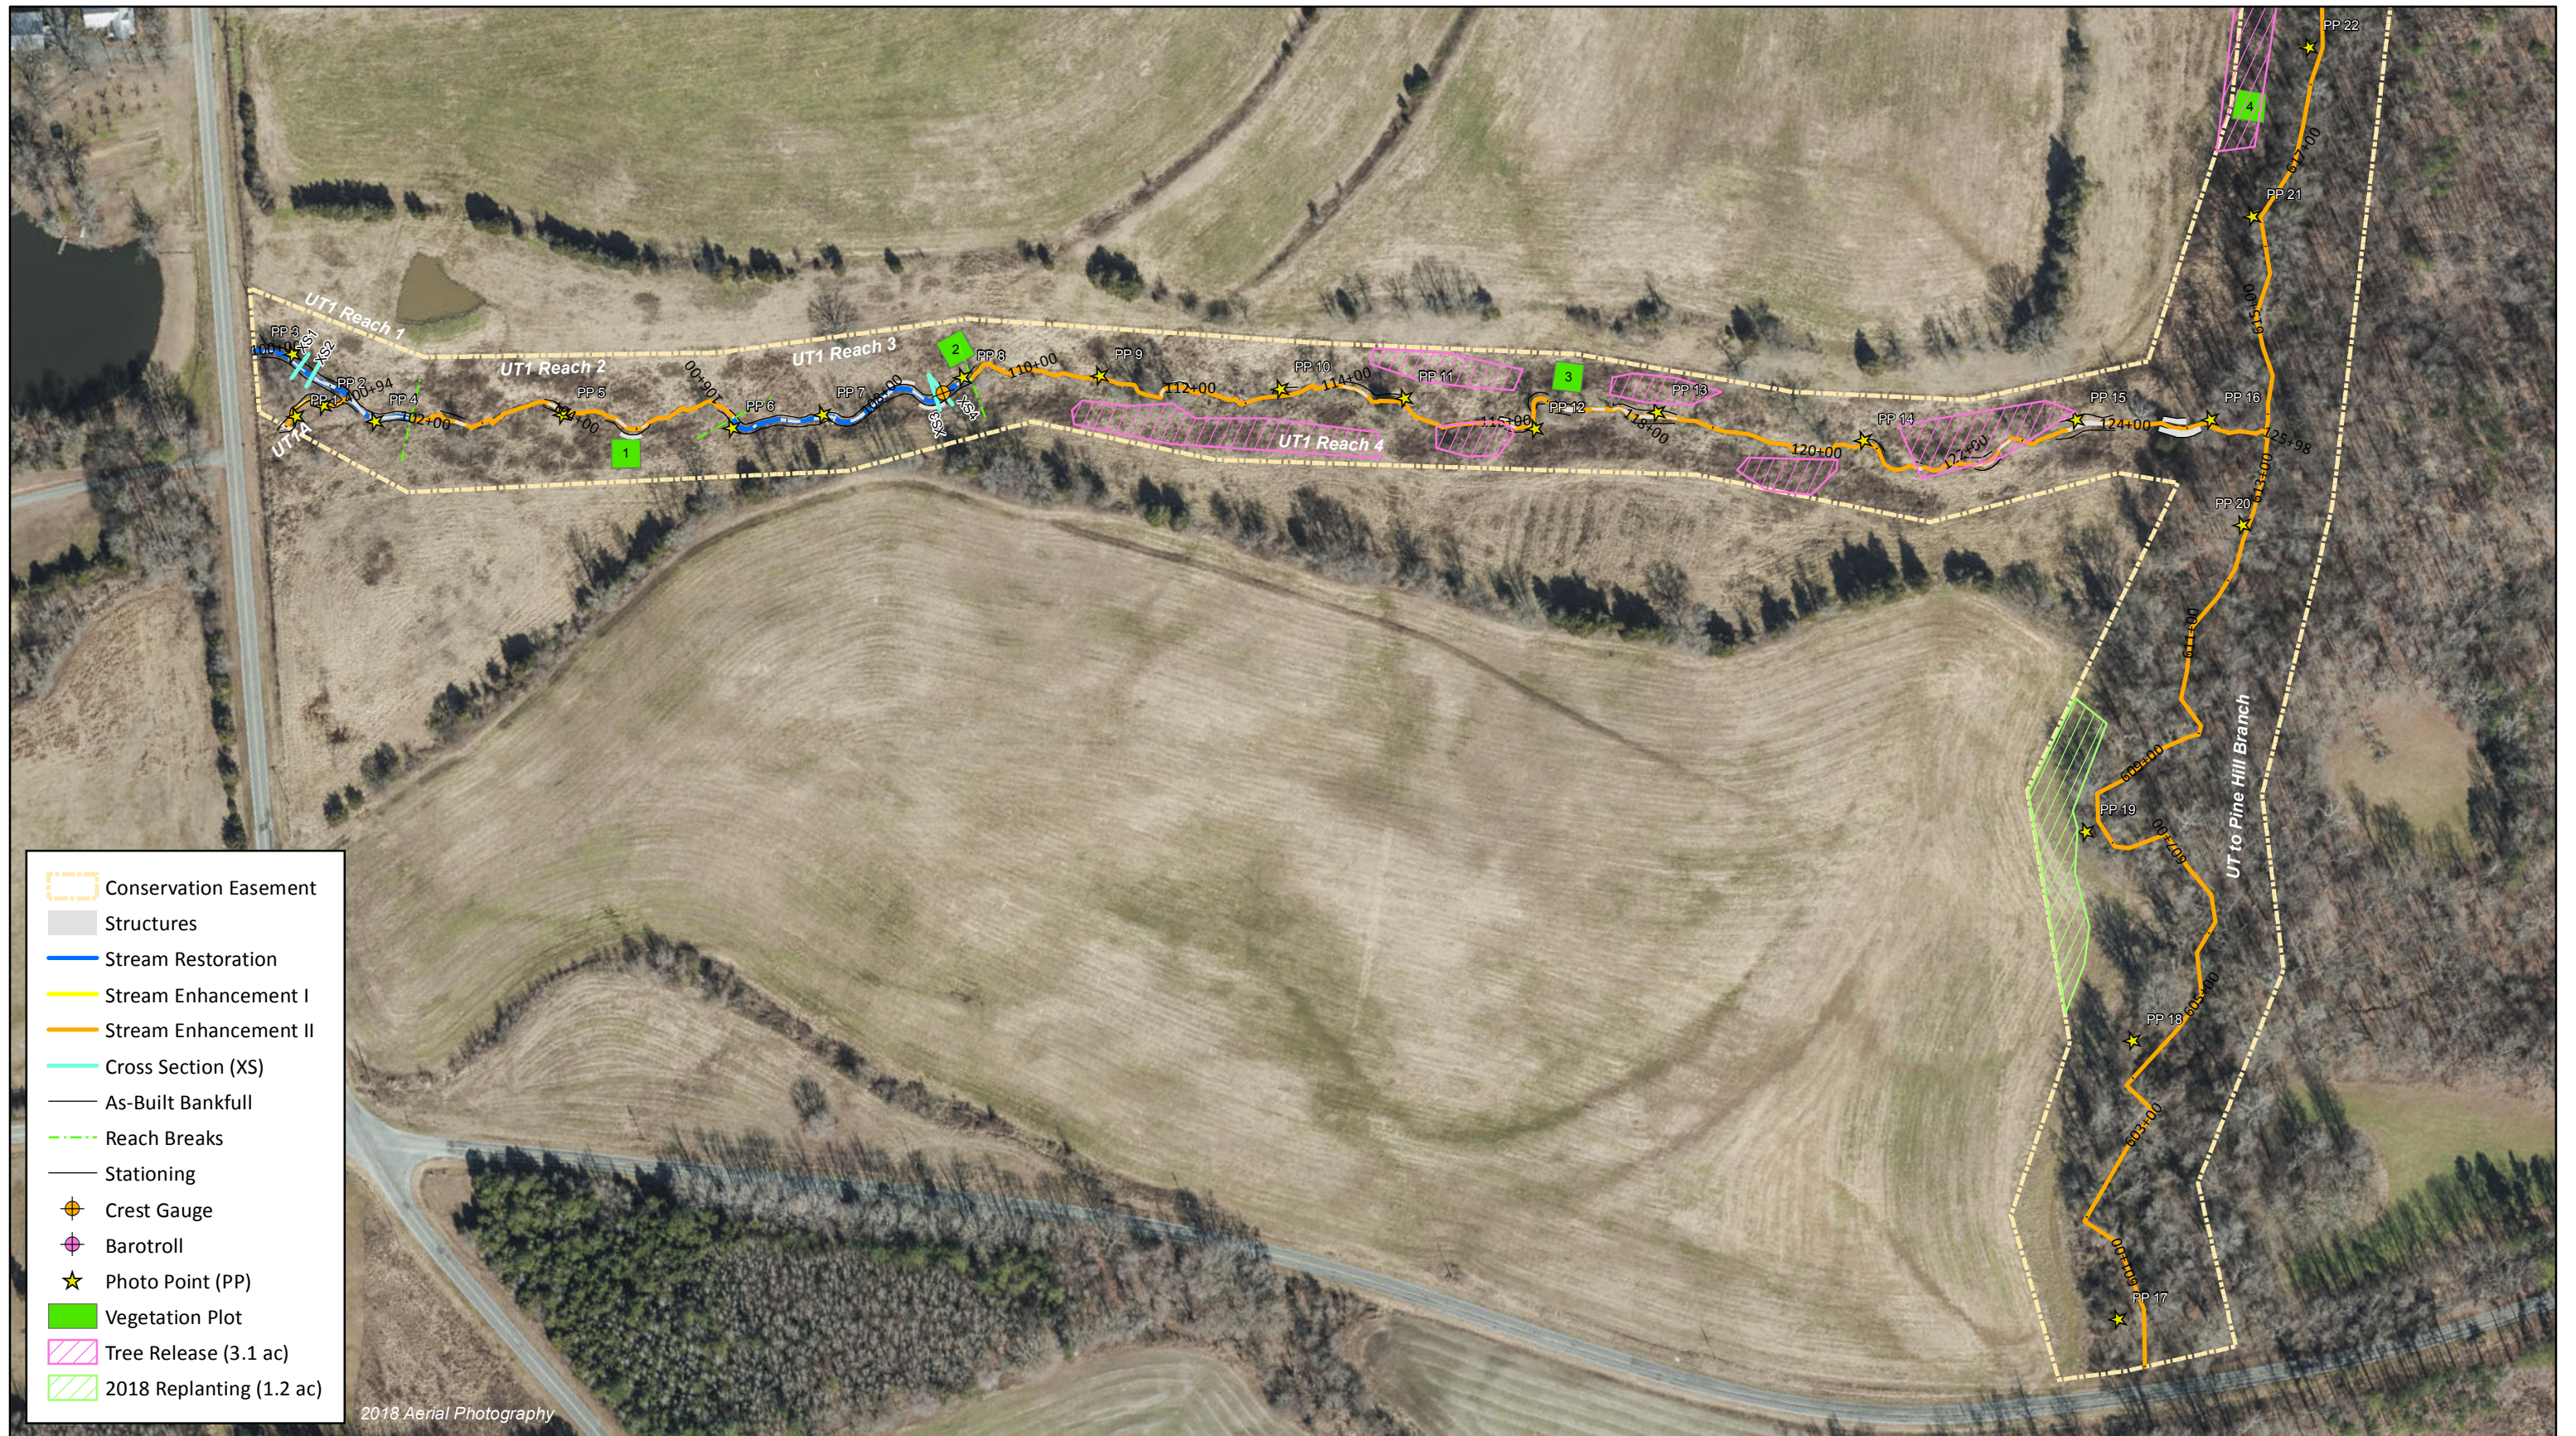
Figure 3.1 Integrated Current Condition Plan View
 Holman Mill Mitigation Site
 DMS Project No. 96316
 Monitoring Year 4 - 2019

Two areas of low stem density identified in MY3 were replanted in December 2018 totaling 1.2 acres (Figure 3.1-3.2). One area is along UT2 Reach 3, and the other is along UT to Pine Hill Branch upstream of its confluence with UT1. A mixture of one-gallon container and bare root green ash (*Fraxinus pennsylvanica*), sycamore (*Platanus occidentalis*), river birch (*Betula nigra*), swamp chestnut oak (*Quercus michauxii*), and willow oak (*Quercus phellos*) were planted at a density of 204 stems per acre. Visual monitoring will continue to assess the survivability of the supplemental planting.

Blackberry (*Rubus occidentalis*), Japanese honeysuckle (*Lonicera japonica*), and coralberry (*Symphoricarpos orbiculatus*) were observed overcrowding the planted trees throughout the Site and stunting their growth (Figure 3.1-3.2). A mechanical and chemical tree release was performed in April 2019 on 3.1 acres throughout the Site. Trees have thrived in the areas where the tree release was performed. Visual monitoring will continue to assess the health of the planted trees.

As described above in Section 1.2.2 additional trees were planted during the winter of 2018 in two low stem density areas shown on the CCPV Maps (Figure 3.1-3.2). Blackberry, Japanese honeysuckle, coralberry, and sweetgum were mechanically and chemically treated on site. Visual monitoring will continue to assess the health and density of the planted trees throughout the Site.

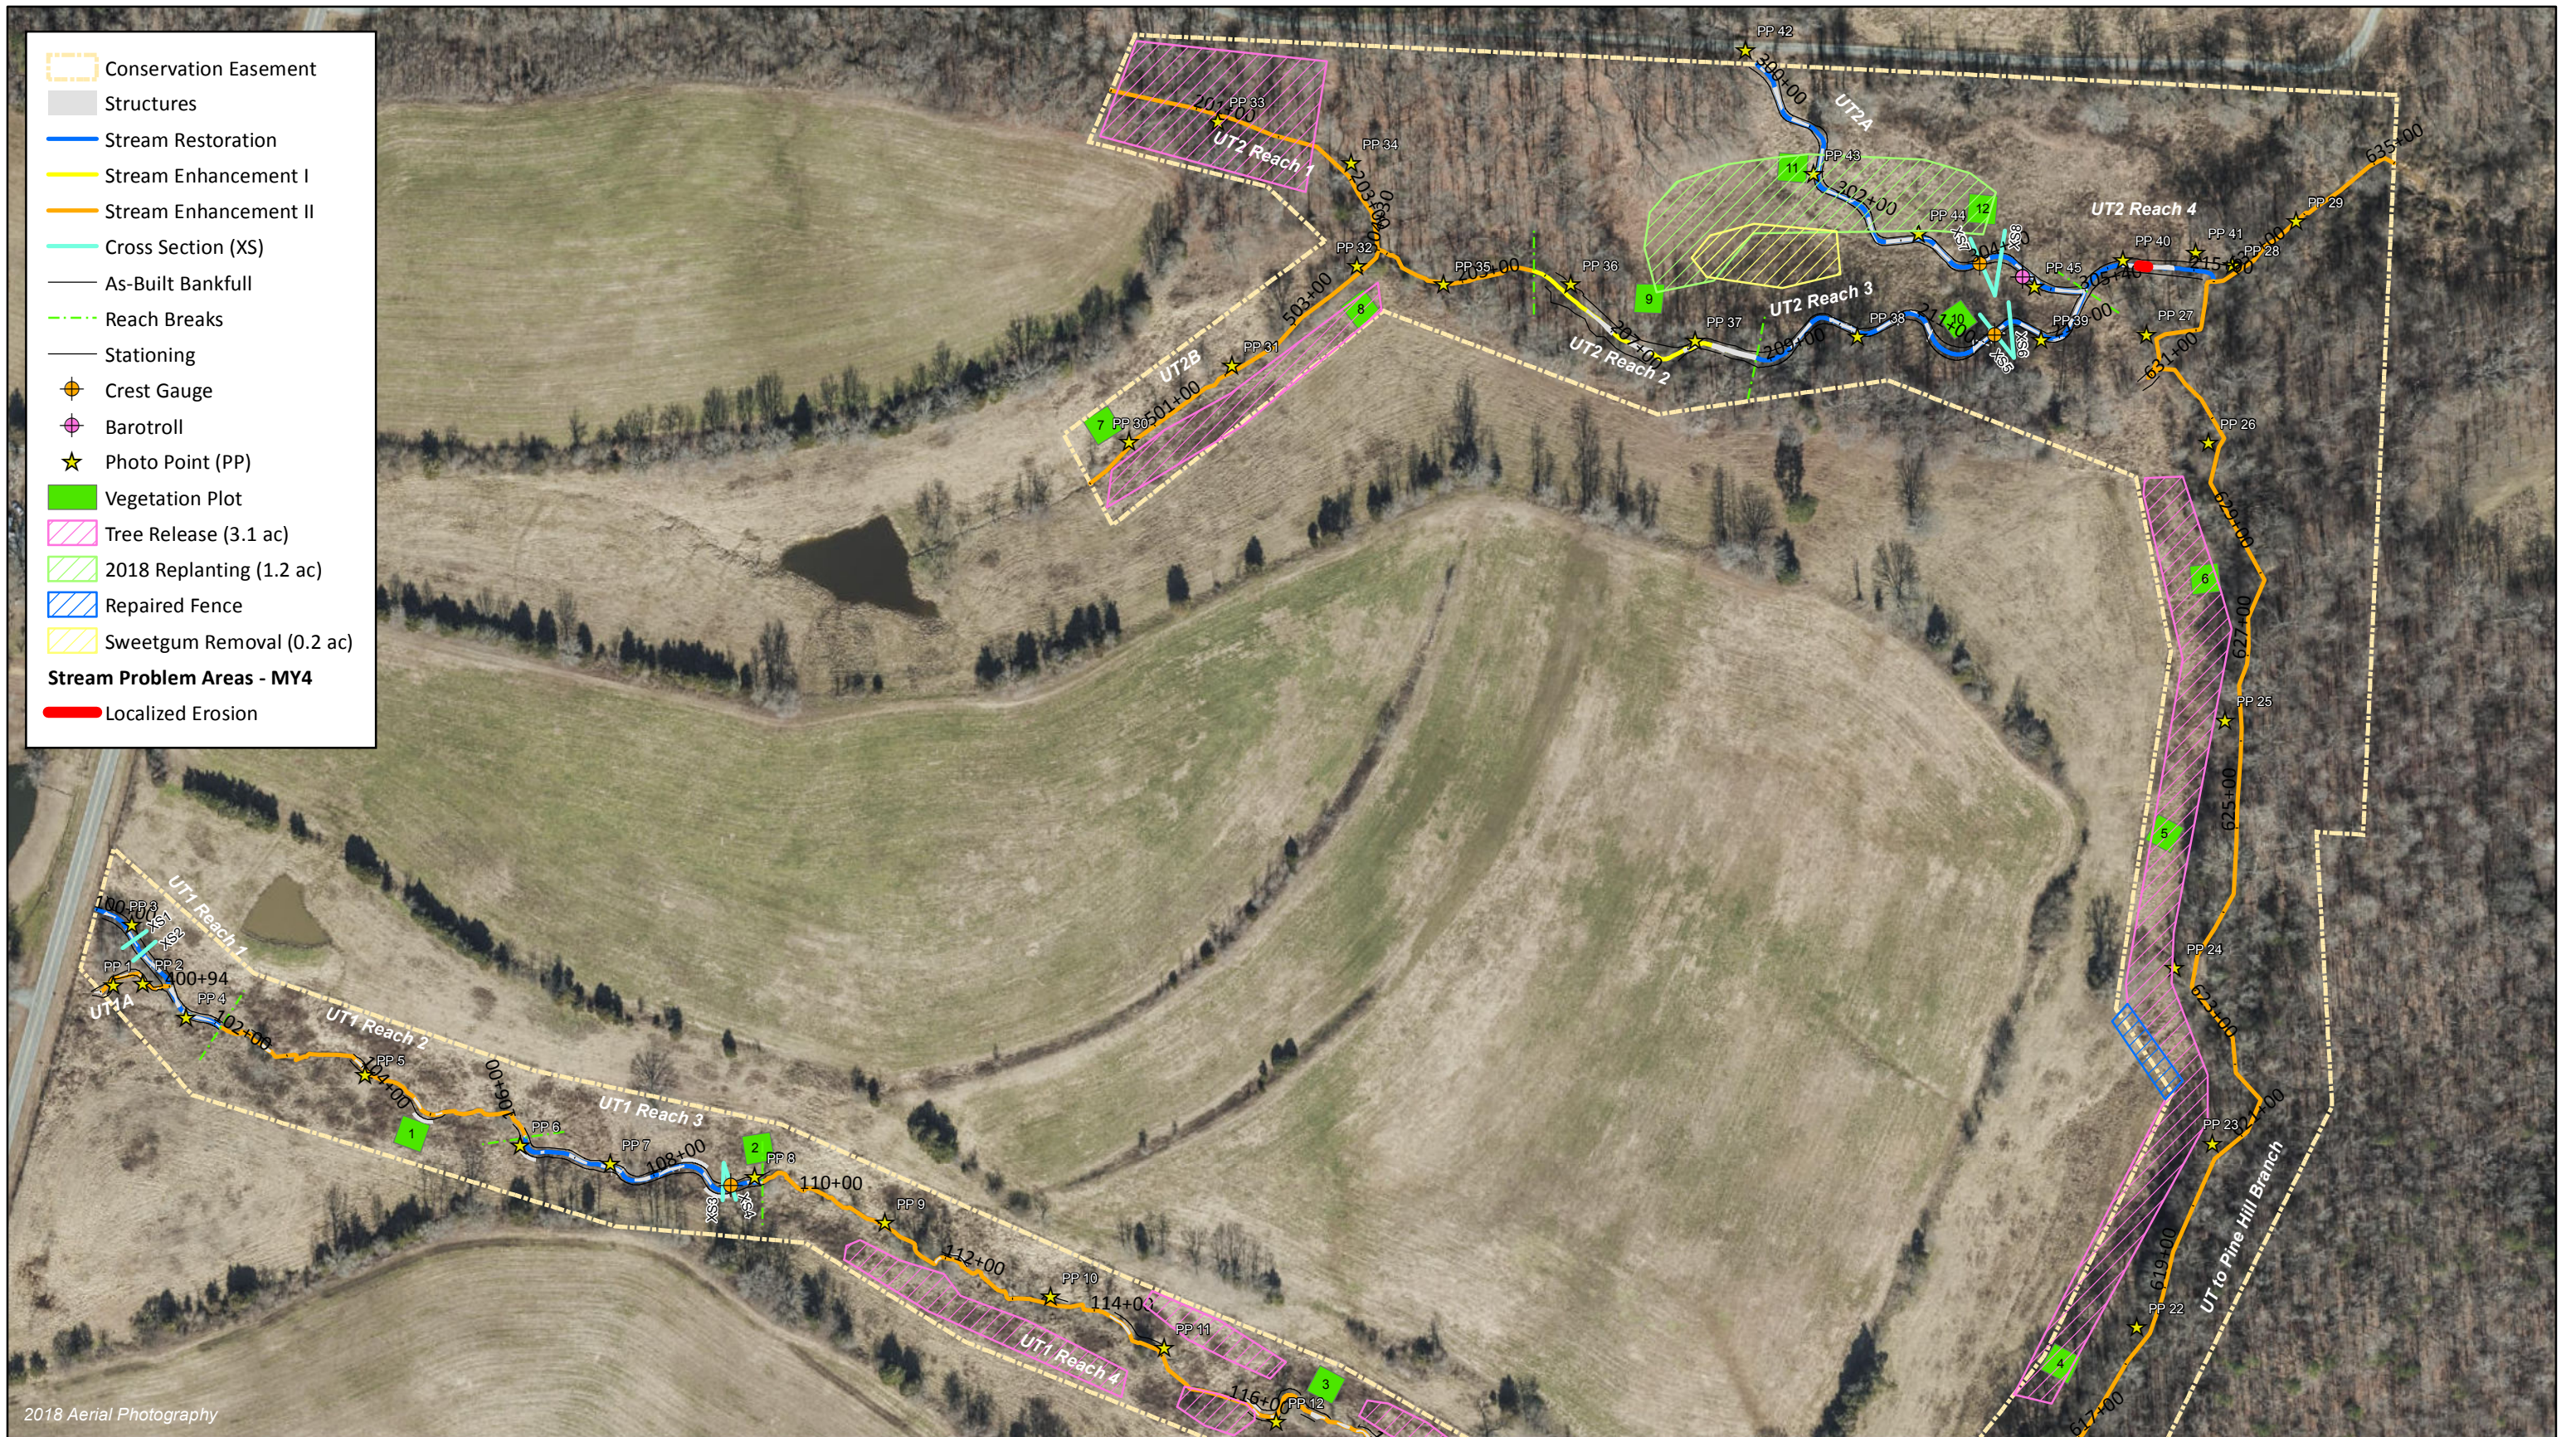
Figure 3.2 Integrated Current Condition Plan View
 Holman Mill Mitigation Site
 DMS Project No. 96316
 Monitoring Year 4 - 2019

A high-density area of sweetgum (*Liquidambar styraciflua*) along UT2 Reach 3 was identified in MY3 totaling 0.2 acres (Figure 3.2). This area was mechanically and chemically treated in April 2019 and will continued to be visually monitored for sweetgums.

Localized erosion was observed around one log sill affecting the downstream pool between stations 214+35 and 214+50 on UT2 Reach 4 (Figure 3.2). The length of channel affected by the scour is approximately 15 linear feet. This area will continue to be monitored and remedial action will be taken if necessary.
